MINERALS PROGRAM INSPECTION REPORT
PHONE: (303) 866-3567

MINE NAME: Rocky Ford South Pit	MINE/PROSPECTING ID#: M-1977-222	MINERAL: Sand and gravel	COUNTY: Otero
INSPECTION TYPE: Monitoring	INSPECTOR(S): Amy Eschberger	INSP. DATE: May 31, 2018	INSP. TIME: 10:50
OPERATOR: All-Rite Paving & Redi-Mix, Inc.	OPERATOR REPRESENTATIVE: Herb Pearson	TYPE OF OPERATION: 112c - Construction Regular Operation	
REASON FOR INSPECTION: Normal I&E Program	BOND CALCULATION TYPE: None	BOND AMOUNT: \$85,500.00	
DATE OF COMPLAINT: NA	POST INSP. CONTACTS: None	JOINT INSP. AGENCY: None	
WEATHER: Clear	INSPECTOR'S SIGNATURE:

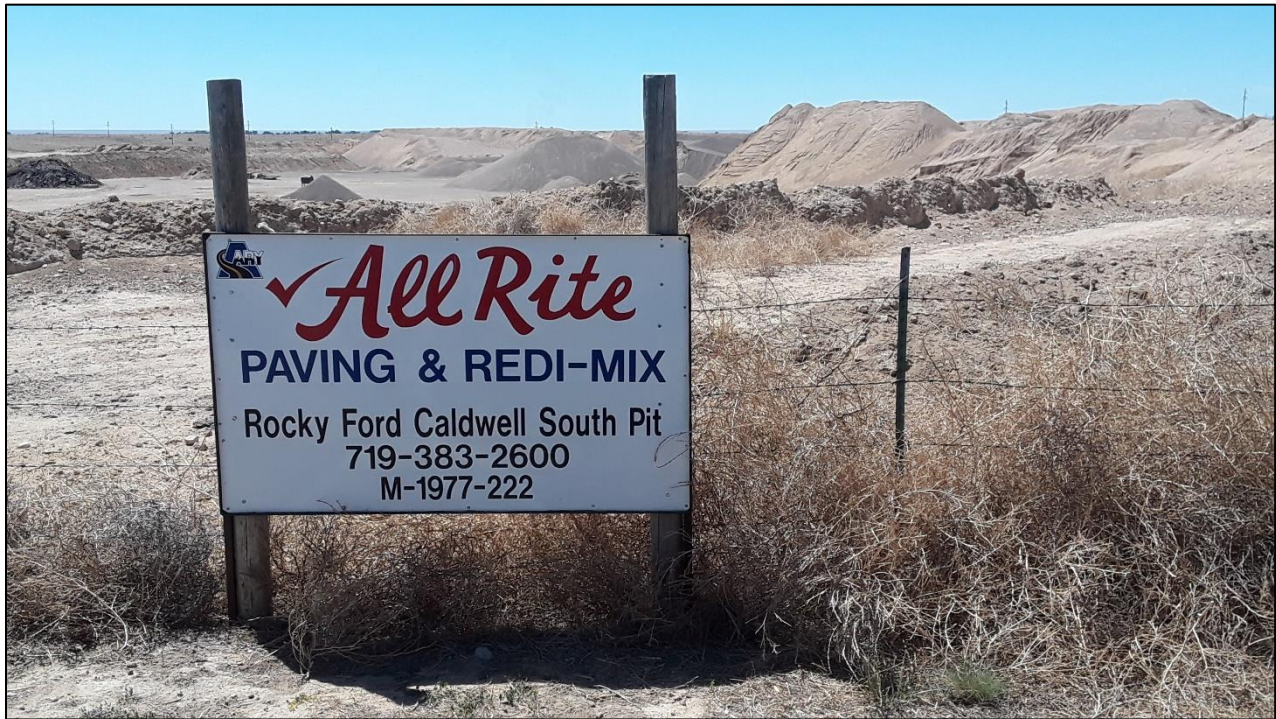
Photo 1. View of permit sign posted at main site entrance off Co Rd 18.

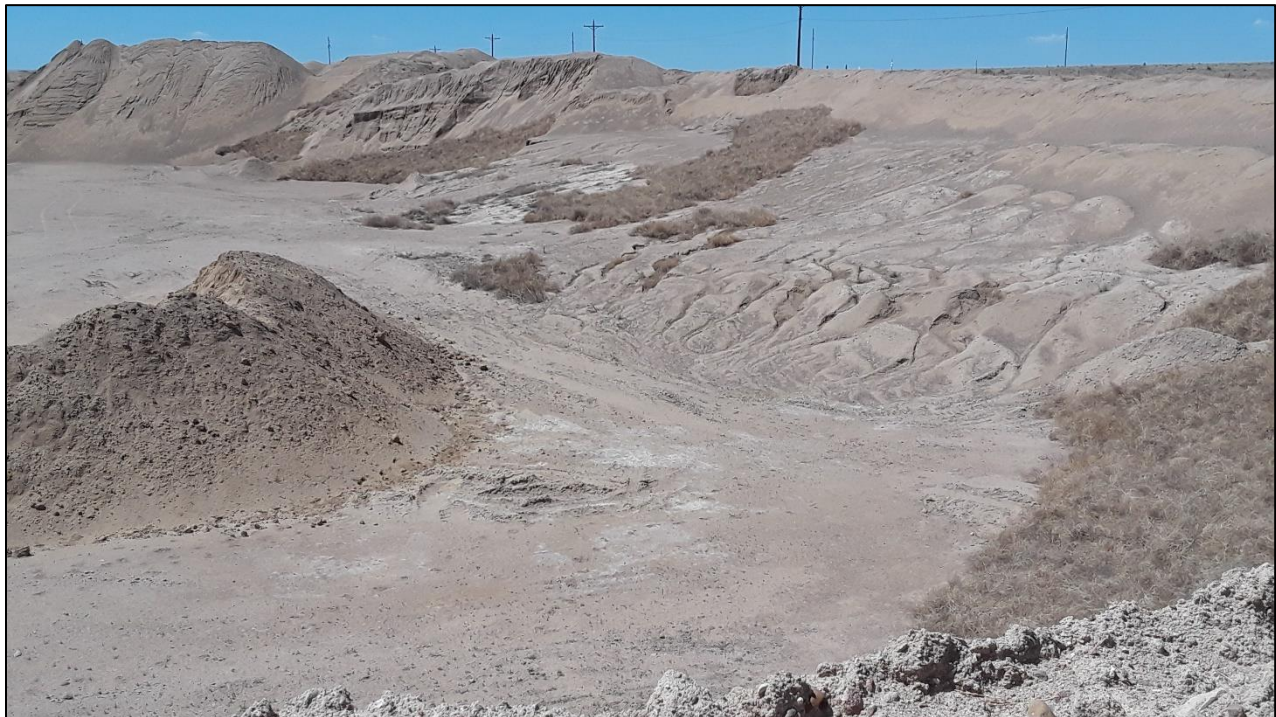
Photo 2. View looking south across western pit wall, showing slopes graded to 3H:1V or flatter.

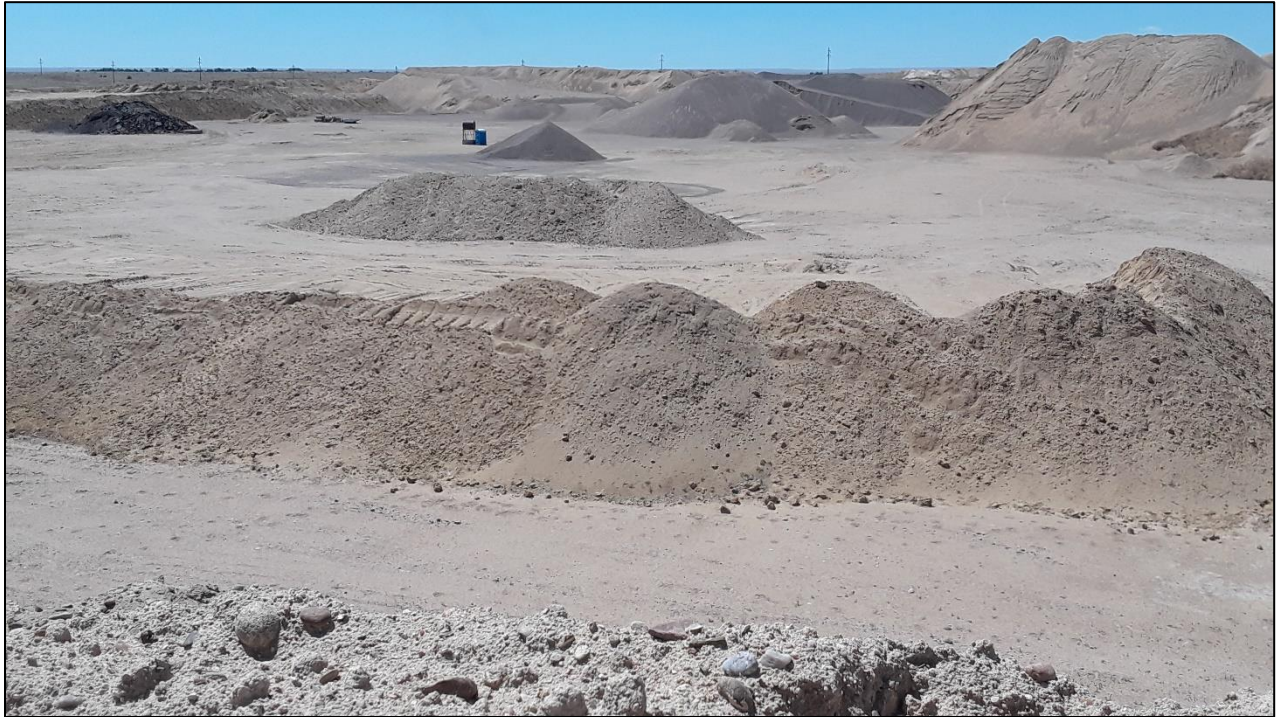
Photo 3. View looking southeast across pit, showing material stockpiles of various sizes stored on pit floor.

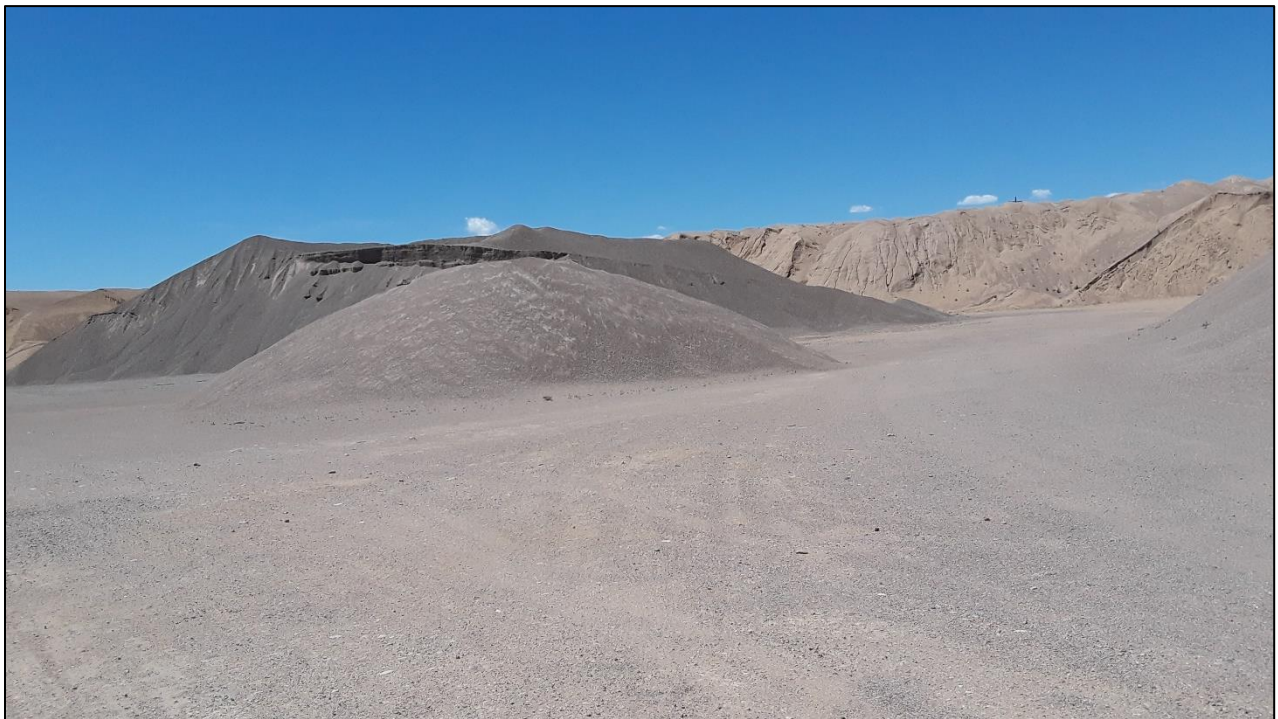
Photo 4. View looking across pit, showing material stored on pit floor.

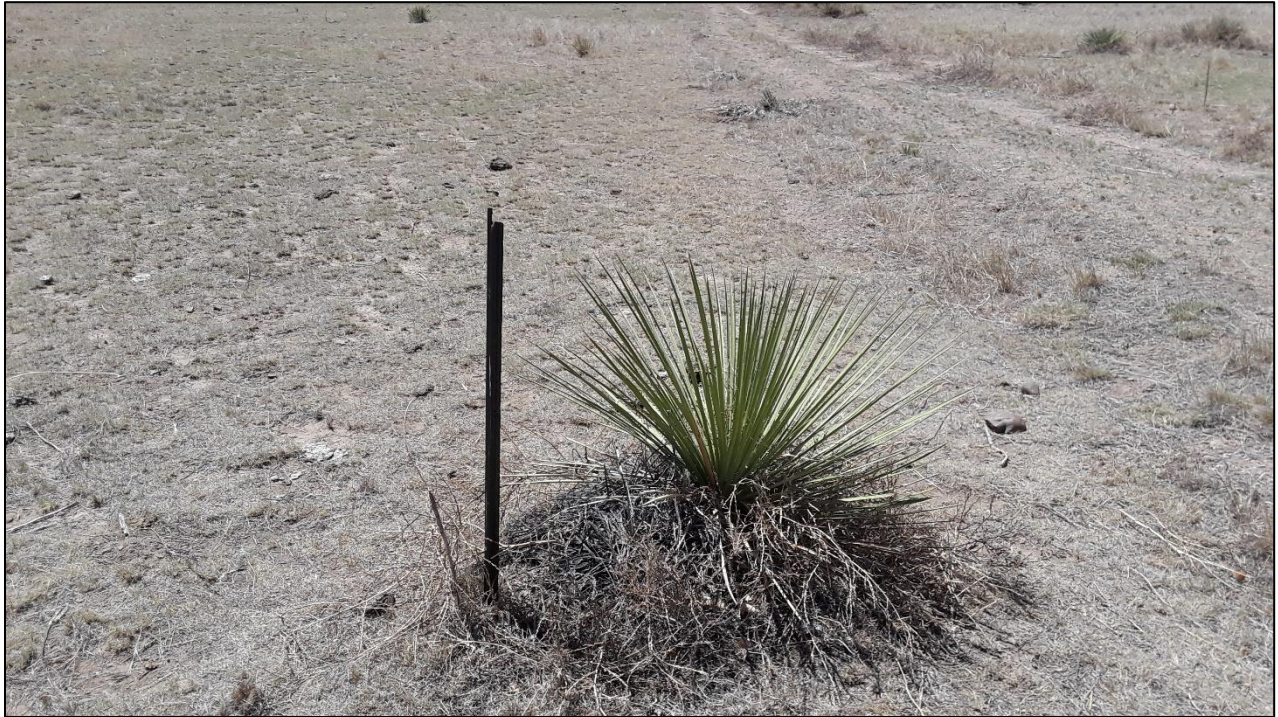
Photo 5. View of t-post marking one of the northeastern corners of the permit boundary (near the main access road).

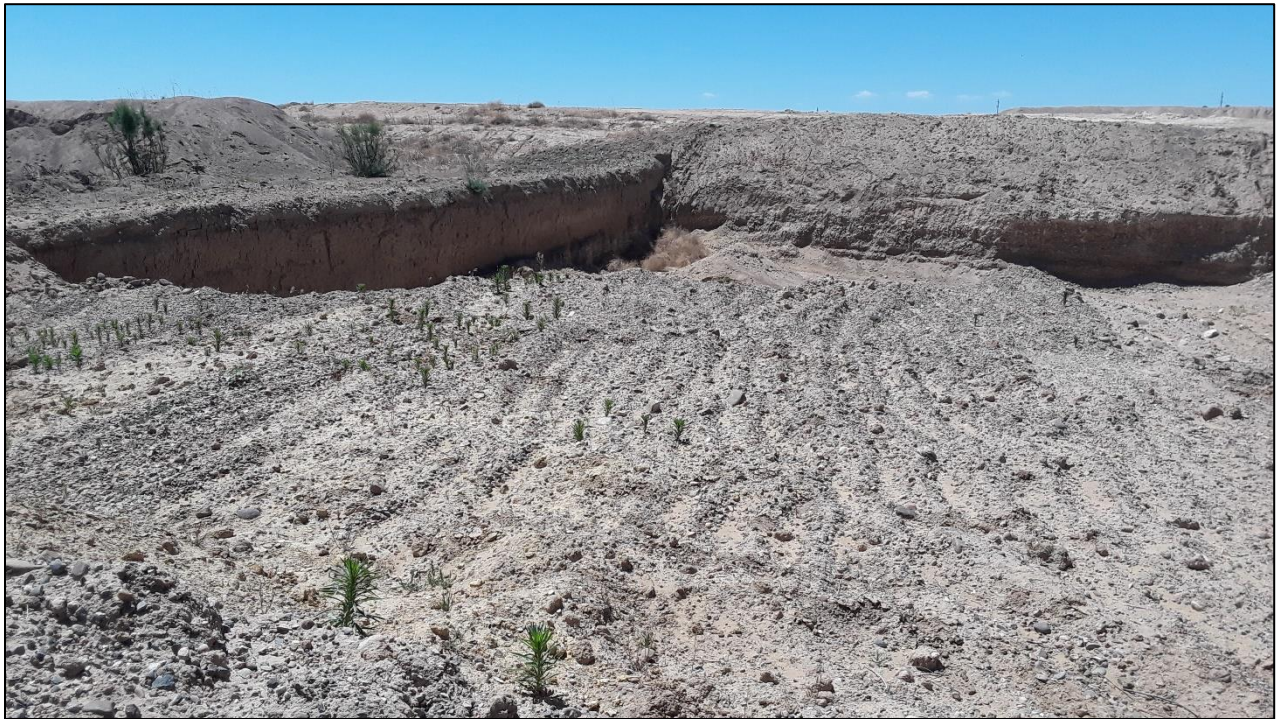
Photo 6. View looking east across small excavation present at northeastern edge of pit, with near vertical slopes.

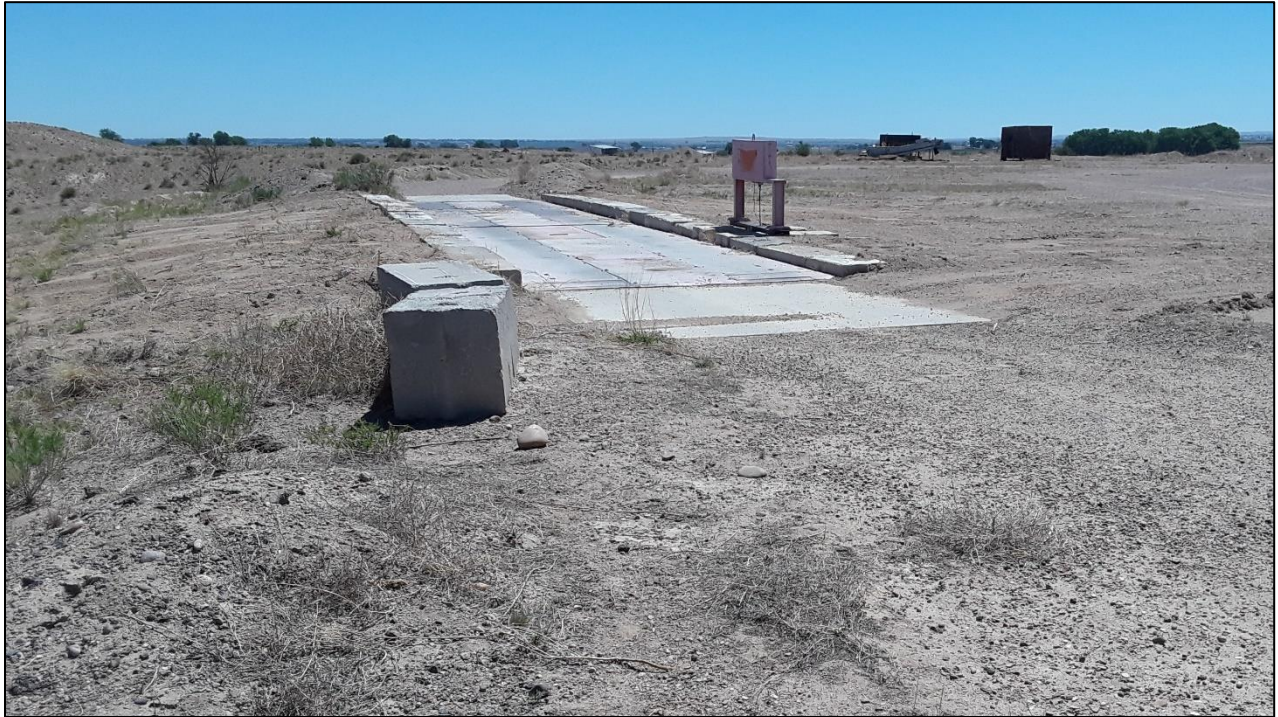
Photo 7. View looking east at scale area near main site entrance, where concrete foundation remains.

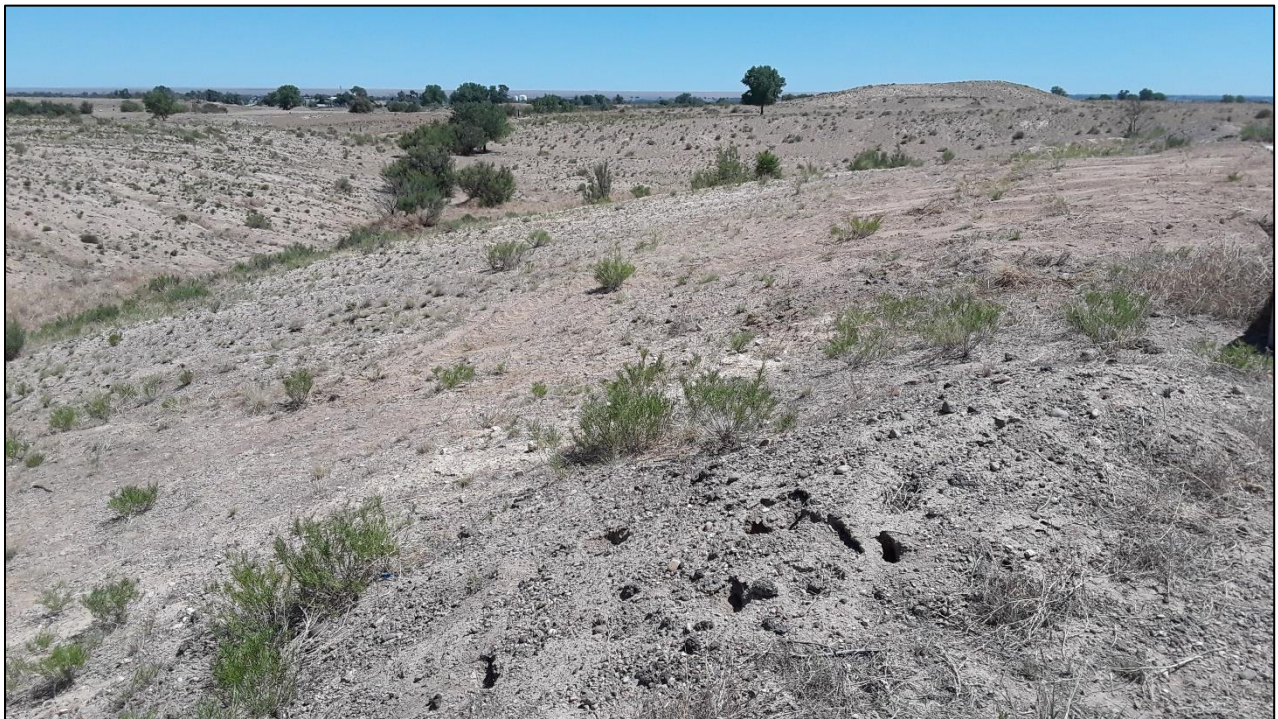
Photo 8. View looking north across northern portion of permit area, north of main access road. This area was previously mined and reclaimed. The slopes in this area are mainly 3H:1V or flatter with vegetative cover consisting primarily of shrubs and annual weeds.

The main access road off of Co Rd 18 crosses the northern portion of the site and continues to Co Rd CC 5/10 outside and east of the permit area. The majority of current disturbance lies south of this road. The portion of the permit area that lies north of the main haul road was previously disturbed and reclaimed. Current disturbance at the site includes an excavated pit that daylights mainly to the east, several material stockpiles of various sizes stored on the pit floor, overburden and topsoil stockpiles stored at the edges of the pit, a scale area (located north of the main access road), and a small excavation located south of the larger pit (close to the southern permit boundary). Mined slopes were mostly graded to 3H:1V, except for a small cut at the northeastern edge of the pit. This cut was approximately 5-10 feet in height, with near vertical slopes. No signs of excessive erosion were observed on site. The overburden and topsoil stockpiles appeared to be stable. The Division did observe a few early growth Tamarisk (salt cedar) trees in the northeastern portion of the pit disturbance area. Because Tamarisk is a state-listed noxious weed species, the operator should implement the weed control plan as soon as possible to remove these trees from the affected lands.
