MINERALS PROGRAM INSPECTION REPORT

MINE NAME: Hancock Gravel Pit	MINE/PROSPECTING ID#: M-1981-279	MINERAL: Sand and gravel	COUNTY: Otero
INSPECTION TYPE: Monitoring	INSPECTOR(S): Amy Eschberger	INSP. DATE: May 31, 2018	INSP. TIME: 11:45
OPERATOR: All-Rite Paving & Redi-Mix, Inc.	OPERATOR REPRESENTATIVE: Herb Pearson	TYPE OF OPERATION: 112c - Construction Regular Operation

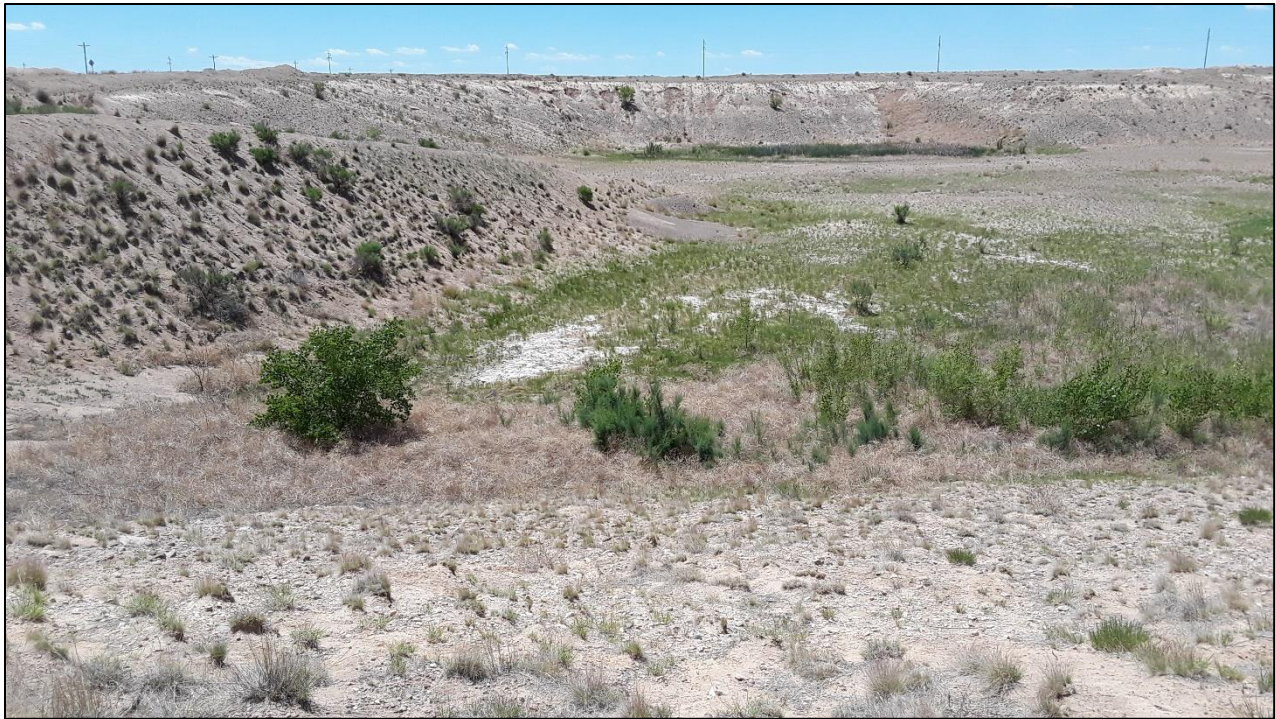
Photo 1. View looking southeast across the excavated pit. Pit walls are graded 2H:1V or flatter and appeared to be stable.

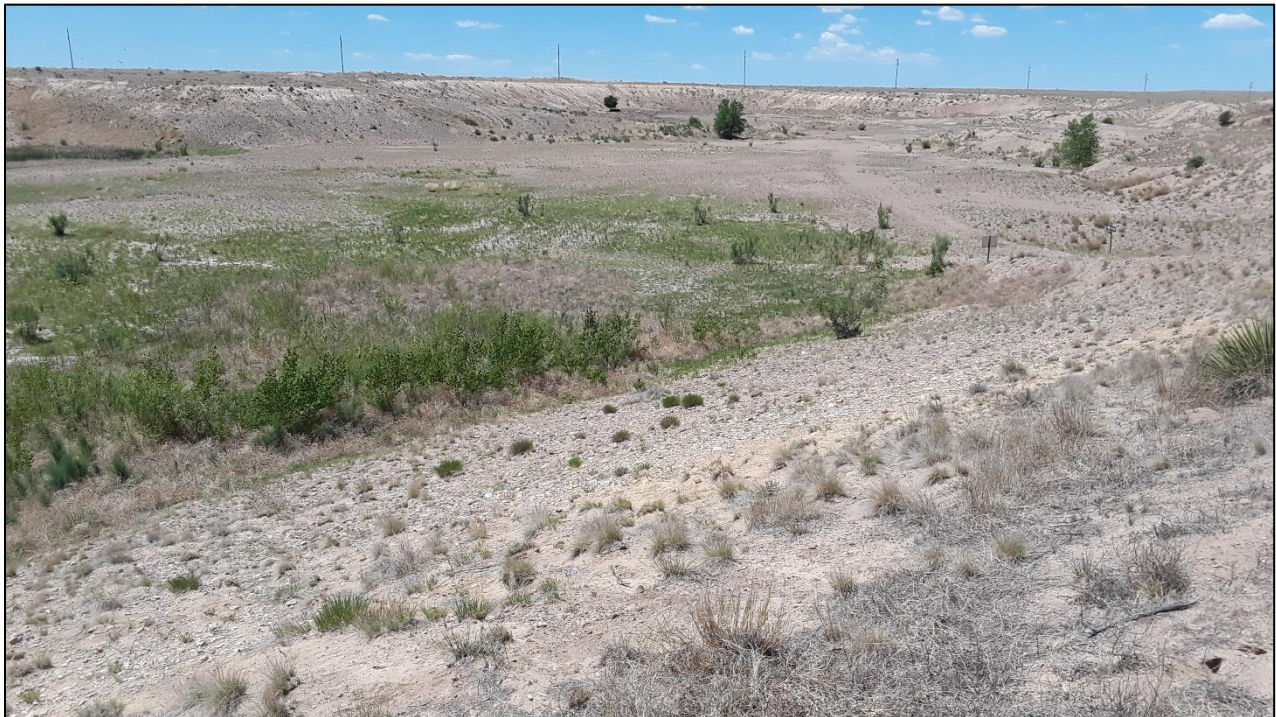
Photo 2. View looking south across the excavated pit. Pit walls are graded 2H:1V or flatter and appeared to be stable.

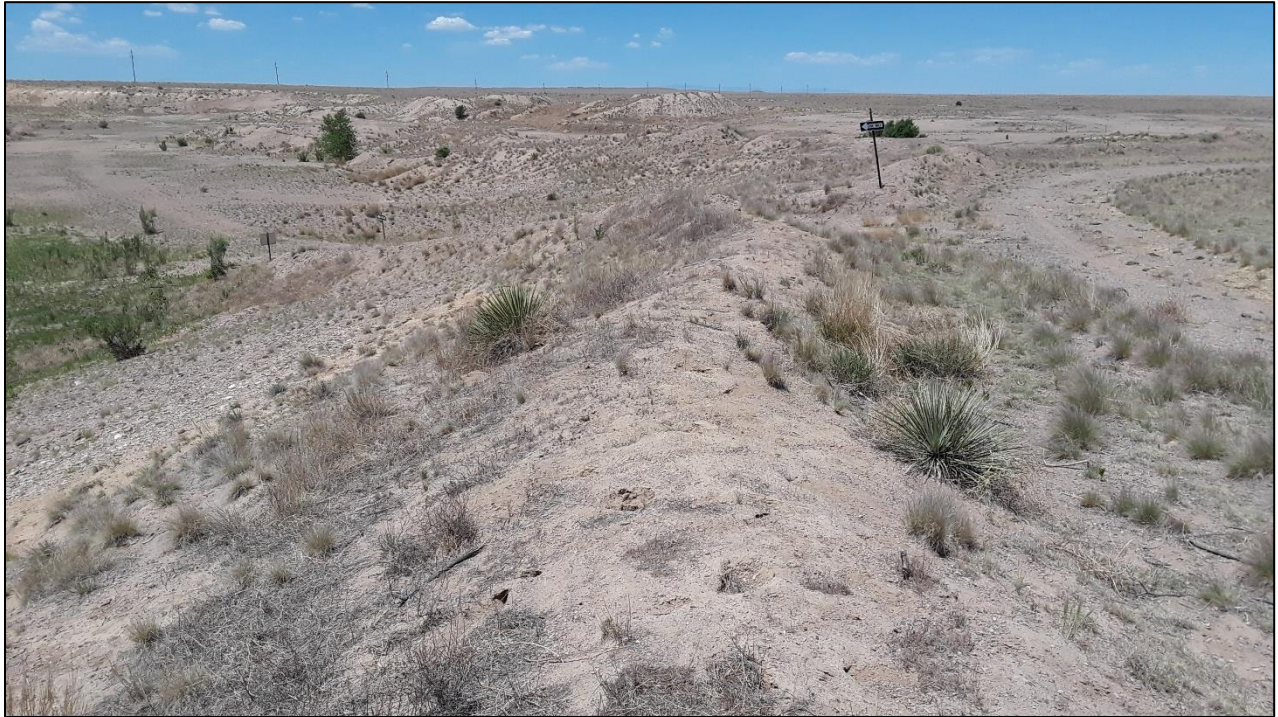
Photo 3. View looking west, showing topsoil stored along northern edge of pit. Topsoil stockpiles appeared to be stable with some vegetative cover.

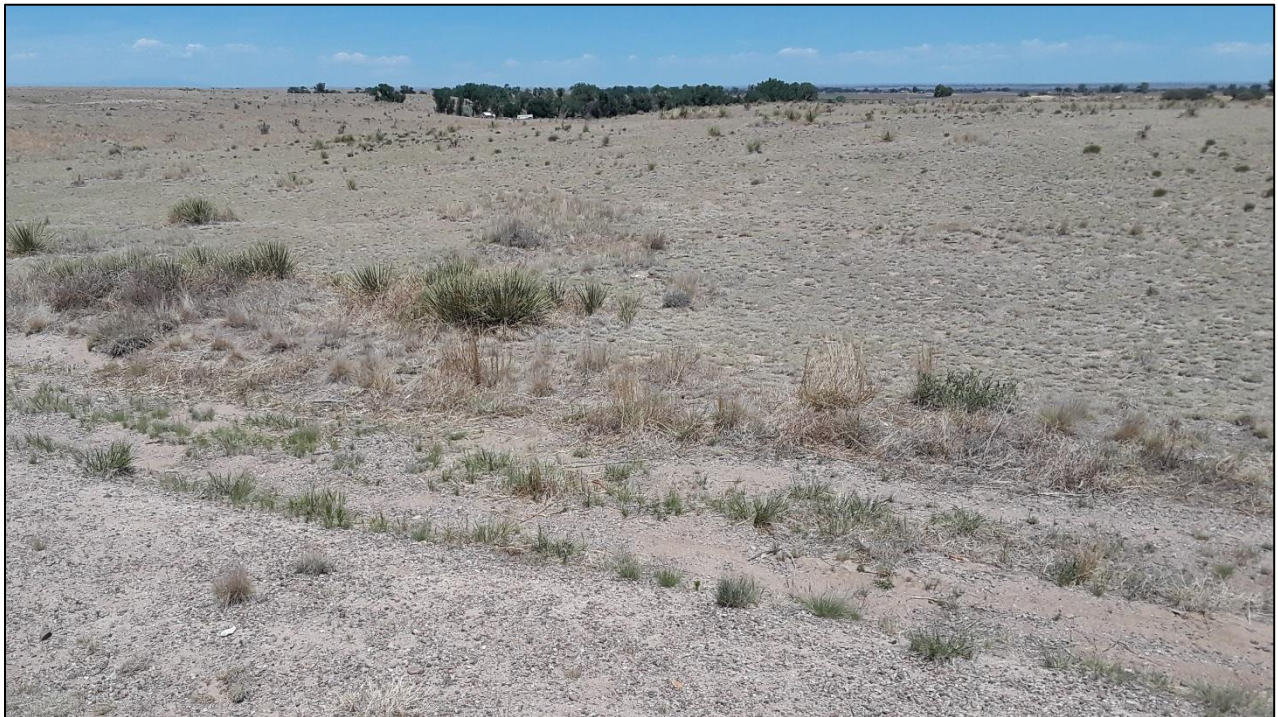
Photo 4. View looking northwest across previously disturbed area located north of active pit which has been reclaimed for many years.

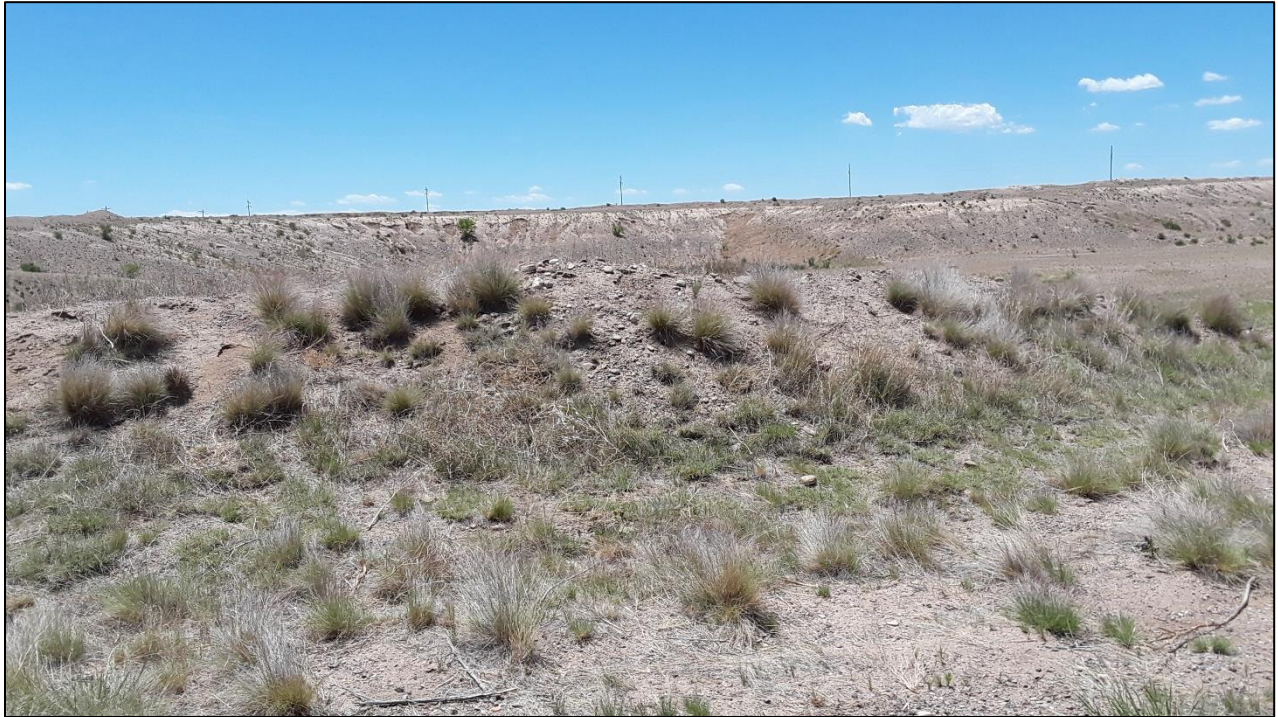
Photo 5. View looking west from main entrance, showing topsoil stored along eastern edge of pit. Topsoil stockpiles appeared to be stable with vegetative cover.

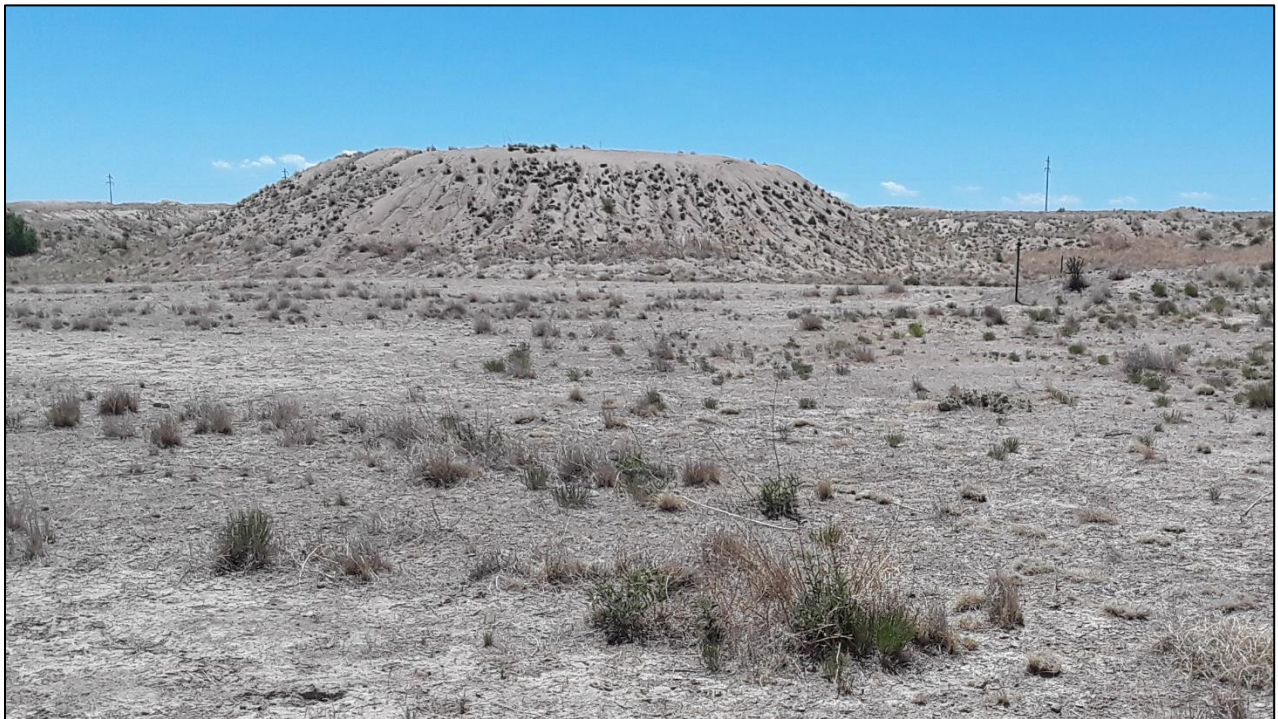
Photo 6. View looking south, showing large overburden stockpile stored on pit floor.

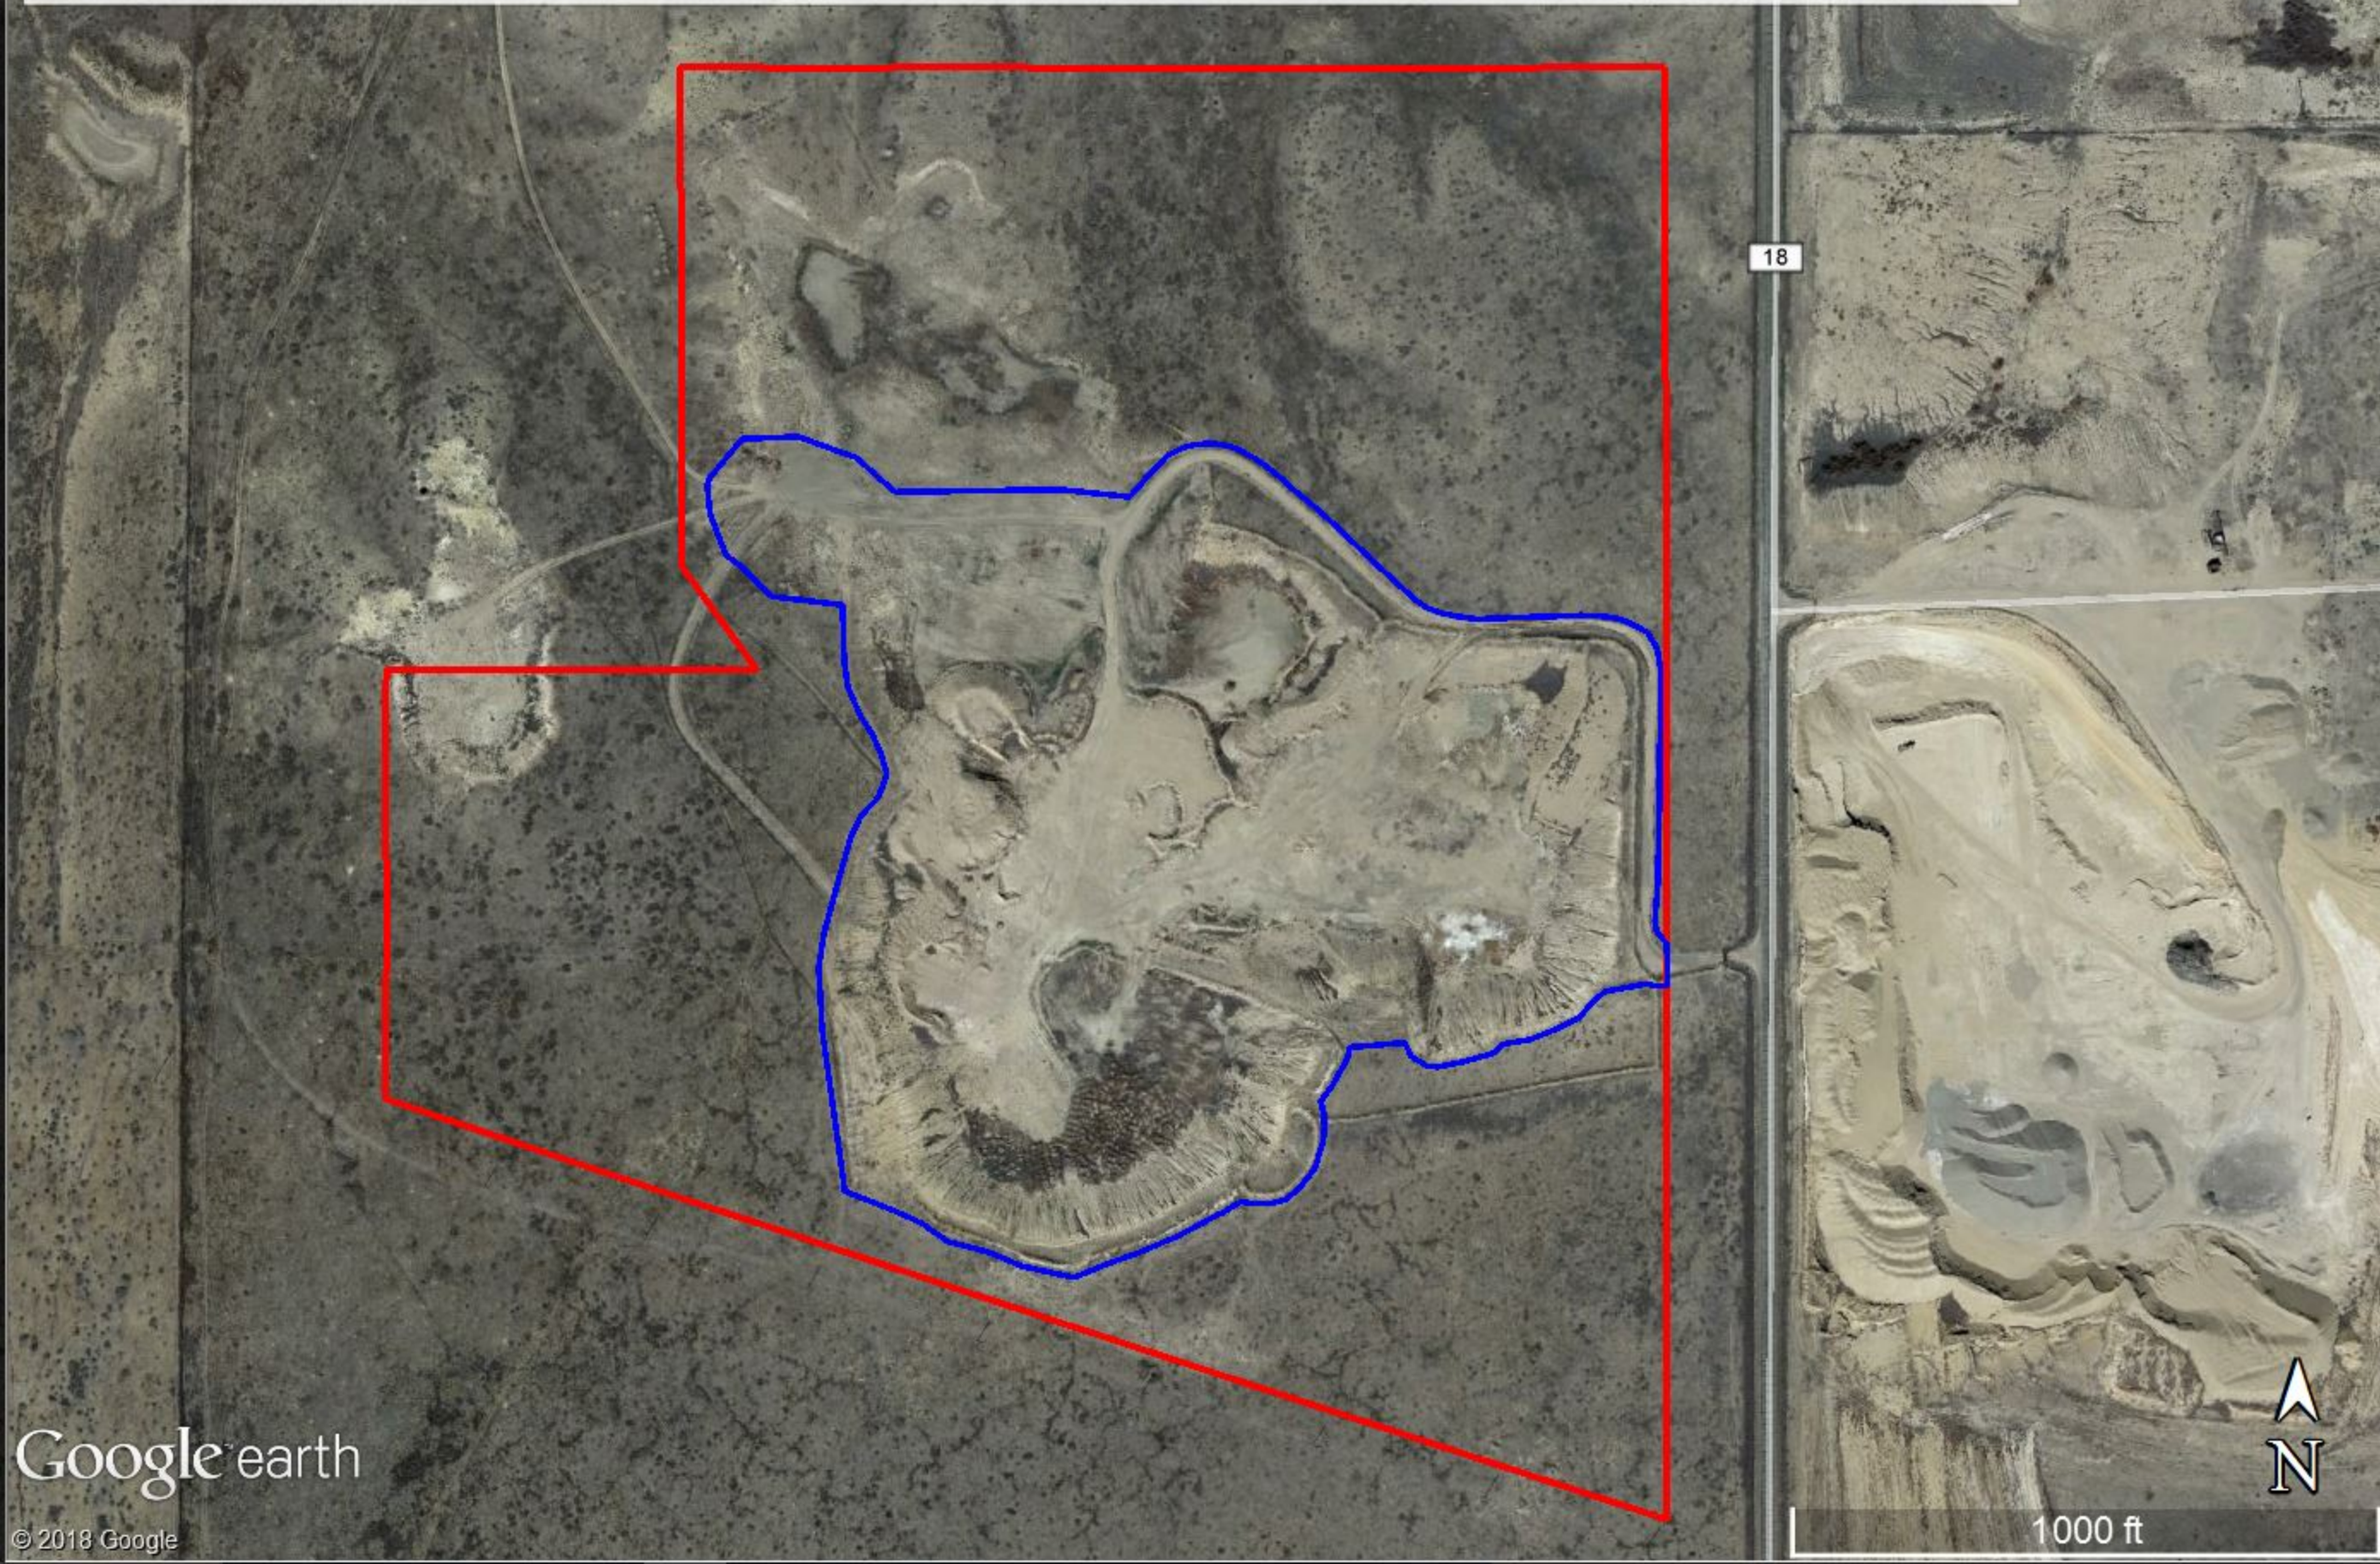
M1981-279 / Hancock Gravel Pit / All-Rite Paving & Redi-Mix, Inc. / (112c)

PROBLEM: The operation has disturbed more than the approved maximum allowed disturbed area at any time. The current mining plan needs to be updated and clarified pursuant to C.R.S. 34-32.5-112 (1)(c)(VI) and (VII), and Rule 6.4.4. The operator must provide sufficient information to describe or identify how the operator intends to conduct the operation, specifically the size of the area to be worked at any one time.

The Division estimates the operation has disturbed a total of 34.3 acres that require reclamation. This was noted in the Division's report for the last inspection conducted on January 19, 2017, in response to a Succession of Operators application submitted by Otero County to transfer the permit to the current operator. For the permit transfer, the Division calculated a reclamation bond for the existing disturbance of 34.3 acres. Therefore, the currently held financial warranty is adequate. However, the Division instructed the new operator to submit a Technical Revision after the permit transfer was finalized to increase the maximum allowed disturbed area. The Division issued the permit transfer on February 21, 2017, but has not yet received the Technical Revision.

Red Outline = 92.0 acres = Approved Permit Area

Blue Outline = 34.3 acres = Disturbed Area

CORRECTIVE ACTIONS: The operator shall submit a Technical Revision, with the required \$216 revision fee, to update and clarify the current approved mining plan to reflect existing and proposed activities by the corrective action date. Specifically, the revision must increase the maximum allowed disturbed area at any time from the current approved 20 acres to at least the existing 34.3 acres disturbed.
