MINERALS PROGRAM INSPECTION REPORT

MINE NAME: Superior S&G Pit	MINE/PROSPECTING ID#: M-1979-189	MINERAL: Sand and gravel	COUNTY: Arapahoe
INSPECTION TYPE: Monitoring	INSPECTOR(S): Jared L. Ebert	INSP. DATE: September 20, 2017	INSP. TIME: 09:00
OPERATOR: City of Aurora	OPERATOR REPRESENTATIVE: Eric Watts, City of Aurora	TYPE OF OPERATION: 112c - Construction Regular Operation

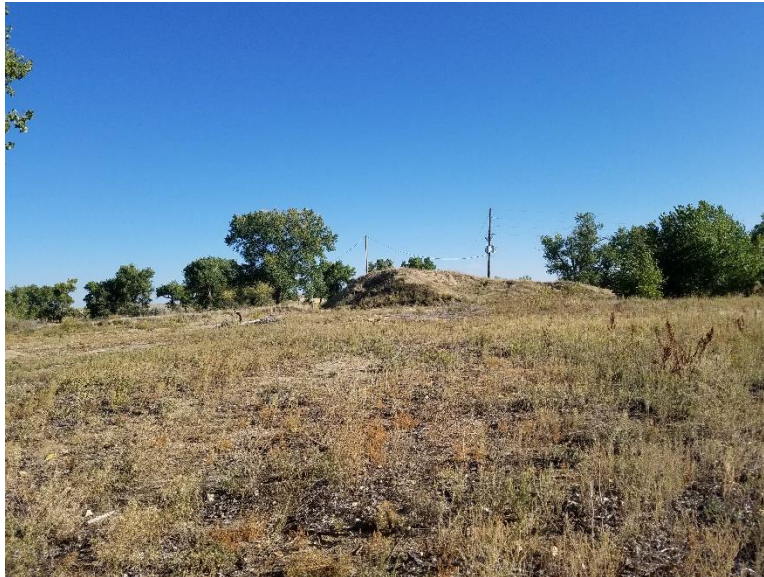
Figure 1. Near the entrance to the site looking north. Old processing/stockpile yard.

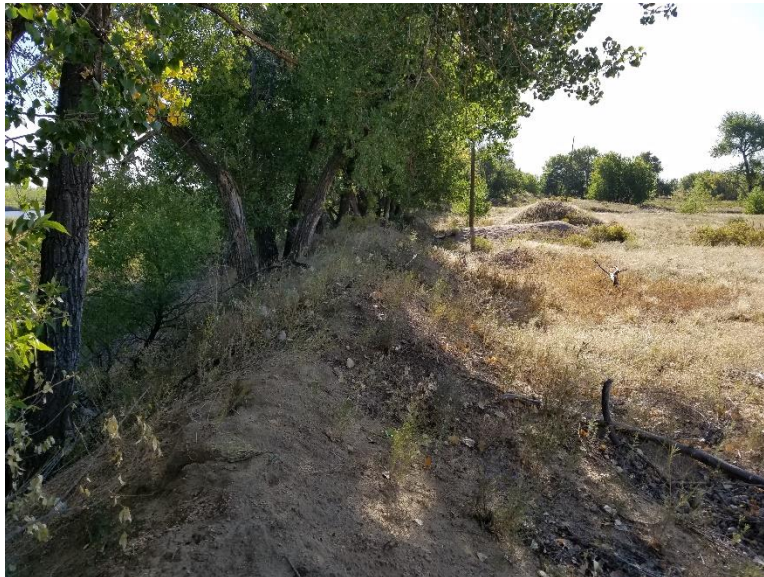
Figure 2. From the south end of the center excavation looking east.

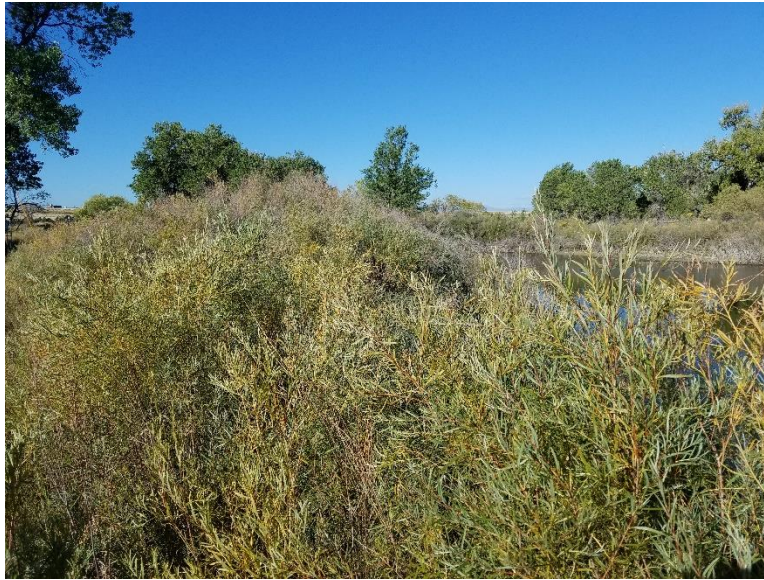
Figure 3. South end of the southernmost pond on the west side of the site.

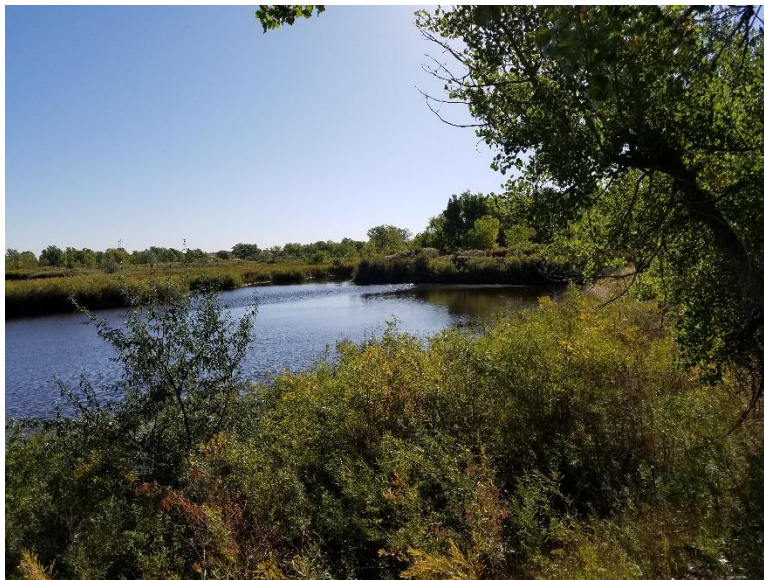
Figure 4. From the south end of the center excavation/pond looking northeast.

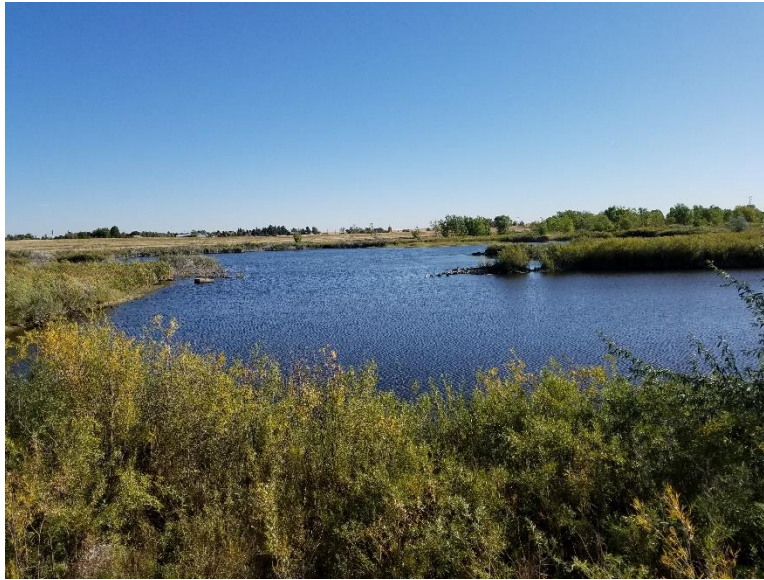
Figure 5. From the south end of the center pit/pond looking north.

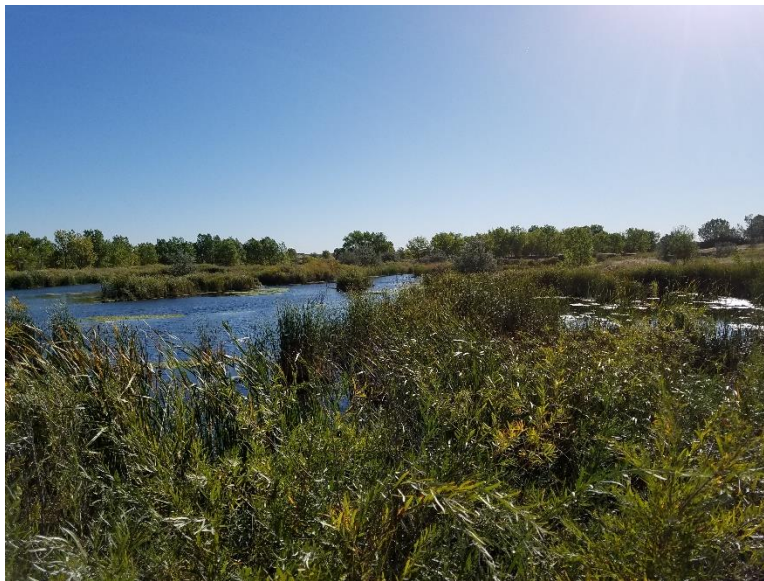
Figure 6. From the south end of the eastern excavation looking north east.

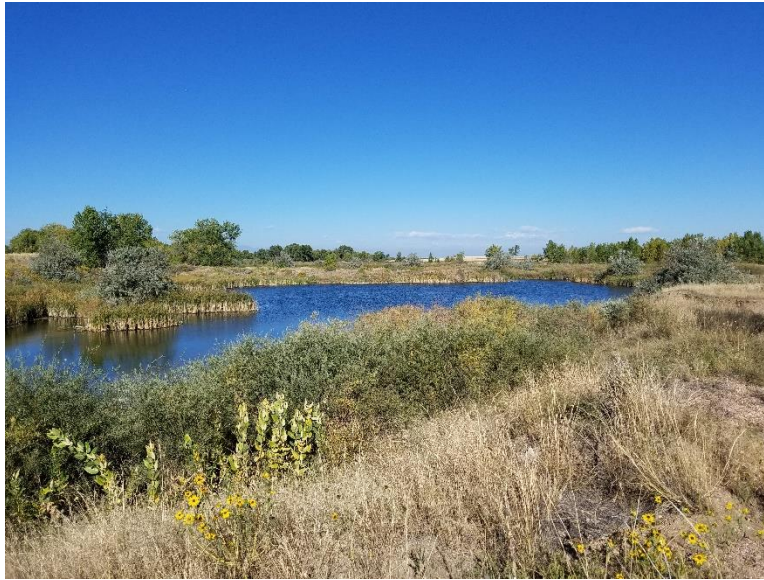
Figure 7. From the southeast end of the eastern excavation looking northwest.

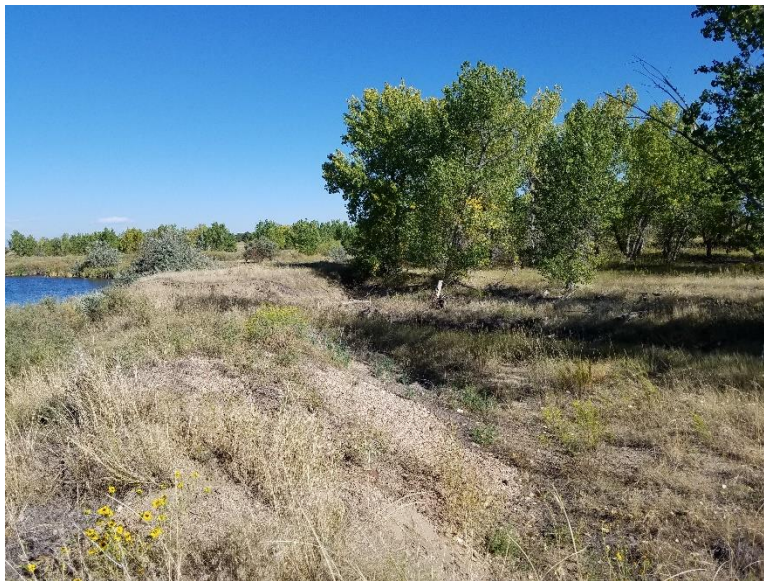
Figure 8. From the southeast end of the eastern excavation looking north.

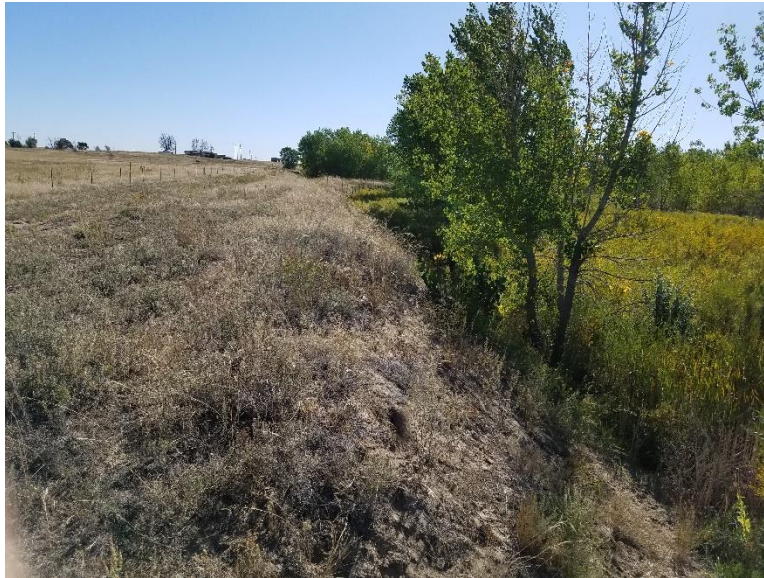
The pit slopes for these excavations vary significantly throughout the site. The pit slopes range from a steep 1H:1V ratio to a very gentle slope in places; however, the majority of the pit slopes above the waterlines of each of the ponds were between a 1H:1V to 2H:1V slope. The approved reclamation plan for the site calls for leaving the pit slopes at a 3H:1V ratio. Also Rule 3.1.5(7) states "In all cases where a lake or pond is produced as a portion of the Reclamation Plan, all slopes, unless otherwise approved by the Board or Office, shall be no steeper than a ratio of 2H:1V, except from 5 feet above to 10 feet below the expected waterline where slopes shall be not steeper than 3H:1V."

Figure 9. From the north central portion of the site looking east. Steep 2:1 slopes near the north boundary.

Significant grading work will need to be completed around the pond slopes to comply with the reclamation plan and the performance standard outlined in the above referenced rule. Also there are a number of stockpiles and berms that have been left in place at the site. These piles and berms vary in size and shape, many of their side slopes are steep. These piles could be spread out and used for backfilling and grading work.

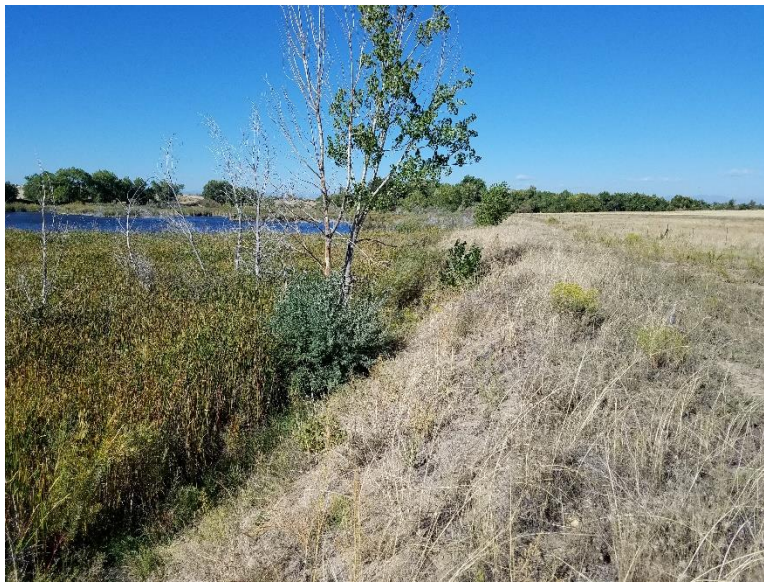
Figure 10. From the north central portion of the site looking west. Steep 2:1 slopes near the north boundary.

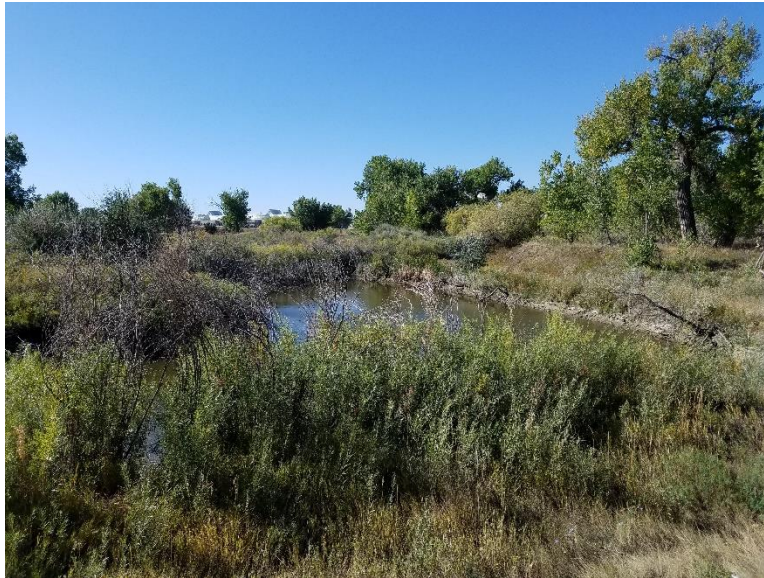
Figure 11. Northernmost excavation/pond on the west side of the site. From the north end looking south.

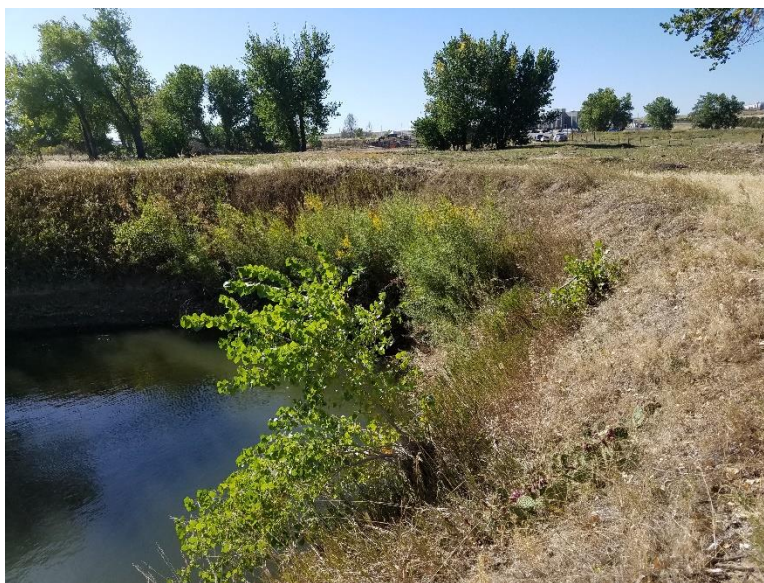
Figure 12. Pond slopes on the southernmost pond/excavation on the west side of the site. Steep 1H:1V slopes into the pond.
