MINERALS PROGRAM INSPECTION REPORT

MINE NAME: Ruby Trust Mine	MINE/PROSPECTING ID#: M-1979-181	MINERAL: Gold and silver	COUNTY: Ouray
INSPECTION TYPE: Monitoring	INSPECTOR(S): Travis H. Marshall	INSP. DATE: July 31, 2018	INSP. TIME: 12:00
OPERATOR: Walker Ruby Mining Company, Inc.	OPERATOR REPRESENTATIVE: Bob Larson	TYPE OF OPERATION: 110(2) - Hard Rock Limited Impact

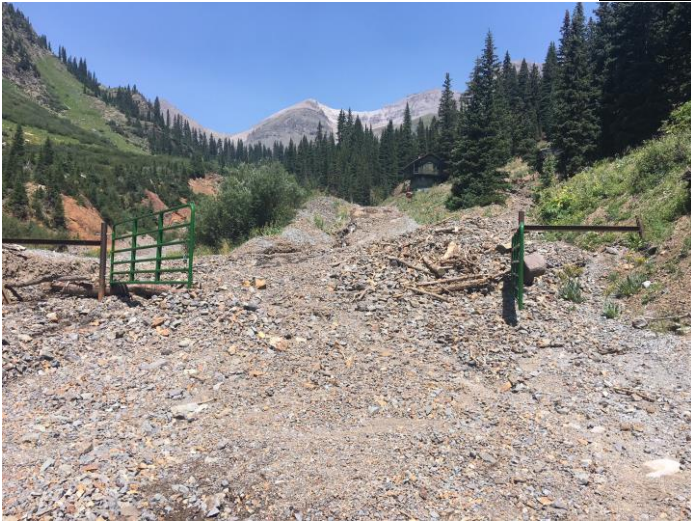
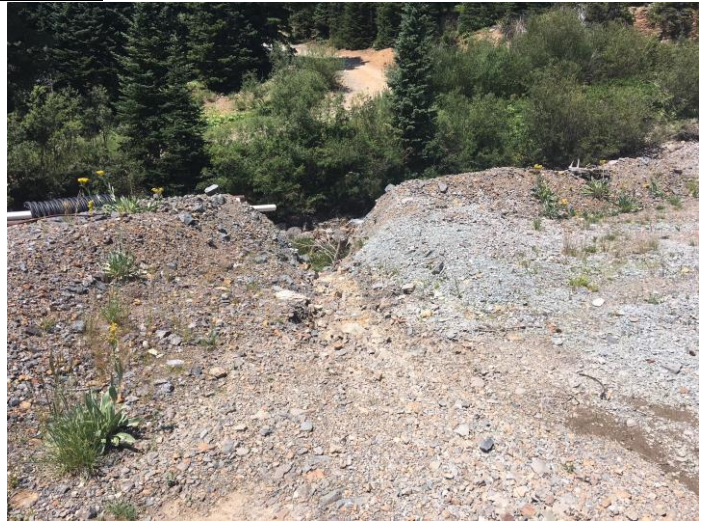
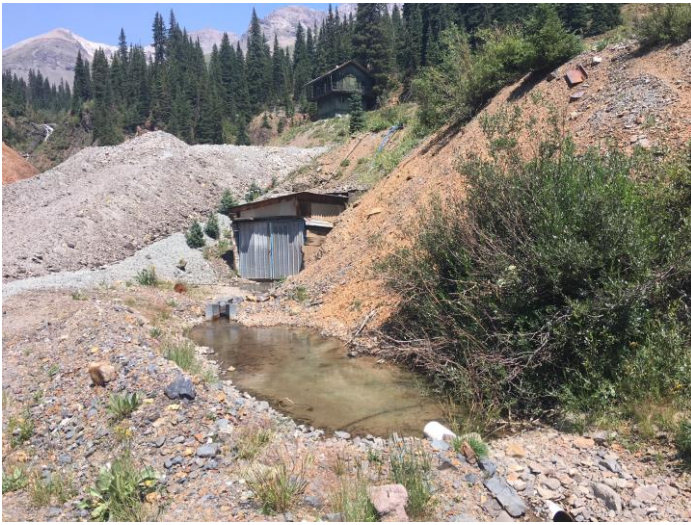
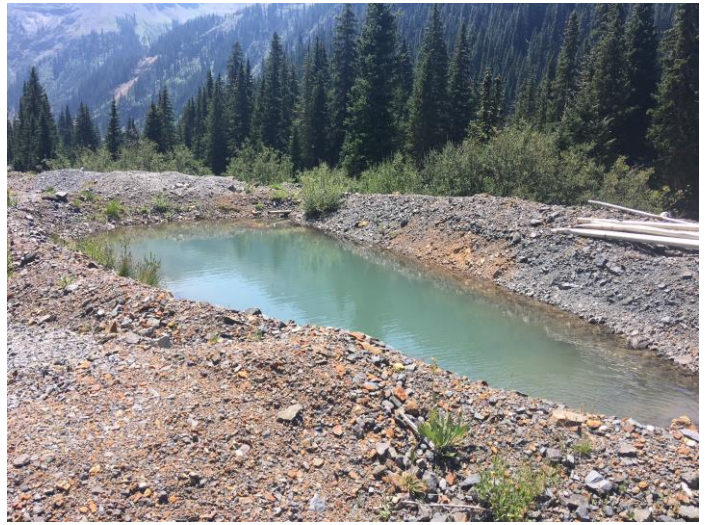
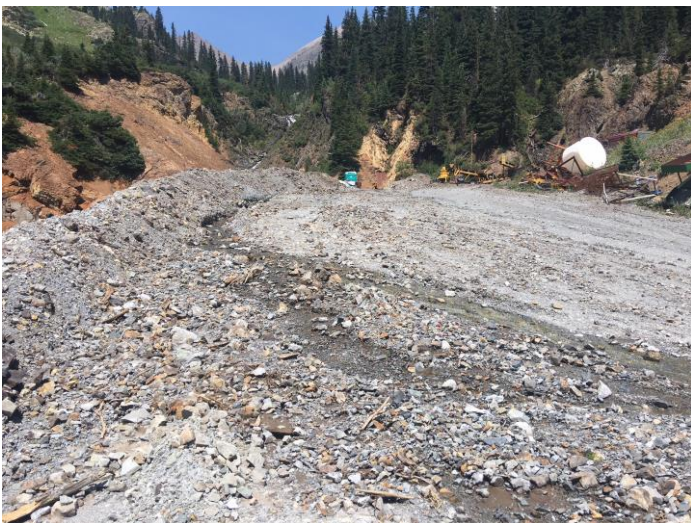
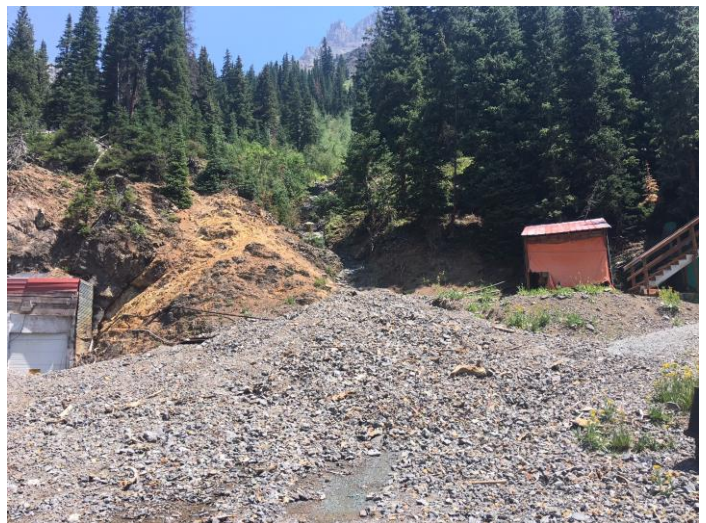
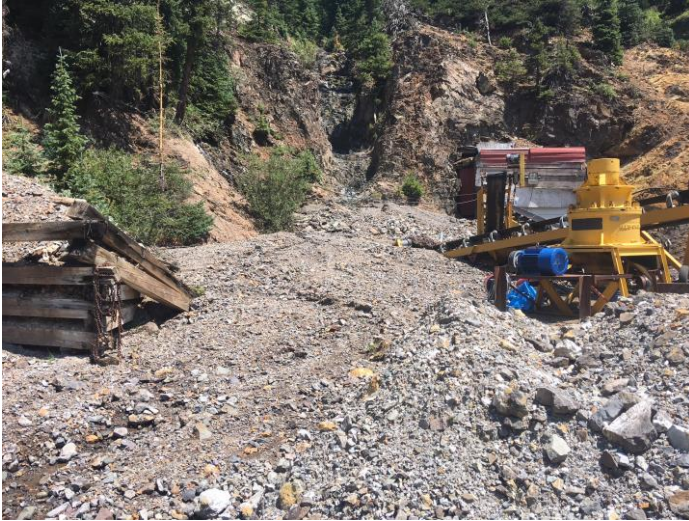
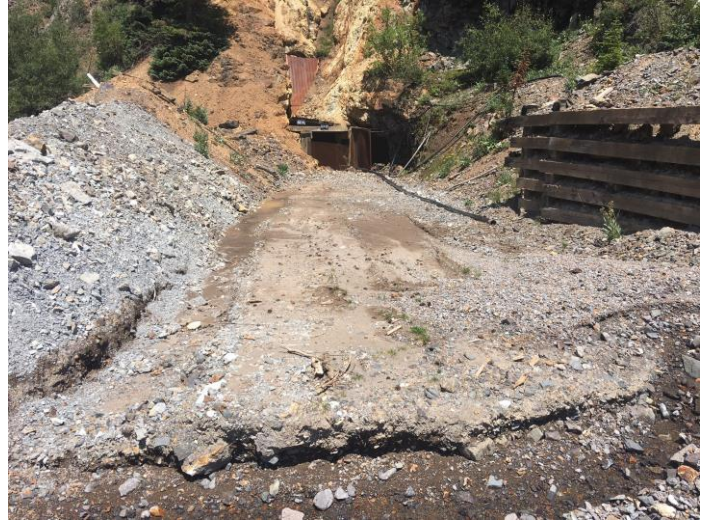
PHOTOGRAPHS

PROBLEM/POSSIBLE VIOLATION: Problem: Erosion gullies and ruts were observed on-site. This is a problem at this time for failure to protect the affected land from erosion pursuant to C.R.S. 34-32.5-116 (4) (j). Current mine bench configuration allows for capture and transport of surface water through mine working.

The mine was not active during the inspection. Evidence of a recent major precipitation event was observed at the main access and working bench of the mine site. The precipitation surface flow entered the mine from the north side from a drainage up-gradient of the mine bench. Bob Larson stated that he plans to get an excavation contractor on site as soon as one is available to fix the erosional issues. This is seen as a problem and the operator is required to provide photo-documentation that the erosional issues have been repaired no later than September 7, 2018.

Mr. Larson pointed out to the inspector that the current configuration of the mine tunnel entrance was altered by the previous operator. The alteration is problematic due to its ability to allow surface water into the original mine entrance and then flowing out of a lower mine entrance. This is also seen as a problem that must be corrected. A technical revision to address the configuration and water capturing issues must also be submitted no later than September 7, 2018.

CORRECTIVE ACTIONS: The operator shall provide photo documentation to the Division verifying erosion gullies and ruts have been repaired, and that the site has been reconstructed and stabilized to prevent erosion damage by the corrective action date. Submittal of a technical revision to address the mine bench configuration to prevent hydrologic issues.
