**MINERALS PROGRAM INSPECTION REPORT**  
**PHONE: (303) 866-3567**

<b>MINE NAME:</b> Nichols Gravel Pit	<b>MINE/PROSPECTING ID#:</b> M-1981-013	<b>MINERAL:</b> Sand and gravel	<b>COUNTY:</b> Mesa
<b>INSPECTION TYPE:</b> Monitoring	<b>INSPECTOR(S):</b> Amy C. Yeldell	<b>INSP. DATE:</b> July 26, 2018	<b>INSP. TIME:</b> 13:30
<b>OPERATOR:</b> Nichols Gravel Pit, L.L.P.	<b>OPERATOR REPRESENTATIVE:</b> John Nichols	<b>TYPE OF OPERATION:</b> 112c - Construction Regular Operation	
<b>REASON FOR INSPECTION:</b> Normal I&E Program	<b>BOND CALCULATION TYPE:</b> None	<b>BOND AMOUNT:</b> \$72,600.00	
<b>DATE OF COMPLAINT:</b> NA	<b>POST INSP. CONTACTS:</b> DRMS	<b>JOINT INSP. AGENCY:</b> None	
<b>WEATHER:</b> Cloudy	<b>INSPECTOR'S SIGNATURE:</b>

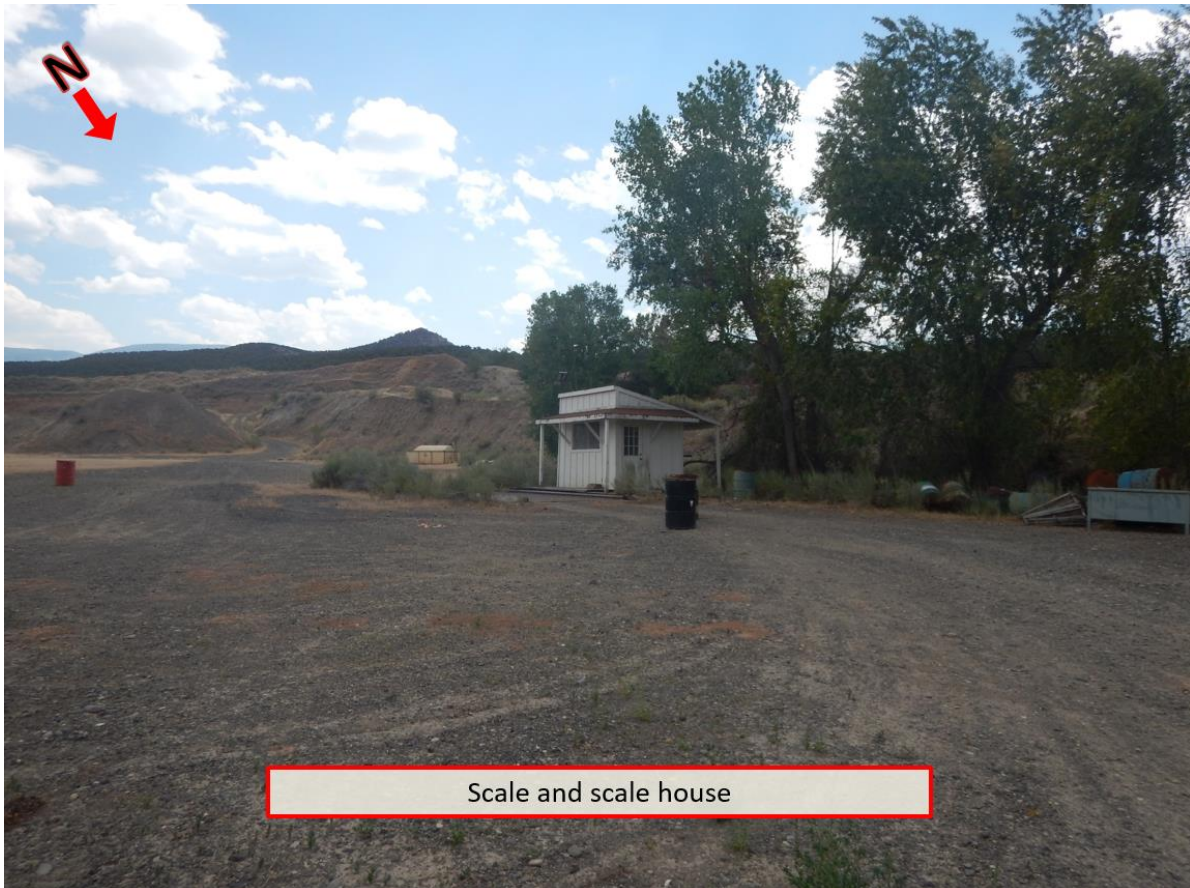
There is a scale and scale house near the lower pit entrance. In the northeast corner of the pit are some steel drums and other various debris. This is used to conduct drills by the Sheriff's Department. The Division requests that this material be stored neatly as to not interfere with mining activities when not in use.

Scale and scale house

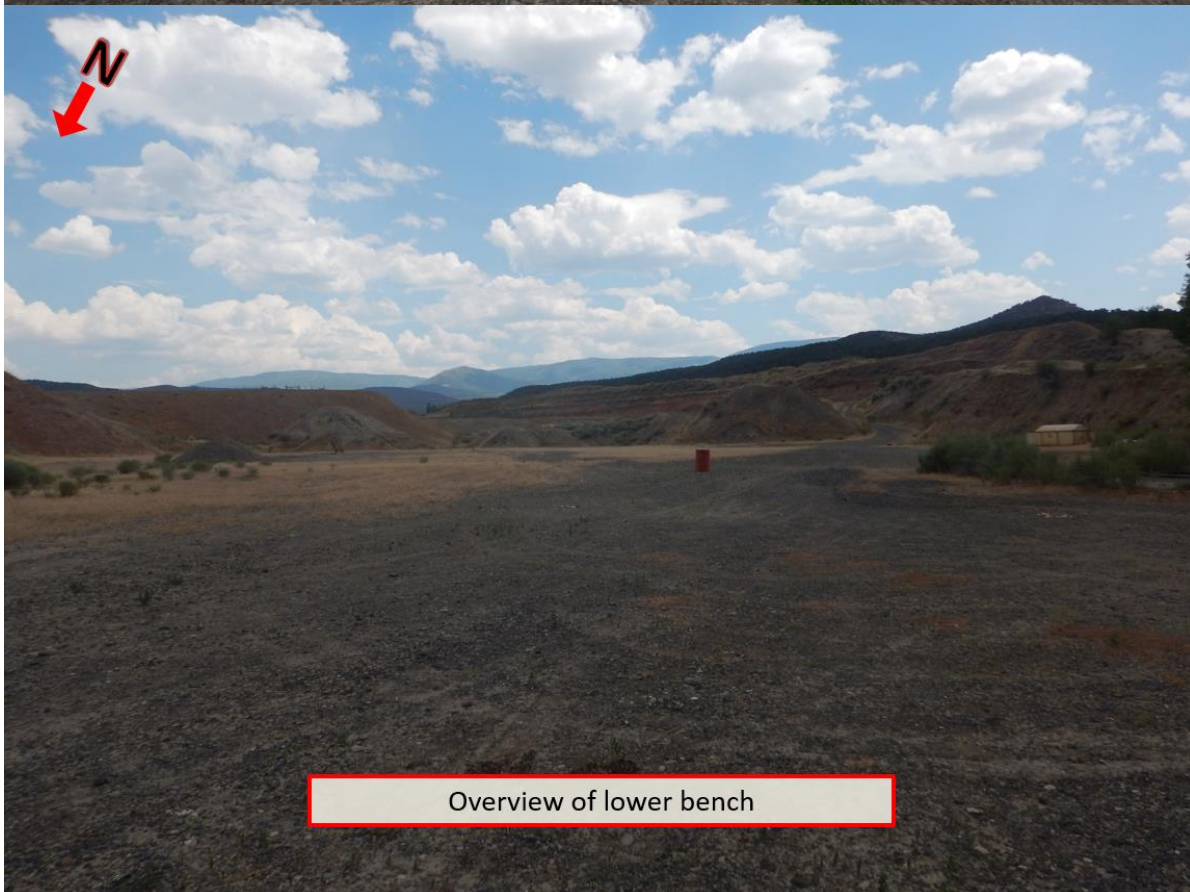
Overview of lower bench

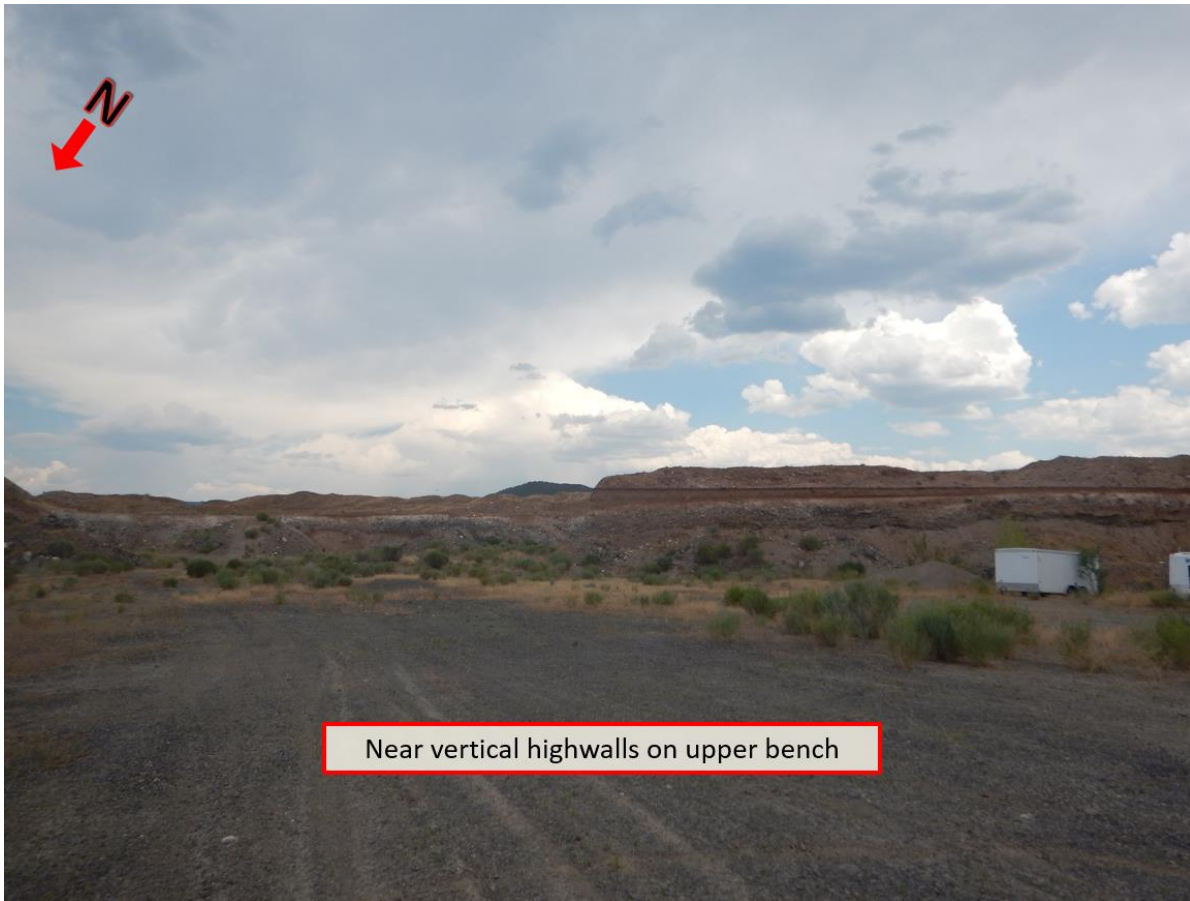
Near vertical highwalls on upper bench

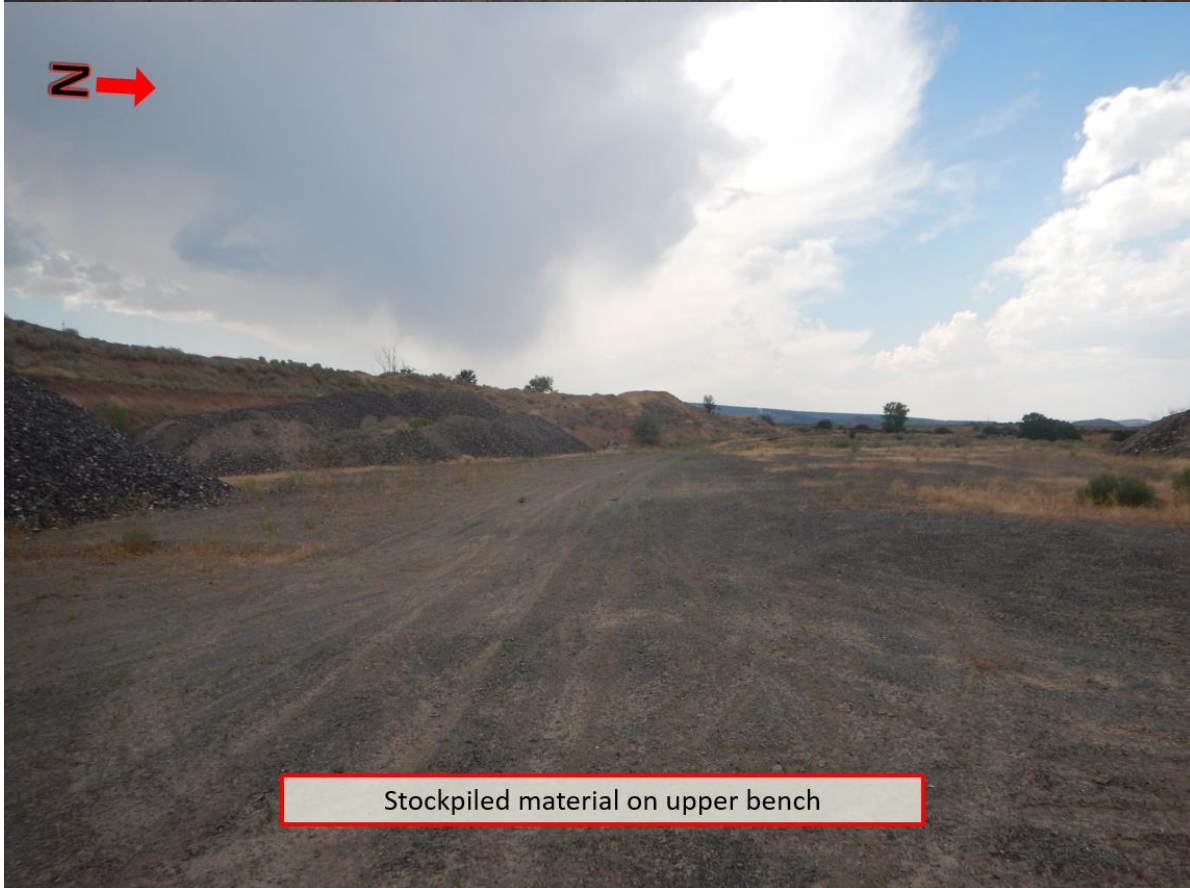
An empty fuel tank and conveyor remain on site from that last crushing operation. The equipment belongs to Moffat Limestone Company. No other mining equipment is on site. The last significant crushing operation took place in 2013. Current mining activity is selling out of existing stockpiles until they are depleted. Equipment will be remobilized if the market supports future mining. There are numerous stockpiles throughout the pit, all of varying size. The stockpile slopes appear to be stable.

Stockpiled material on upper bench

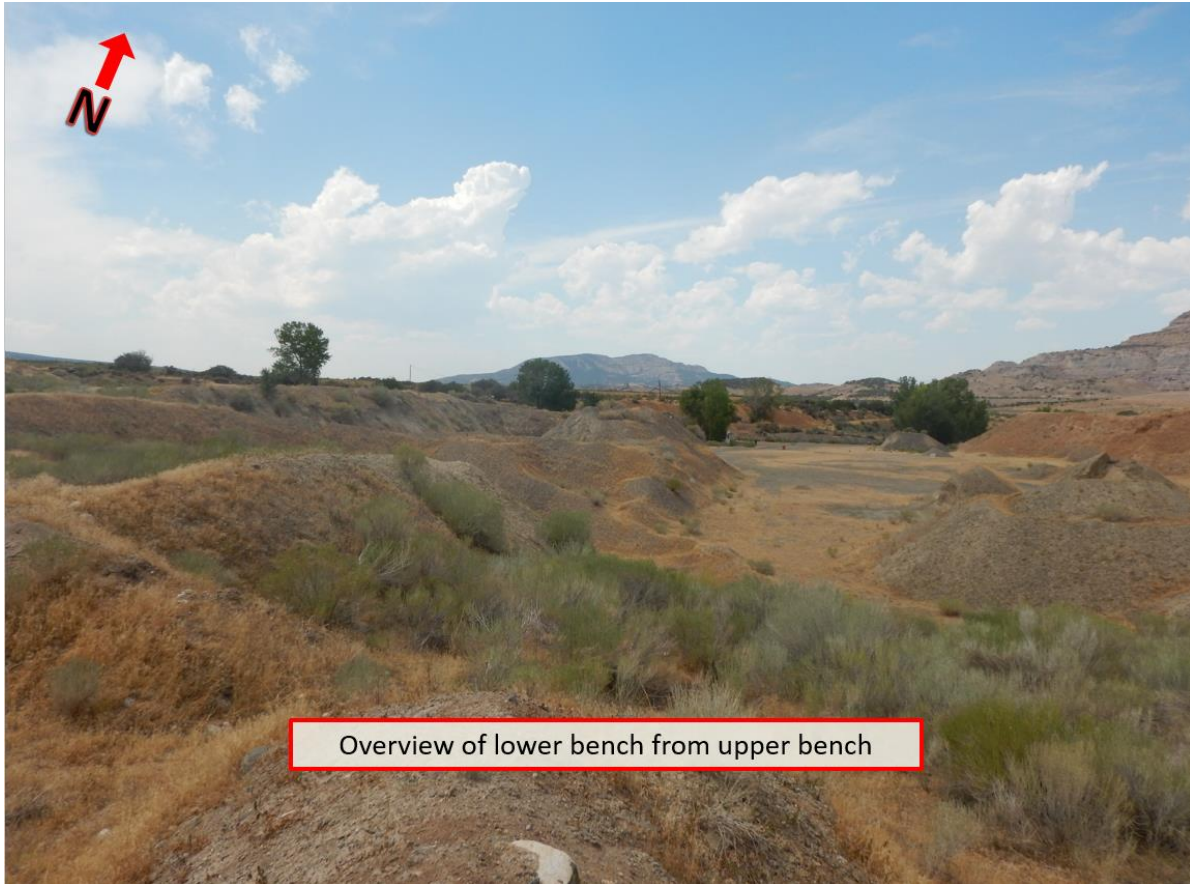
Overview of lower bench from upper bench
