MINERALS PROGRAM INSPECTION REPORT
PHONE: (303) 866-3567

MINE NAME: Woodring Pit	MINE/PROSPECTING ID#: M-1978-323	MINERAL: Sand and gravel	COUNTY: Mesa
INSPECTION TYPE: Surety-Related Inspection	INSPECTOR(S): Amy C. Yeldell	INSP. DATE: July 26, 2018	INSP. TIME: 09:20
OPERATOR: Kilgore Companies LLC dba Elam Constructi	OPERATOR REPRESENTATIVE: Jon Muller	TYPE OF OPERATION: 112c - Construction Regular Operation	
REASON FOR INSPECTION: Priority	BOND CALCULATION TYPE: Complete Bond	BOND AMOUNT: \$137,761.43	
DATE OF COMPLAINT: NA	POST INSP. CONTACTS: None	JOINT INSP. AGENCY: None	
WEATHER: Clear	INSPECTOR'S SIGNATURE:

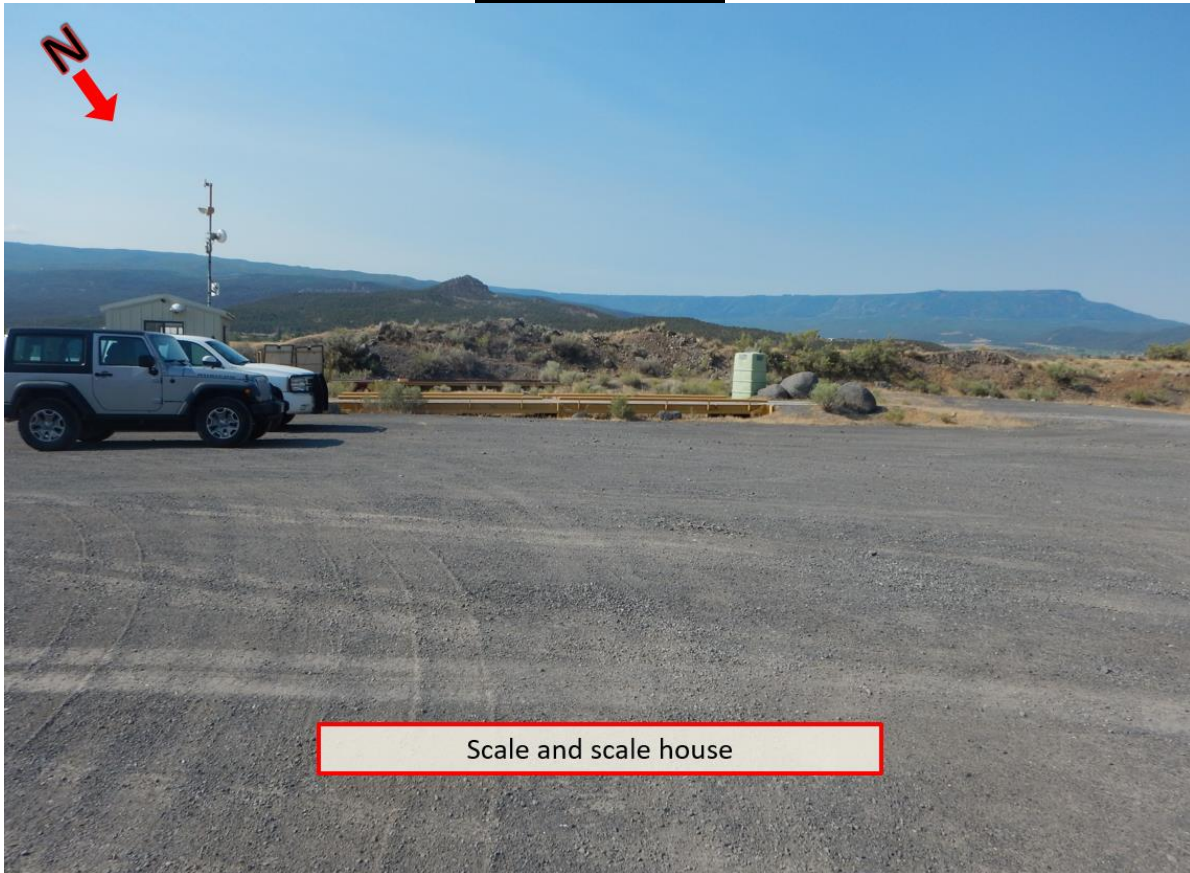
The site was active at the time of the inspection. A loader was observed filling a dump truck. No other processing equipment or fuel was on site. There is no exposed water or water used for washing of material. There is a scale and scale house near the pit entrance. No structure agreements are required.

Scale and scale house

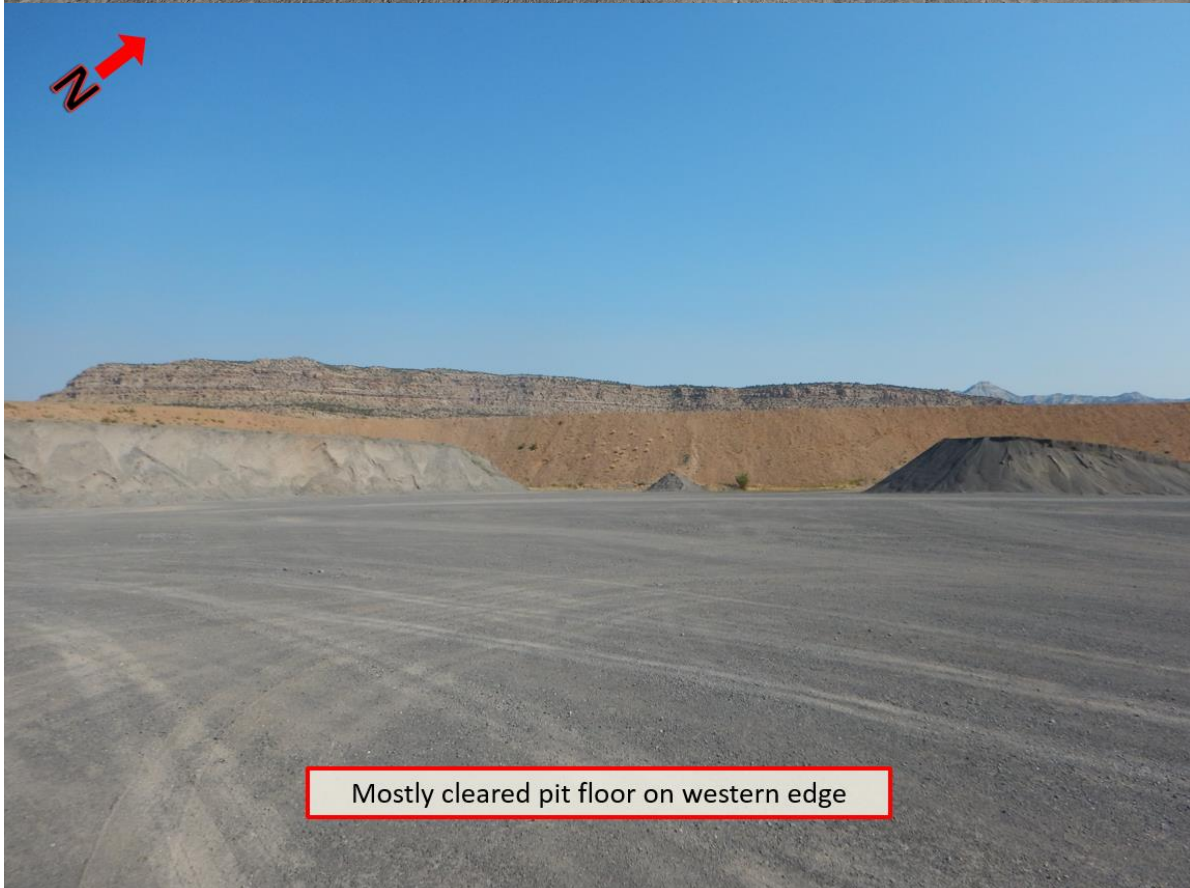
There are several large stockpiles on site. All of which are stored neatly and have little to no evidence of erosion. The pit floor is bare of vegetation with very few weeds. The 1:1 highwall slopes have some volunteer vegetation that is mainly grasses. The near vertical portions of the highwall are void of vegetation. To date there appears to be no reclamation.

Mostly cleared pit floor on western edge

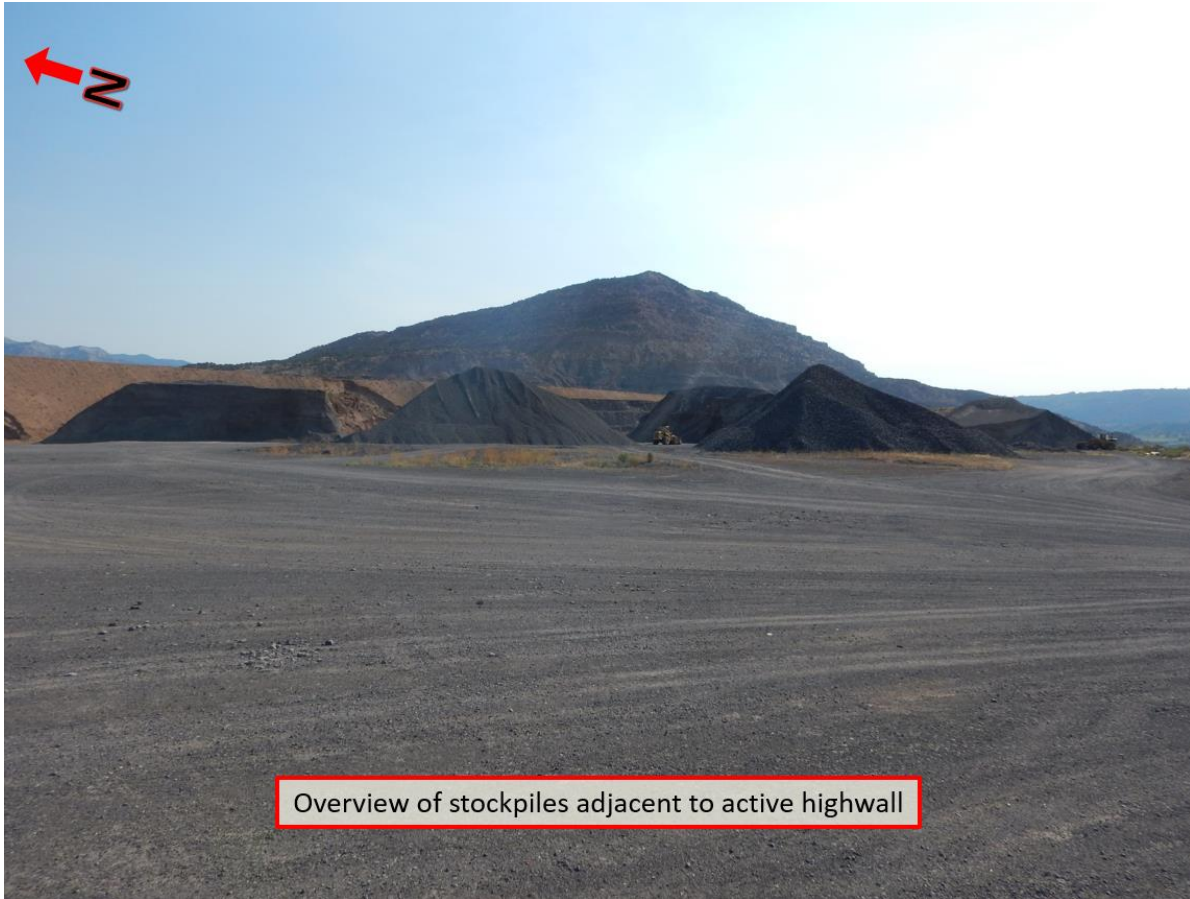
Overview of stockpiles adjacent to active highwall

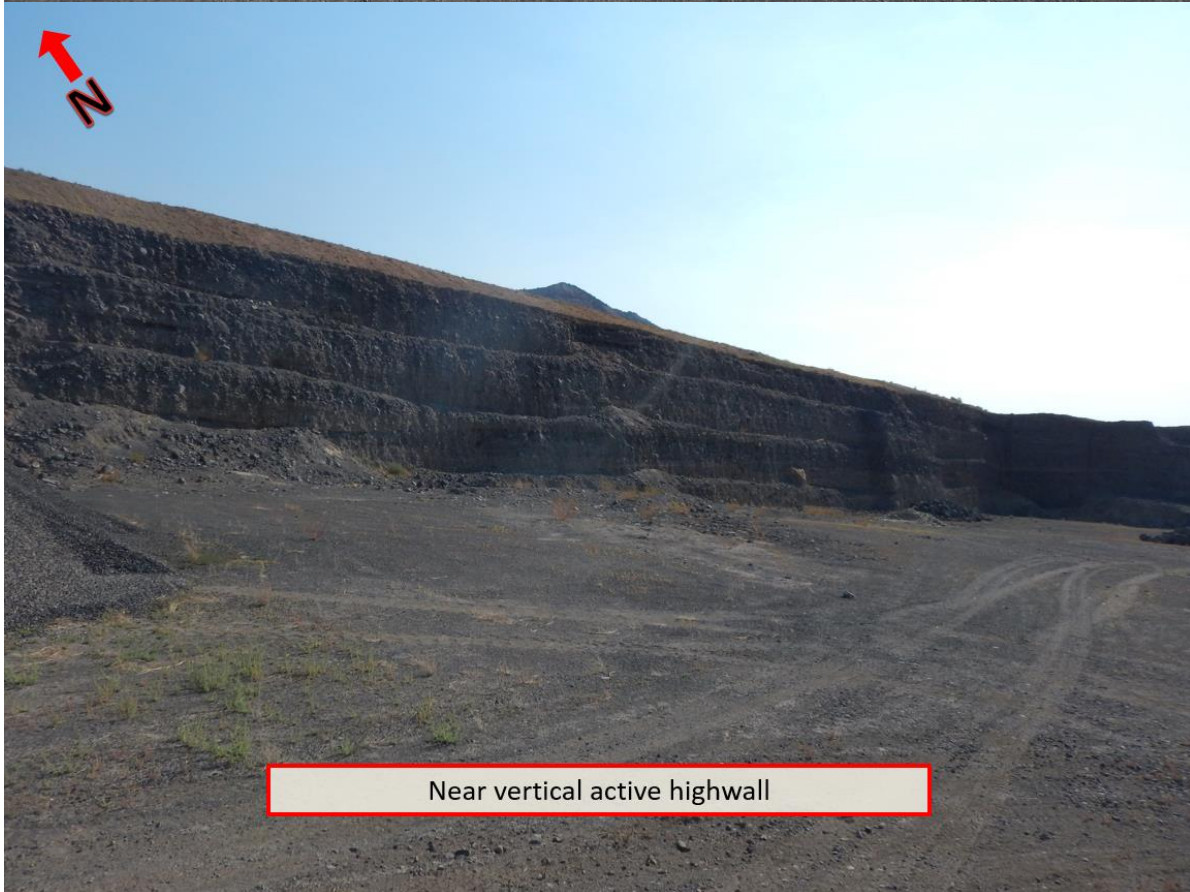
The active portion of mining is in the northeast corner. A 300 linear foot long near vertical highwall remains. The highwall is approximately; 40-50 feet tall. The rest of the perimeter highwalls have been sloped to approximately a 1:1 slope. There are a few spots where overburden has been excavated out of the 1:1 slopes making the appearance of a slide. Exterior highwalls are stable and only material being excavated sloughed. Topsoil is stored in a berm along the top of the highwalls.

Near vertical active highwall

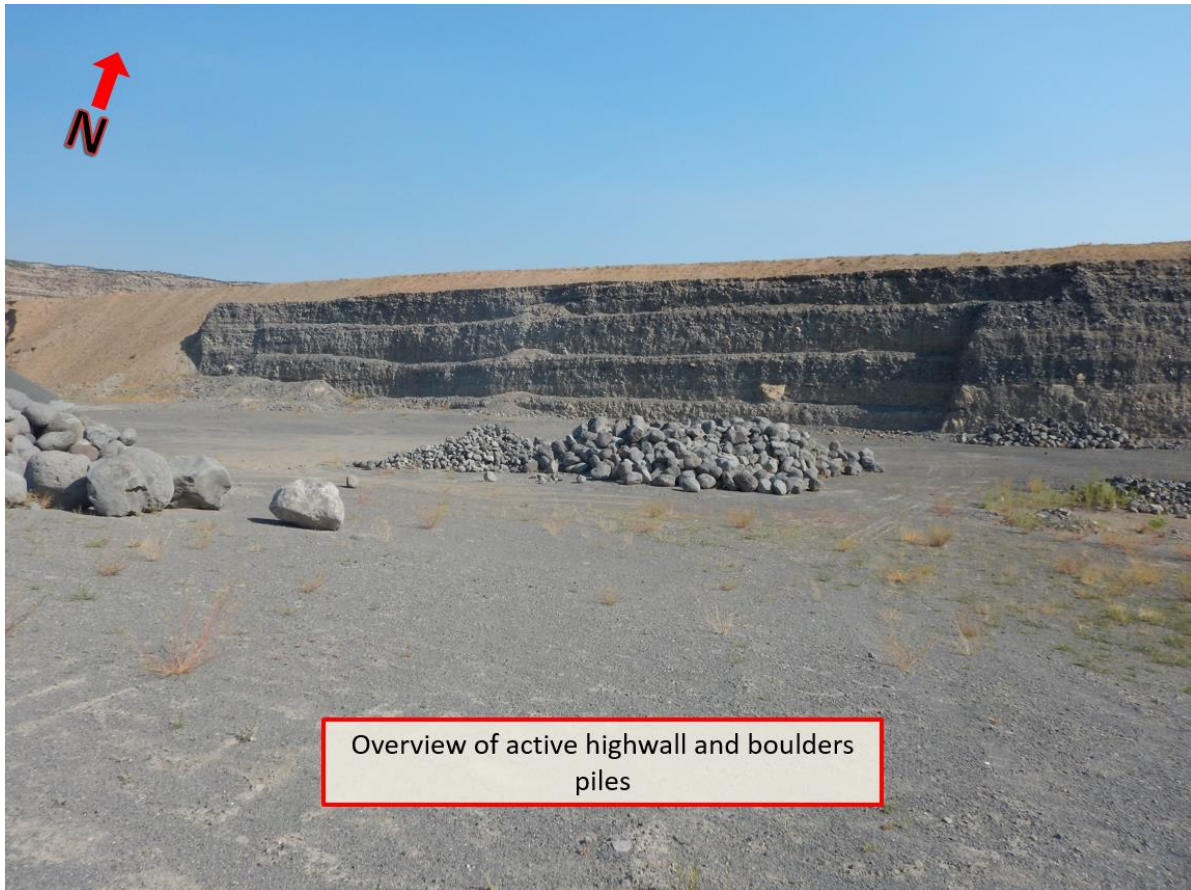
Overview of active highwall and boulders
piles
