**COLORADO**Division of Reclamation,
Mining and Safety

MINERALS PROGRAM INSPECTION REPORT**PHONE: (303) 866-3567**

MINE NAME: Holsinger Gravel Pit	MINE/PROSPECTING ID#: M-1980-052	MINERAL: Sand and gravel	COUNTY: Jackson
INSPECTION TYPE: Monitoring	INSPECTOR(S): Peter S. Hays	INSP. DATE: August 1, 2018	INSP. TIME: 13:00
OPERATOR: Keith Holsinger	OPERATOR REPRESENTATIVE: None	TYPE OF OPERATION: 110c - Construction Limited Impact	
REASON FOR INSPECTION: Normal I&E Program	BOND CALCULATION TYPE: Partial Bond	BOND AMOUNT: \$20,000.00	
DATE OF COMPLAINT: NA	POST INSP. CONTACTS: None	JOINT INSP. AGENCY: None	
WEATHER: Cloudy	INSPECTOR'S SIGNATURE:

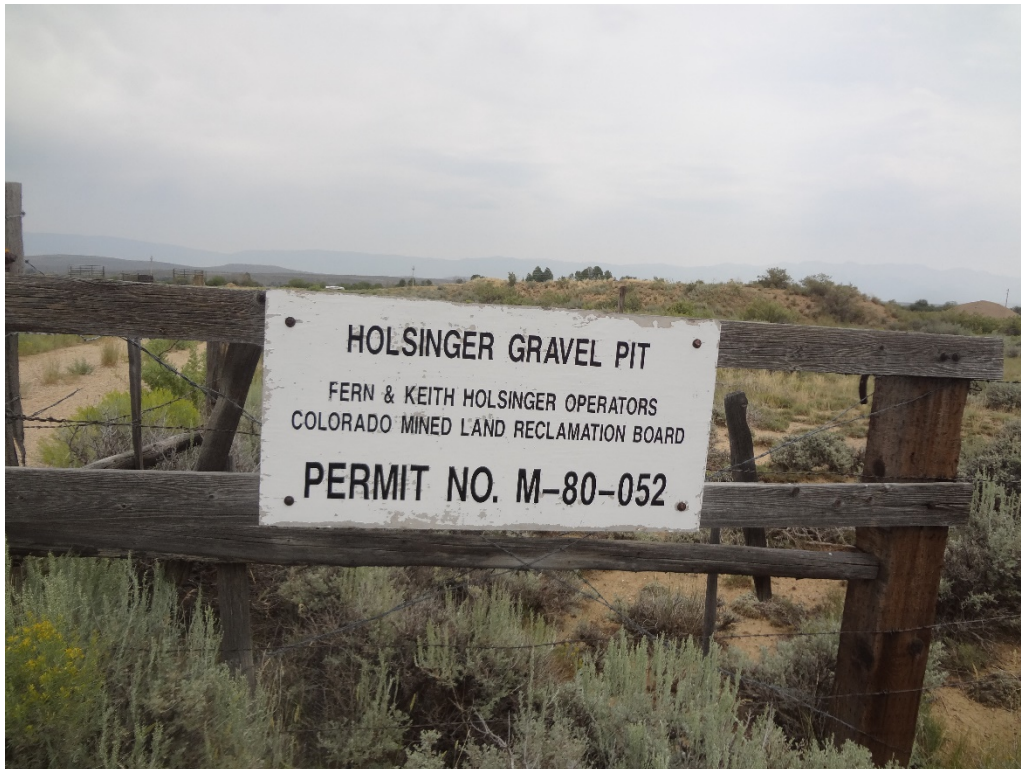
The Division currently holds a financial warranty of \$20,000.00, which appeared adequate to reclaim the site based on this inspection. An entrance sign was posted as required by Rule 3.1.12.

Holsinger Gravel Pit mine sign

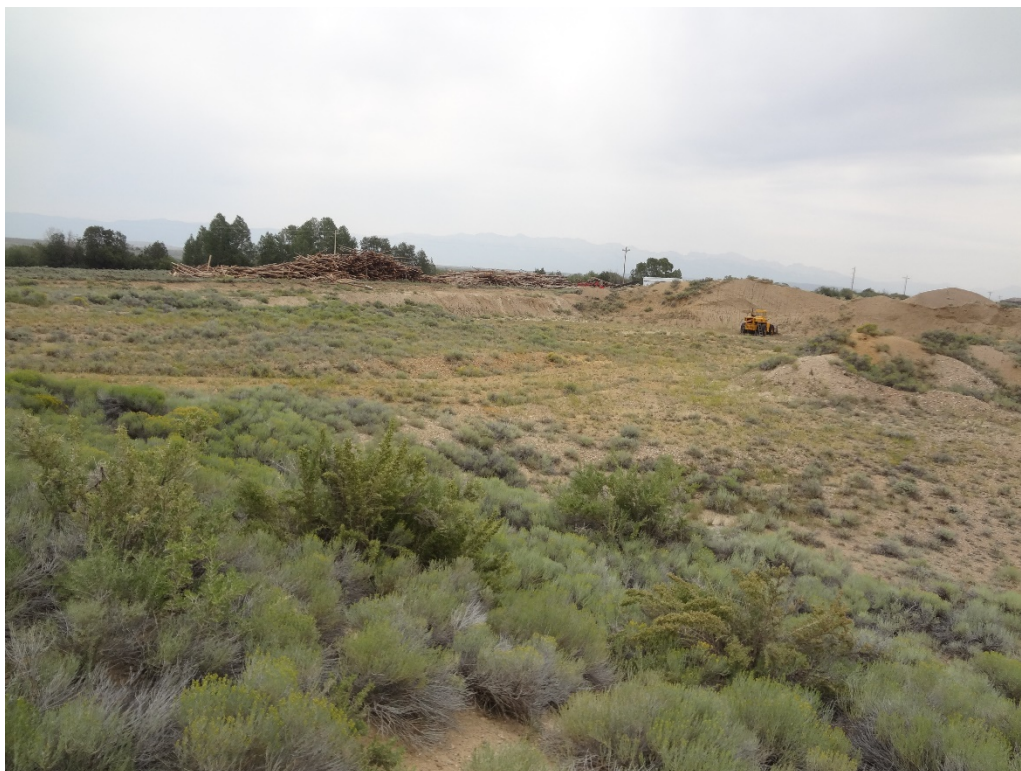
View of pit from the north end of the topsoil stockpile looking NE

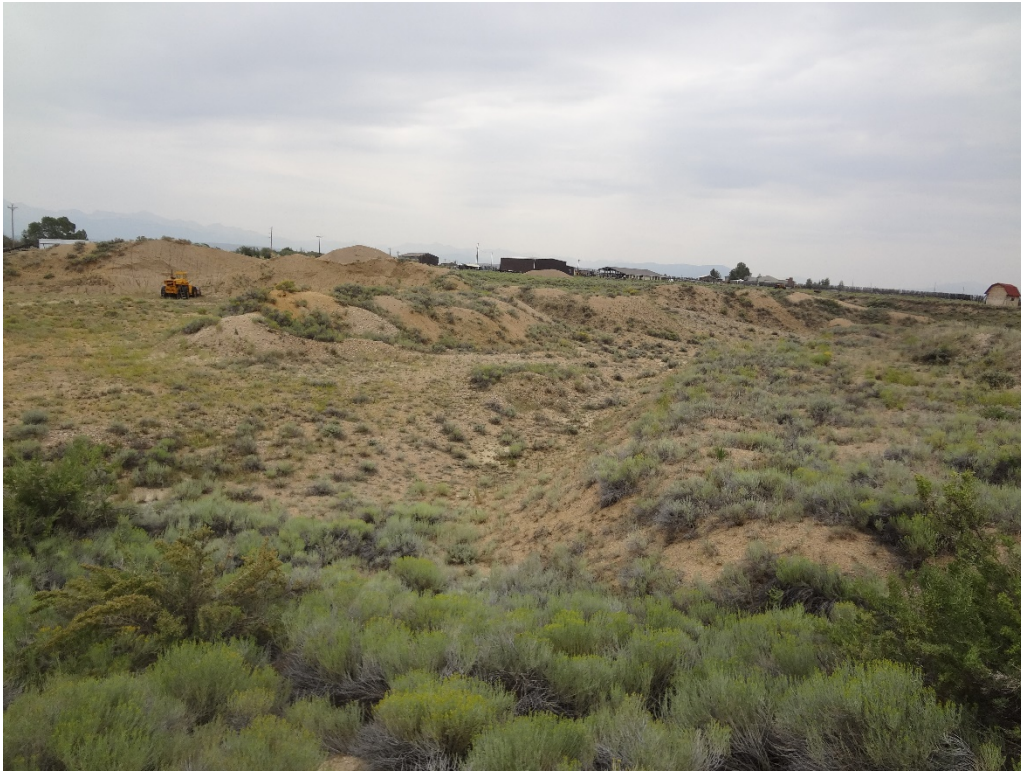
View of pit from the north end of the topsoil stockpile looking east

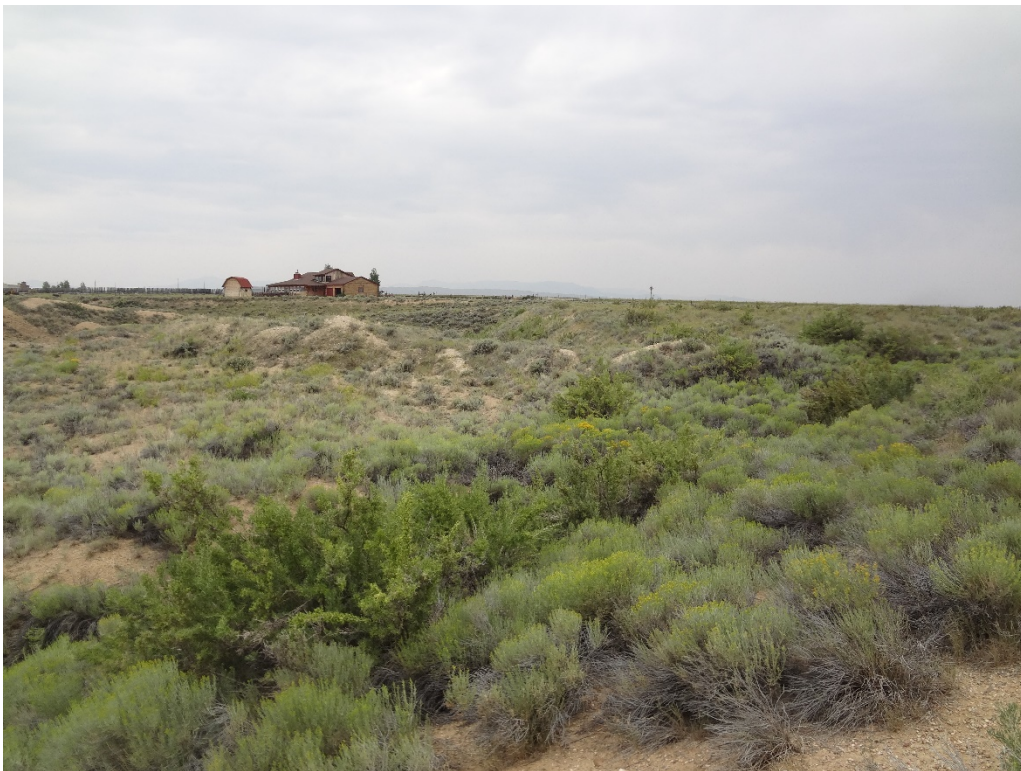
View of pit from the north end of the topsoil stockpile looking SE

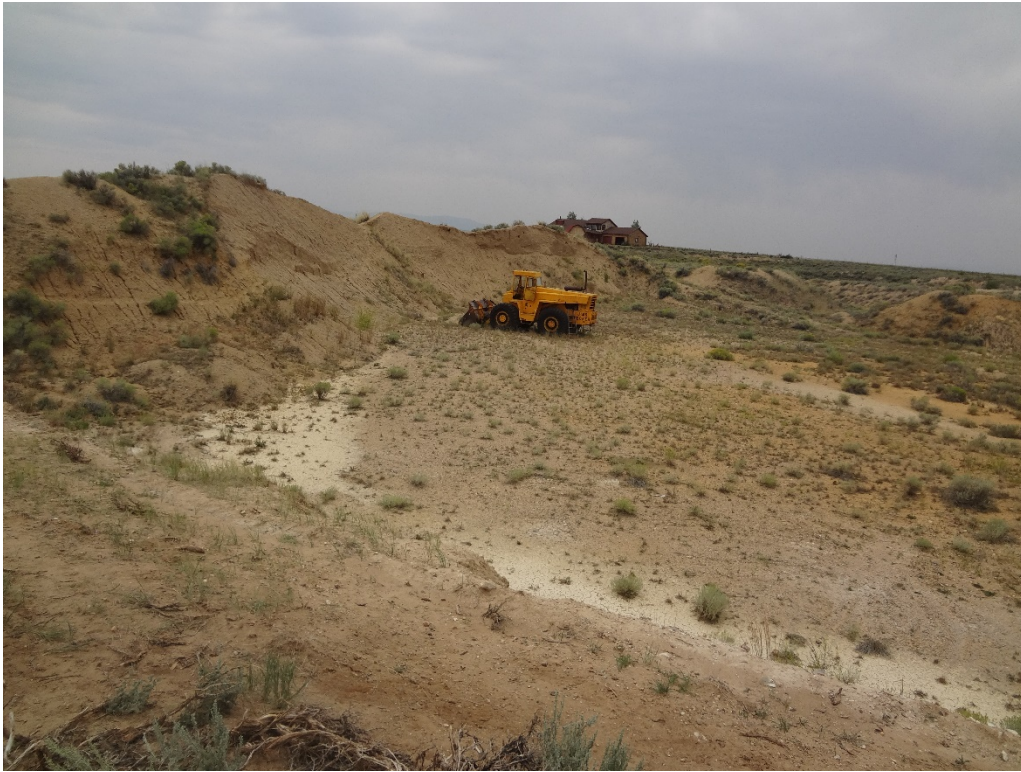
View of pit and highwall from north end of pit looking south

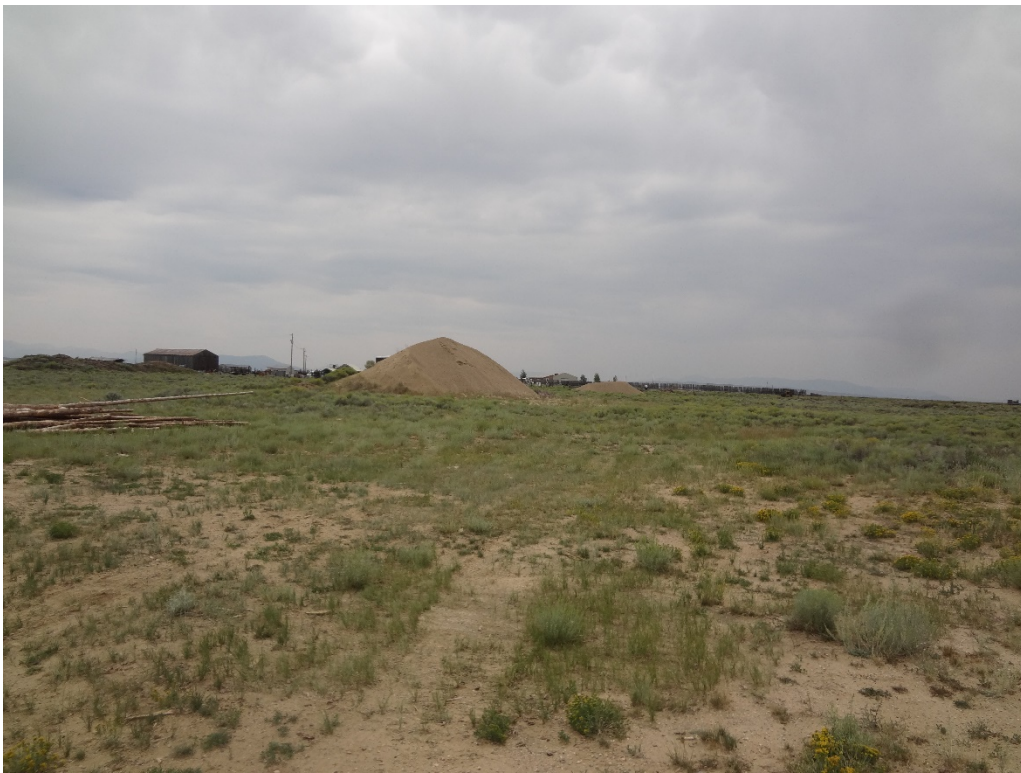
View of stockpiles east of the pit

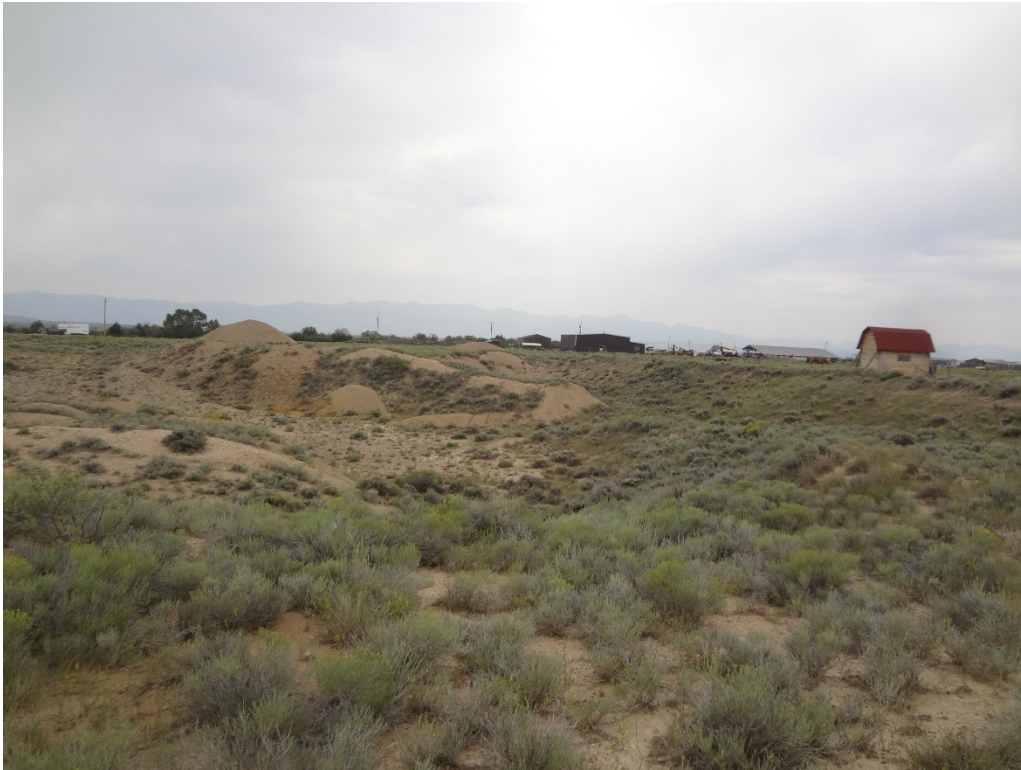
View of the site from the southeast corner looking north

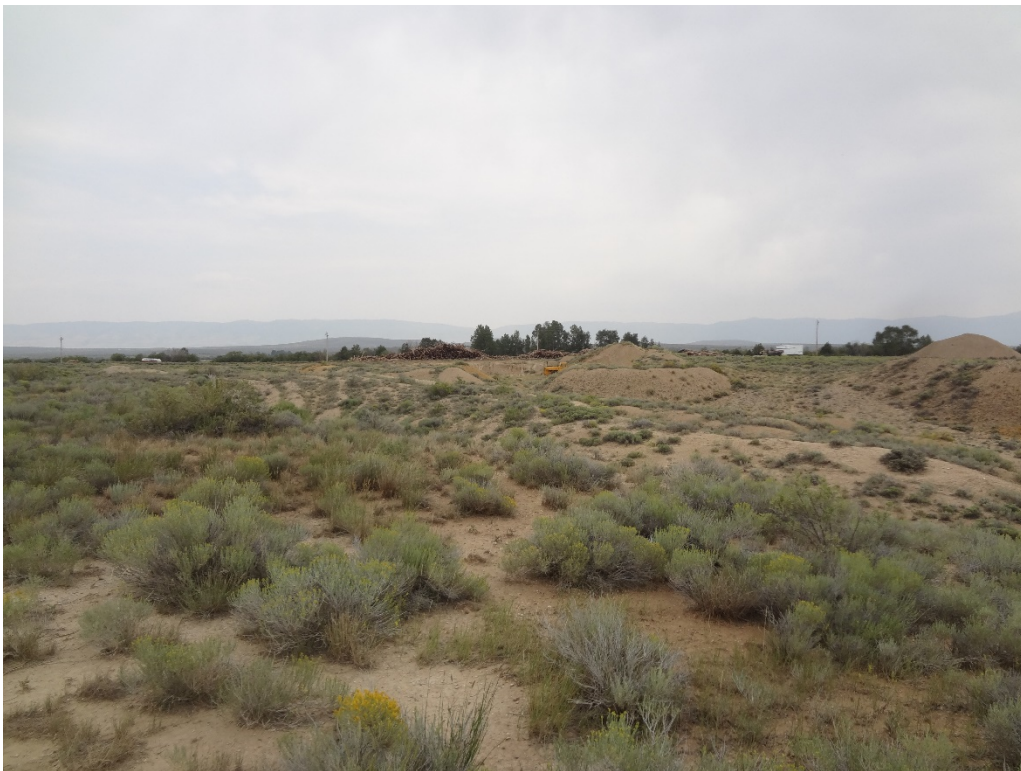
View of the site from the southeast corner looking NW
