**COLORADO**Division of Reclamation,
Mining and Safety

MINERALS PROGRAM INSPECTION REPORT**PHONE: (303) 866-3567**

MINE NAME: BLM East Gravel Pit	MINE/PROSPECTING ID#: M-1977-472	MINERAL: Sand and gravel	COUNTY: Jackson
INSPECTION TYPE: Monitoring	INSPECTOR(S): Peter S. Hays	INSP. DATE: August 2, 2018	INSP. TIME: 11:00
OPERATOR: Jackson County	OPERATOR REPRESENTATIVE: Andy Norris	TYPE OF OPERATION: 112c - Construction Regular Operation

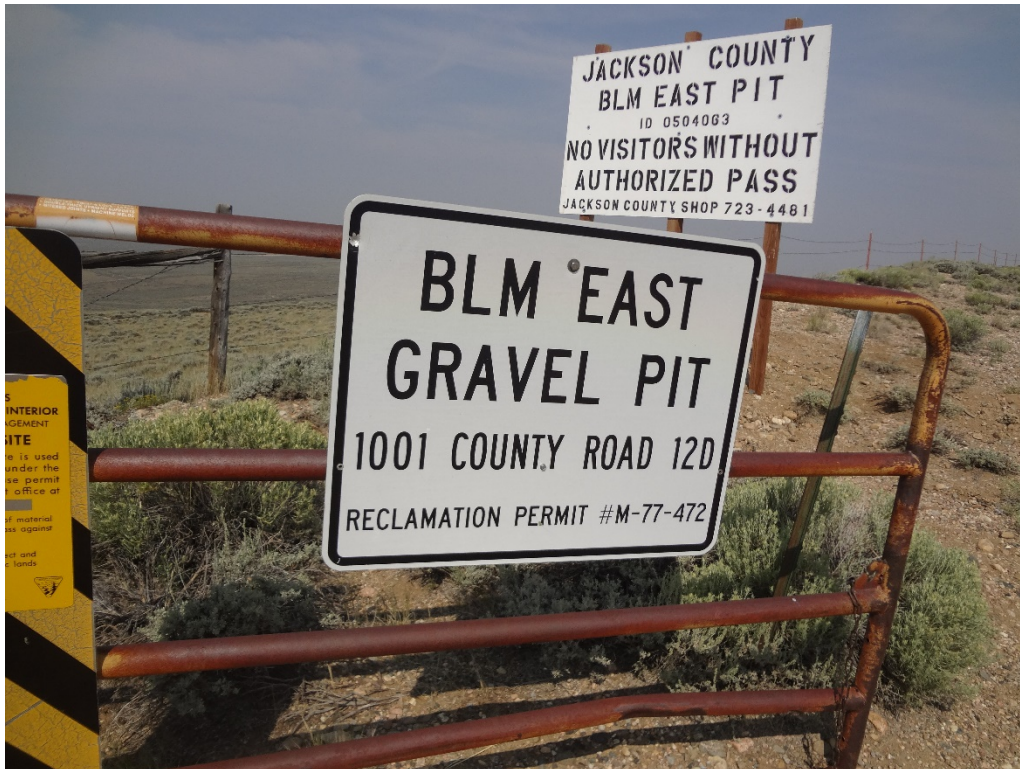
BLM East Gravel Pit mine sign

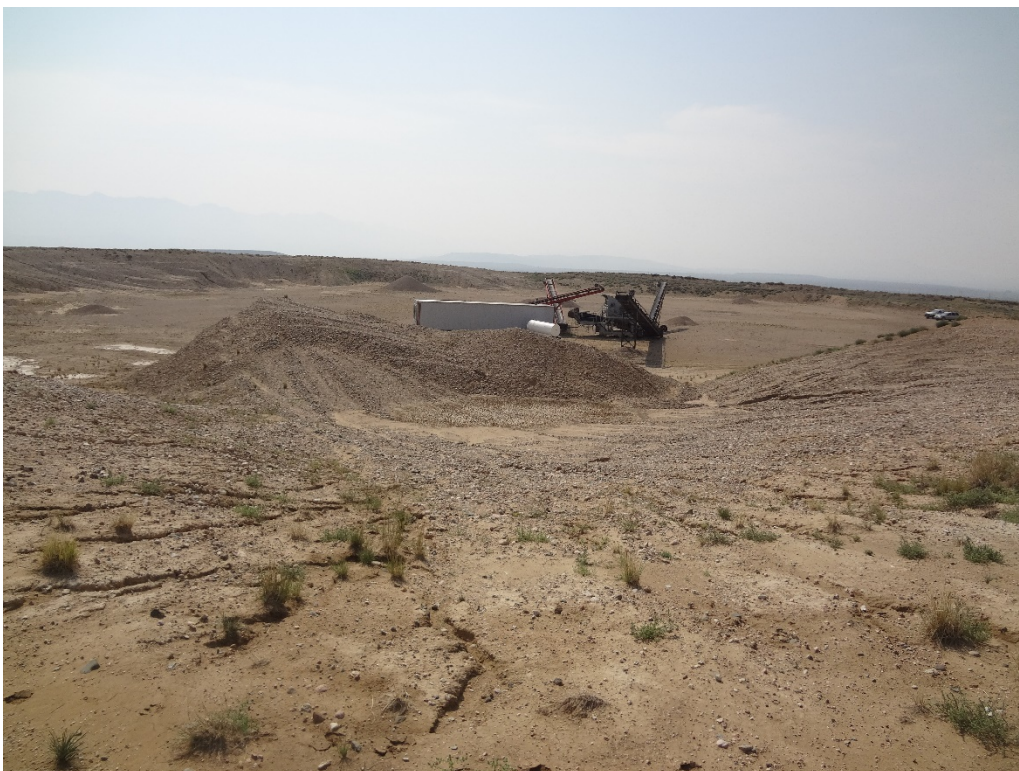
The site was not active during the inspection. Mining excavation in the peninsula section located in the northwest section of the permit was most recently mined. Topsoil was stripped ahead of mining excavation and stockpiled along the permit boundary. Mining excavation will continue towards the west in the peninsula section and be reclaimed concurrently. A processing plant and material stockpiles were located on the pit floor.

View of recent mining excavation and pit floor looking east

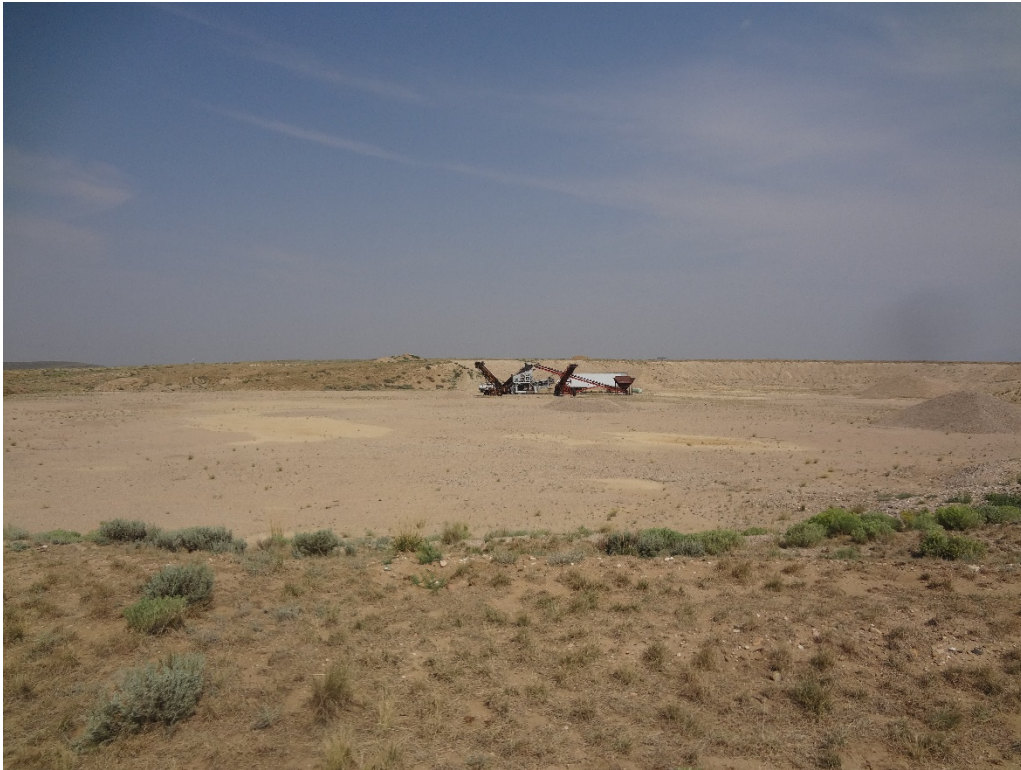
View of site from south end looking north

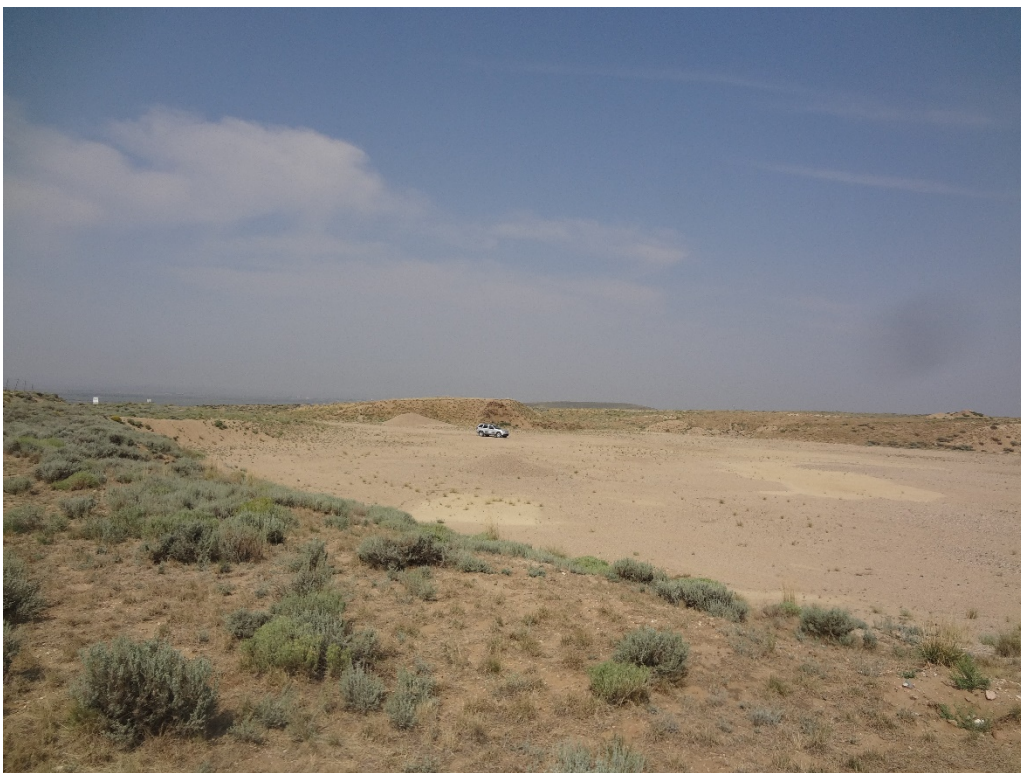
View of the site from the SE corner looking west

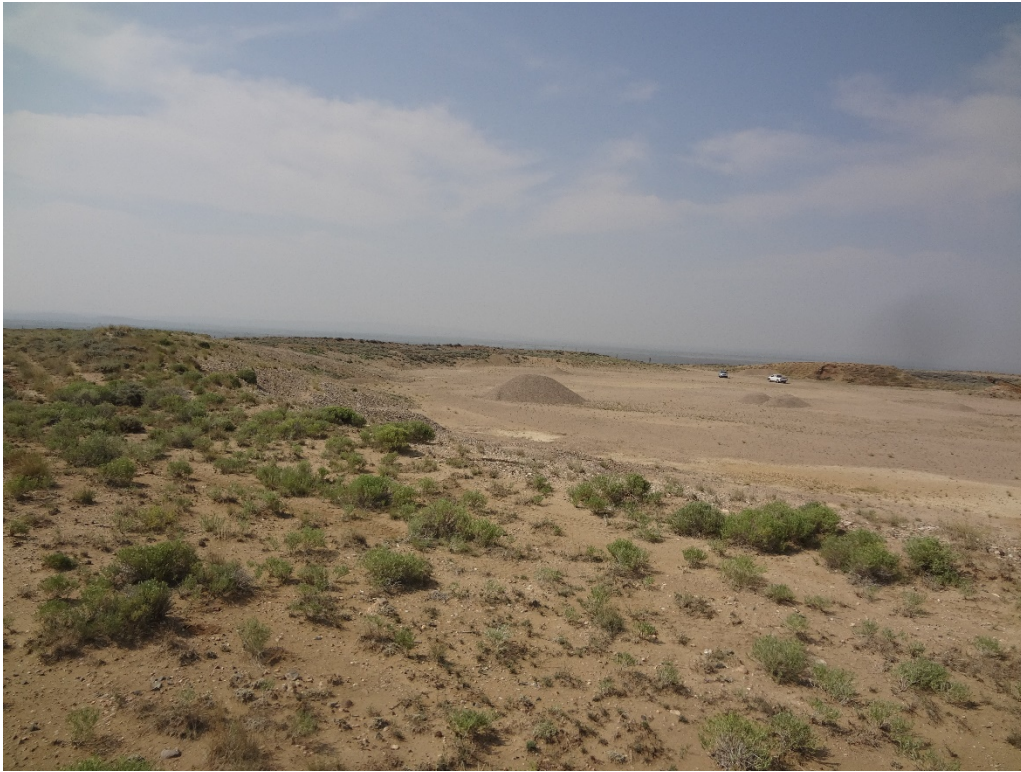
View of site from the north end looking SE

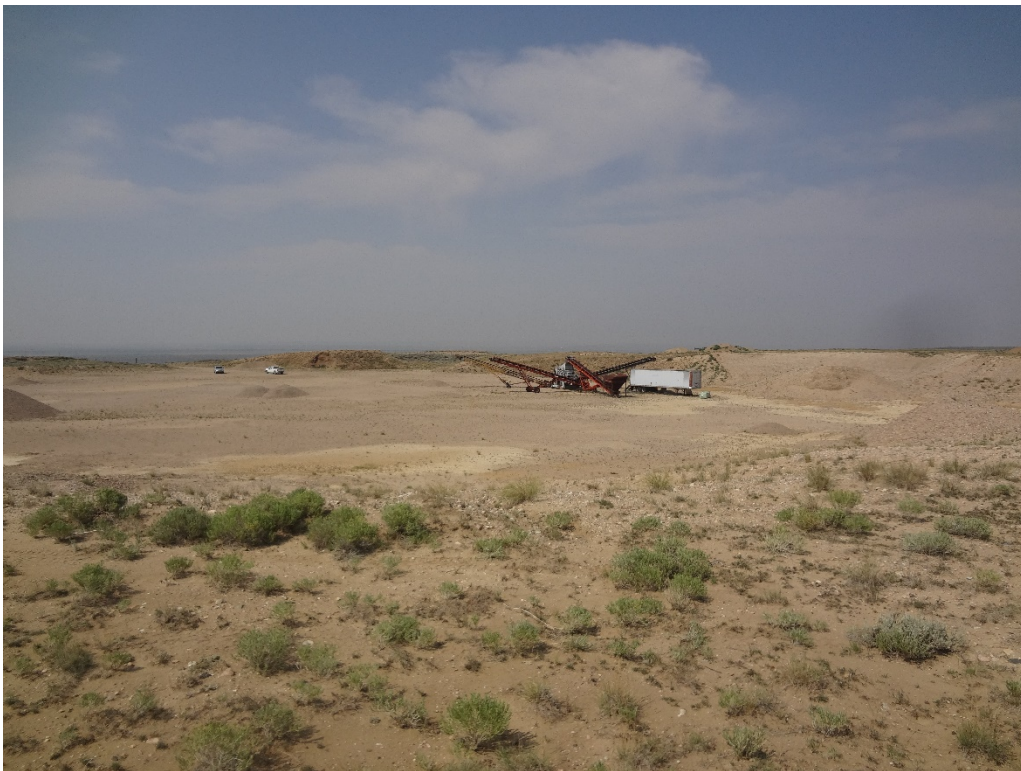
View of site from the north end looking SW

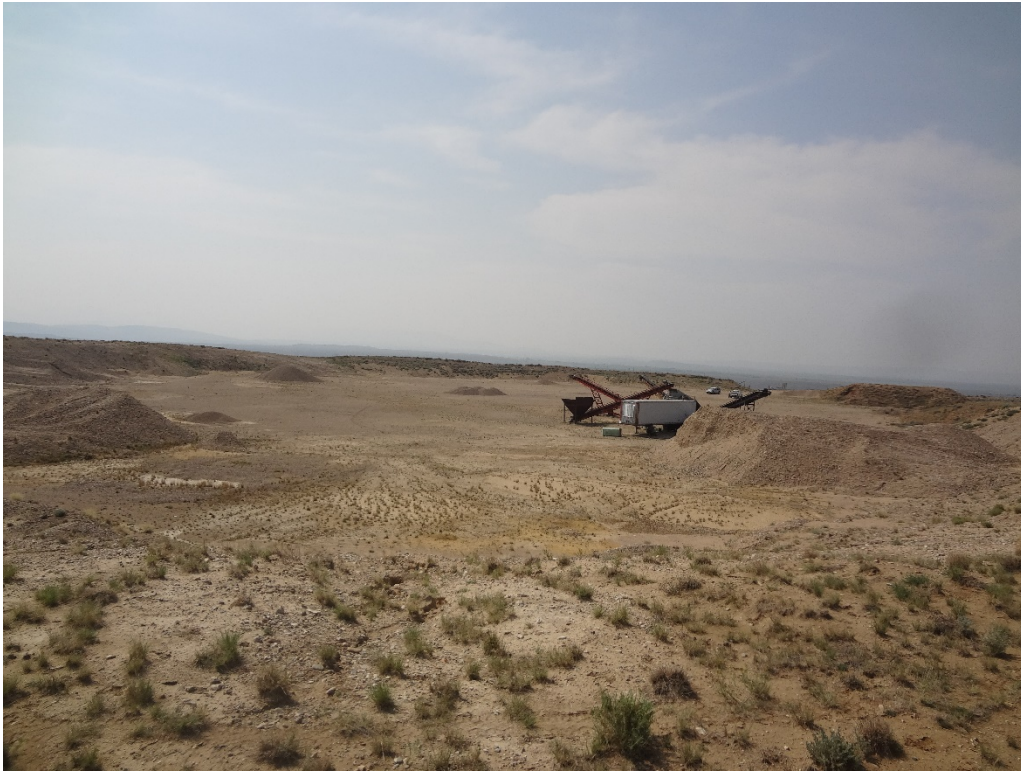
View of site from the NW corner looking SE

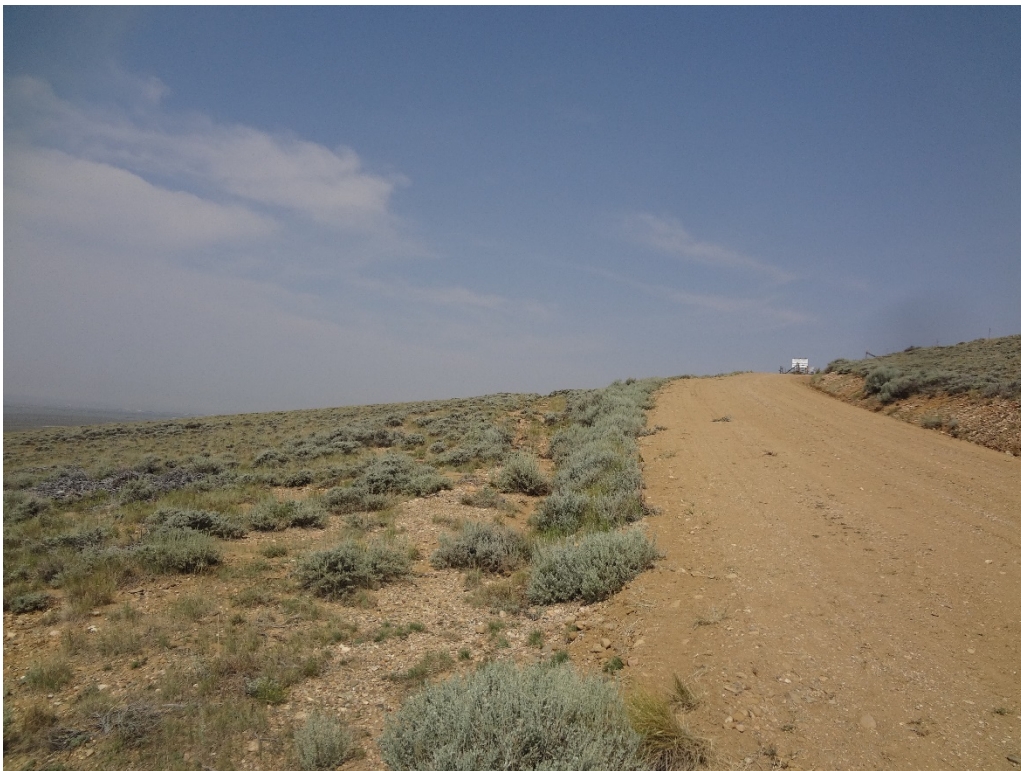
The approved post-mining land use for the site is rangeland. The reclamation of the old access road is complete. The road surface was vegetated by sagebrush and appeared stable. The imported topsoil stockpile remains in the southwest corner of the site. The topsoil and overburden stockpiles were signed accordingly, well-vegetated and stable. The approved reclamation plan states the slopes will be graded to 3H:1V to 4H:1V slopes, 12 inches of topsoil will be replaced and the site will be revegetated with the approved BLM seed mixture.

View of current and reclaimed road (to left) looking west
