MINERALS PROGRAM INSPECTION REPORT
PHONE: (303) 866-3567

MINE NAME: State Pit No. 38	MINE/PROSPECTING ID#: M-2006-076	MINERAL: Sand, gravel and clay	COUNTY: Moffat
INSPECTION TYPE: Monitoring	INSPECTOR(S): Amy C. Yeldell	INSP. DATE: August 7, 2018	INSP. TIME: 16:30
OPERATOR: Moffat County	OPERATOR REPRESENTATIVE: None	TYPE OF OPERATION: 112c - Construction Regular Operation	
REASON FOR INSPECTION: Normal I&E Program	BOND CALCULATION TYPE: IT.Bondcalculationtype.CD.Desc	BOND AMOUNT: \$0.00	
DATE OF COMPLAINT: NA	POST INSP. CONTACTS:	JOINT INSP. AGENCY: None	
WEATHER: Clear	INSPECTOR'S SIGNATURE:

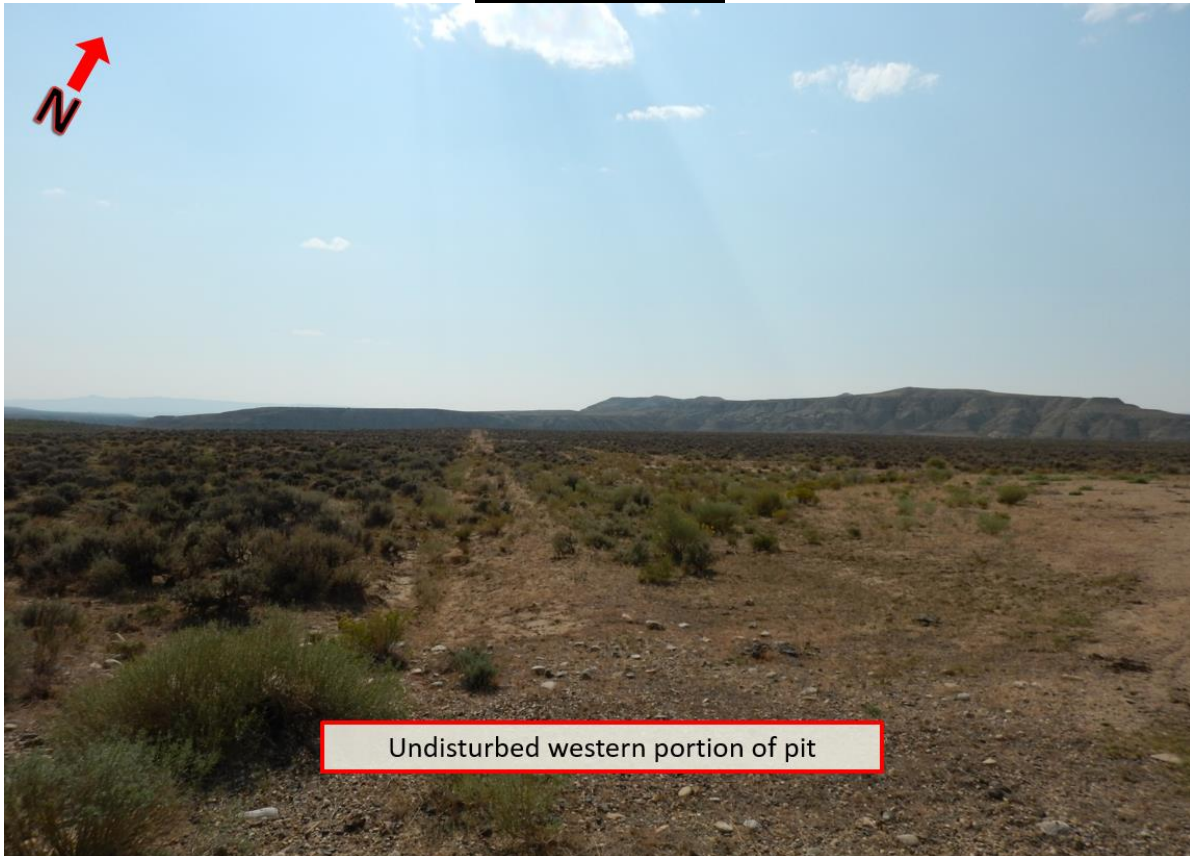
Undisturbed western portion of pit

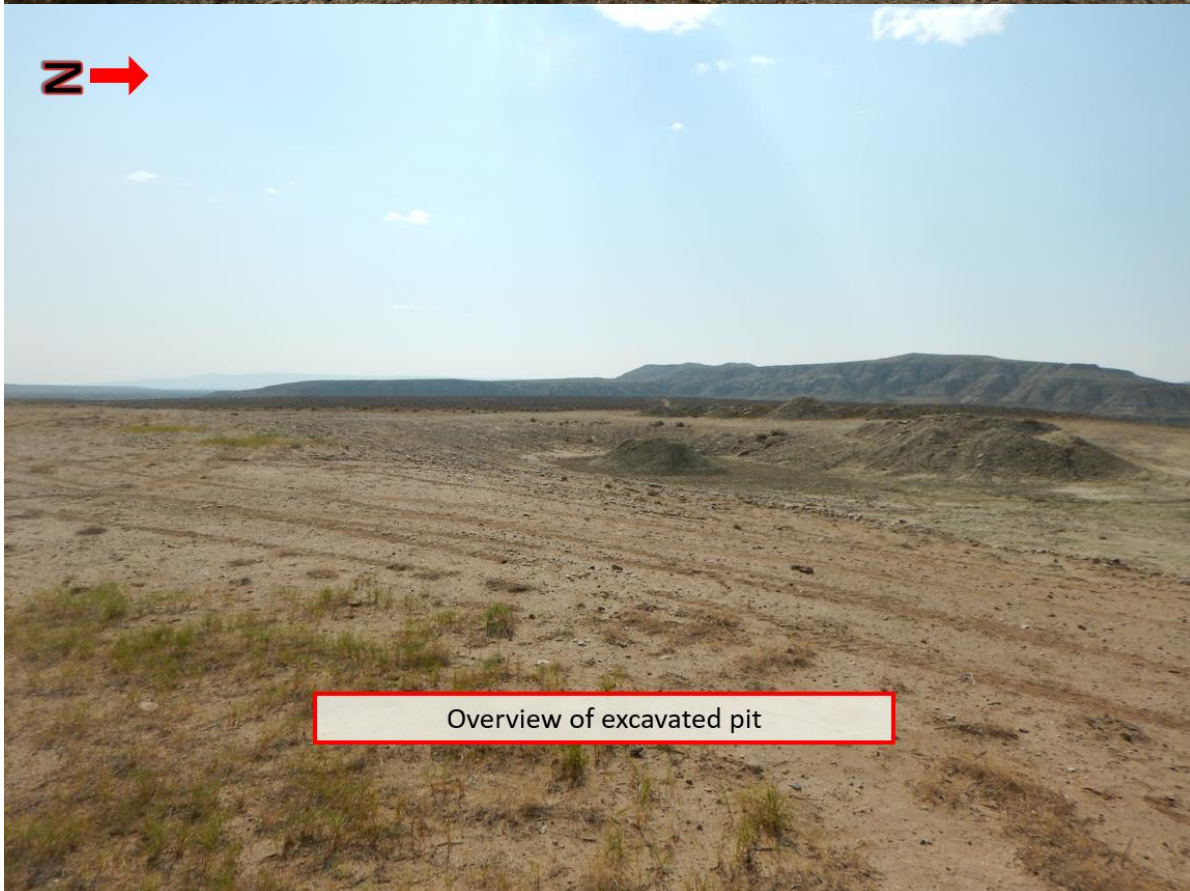
There was some bank erosion in the excavated pit, however all water flows into the pit so there is no threat to offsite impacts.

Overview of excavated pit
