MINERALS PROGRAM INSPECTION REPORT
PHONE: (303) 866-3567

MINE NAME: Wagner Pit	MINE/PROSPECTING ID#: M-2010-002	MINERAL: Sand and gravel	COUNTY: Moffat
INSPECTION TYPE: Monitoring	INSPECTOR(S): Amy C. Yeldell	INSP. DATE: August 8, 2018	INSP. TIME: 08:00
OPERATOR: Wagner Rock LLC	OPERATOR REPRESENTATIVE: Jay Wagner	TYPE OF OPERATION: 110c - Construction	
REASON FOR INSPECTION: Normal I&E Program	BOND CALCULATION TYPE: Complete Bond	BOND AMOUNT: \$13,600.00	
DATE OF COMPLAINT: NA	POST INSP. CONTACTS: DRMS	JOINT INSP. AGENCY: None	
WEATHER: Clear	INSPECTOR'S SIGNATURE:

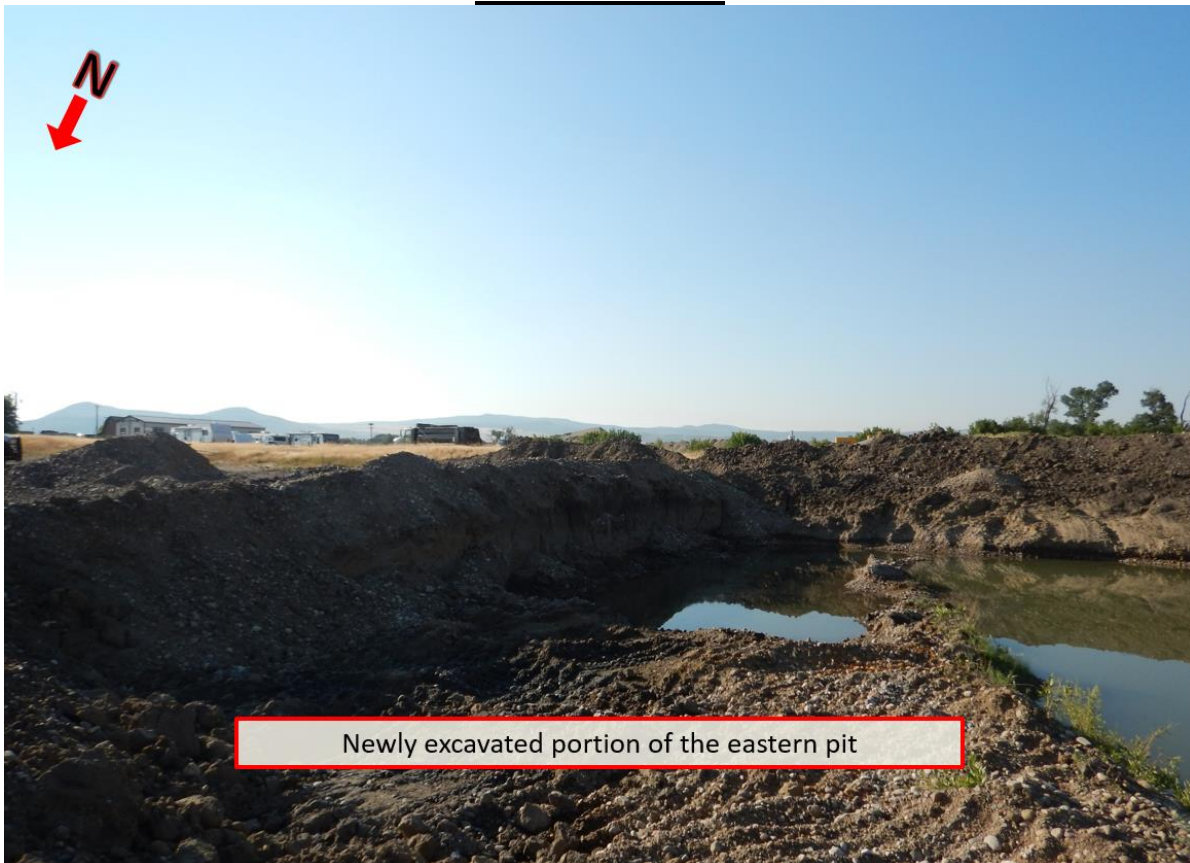
The eastern pit has been increased in size to be approximately 100 x 200 feet with 1:1 slopes. The pit is approximately 15 feet deep with 5 feet of water in the bottom at the deepest spots. Previously the pit was dewatered by pumping into the western pit. However at this time material is excavated wet and dries out before it's processed due to the very dry weather conditions. There are several small stockpiles adjacent to the excavated pit and plant. Overburden and topsoil stockpile is stored to the south of the excavation. They have not yet been reseeded. If stockpiles are going to sit and not be utilized later this season they should be stabilized per Rule 3.1.9(1).

Newly excavated portion of the eastern pit

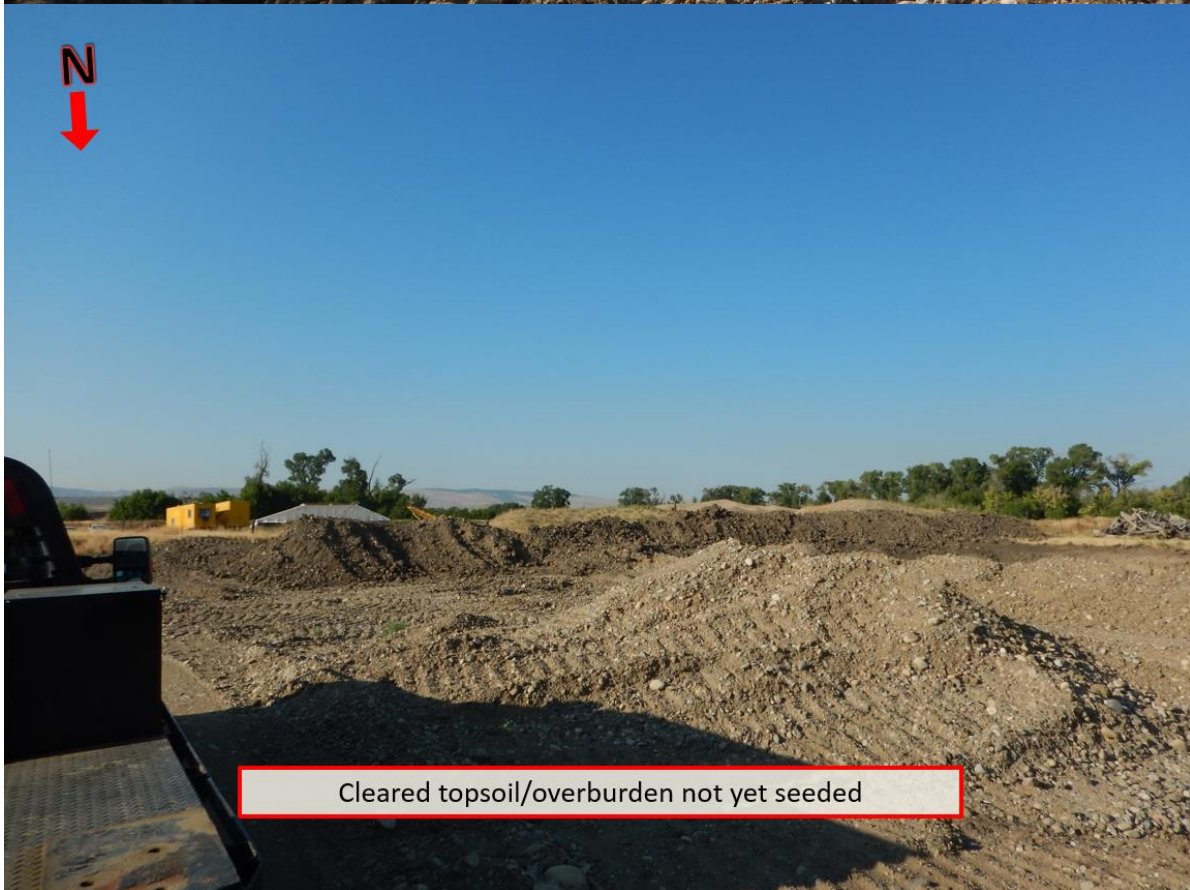
Cleared topsoil/overburden not yet seeded
