**MINERALS PROGRAM INSPECTION REPORT**  
**PHONE: (303) 866-3567**

<b>MINE NAME:</b> Williams/Illinois Gravel Pit	<b>MINE/PROSPECTING ID#:</b> M-1997-039	<b>MINERAL:</b> Gravel and sand	<b>COUNTY:</b> Jackson
<b>INSPECTION TYPE:</b> Monitoring	<b>INSPECTOR(S):</b> Peter S. Hays	<b>INSP. DATE:</b> August 1, 2018	<b>INSP. TIME:</b> 10:30
<b>OPERATOR:</b> High Country Hard Rock, LLC	<b>OPERATOR REPRESENTATIVE:</b> Josh Sibson	<b>TYPE OF OPERATION:</b> 112c - Construction Regular Operation	
<b>REASON FOR INSPECTION:</b> Priority	<b>BOND CALCULATION TYPE:</b> Complete Bond	<b>BOND AMOUNT:</b> \$40,000.00	
<b>DATE OF COMPLAINT:</b> NA	<b>POST INSP. CONTACTS:</b> None	<b>JOINT INSP. AGENCY:</b> None	
<b>WEATHER:</b> Clear	<b>INSPECTOR'S SIGNATURE:</b>

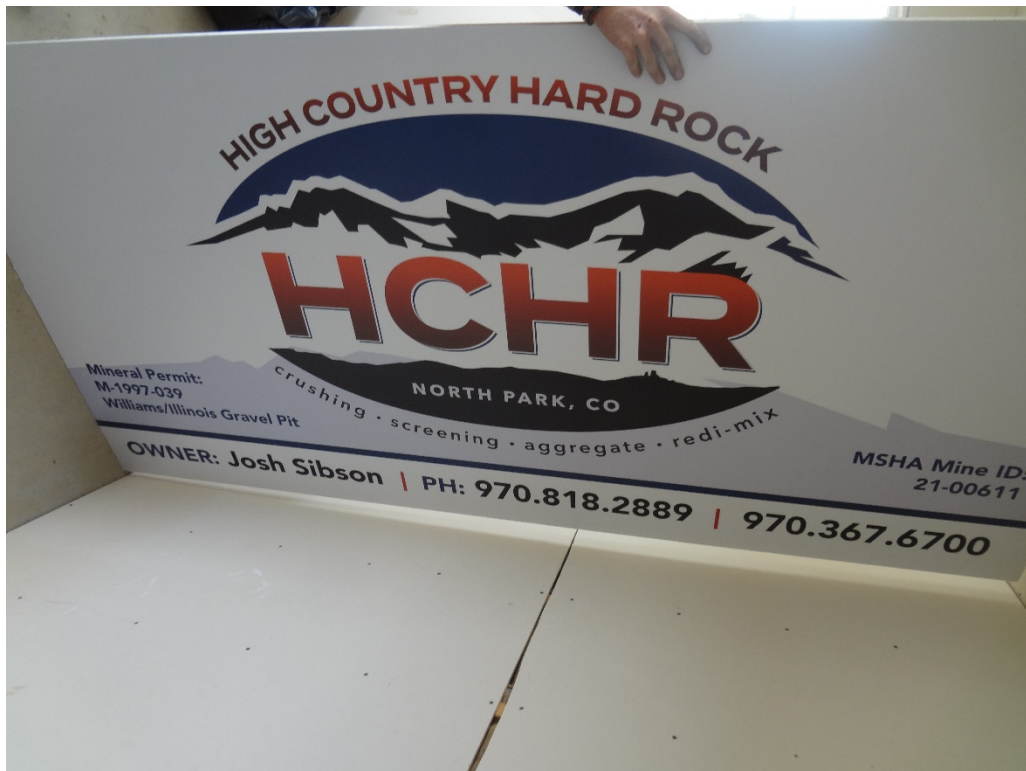
A new entrance sign was being installed at the entrance and permit boundary markers were observed as required by Rule 3.1.12.

New Mine Sign

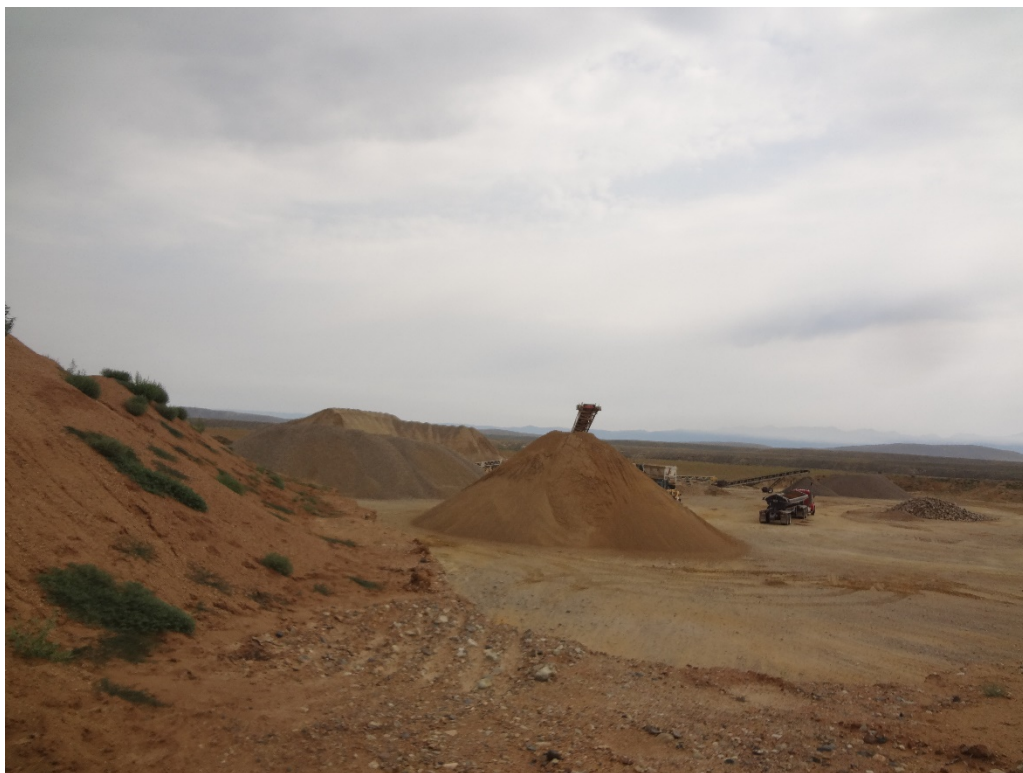
View of site from the SW corner of Phase 1 looking NE

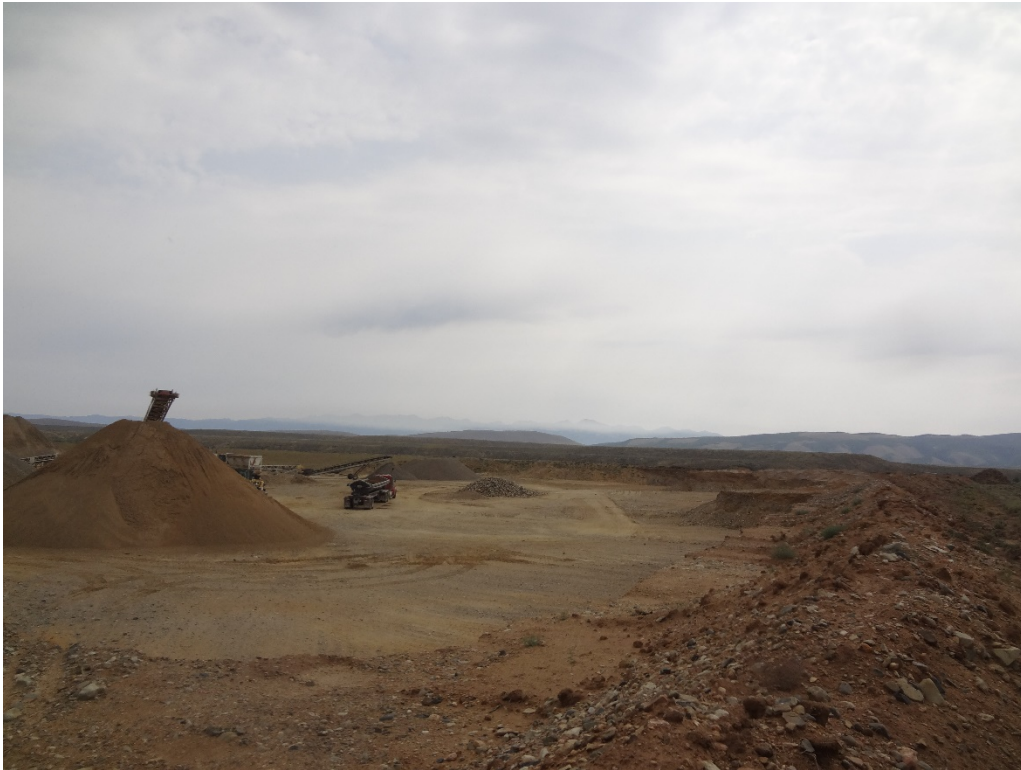
View of site from the SW corner of Phase 1 looking east

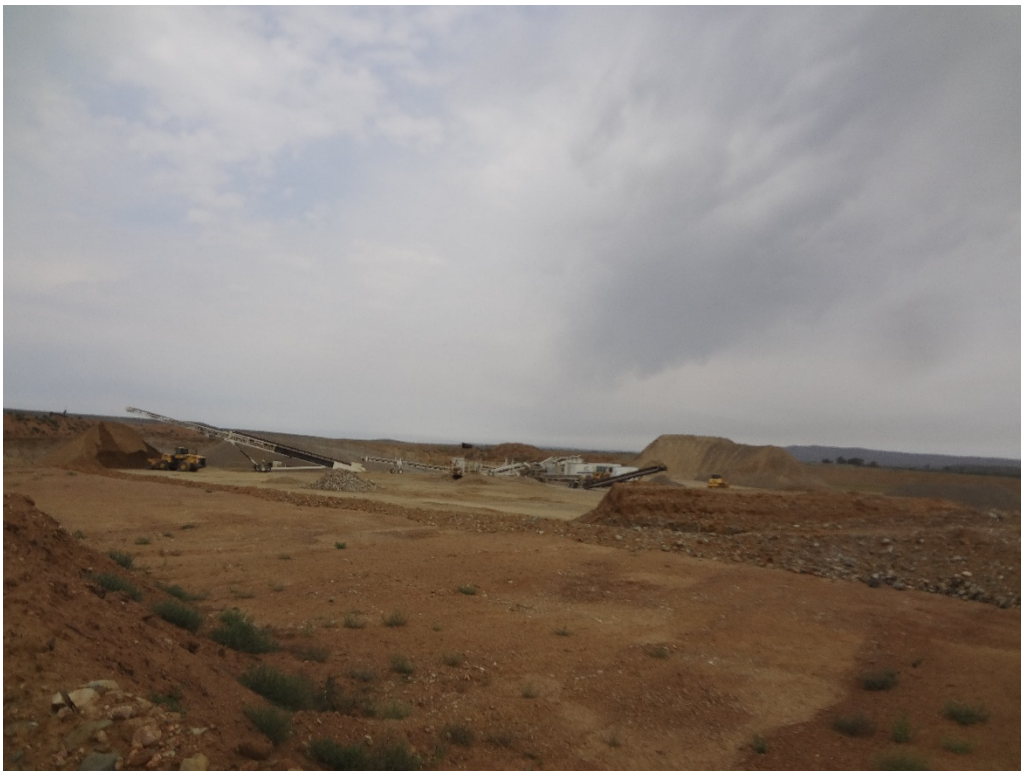
View of site from the SE corner of Phase 1 looking NW, remaining mine area in foreground

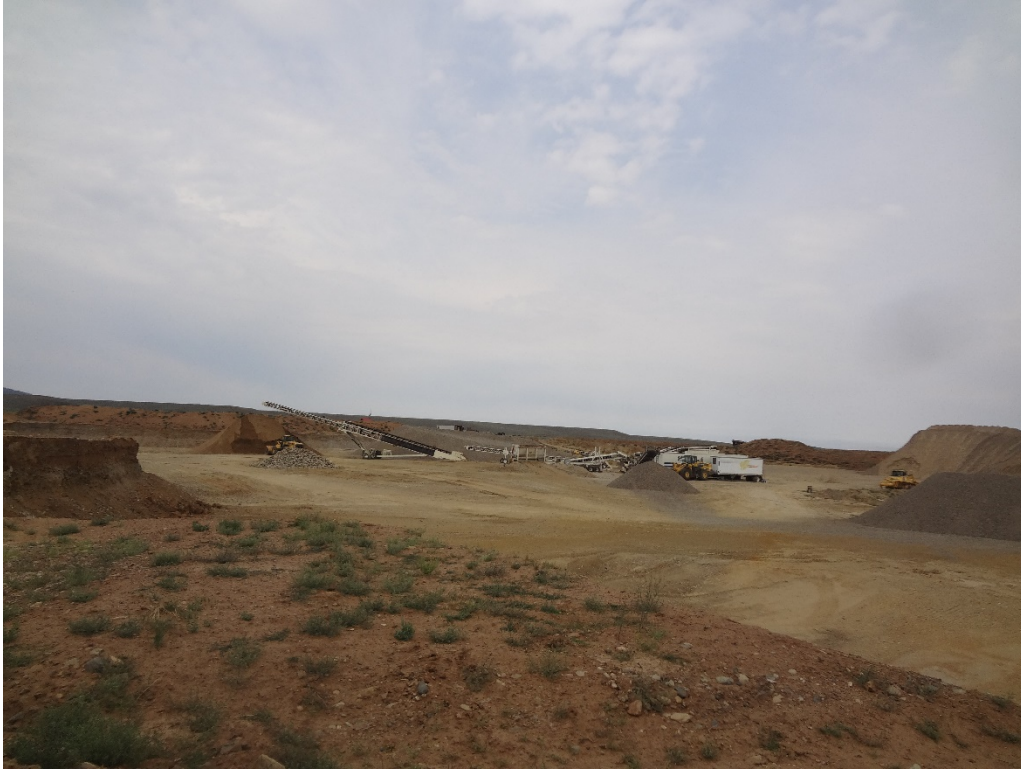
View of site from the NE corner of Phase 1 looking west

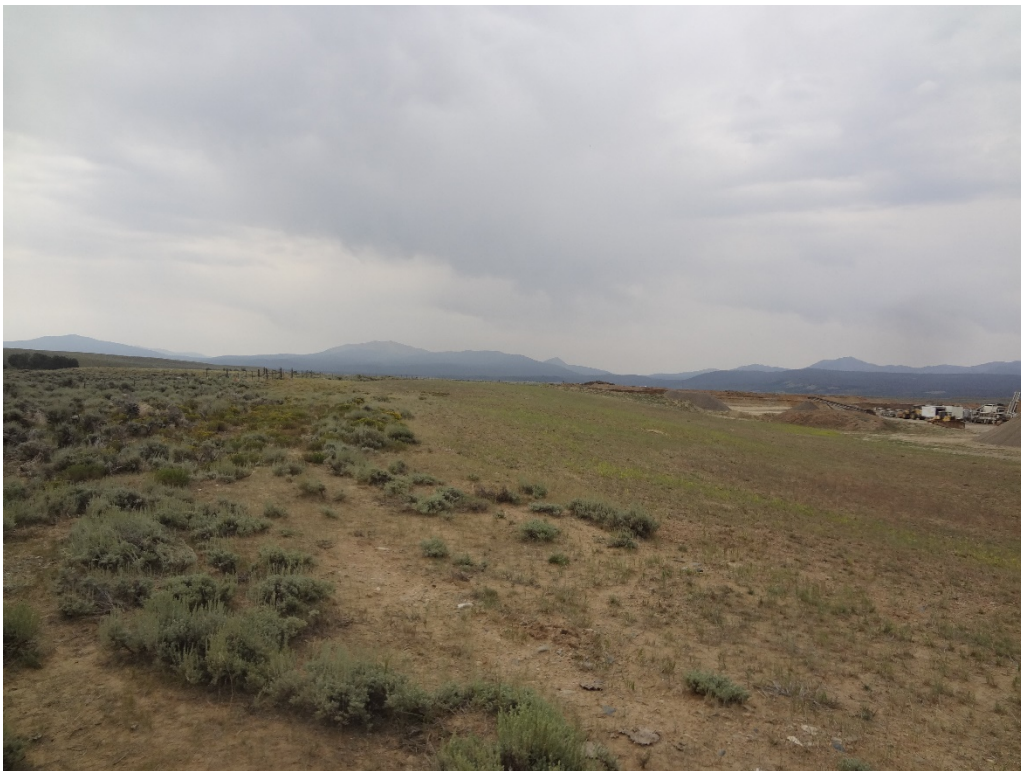
View of site from the NE corner of the 110c pit looking south

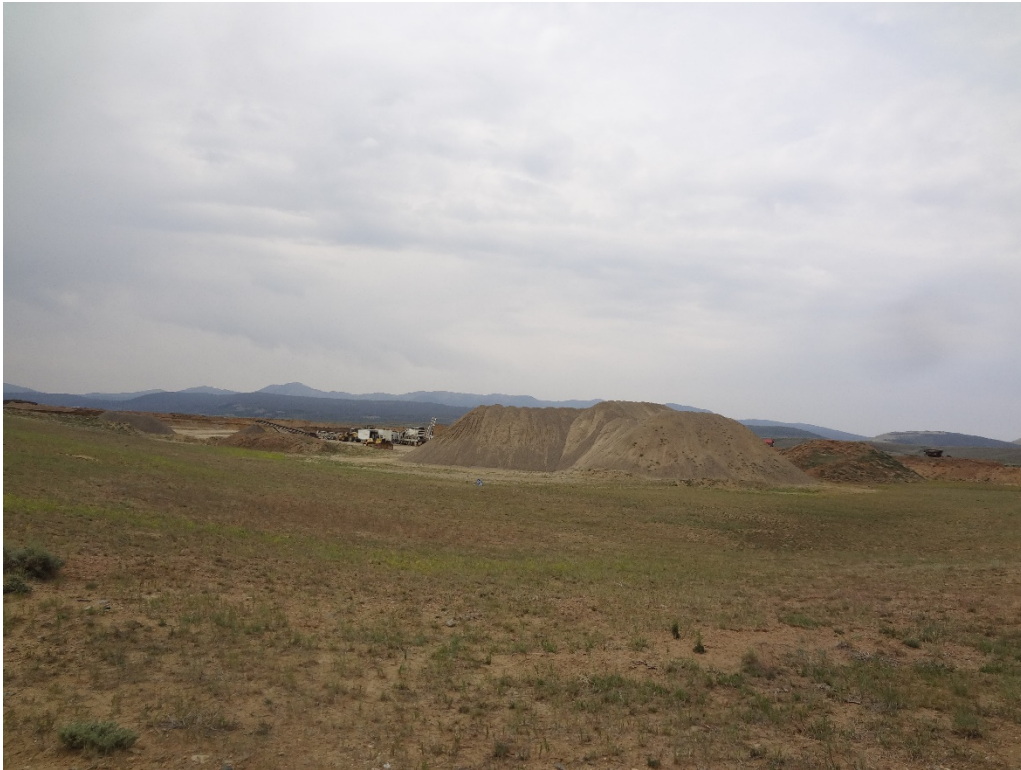
View of site from the NE corner of the 110c pit looking SW

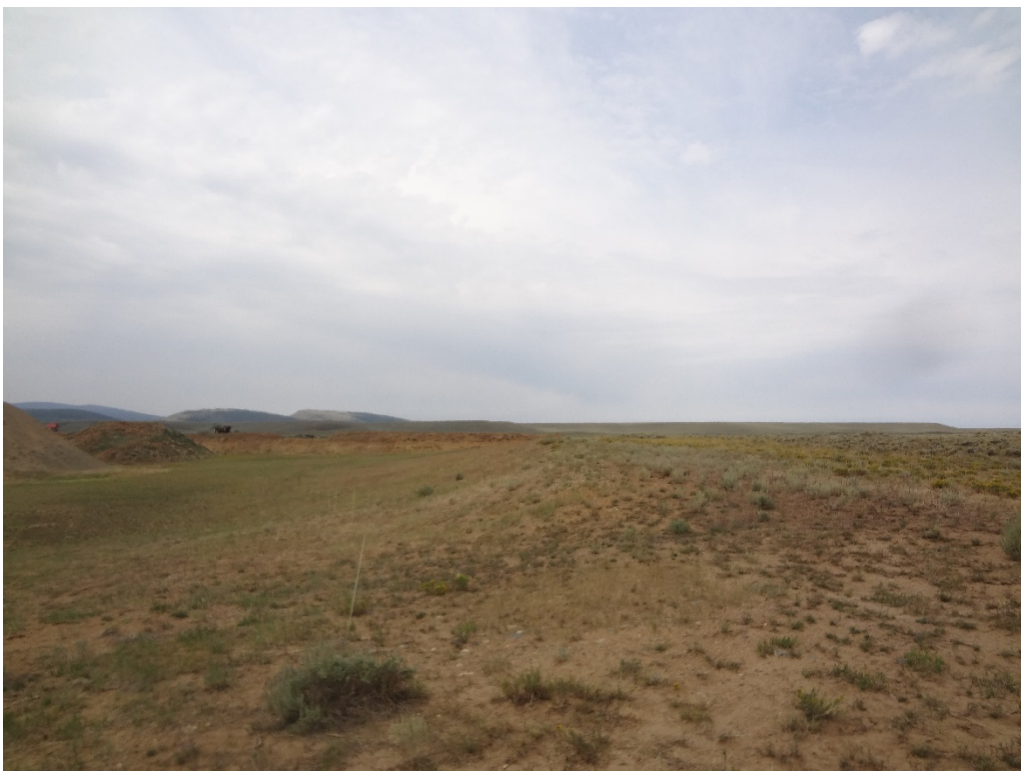
View of site from the NE corner of the 110c pit looking west
