**COLORADO**Division of Reclamation,
Mining and Safety

MINERALS PROGRAM INSPECTION REPORT**PHONE: (303) 866-3567**

MINE NAME: Pitch Project	MINE/PROSPECTING ID#: M-1977-004	MINERAL: Uranium	COUNTY: Saguache
INSPECTION TYPE: Monitoring	INSPECTOR(S): Dustin M. Czaplá	INSP. DATE: July 25, 2018	INSP. TIME: 11:00
OPERATOR: Homestake Mining Company	OPERATOR REPRESENTATIVE: David Wykoff	TYPE OF OPERATION: 112d-3 - Designated Mining Operation	
REASON FOR INSPECTION: Normal I&E Program	BOND CALCULATION TYPE: None	BOND AMOUNT: \$2,263,000.00	
DATE OF COMPLAINT: NA	POST INSP. CONTACTS: None	JOINT INSP. AGENCY: None	
WEATHER: Clear	INSPECTOR'S SIGNATURE:

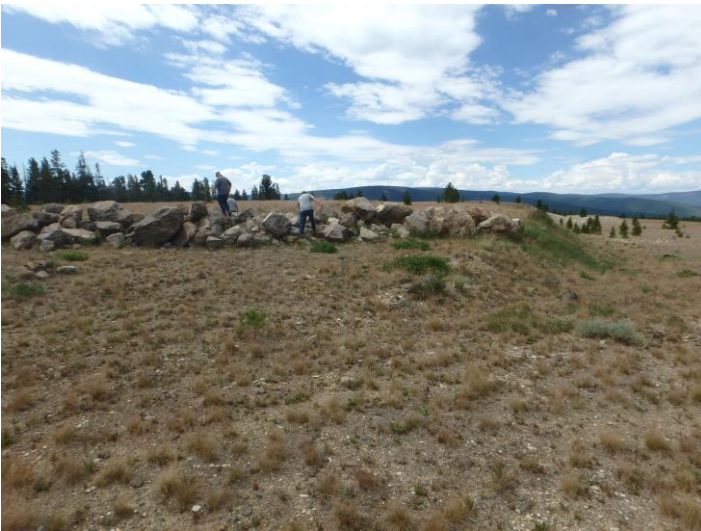
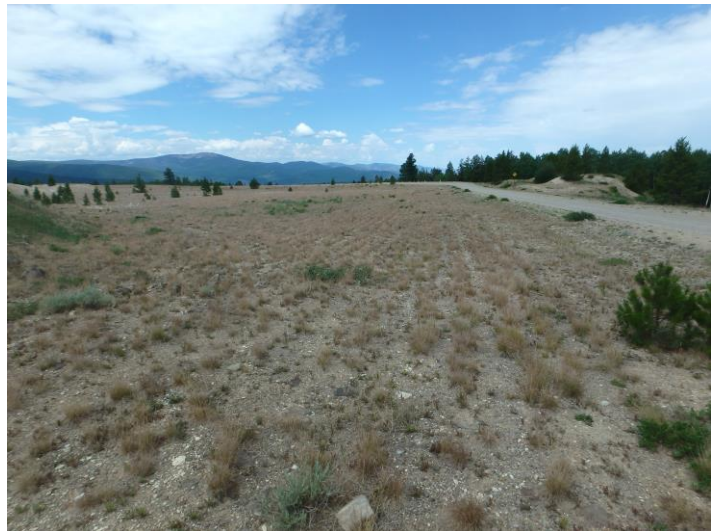
Mill Site: Final reclamation grading has been completed in the mill site area. The area has been seeded and vegetation is well established.

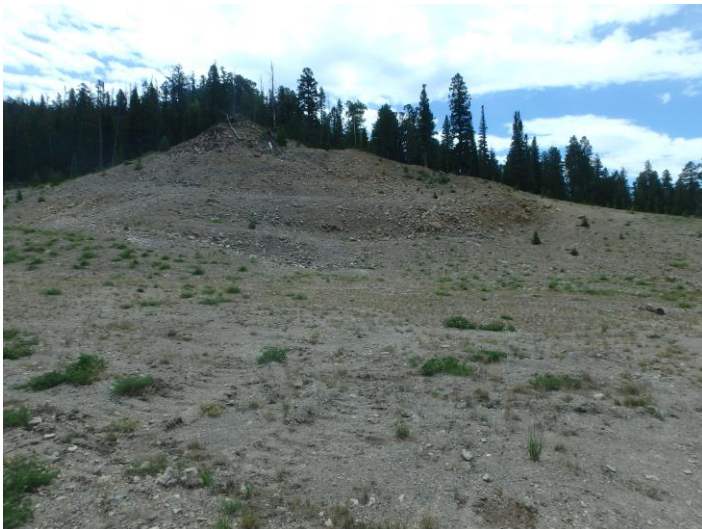
Limestone Quarry: The limestone quarry slopes appear stable. Reclamation has not occurred in this area yet. Slope reduction, topsoil replacement and revegetation will be required in this area upon final reclamation.

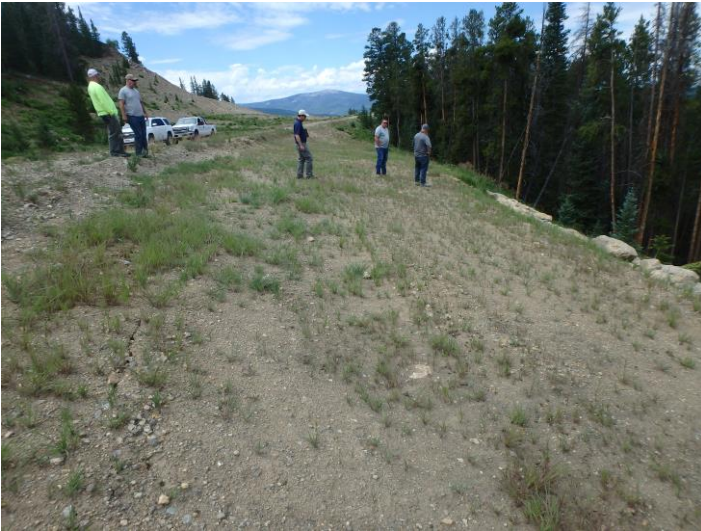
Roads: No problems were noted with any of the internal roads. The roads are well maintained. The repair work completed in 2015 on the failed portion of the access road appears stable. The repair area has been seeded and vegetation is becoming well established.

Repaired slough area on access road

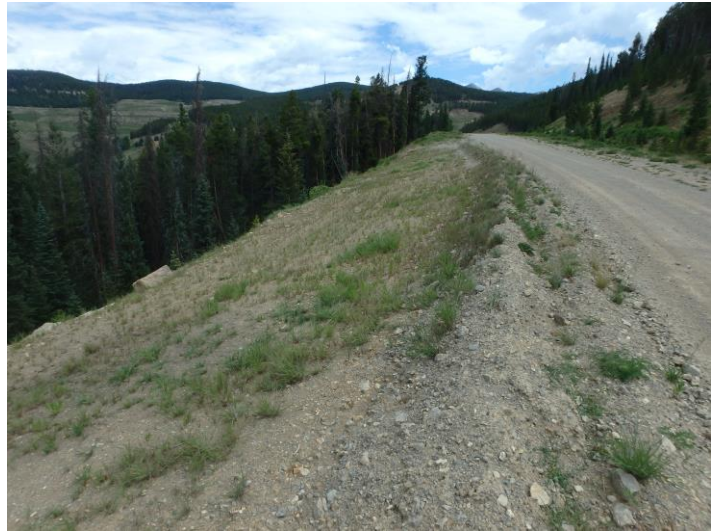
Repaired slough area on access road

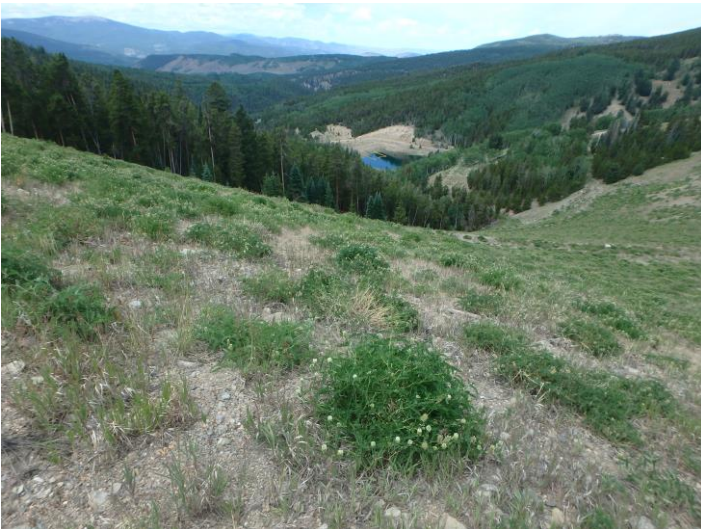
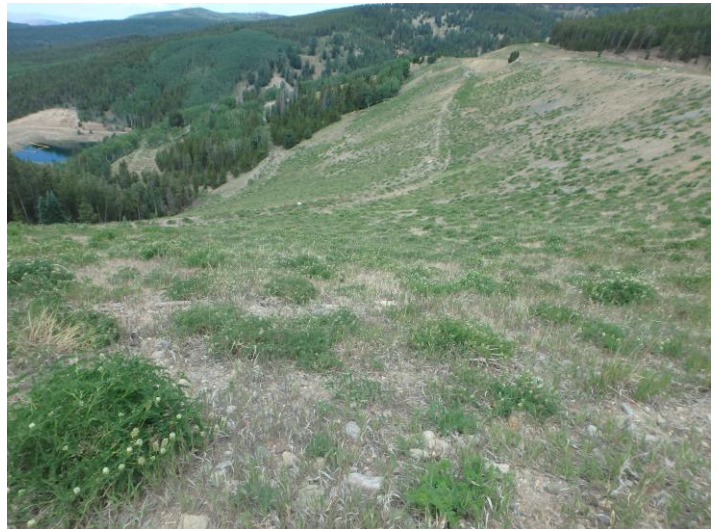
Tie Camp Rock Dump: The slope below the access road still appears stable. Vegetation is well established on the slope.

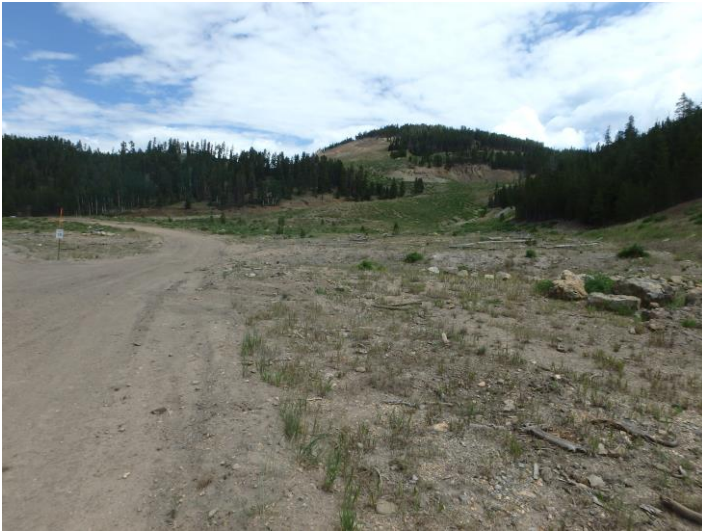
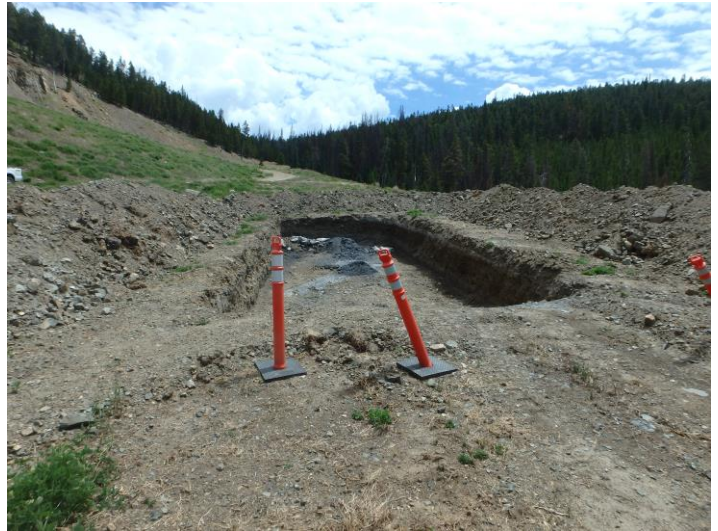
Tie Camp Disposal Cell: Slopes are stable in this area and vegetation is well established. A small portion of the disposal cell has been reopened for disposal of drill cuttings associated with the ongoing phosphate injection program. The cap material is bermed around the perimeter of the disposal pit.

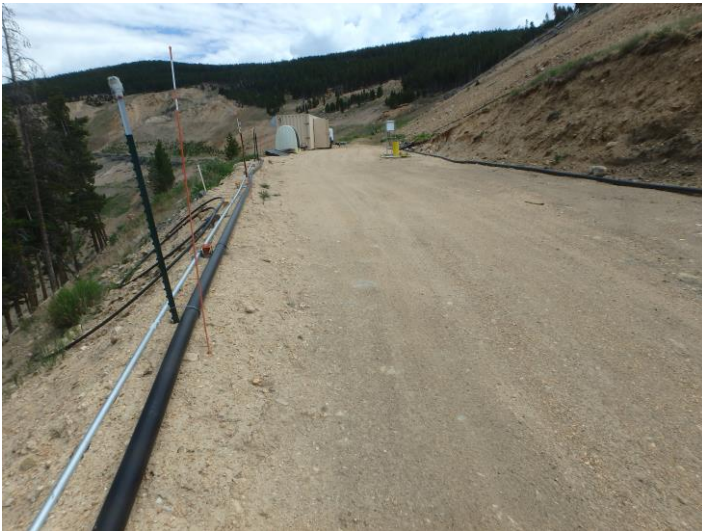
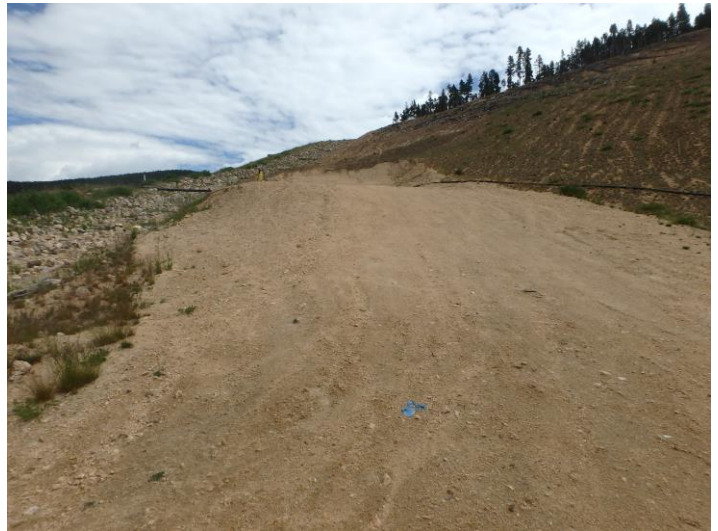
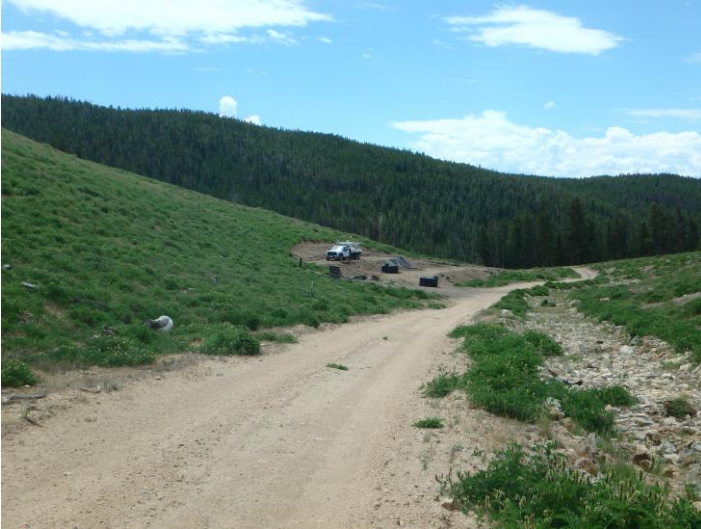
South Pit: The phosphate injection program is ongoing in this area. No problems were noted with the drill pads, wells or associated equipment. The Division's June 2017 inspection report noted an area of slope failure in the upper part of the south pit. The failure area was not inspected during this inspection. The operator stated that repair work has not yet taken place on the slope. The failure poses no risk to public safety.

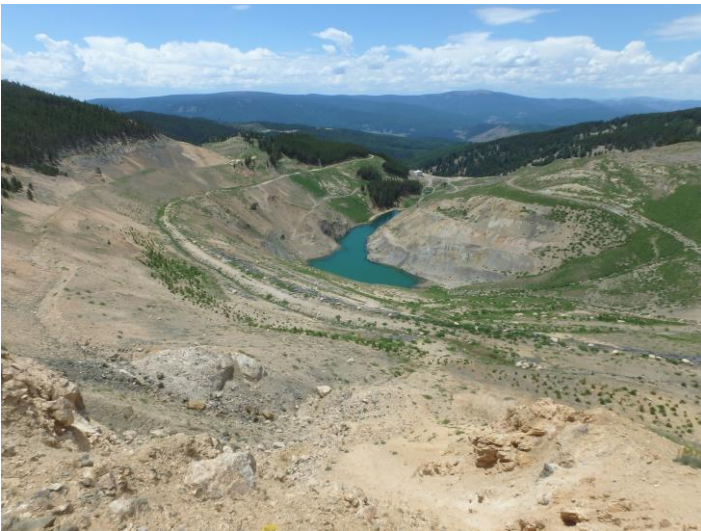
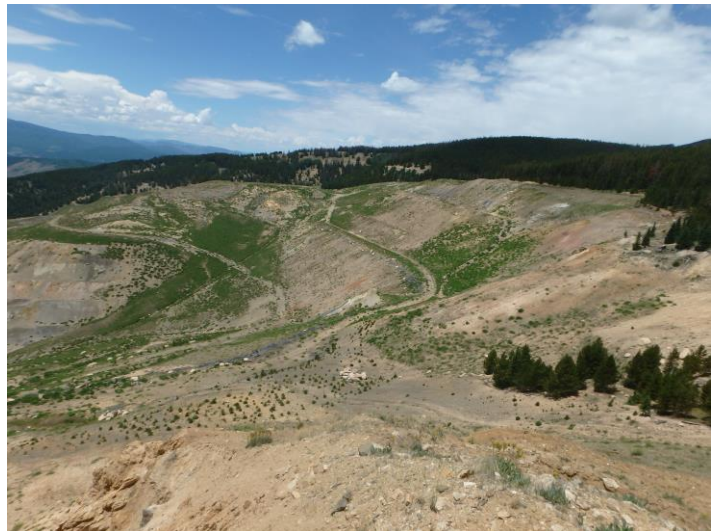
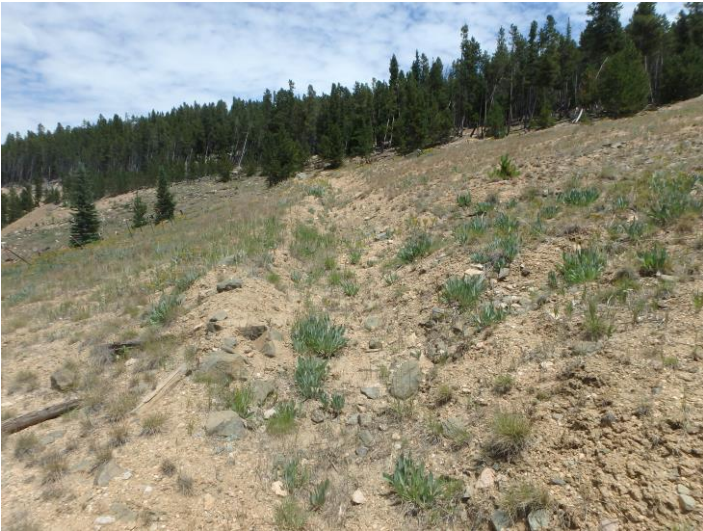
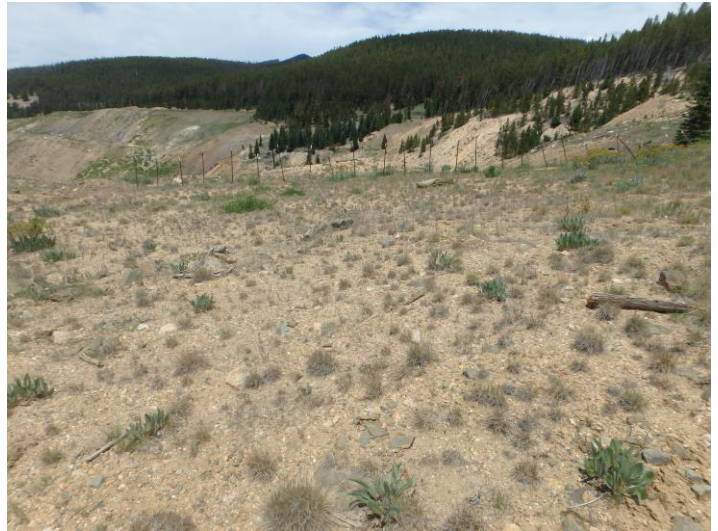
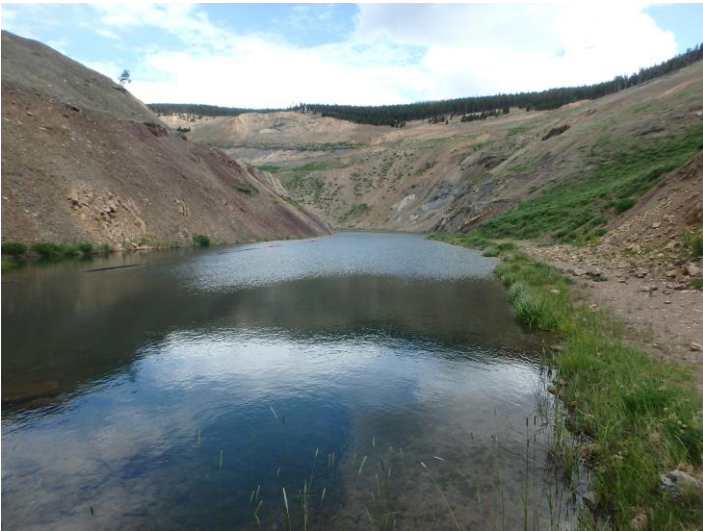
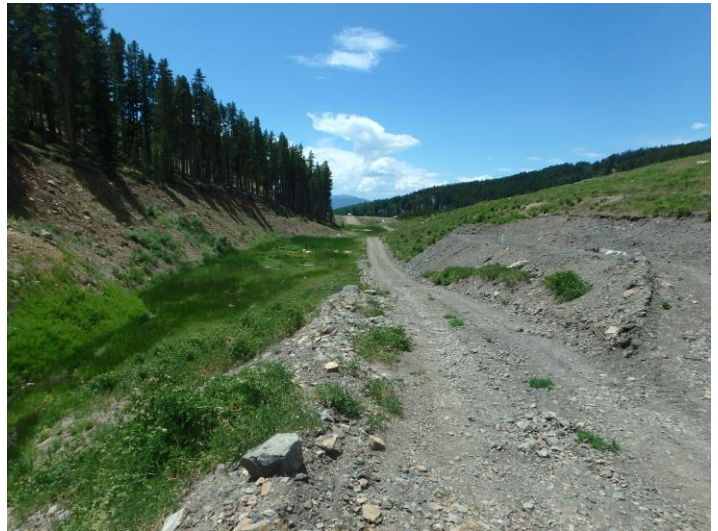
North Pit: Slope movement above the North Pit continues to be monitored. A final reclamation/stabilization plan is not yet developed for this area. Efforts are ongoing to control erosion and drainage on the east wall of the north pit.

Discharge from the North Pit Lake flows through the valve and culvert as designed. The Pinnacle Portal continues to discharge and flow is measured through a v-notch weir. The discharge reports to a marsh area above the facilities shop building.

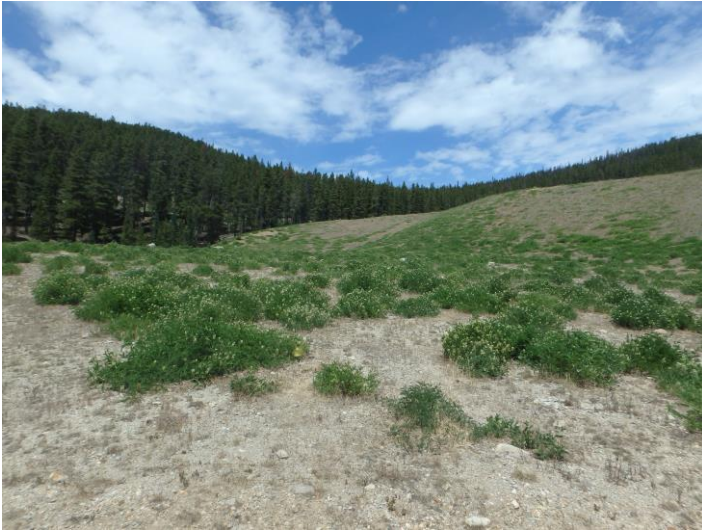
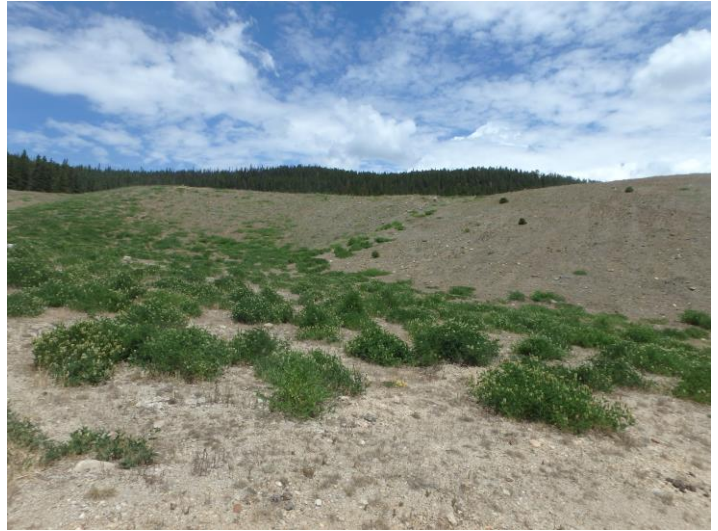
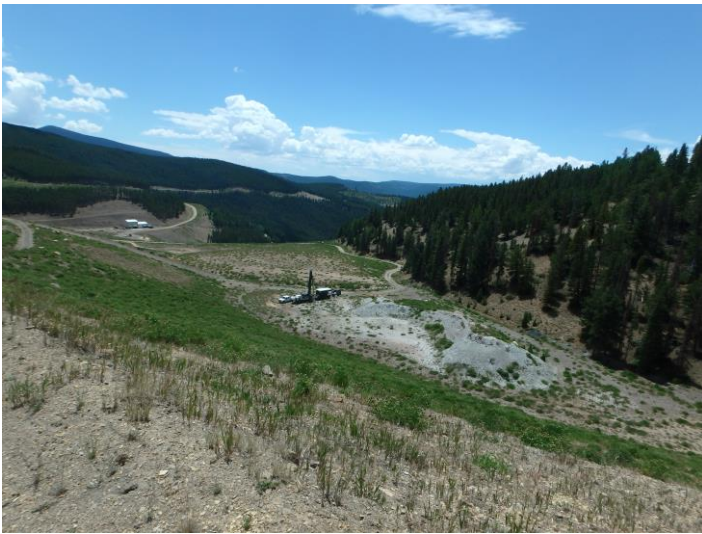
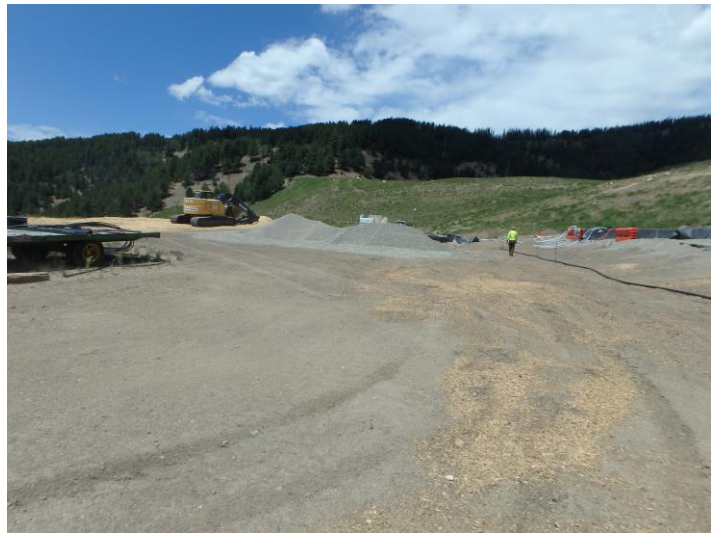
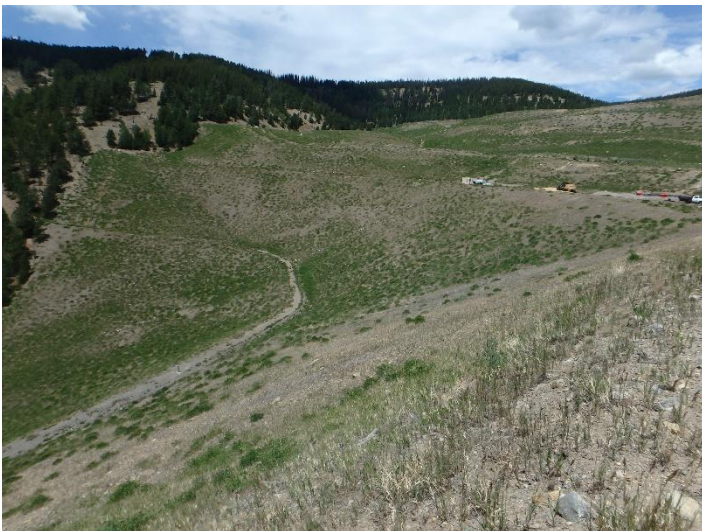
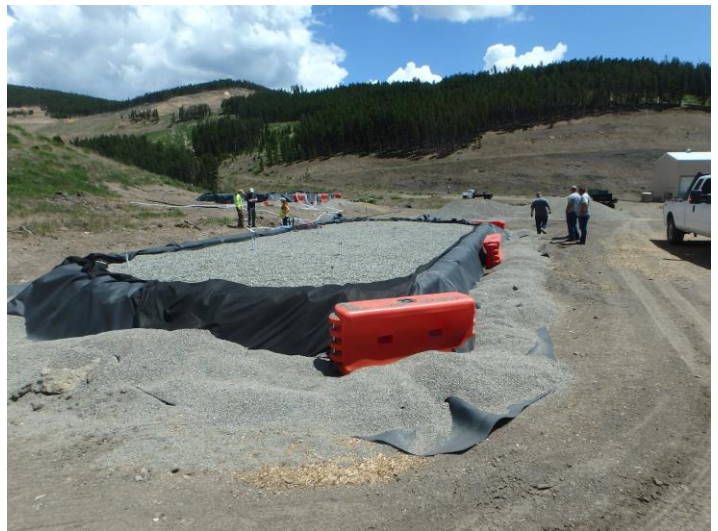
Indian Rock Dump: Slopes appear stable and vegetation is becoming well established on the reclaimed slopes. No significant erosional features were noted. The phosphate injection program and geotechnical study are ongoing in this area. Drilling was occurring during this inspection. No problems with the drill pads, wells or associated equipment were noted.

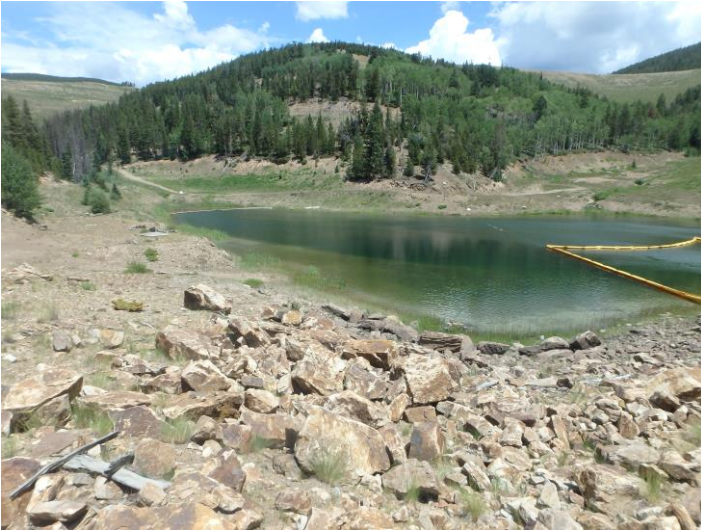
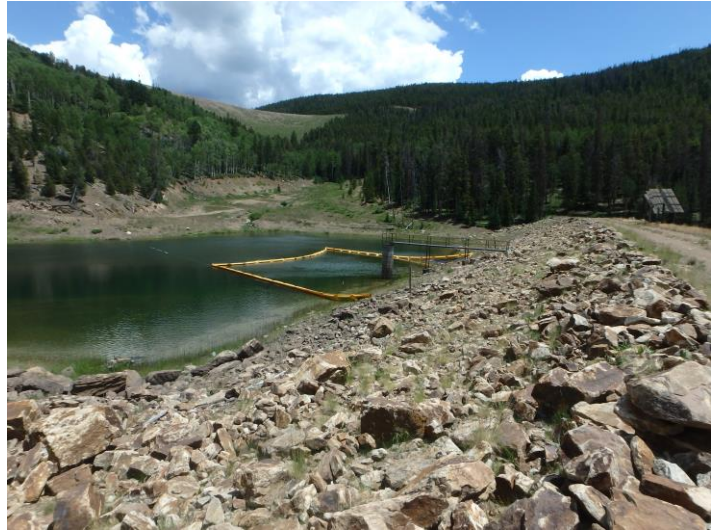
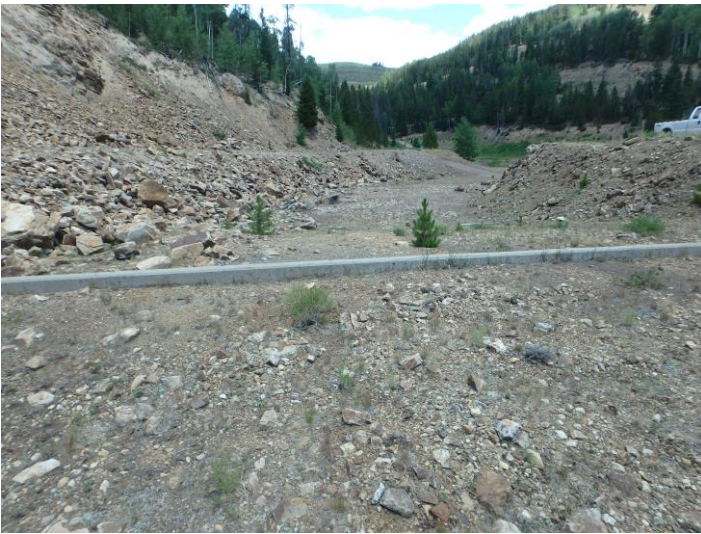
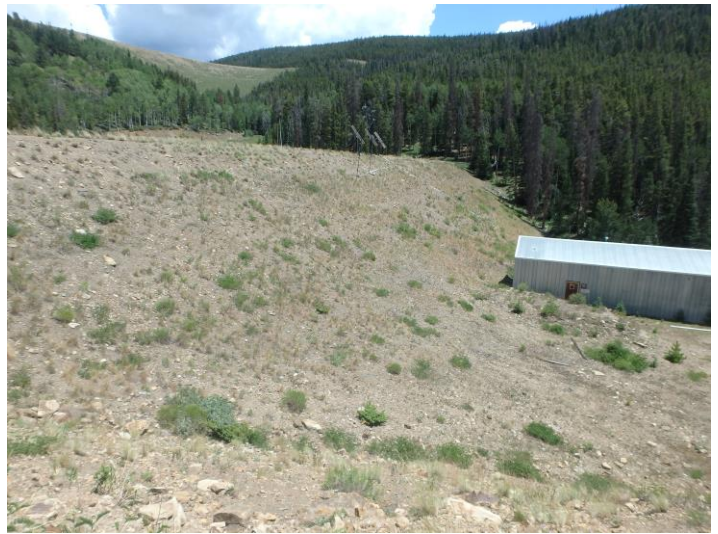
Sediment Pond: The sediment pond appears functional and the pond slopes appear stable. Surface filter booms placed at the upper and lower ends of the pond are maintained and appear in good working order. No seepage or stability concerns were noted around the dam. The spill way channel appears to be maintained and in good working order.

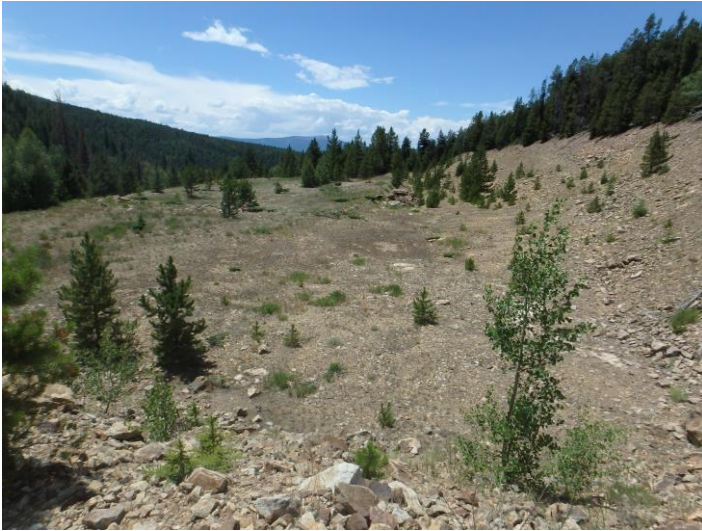
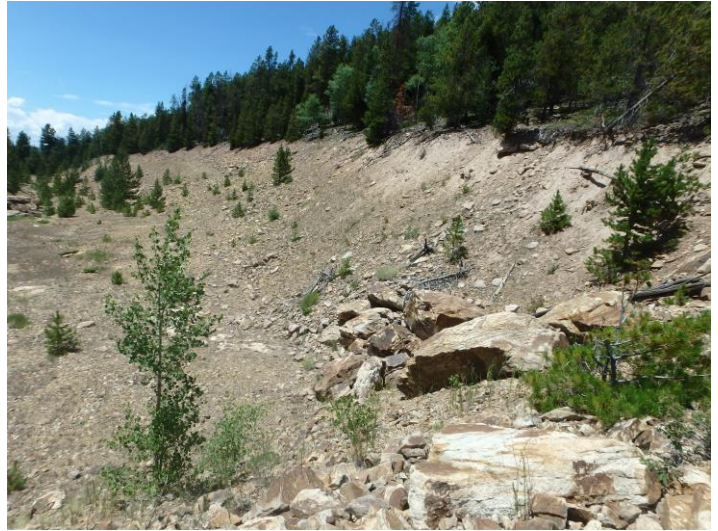
Sandstone Quarry: The sandstone quarry area is in final reclamation. The area has been regraded and reseeded. Vegetation is well established over most of the area. There is a small portion of the slope at the northeast end of the quarry that will likely require some "touch up" grading, topsoil replacement and reseeded in order to establish a vegetative cover.
