MINERALS PROGRAM INSPECTION REPORT PHONE: (303) 866-3567

MINE NAME:		MINE/PROSPECTING ID#:	MINERAL:	COUNTY:		
Half Moon Site		P-2015-014	Sand and gravel	Lake		
INSPECTION TYPE:		INSPECTOR(S):	INSP. DATE:	INSP. TIME:		
Monitoring		Dustin M. Czapla	August 8, 2018	18:00		
OPERATOR:		OPERATOR REPRESENTATIVE:	TYPE OF OPERATION:			
City of Leadville			MP - Mineral Prospecting			
REASON FOR INSPECTION:		BOND CALCULATION TYPE:	BOND AMOUNT:			
Normal I&E Program		NA	\$0.00			
DATE OF COMPLAINT:		POST INSP. CONTACTS:	JOINT INSP. AGENCY:			
NA		None	None			
WEATHER:	INSPECTOR'S SIGNATURE:		SIGNATURE DATE:			
Clear	De		August 17, 2018

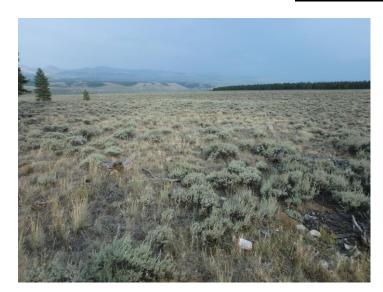
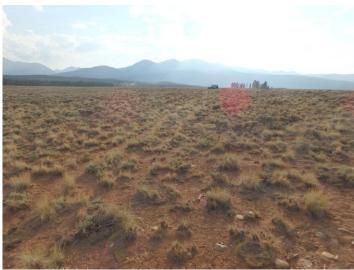
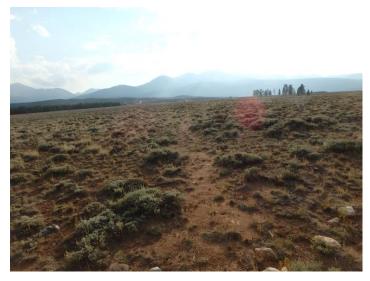
This inspection confirmed that there is no unreclaimed disturbance at the site. The operator should be released from any further reclamation responsibility for the NOI.
