Subject:       Geotechnical/Geologic Hazards Response  
                  Lilly Mines  
                  Highwall Considerations  
                  Gunnison County, Colorado  
                  Project No. 18.5056

### **Lilly Mines Joint Set Analysis**

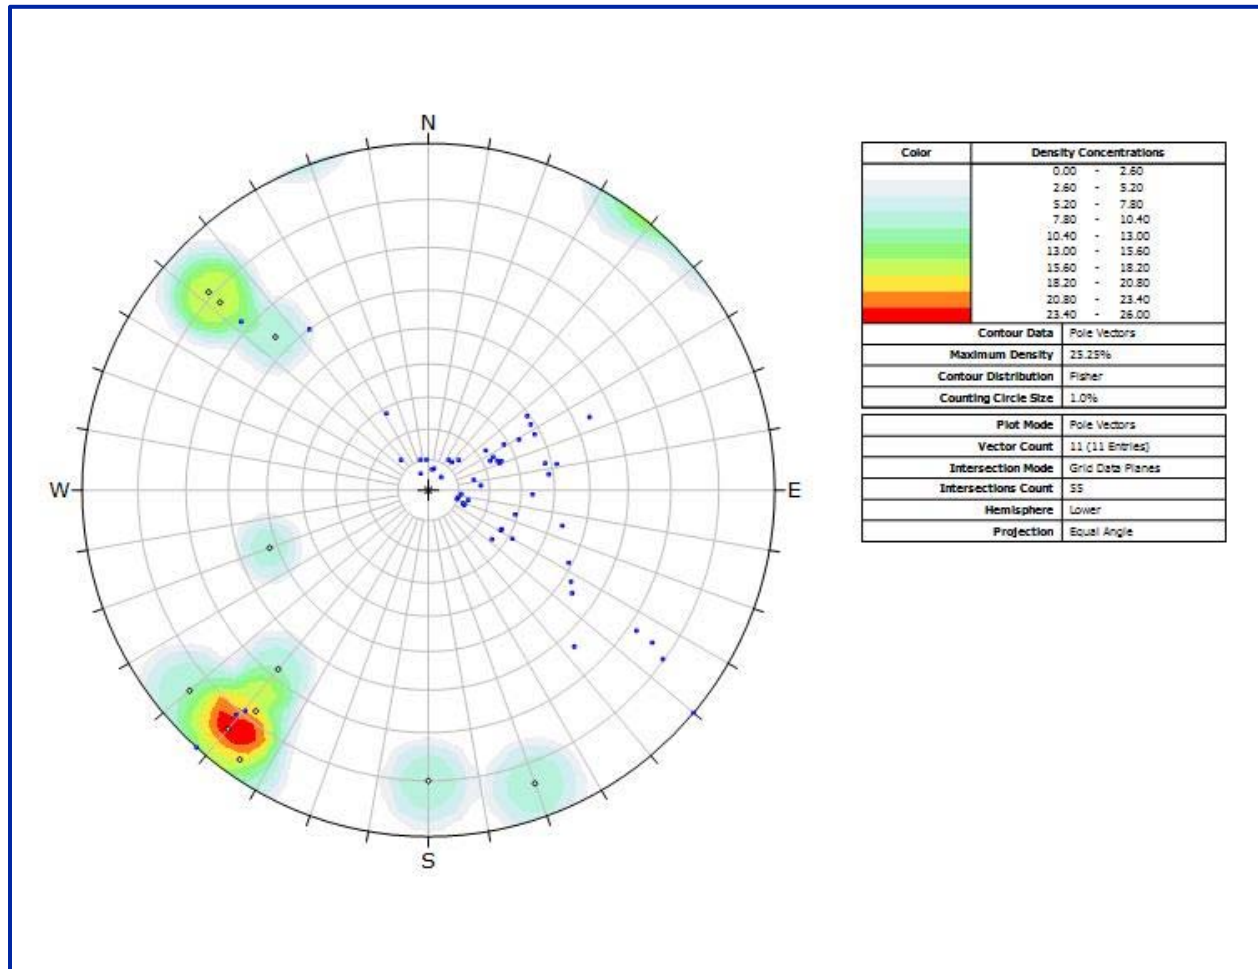
**FIGURE 1. Stereonet Plot of Lower Bench Joints**

Measurements from the lower bench indicate two major joint sets that intersect the north striking high angle dip of the marble unit to create a wedge pattern (Figure 1). This is visible in the highwall

of the quarry. It has been established that this failure mechanism does not adversely affect the short term control of the rock stability.

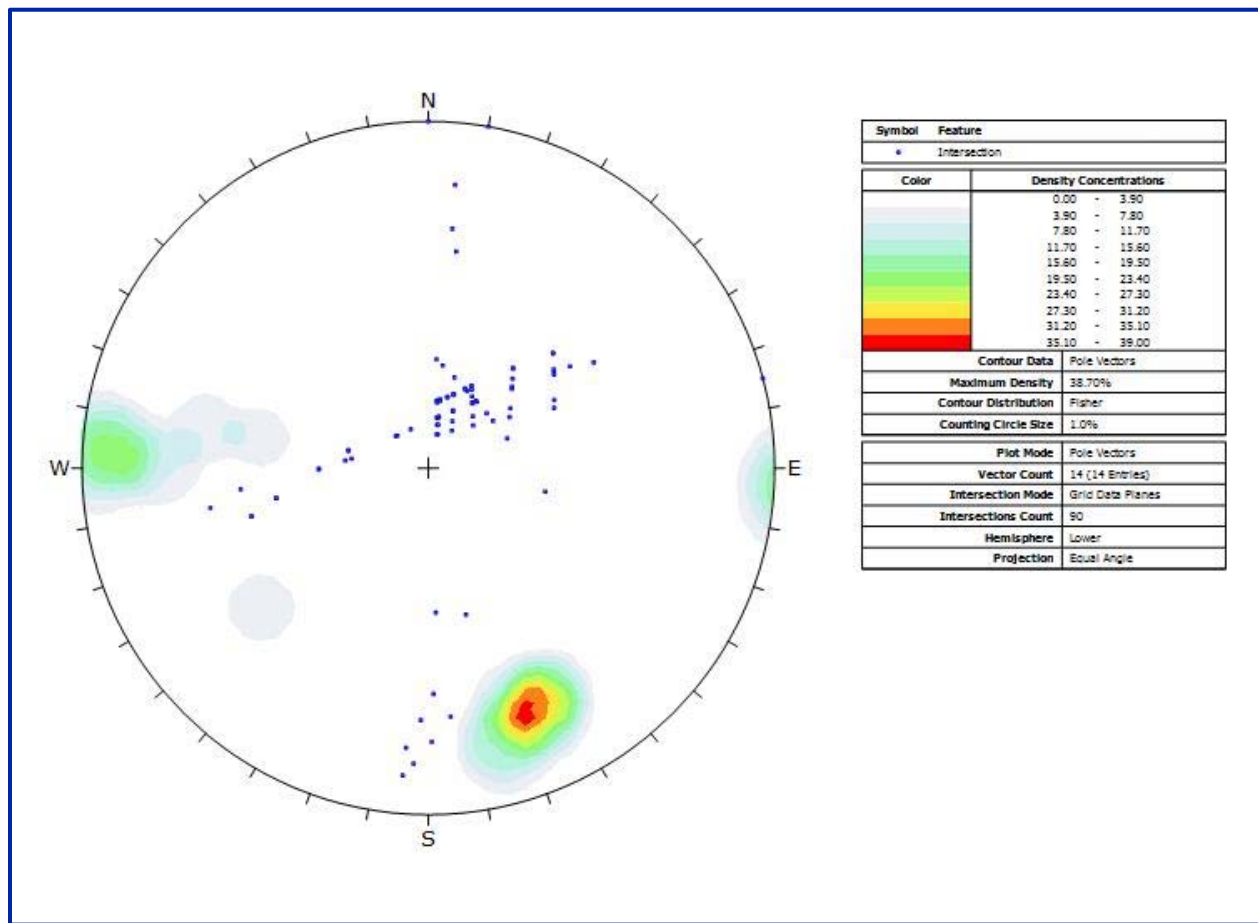
**FIGURE 2. Stereonet Plot of Upper Bench Joints**

measurements from the upper bench also indicate two major joint sets that intersect the highwall. The intersections are similar and they create a wedge pattern in the marble unit which daylights in the cut face of the marble. These fracture sets do not affect the short term control of the cut face. Long term control of the failure mechanism in the highwall will be addressed by the backfill plan presented by Monarch Mountain Minerals and Aggregate.
