**MINERALS PROGRAM INSPECTION REPORT**  
**PHONE: (303) 866-3567**

<b>MINE NAME:</b> Brighton Mine	<b>MINE/PROSPECTING ID#:</b> M-1977-436	<b>MINERAL:</b> Sand and gravel	<b>COUNTY:</b> Adams
<b>INSPECTION TYPE:</b> Surety Release Inspection	<b>INSPECTOR(S):</b> Jared L. Ebert	<b>INSP. DATE:</b> August 17, 2018	<b>INSP. TIME:</b> 09:00
<b>OPERATOR:</b> Aggregate Industries - WCR, Inc.	<b>OPERATOR REPRESENTATIVE:</b> Connie Davis	<b>TYPE OF OPERATION:</b> 112c - Construction Regular Operation	
<b>REASON FOR INSPECTION:</b> Surety Release Requested	<b>BOND CALCULATION TYPE:</b> Partial Bond	<b>BOND AMOUNT:</b> \$150,000.00	
<b>DATE OF COMPLAINT:</b> NA	<b>POST INSP. CONTACTS:</b> None	<b>JOINT INSP. AGENCY:</b> None	
<b>WEATHER:</b> Clear	<b>INSPECTOR'S SIGNATURE:</b>

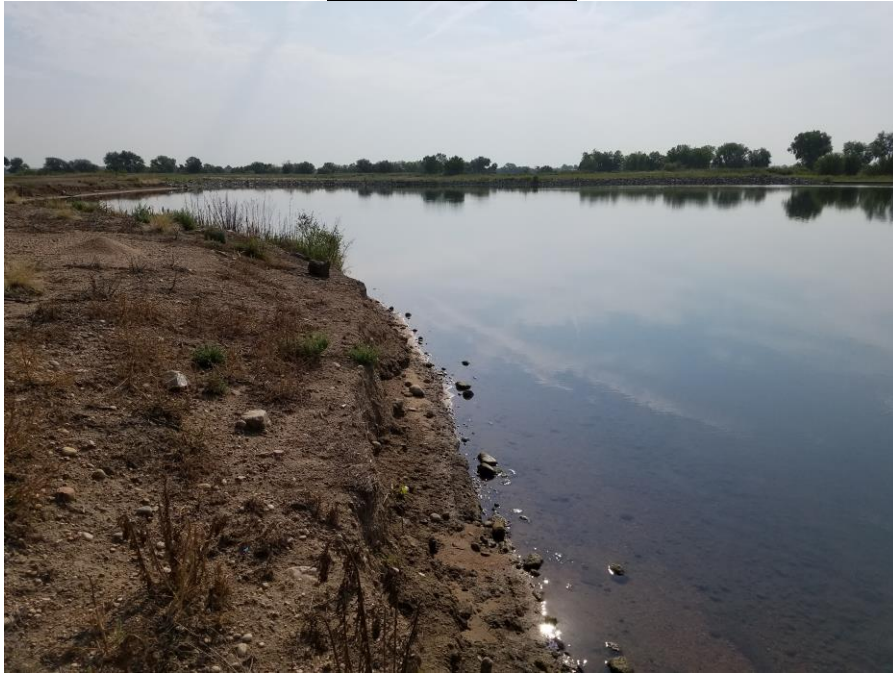
Figure 1. From the northwest corner of the Central Pond Looking east.

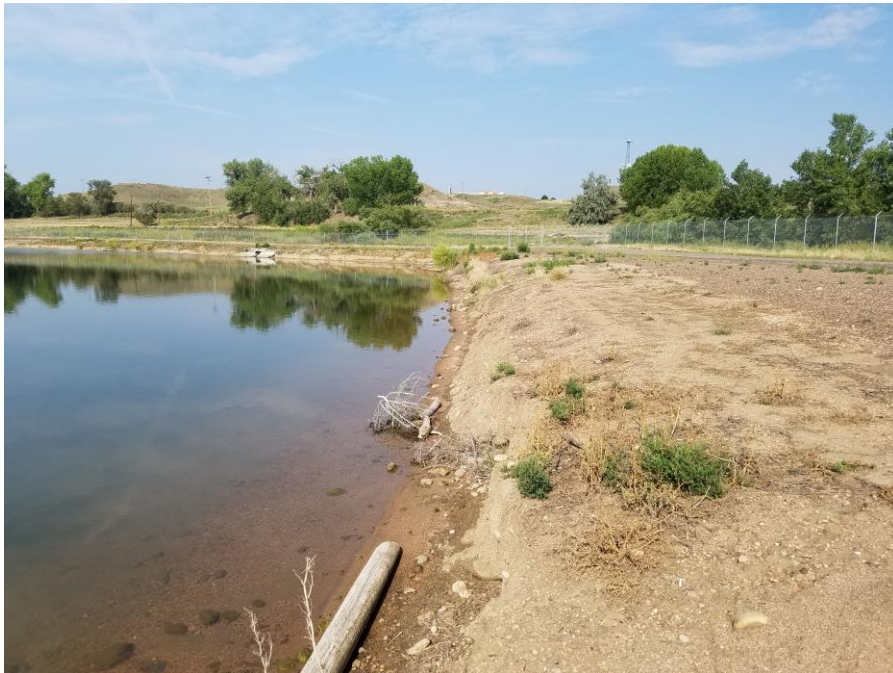
Figure 2. From the northwest corner of the Central Pond looking southwest.

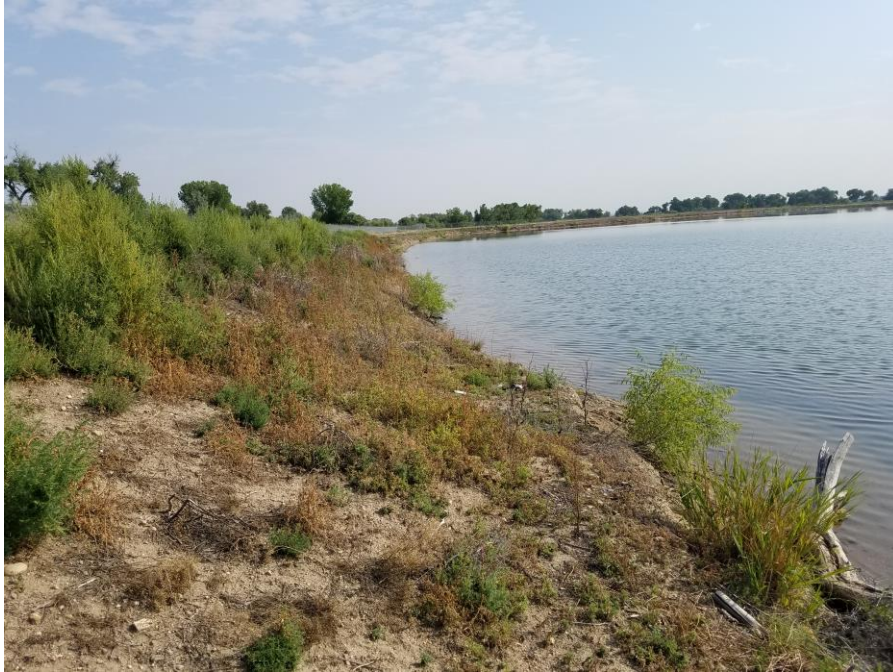
The final pit slopes of the Central and South Ponds have been graded to what appears to be a 3H:1V ratio above the water line. Both ponds were at least partially filled with water, the visible portion of the pit slopes below the water line appeared relatively gentle. The north and west pit slopes of the central reservoir has some minor shoreline cutting, meaning at the water line a small nearly vertical 1 to 2 foot cut has developed. This cutting results due to the managed and fluctuating water levels of the reservoir and possibly resulting from wave action. The below water line slope at the cut areas appeared relatively gentle. A lateral berm spillway has been constructed at the south west corner of the Central Pond. Portions of the south pit slope and all of the eastern pit slope of the Central Pond have been armored with rip-rap and appear stable.

Figure 3. Western pit slope of the Central Pond from the south end looking north.

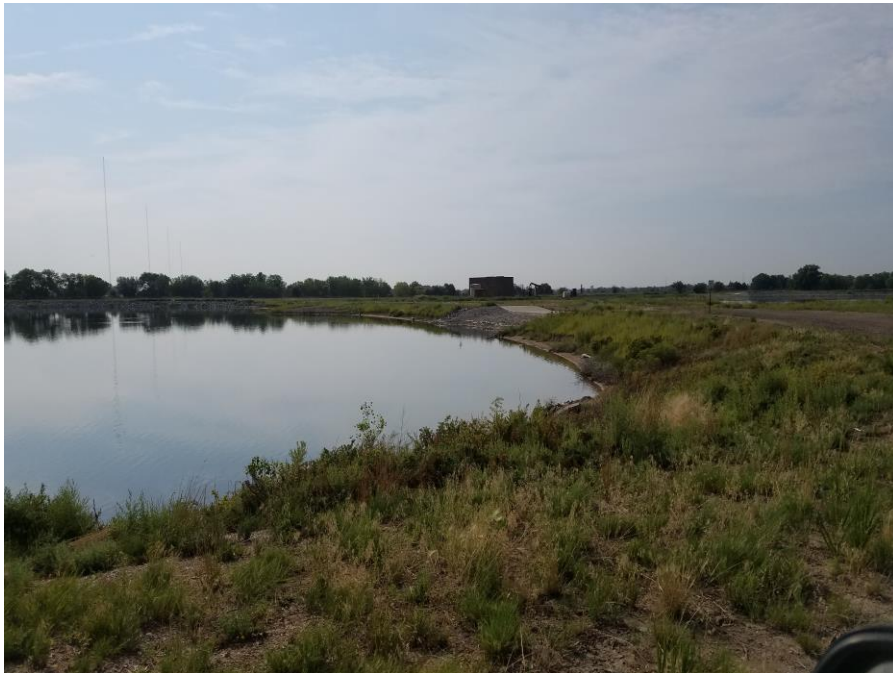
Figure 4. From the southwest corner of the Central Pond looking east.

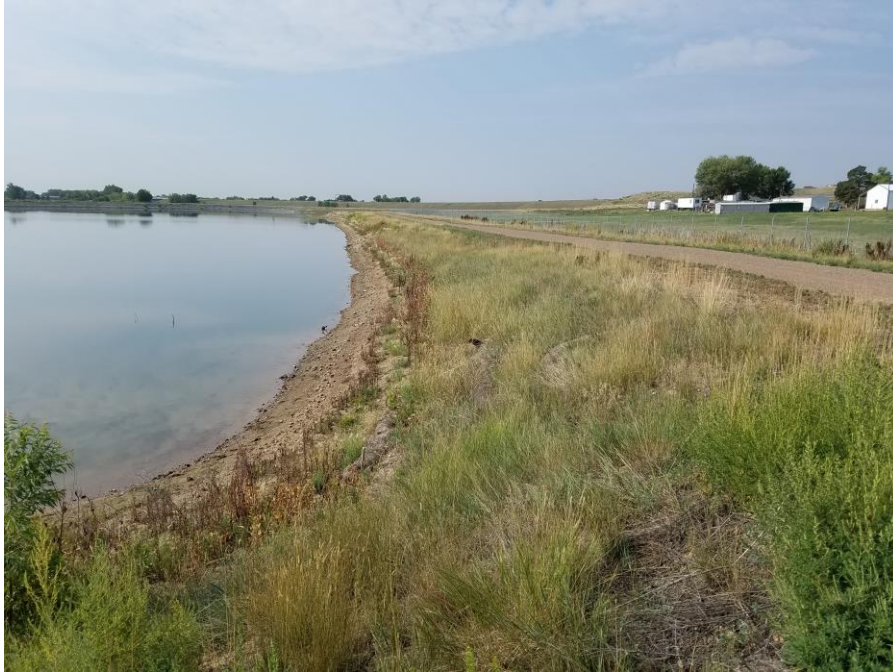
The pit slopes around the South Pond have been graded to a 3H:1V angle and portions of the southern and all of the eastern pit slopes have been armored with rip-rap. The remaining pit slopes of the southern pond have grassy vegetation established. The south pond pit slopes are stable.

Figure 5. From the northwest corner of the South Pond looking south.

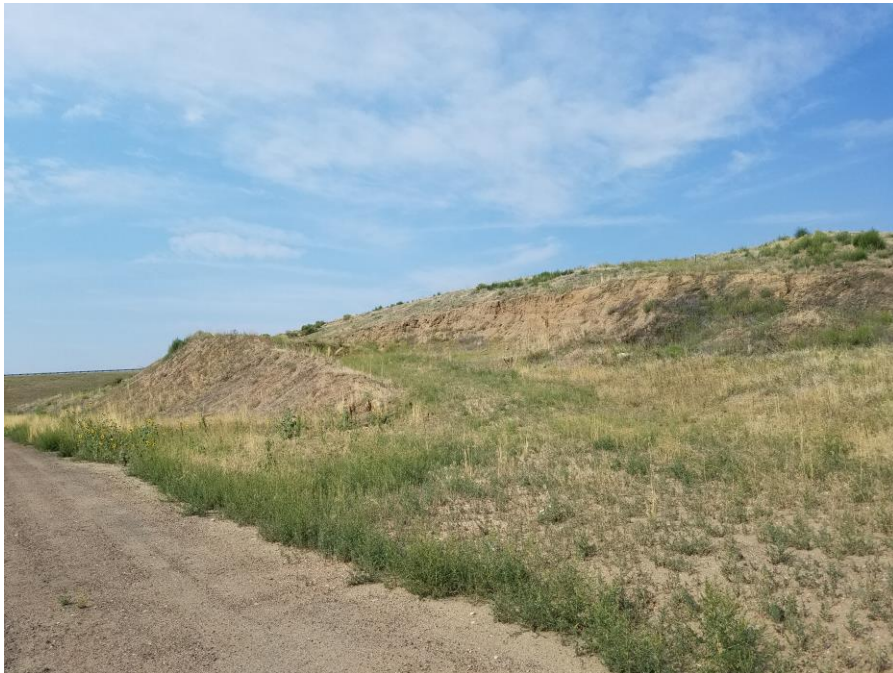
has established throughout the site in portions of the affected land outside of the water storage area and access roads. A large stockpile of material is stored in the southeast corner of the permit area outside of the South Pond reservoir. This pile has been partially excavated into on the eastern side, otherwise the pile is vegetated and stable. The Division could not locate any documentation this stockpile was to remain on the site after reclamation. Prior to the approval of this acreage reduction, AI will need to submit documentation the landowner has no objection to leaving this pile in place and that they acknowledge this stockpile of material cannot leave the site unless a reclamation permit is obtained from DRMS. The Division is required to issue a decision to approve or deny the AR01 application by October 16, 2018. AI will need to submit this documentation to the Division prior to the October 16, 2018 decision date. The Division will issue a decision to approve this acreage release if this documentation is obtained prior to this date. If additional time is needed to obtain this documentation, AI will need to request an extension of the decision date.

Figure 6. Stockpile of material at the southwest corner of the bond release area.

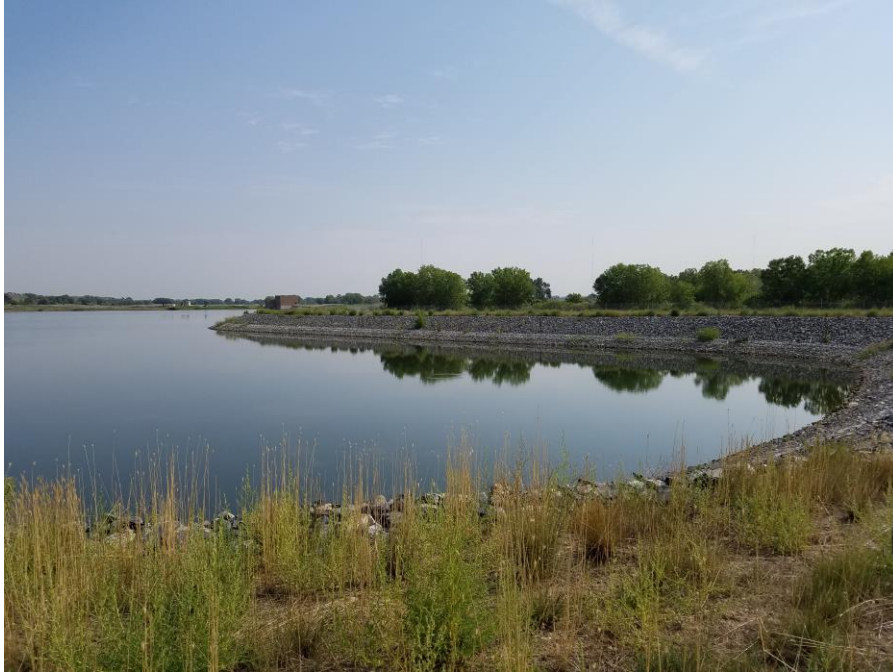
Figure 7. From the southeast corner of the South Pond looking north.

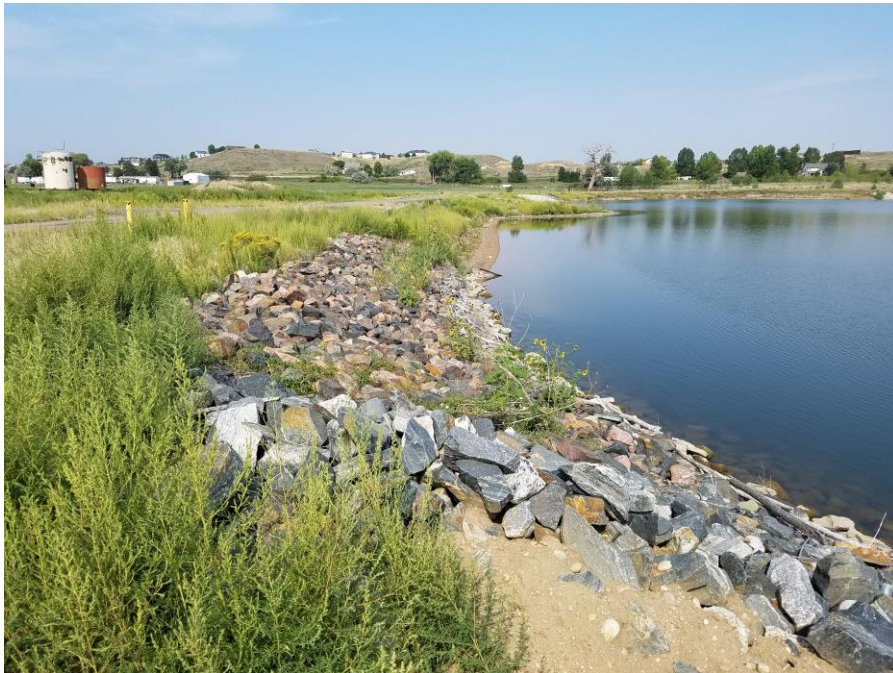
Figure 8. From the southeast corner of the Central Pond looking west.

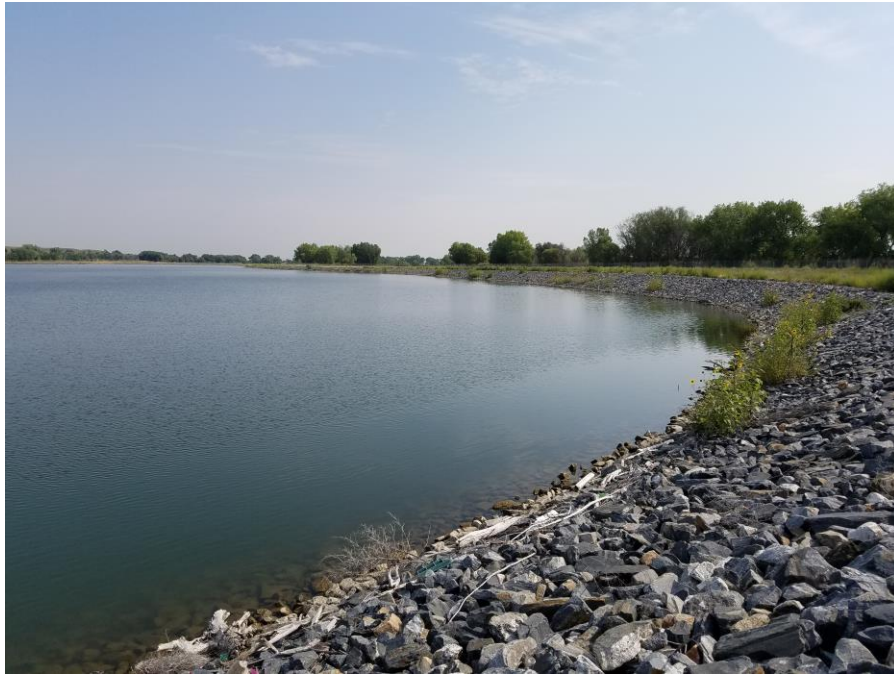
**Figure 9. From the southeast corner of the Central Pond looking north.**
