**MINERALS PROGRAM INSPECTION REPORT**  
**PHONE: (303) 866-3567**

<b>MINE NAME:</b> Montoya Pit	<b>MINE/PROSPECTING ID#:</b> M-1980-146	<b>MINERAL:</b> Sand and gravel	<b>COUNTY:</b> La Plata
<b>INSPECTION TYPE:</b> Preoperation Inspection	<b>INSPECTOR(S):</b> Lucas J. West	<b>INSP. DATE:</b> August 7, 2018	<b>INSP. TIME:</b> 13:30
<b>OPERATOR:</b> C & J Gravel Products, Inc.	<b>OPERATOR REPRESENTATIVE:</b> John Gilliland	<b>TYPE OF OPERATION:</b> 112c - Construction Regular Operation	
<b>REASON FOR INSPECTION:</b> Pre-operation Inspection	<b>BOND CALCULATION TYPE:</b> Complete Bond	<b>BOND AMOUNT:</b> \$85,476.00	
<b>DATE OF COMPLAINT:</b> NA	<b>POST INSP. CONTACTS:</b> None	<b>JOINT INSP. AGENCY:</b> None	
<b>WEATHER:</b> Clear	<b>INSPECTOR'S SIGNATURE:</b>

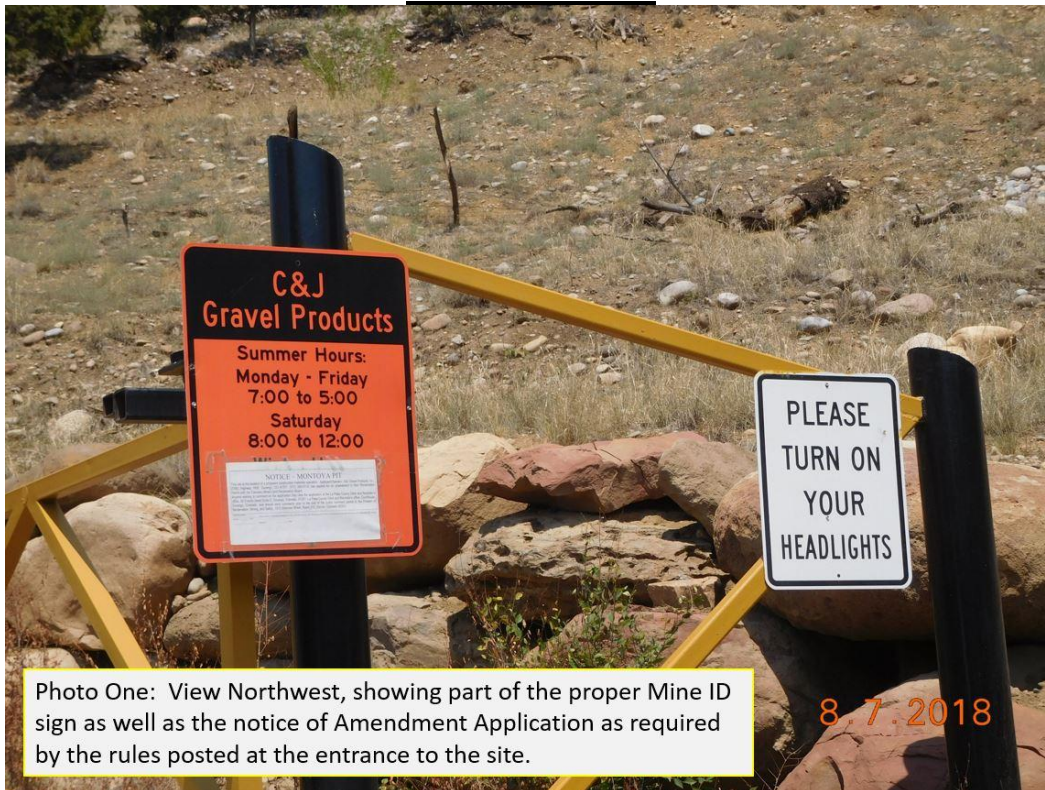
The proper mine identification signage and notice of amendment application as required by Rule 1.6.2 (1)(b) and can be seen in Photo One. The site was active during the day of the inspection, front end loaders were loading material into the screens and crushers while material was being actively stockpiled. All operations were confined to the previously approved affected acreage and were in compliance with the approved mine plan. All reclaimed and backfilled slopes appear to be stable and in good condition. Several stockpiles are currently located on the pit floor. All stockpiles of material appear to be stable and in good condition. Throughout the active permit area there was no signs of settling, slumping or significant erosion, nor were any state listed noxious weeds observed.
