MINERALS PROGRAM INSPECTION REPORT**PHONE: (303) 866-3567**

MINE NAME: Longmont Distel Operations	MINE/PROSPECTING ID#: M-1989-029	MINERAL: Sand and gravel	COUNTY: Weld
INSPECTION TYPE: Surety-Related Inspection	INSPECTOR(S): Peter S. Hays	INSP. DATE: August 14, 2018	INSP. TIME: 10:00
OPERATOR: Aggregate Industries - WCR, Inc.	OPERATOR REPRESENTATIVE: Christine Felz	TYPE OF OPERATION: 112c - Construction Regular Operation

The Longmont Distel Operations site was inspected by Peter Hays with the Division of Reclamation, Mining and Safety (Division/DRMS) in response to an acreage reduction request (AR-01) and surety reduction request (SR-01) submitted by the Operator on July 2, 2018. The acreage and surety reduction requests were considered filed by the Division on July 2, 2018. The Division is required by Rule 4.17.2 to inspect the site within 60-days from the filed date to determine if the Permittee has complied with all applicable requirements of the Reclamation Plan. The decision due date for approval of the acreage and surety reductions is

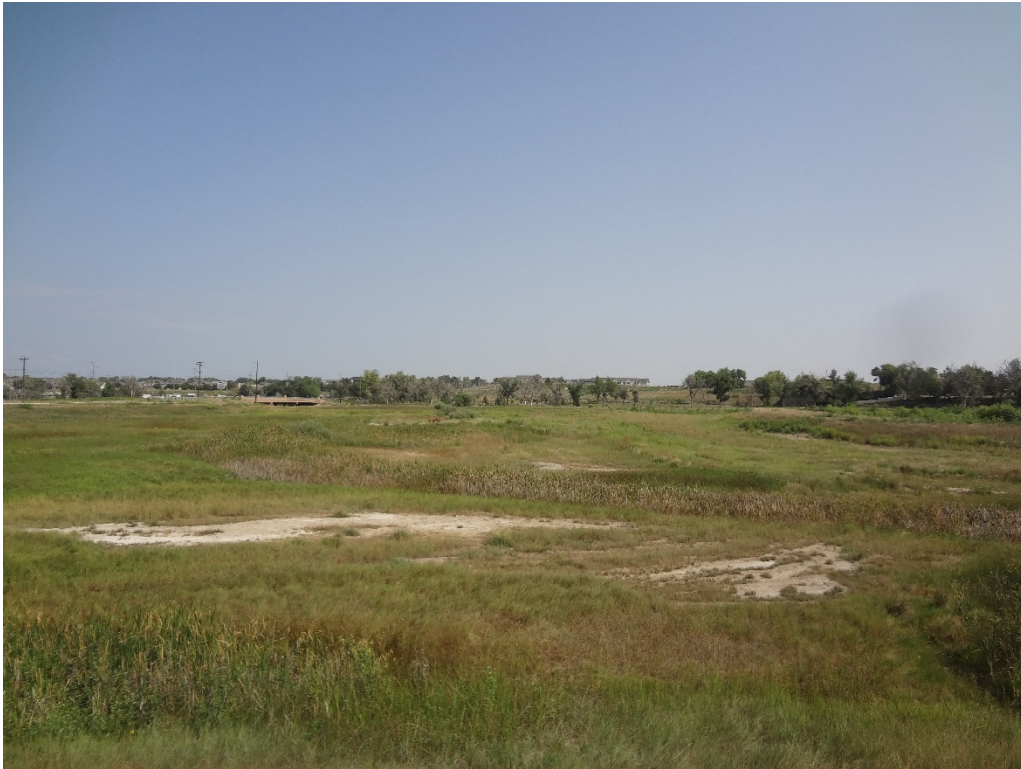
The northwest portion of the Peschel parcel was heavily impacted when the pit captured the St. Vrain River in 2013. The permit was amended in 2016 to revise the Reclamation Plan to incorporate the captured river through the mine site. The City of Longmont, property owner, worked with FEMA to fund the repair and restoration costs for portions of the site. The two (2) repaired sections of riverbank, north side of the access road to the Peschel residence and near the eagle nest, were stable and establishing vegetation, mainly forbs and annual weeds. The root wads structure constructed near the eagle's nest shoreline was stable and appeared to be working as designed. The parcel contained small patches of annual and noxious weeds; including kochia, Canada thistle, common mullein and downy brome, but overall the vegetation was well-established with a diverse mix of native grass species and consistent with the surrounding rangeland areas. The observed noxious and annual weeds will be monitored and controlled by the City as part of the operation of the parcel as open space.

View of northwest Peschel parcel from southwest corner looking north

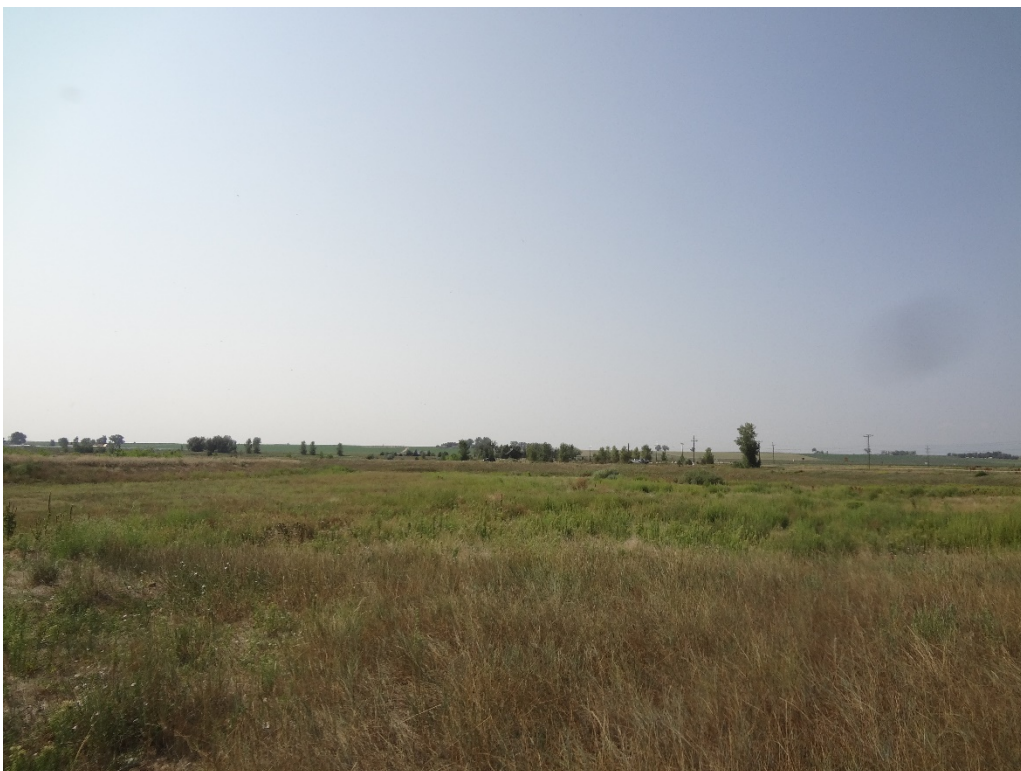
View of northwest Peschel parcel from river bank looking southwest

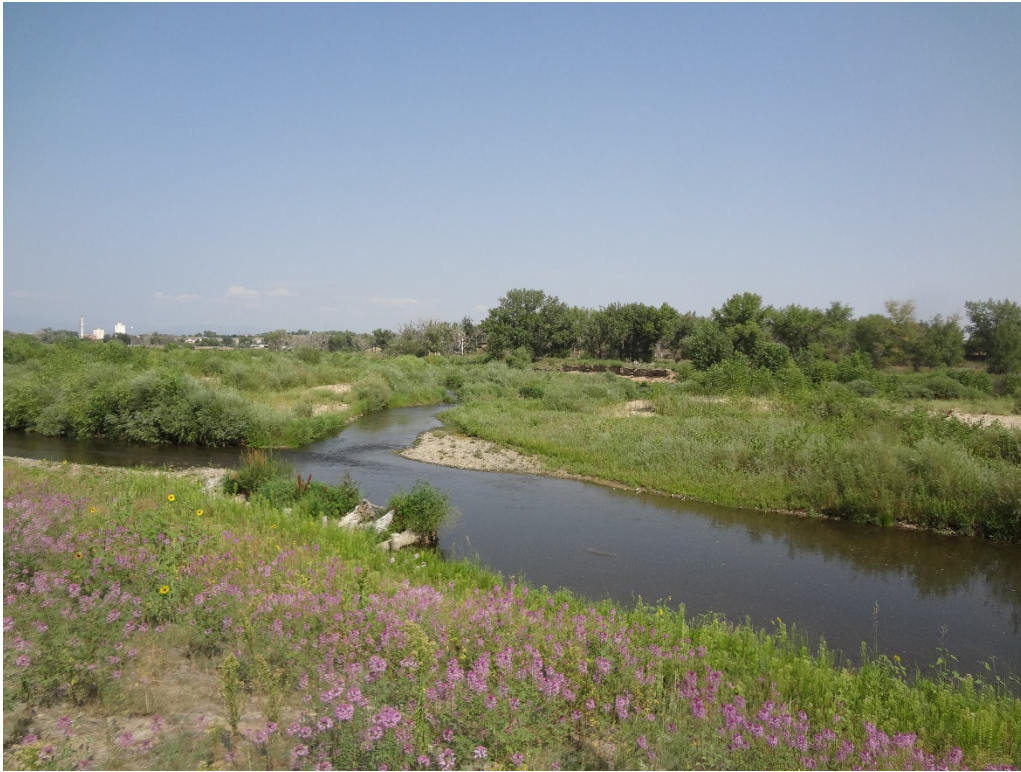
View of northwest Peschel parcel from the repaired slope looking northwest

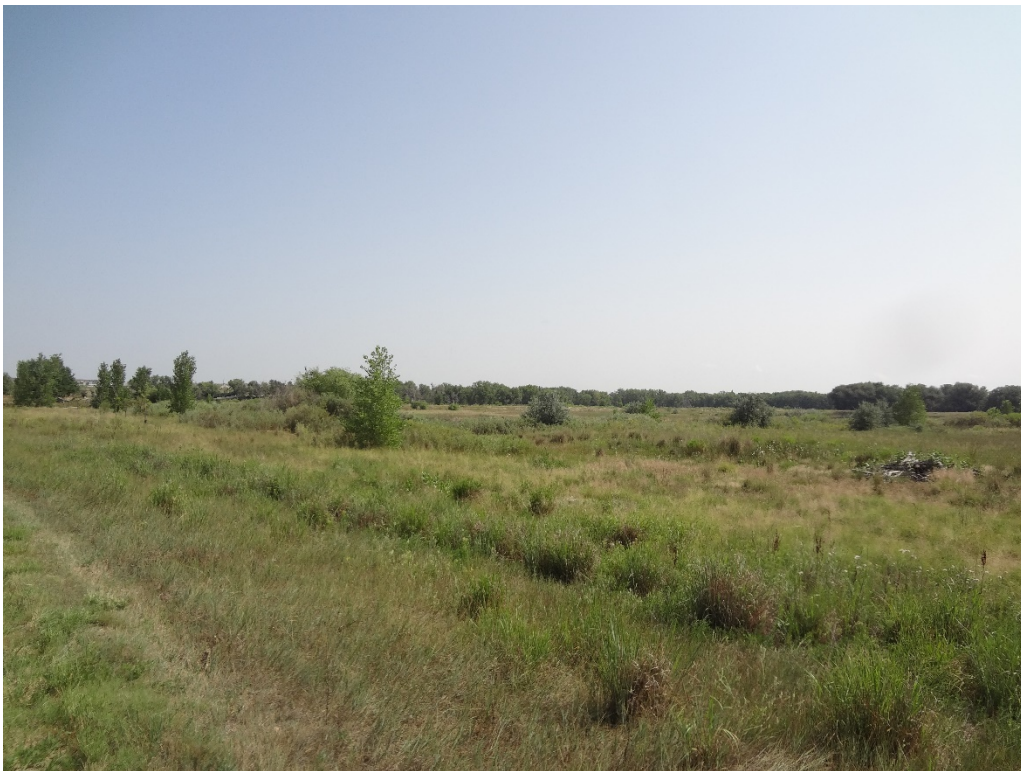
The southern half of the Peschel parcel was relatively unaffected by the 2013 flood event compared to the north half of the parcel. The south portion of the parcel was well-vegetated by native grasses and forbs, including wetland species and cottonwood trees along the pond banks and wetland areas. As cited as a problem above, several clusters of Russian olive trees were located in the south half of the parcel. The Operator will be required to remove the trees and treat the stumps to prevent the spread of the trees on the site and provide evidence the work has been completed by the corrective action date. **The Division will deny the requested acreage reduction and surety reduction requests unless evidence of the completed Russian olive tree removal is provided to the Division by the corrective action date.**

View of south Peschel parcel from southwest corner looking northeast

CORRECTIVE ACTIONS: The Operator shall implement the existing weed control plan and provide evidence of the Russian olive tree removal and stump treatment in the requested release area by the corrective action date.

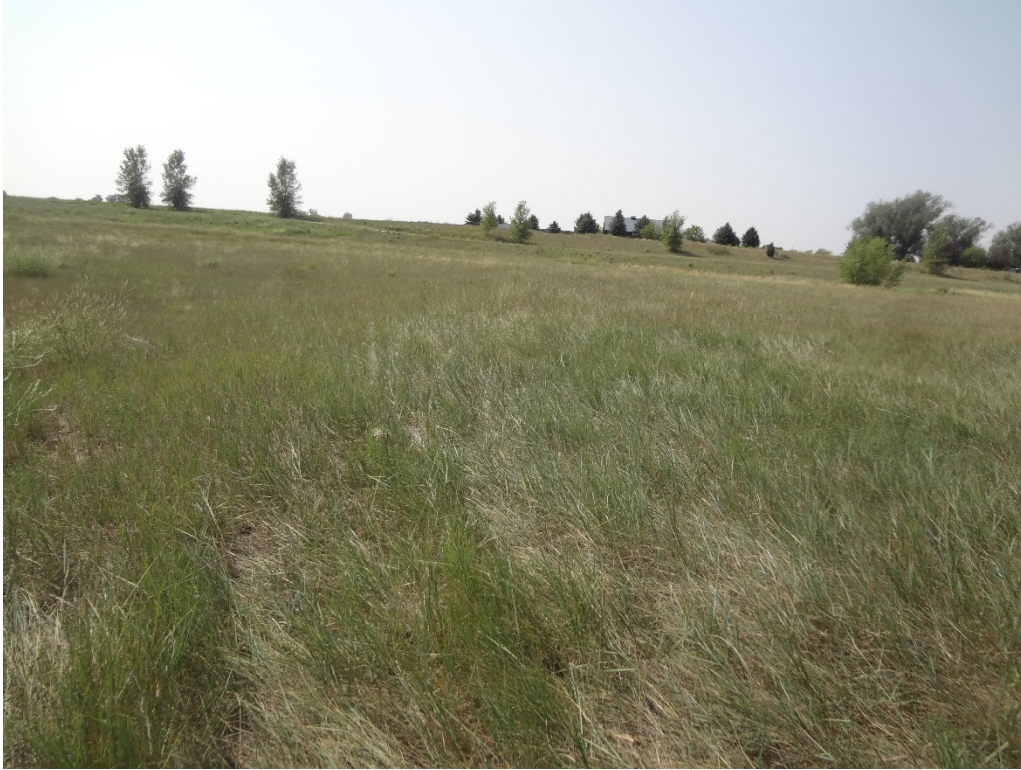
View of south Peschel parcel from north side looking south

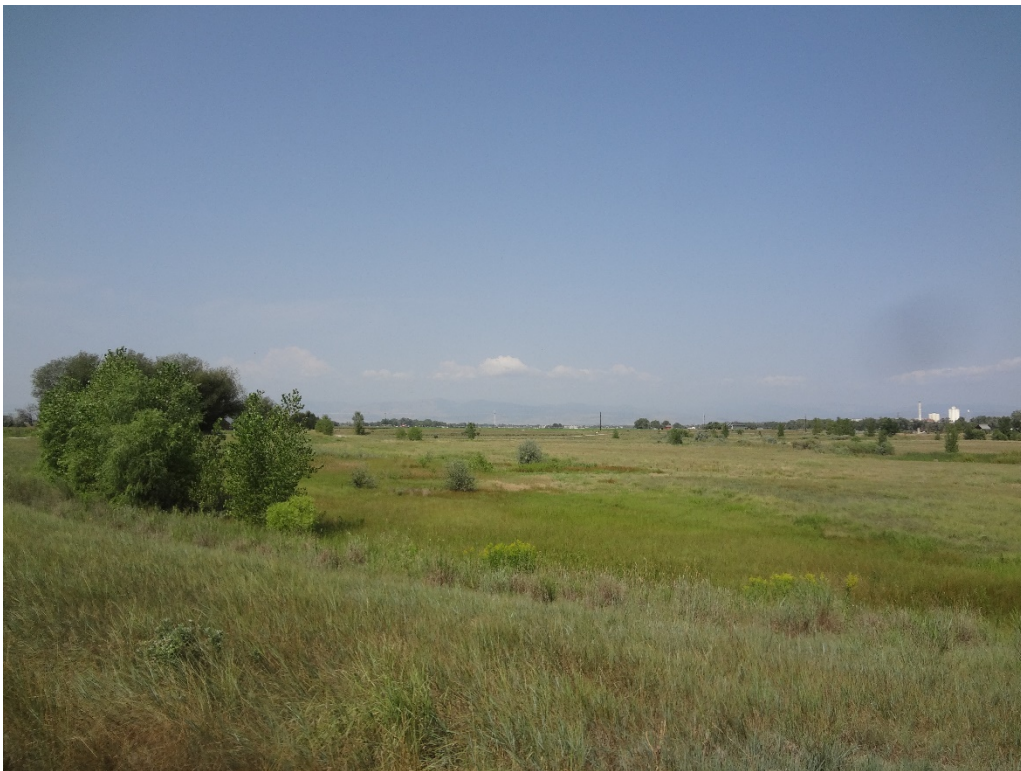
View of south Peschel parcel from southeast corner looking west

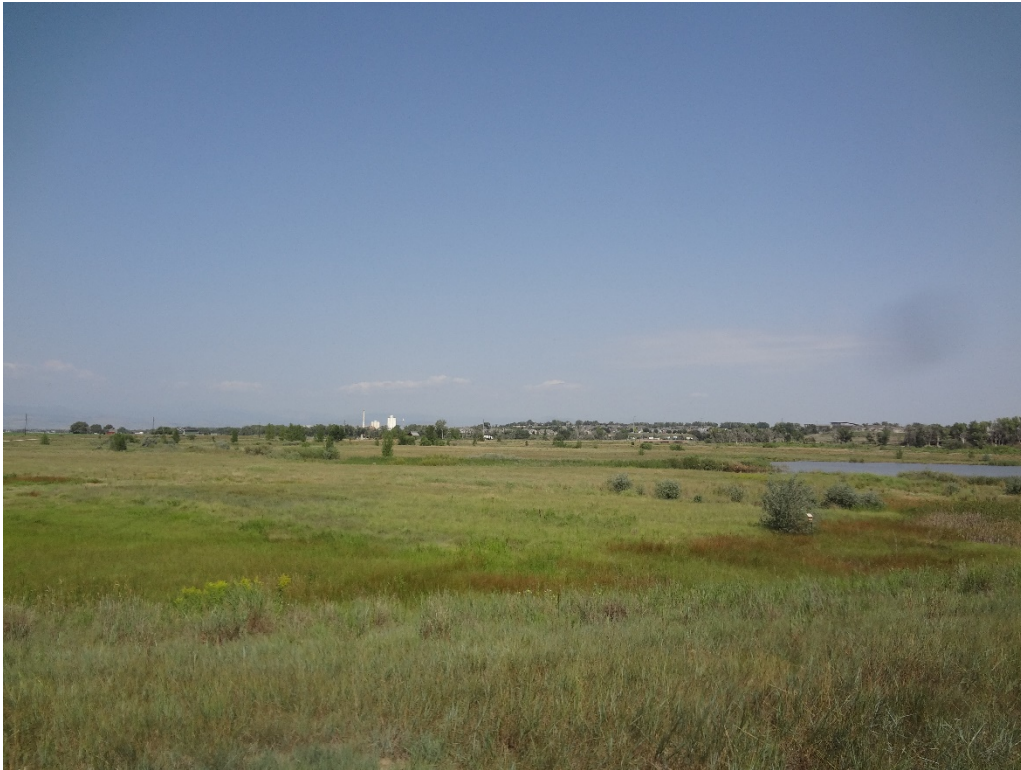
View of south Peschel parcel from southeast corner looking northwest

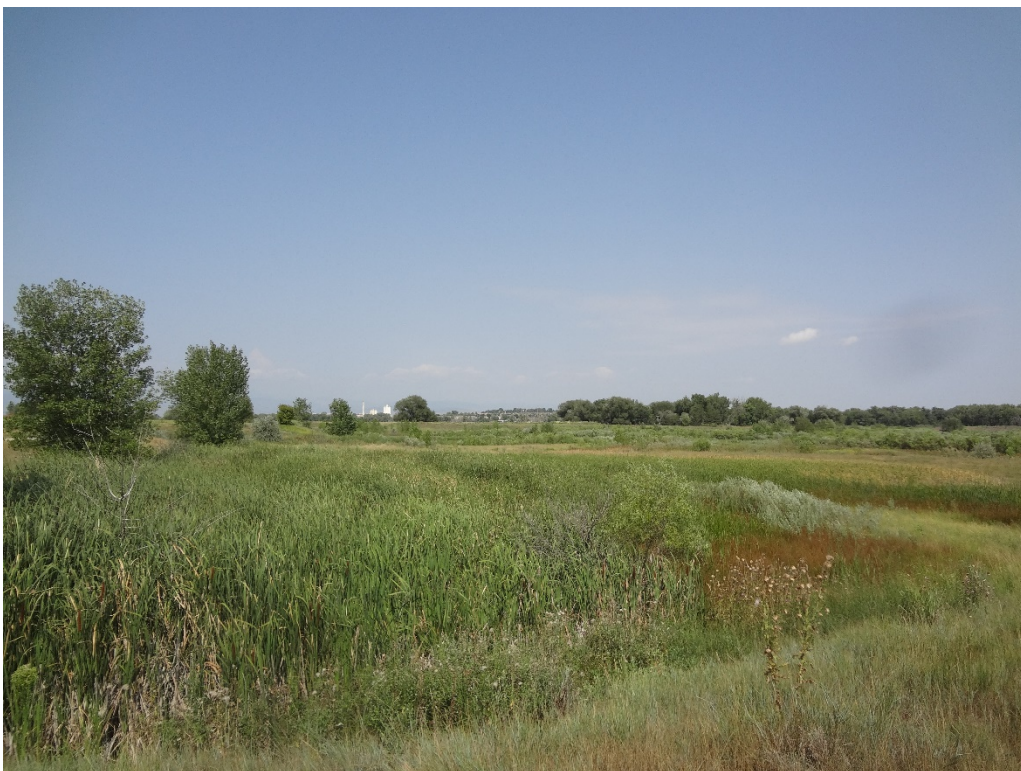
The Sherwood parcel was impacted by the 2013 river capture event resulting in the erosion of the bike trail embankment. The embankment was repaired as part of the FEMA restoration work. The repaired slope was stable, covered by jute netting and vegetated with reclamation seed mix forbs and annual weeds. Russian olive trees and Canada thistle were observed south of the St. Vrain River. As cited as a problem above, the

View of Sherwood parcel from south side looking northwest

Operator will be required to remove the Russian olive trees and treat the stumps to prevent the spread of the trees on the site and provide evidence the work has been completed by the corrective action date. The northern half of the parcel consists of the braided channels of the St. Vrain River. Overall, the parcel was well-vegetated with a diverse mix of native grass species, stable and consistent with the surrounding rangeland areas.

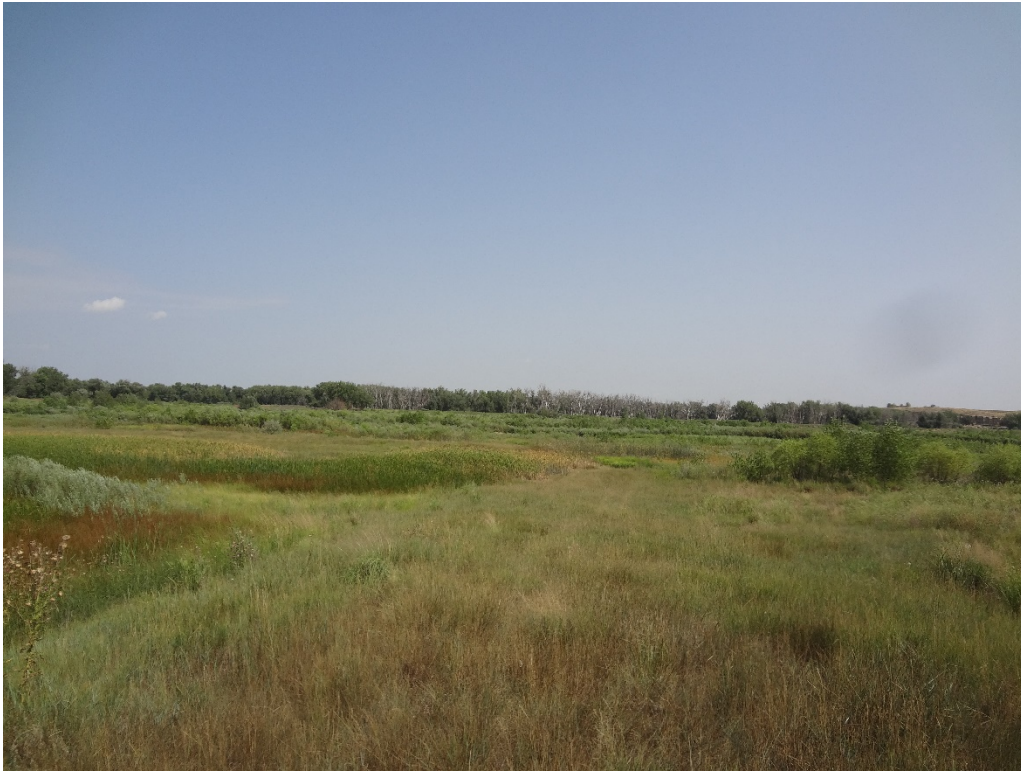
View of Sherwood parcel from south side looking north

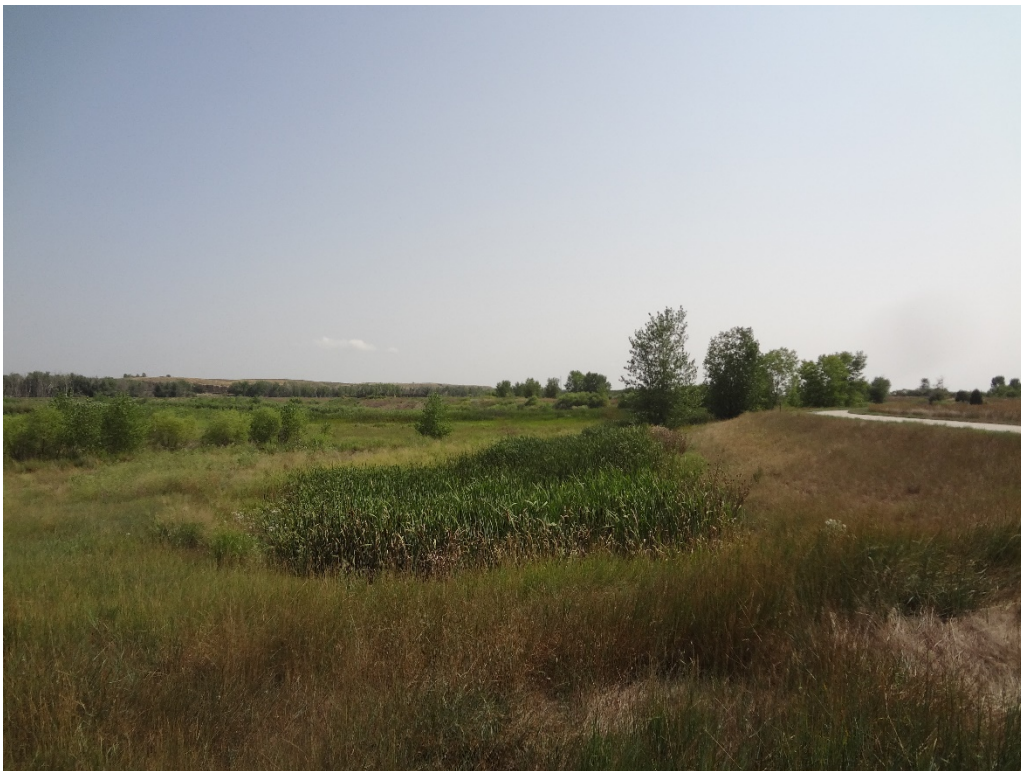
View of Sherwood parcel from south side looking east

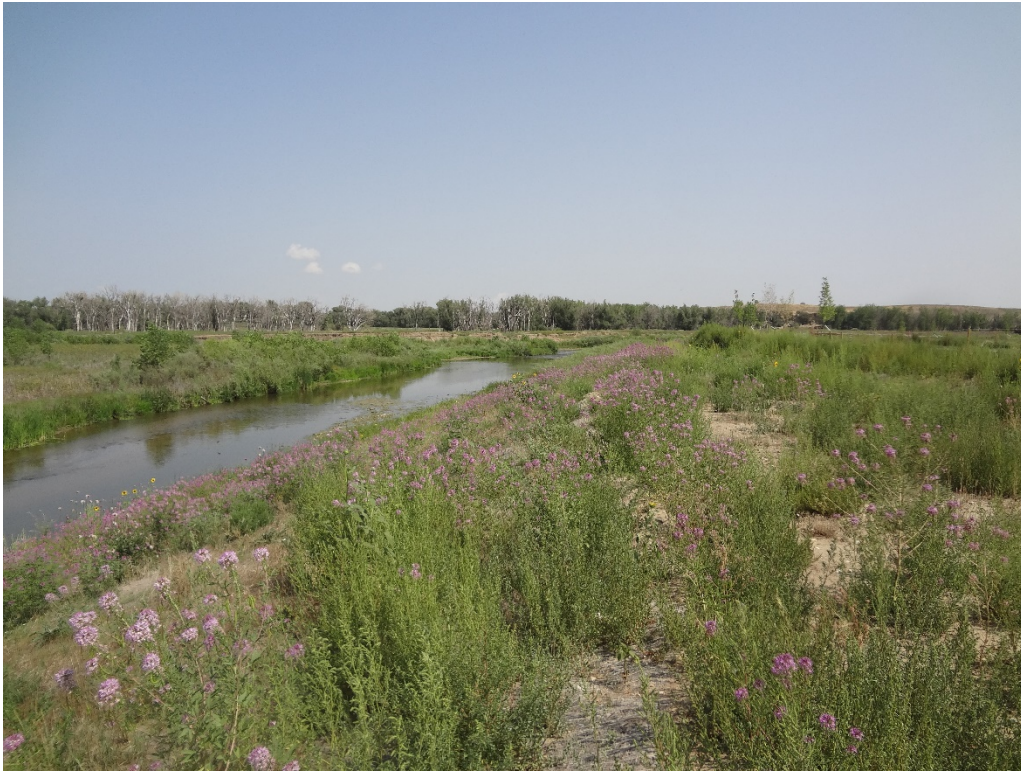
View of repaired bike path embankment in the Sherwood parcel looking north

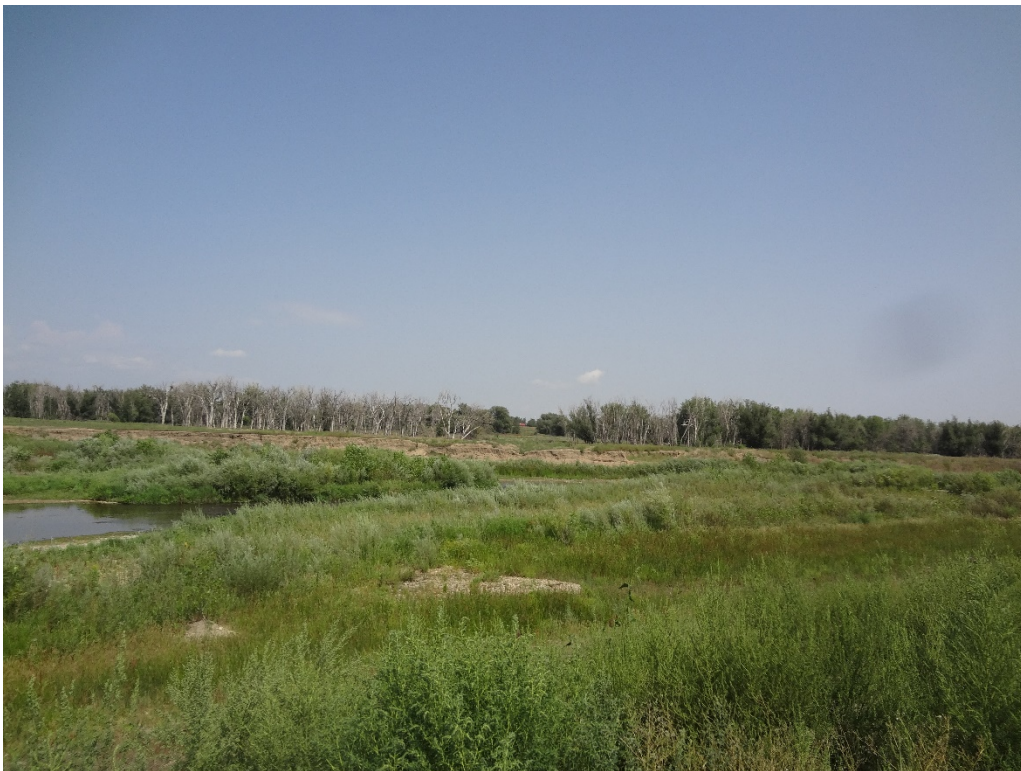
View of the Sherwood parcel from oil and gas well looking northwest

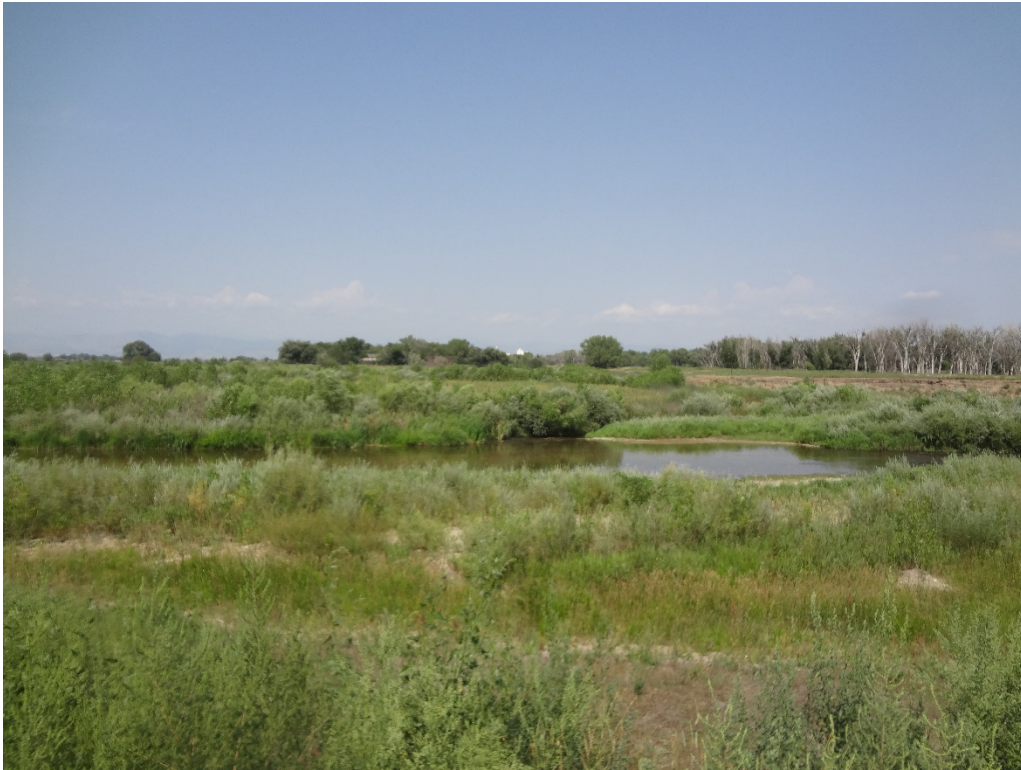
View of the Sherwood parcel from oil and gas well looking west

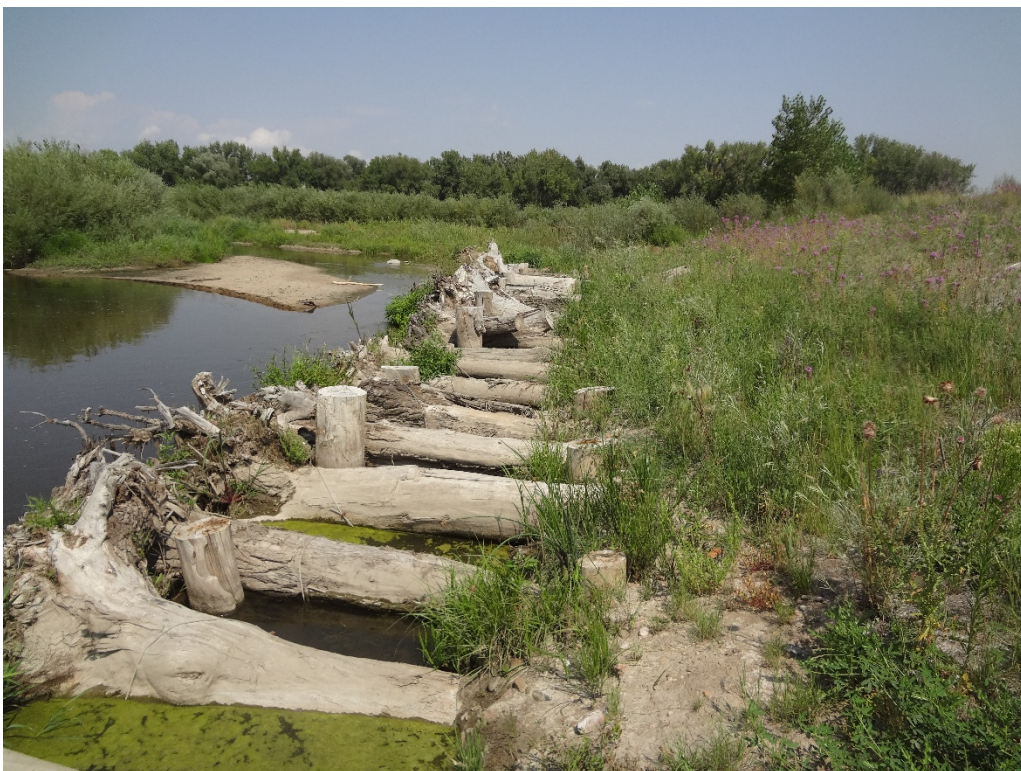
View of root wads structure in the northeast Peschel parcel looking north

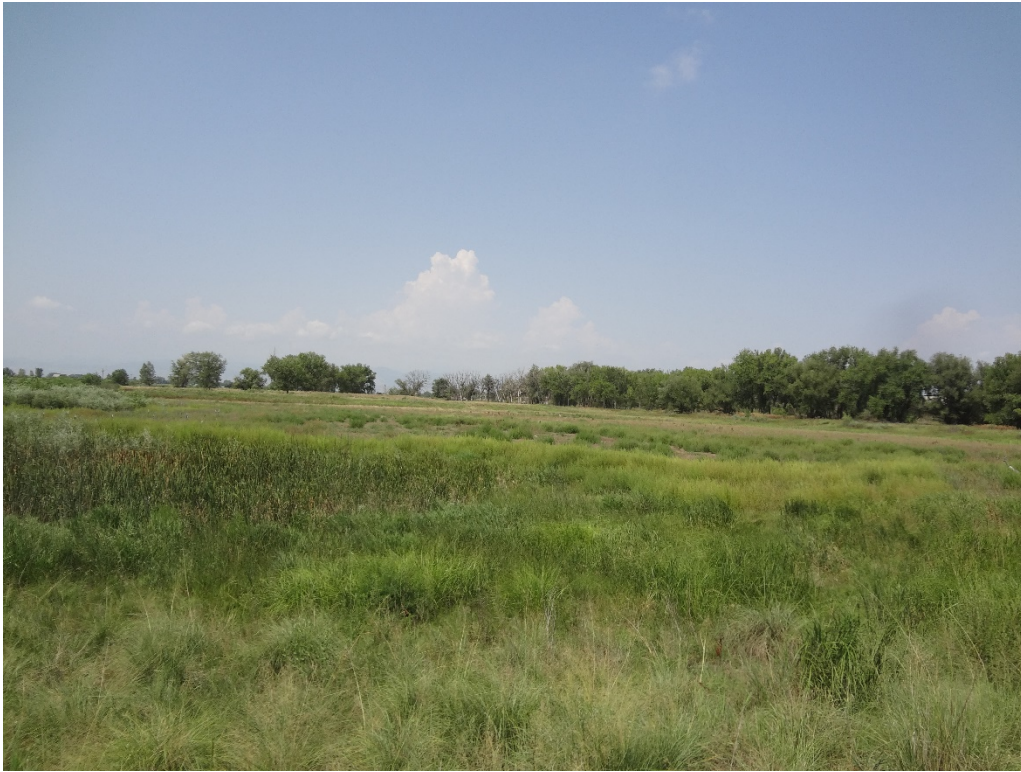
The northeast portion of the Peschel parcel consists of a former silt pond and unmined upland areas. The vegetation was well-established with a diverse mix of grass species and is consistent with the surrounding rangeland areas. A few small patches of Canada thistle were observed which will be monitored and controlled by the City as part of the operation of the parcel as open space. The access road to the parcel from the pedestrian bridge was vegetated with kochia and forbs and appeared stable.

View of the northeast Peschel parcel from the east side looking west

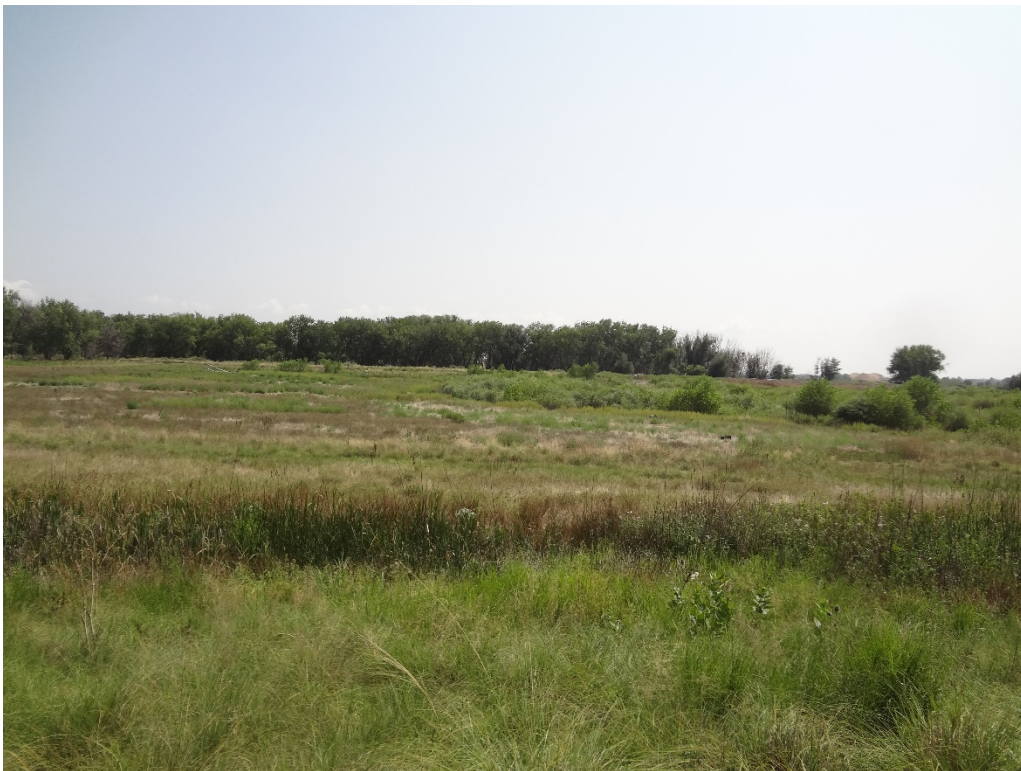
View of the northeast Peschel parcel from the middle looking east

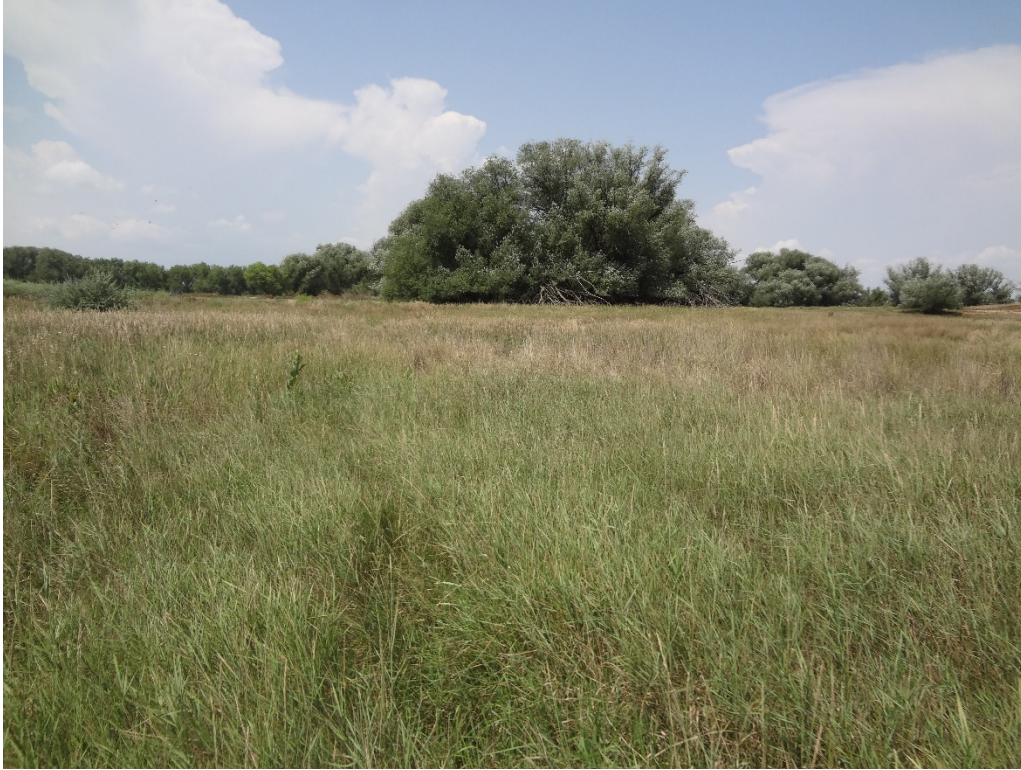
The northwest portion of the Bigelow parcel did not appear to have been disturbed by mining activity. The parcel contains two small lakes, the City of Longmont Sandstone Ranch visitor's center and a historic barn. The site vegetation was well-established with a diverse mix of native grass species. The site appeared to be well maintained by the City.

View of northwest Bigelow parcel from the east side looking west

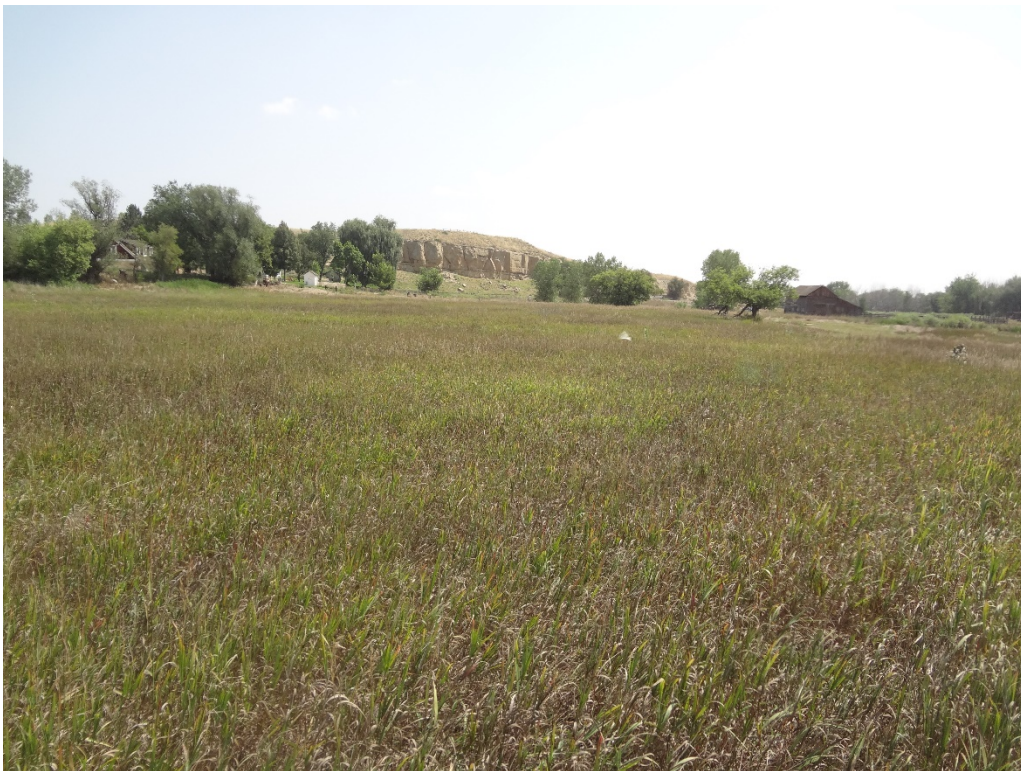
View of northwest Bigelow parcel from the southwest corner looking northeast at barn and visitor's center
