Re: Prowers Aggregate Operators, LLC  
West Farm Pit, Permit No. M-2008-078

I am writing to confirm that Prowers Aggregate Operators, LLC has responded to the Division's Mineral Program Inspection Report dated June 14, 2018 as described below.

# Inspection Area Photos

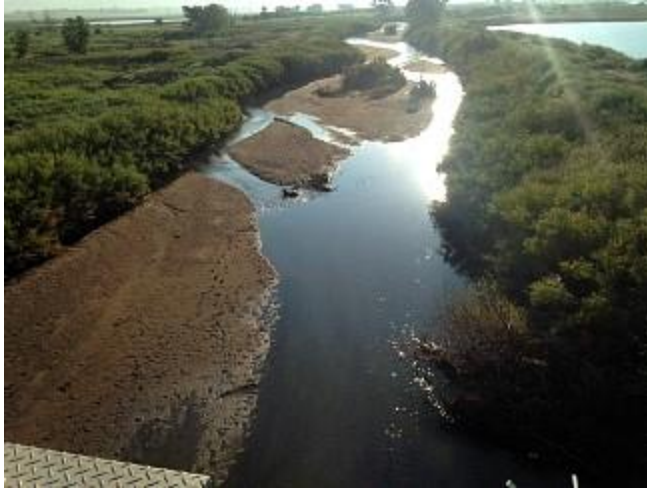
Corresponds to Inspection Report Photo No. 1. No sediment discharge into river.

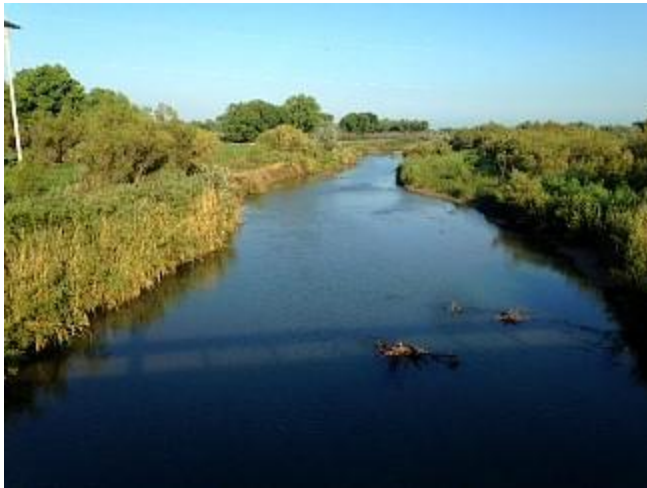
Corresponds to Inspection Report Photo No. 2. No sediment discharge into river.

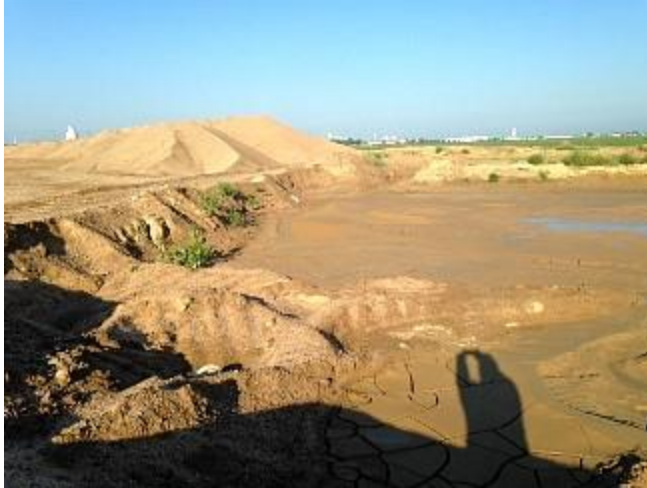
Corresponds to Inspection Report Photo No. 3. Sediment pond has been cleaned.

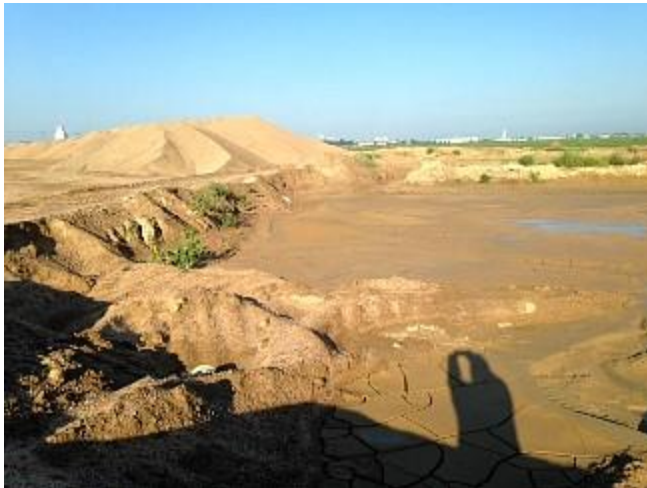
Corresponds to Inspection Report Photo No. 4. Sediment pond has been cleaned.

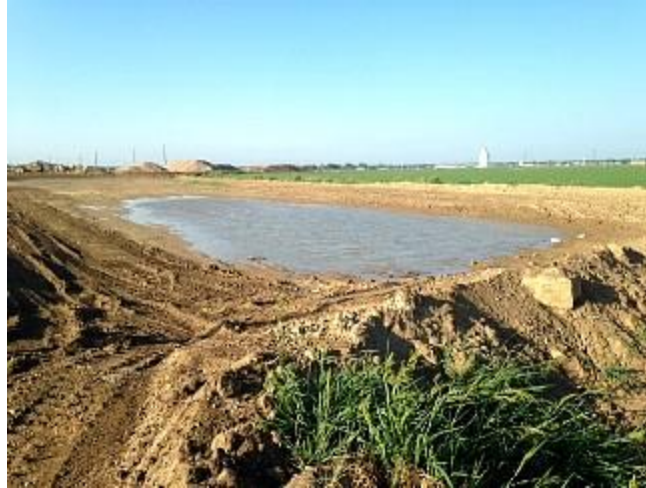
Corresponds to Inspection Report Photo Nos. 5, 6. Sediment pond is being filled in and disturbed area will be seeded.

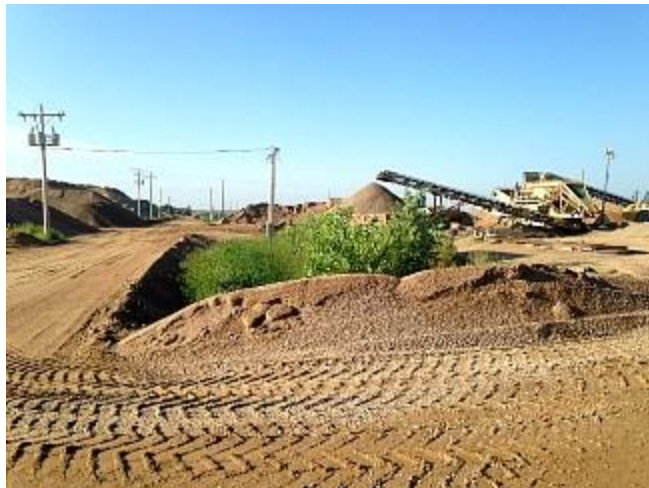
Corresponds to Inspection Report Photo No. 8. No wash plant discharge into roadside ditch.

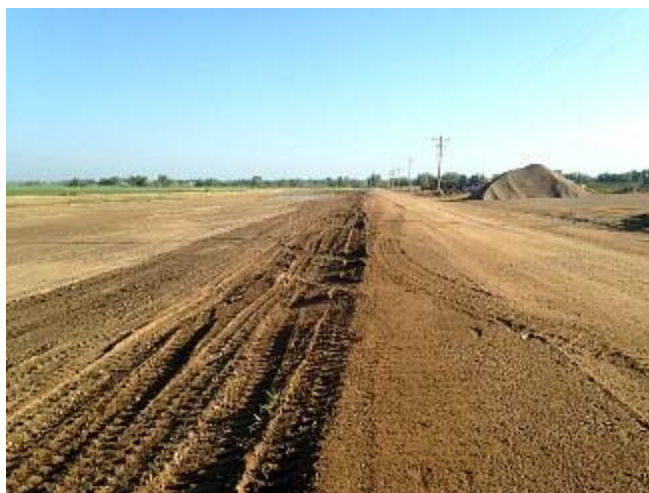
Corresponds to Inspection Report Photo No. 9. Ditch has been filled in and will be seeded.

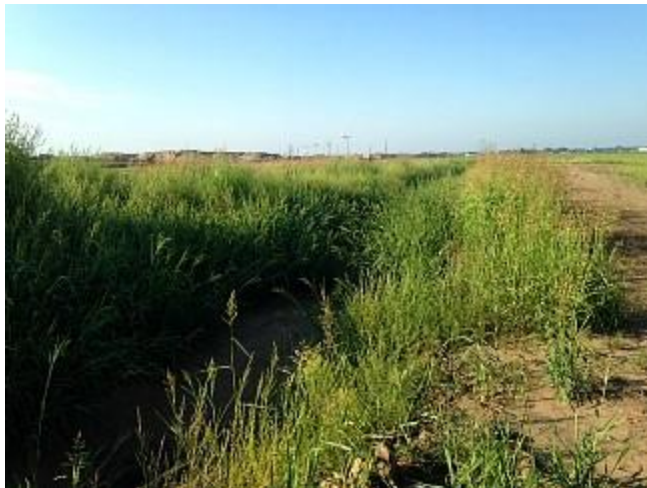
Corresponds to Inspection Report Photo No. 10. Sediment has been cleaned from ditch and grasses are filling in.

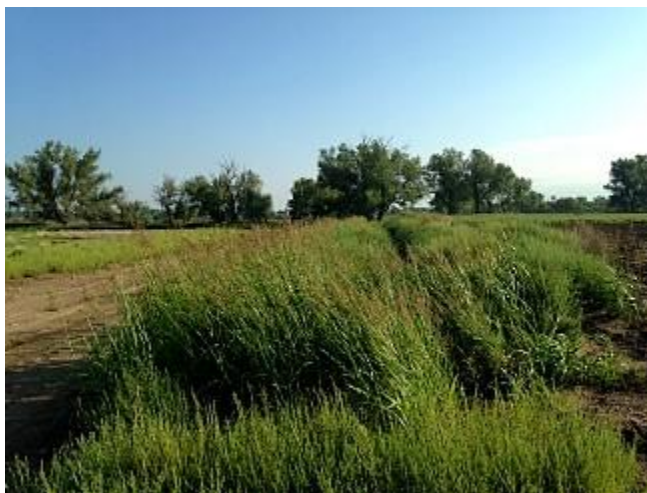
Corresponds to Inspection Report Photo No. 11. Sediment has been cleaned from ditch and grasses are filling in.

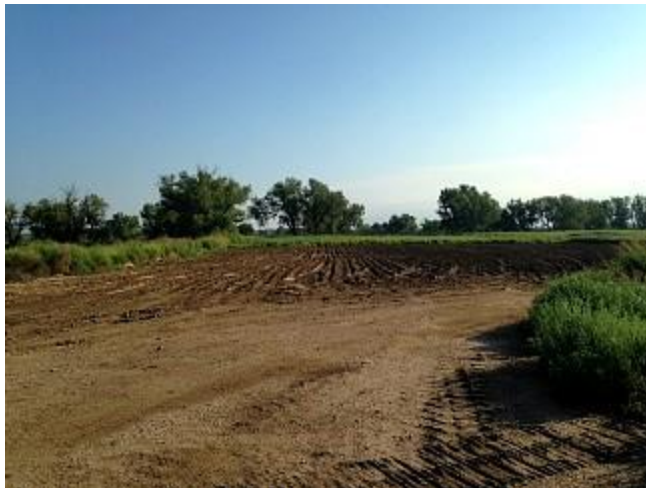
Corresponds to Inspection Report Photo No. 12. Equipment/truck storage area has been scarified and will be seeded.

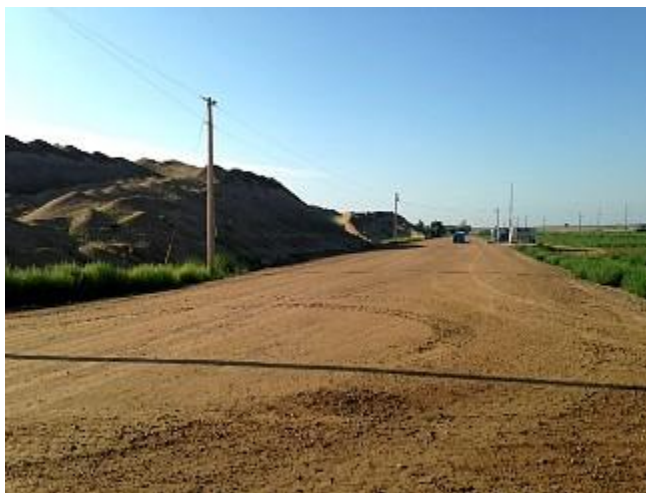
Corresponds to Inspection Report Photo No. 13. Scale house and stockpiles within amended permit boundary.

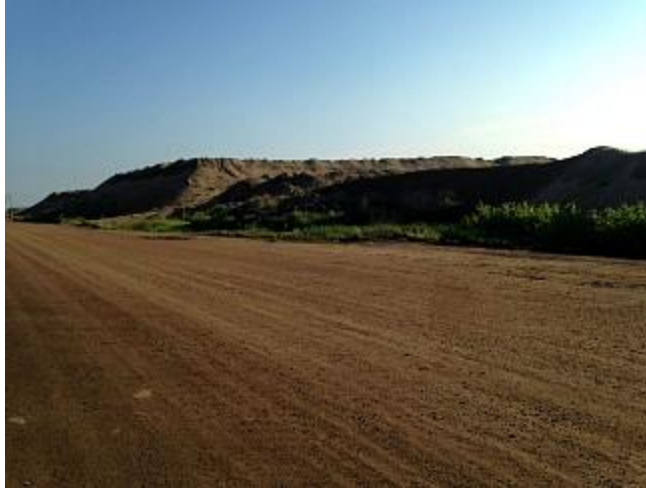
Corresponds to Inspection Report Photo No. 14. Stockpiles are within amended permit boundary.

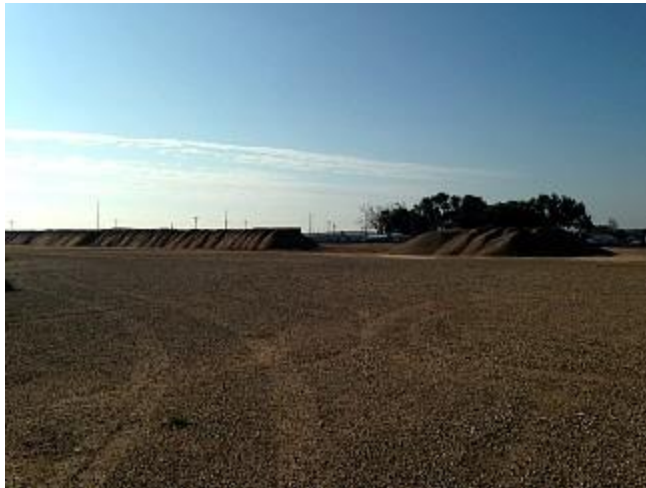
Corresponds to Inspection Report Photo No. 15. Disturbed area is within amended permit boundary.

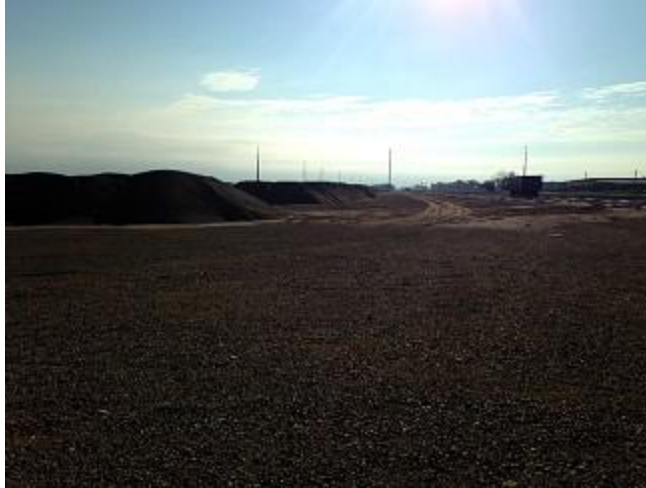
Corresponds to Inspection Report Photo No. 16. Disturbed area is within amended permit boundary.
