Coal Creek Resources, M-1988-044, Inspection Report

MINERALS PROGRAM INSPECTION REPORT**PHONE: (303) 866-3567**

MINE NAME: Coal Creek Resources	MINE/PROSPECTING ID#: M-1988-044	MINERAL: Sand	COUNTY: Arapahoe
INSPECTION TYPE: Monitoring	INSPECTOR(S): Jared L. Ebert	INSP. DATE: July 18, 2018	INSP. TIME: 09:00
OPERATOR: Schmidt Construction Company	OPERATOR REPRESENTATIVE: Dan Chavez with Schmidt Construction Company, Mark Heifner	TYPE OF OPERATION: 112c - Construction Regular Operation

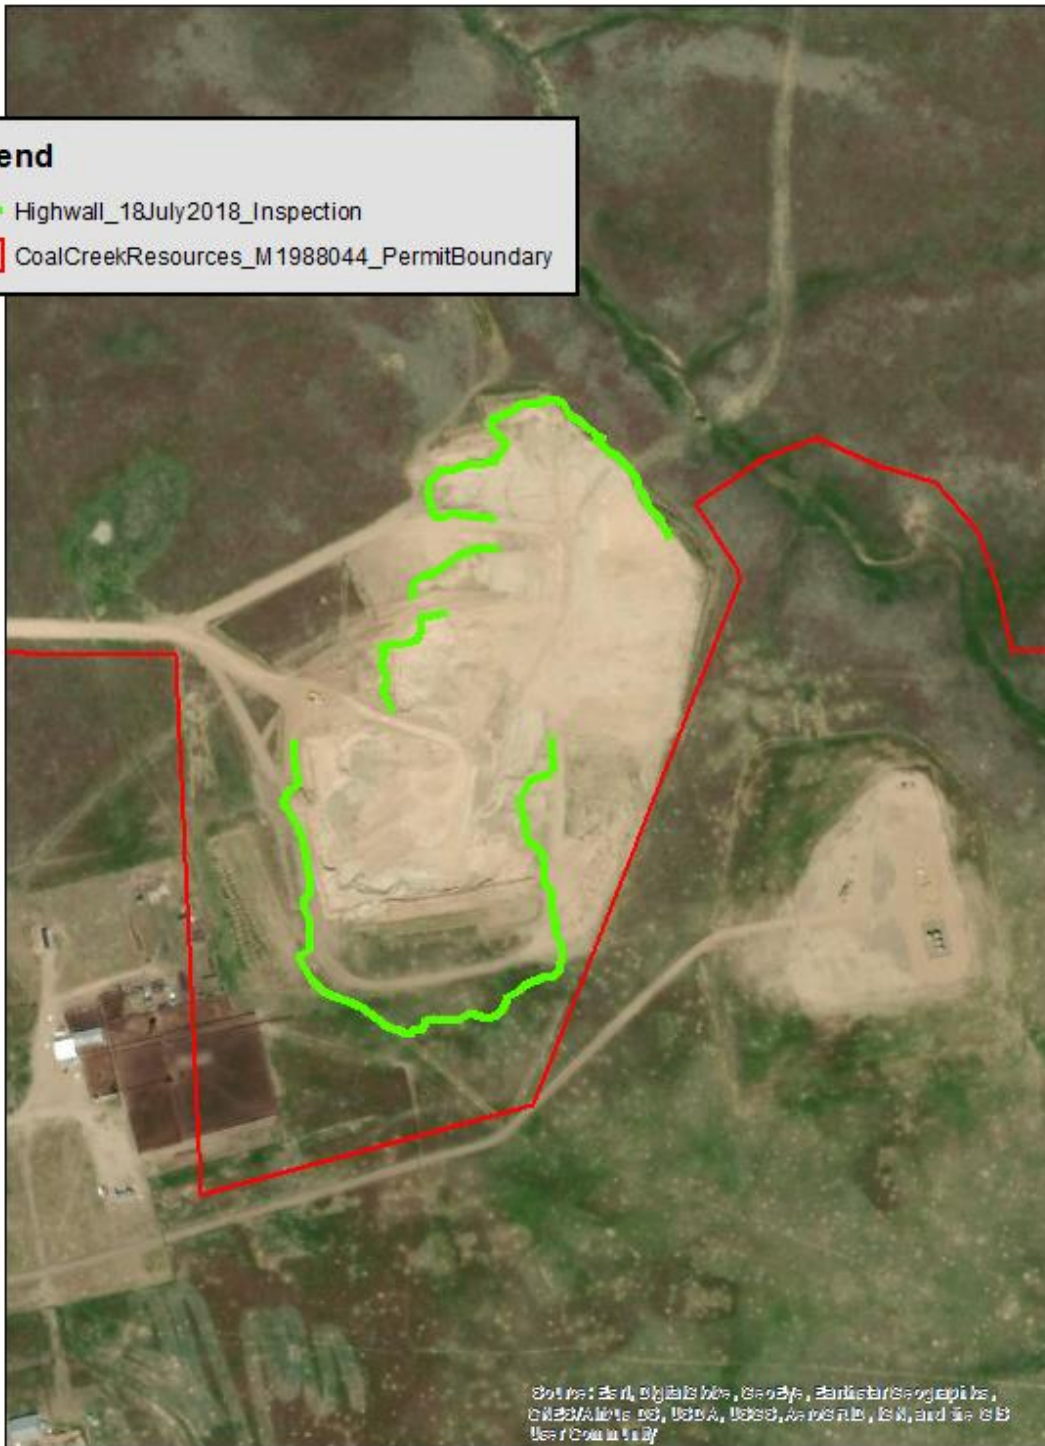
Coal Creek Resources, M-1988-044

Active mining is occurring in the southeast portion of the permit area. The access road enters the site from the east and drops down into the pit. The pit excavation consists of a series of highwalls that are about 20 to 30 feet in height creating a small bowl. The highwalls were vertical to near vertical in angle. The location of the highwall were collected using the ArcCollector application and are depicted on the enclosed map. The operator was actively mining at the southern end of the active mine area. The Division estimates about 3,400 feet of highwall exists at the site.

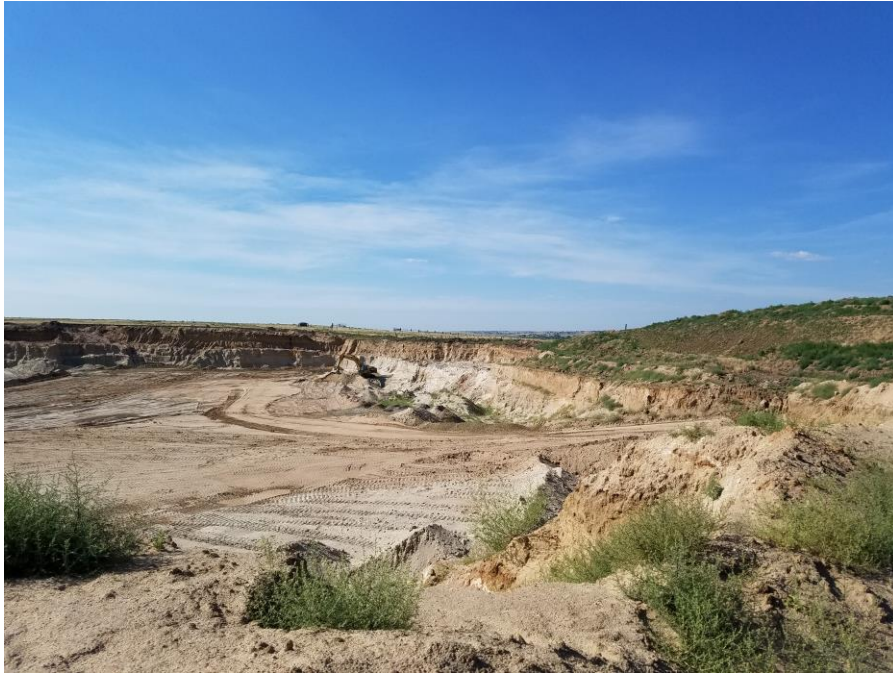
Figure 1. From the north end of the active mine area looking south.

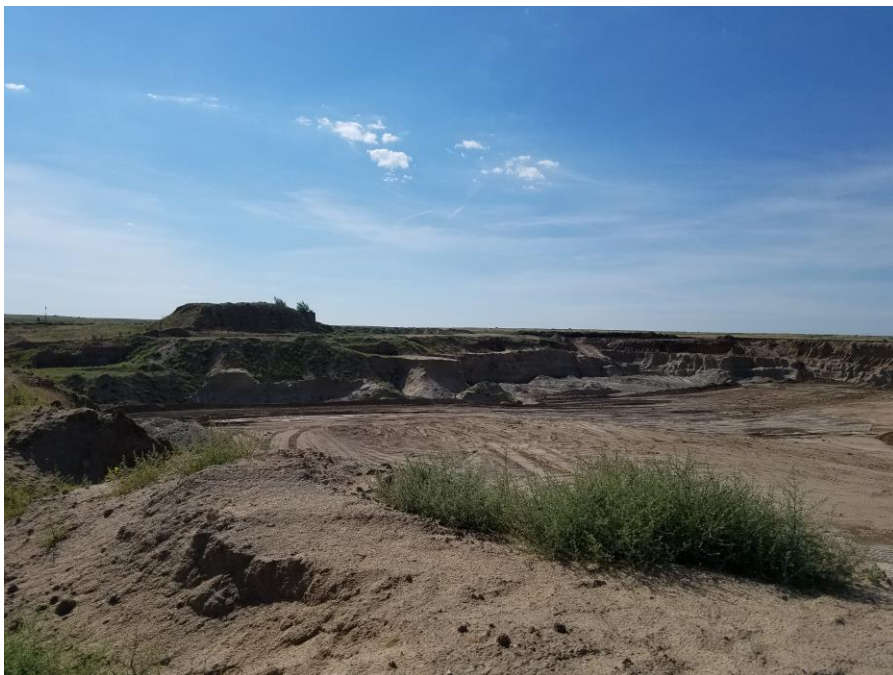
Figure 2. From the north end of the active mine area looking southeast.

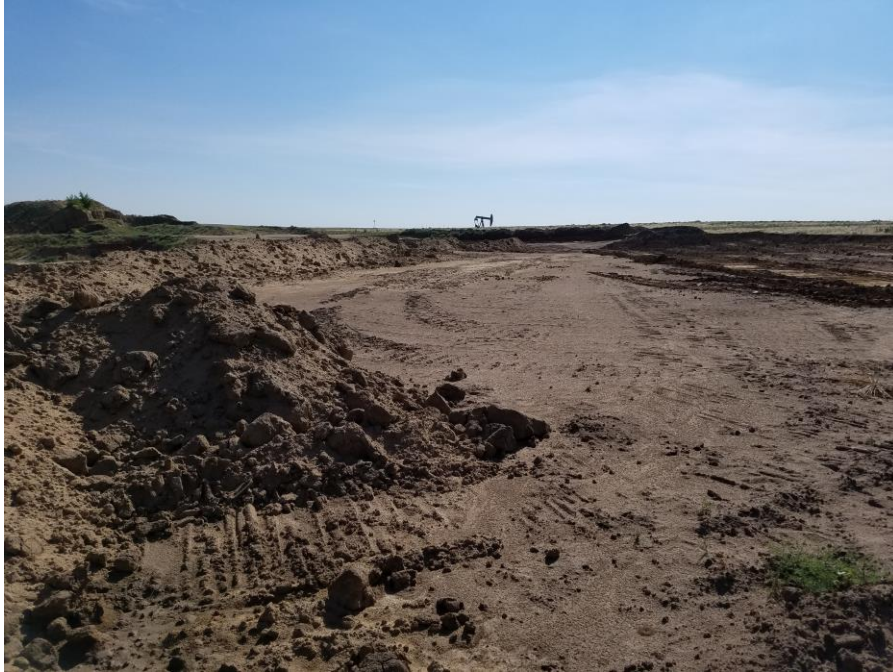
An excavator was active in the pit at the time of the inspection and the Operator was hauling material from the pit to the processing area. A small area was stripped of topsoil in advance of mining at the southern end of the affected area.

Figure 3. Area stripped of topsoil at the southeast corner of the active mine area.

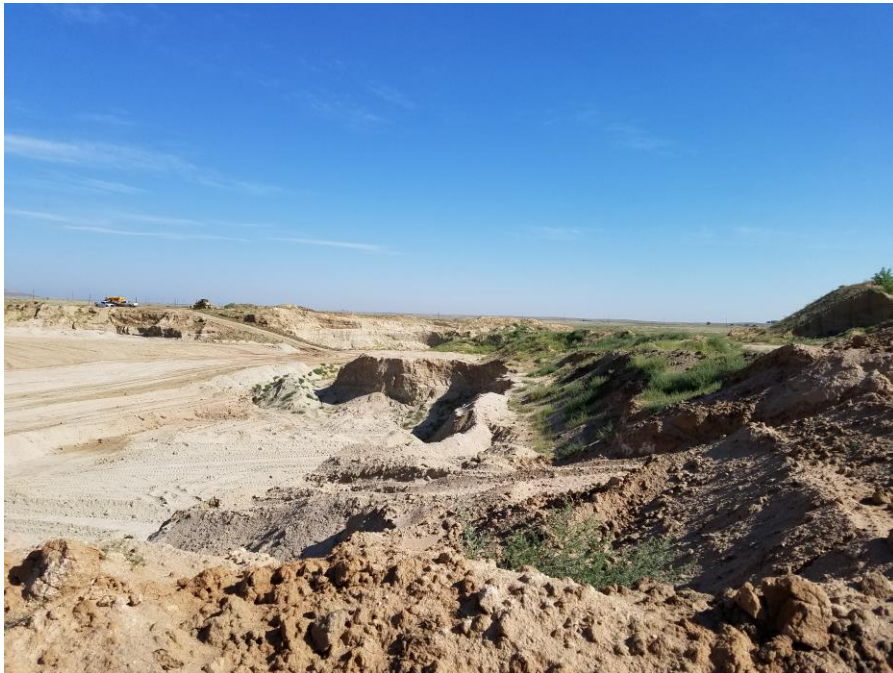
Figure 4. From the southeast corner of the active mine area looking north.

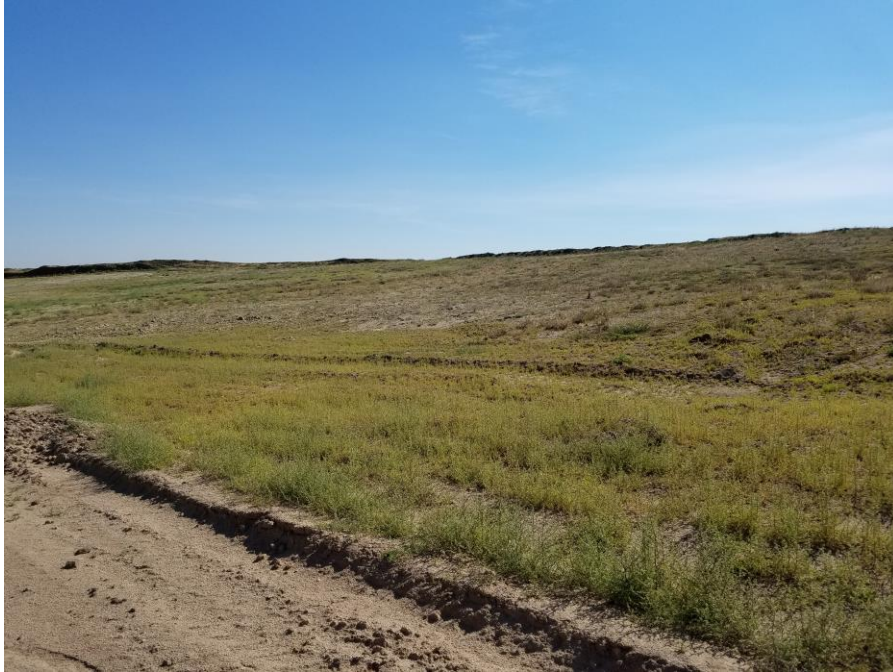
A portion of the active mine area located in the southeast portion of the site has been backfilled and graded. The location of this area is depicted on the annual report map submitted in March of 2018. The area graded has a gentle slope that appeared to be set at a 5H:1V angle or less.

Figure 5. Backfilled and graded area on the east side of the active mine area.

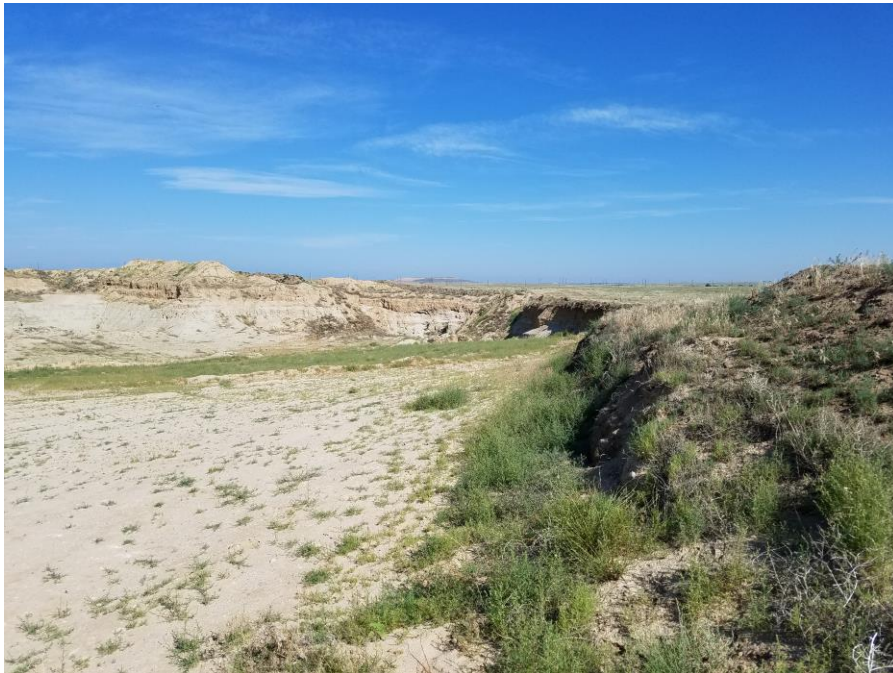
Figure 6. From the east side of the active mine area looking northwest.

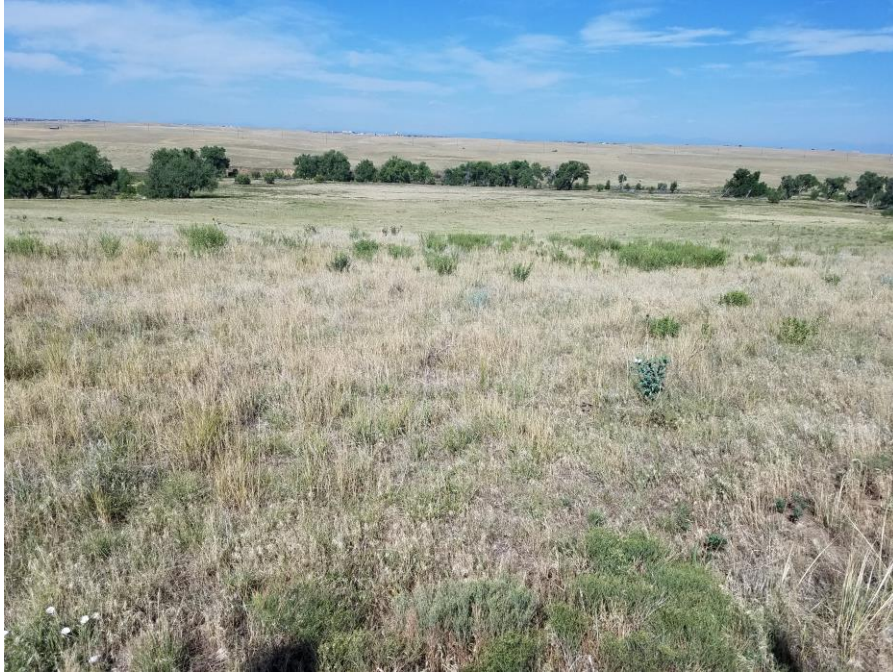
An area about 32 acres in size shown on the latest annual report map as being planted in 2014 was observed. The area appears stable with very gentle slopes that have a western aspect. Dense vegetation has established throughout this parcel that include a diverse mixture of native grasses and forbs. The dominant native grasses

observed was western wheatgrass, blue grama and sand dropseed. Several noxious thistle species were observed, but were not well established. The Operator is encouraged to monitor this area and treat the weeds in accordance with the approved weed control plan. Cheatgrass was established in this area as it is throughout adjacent un-affected land. The Division encourages the Operator to seek bond release on this parcel.

Figure 7. From the east end of the 2014 reclaimed area looking west.

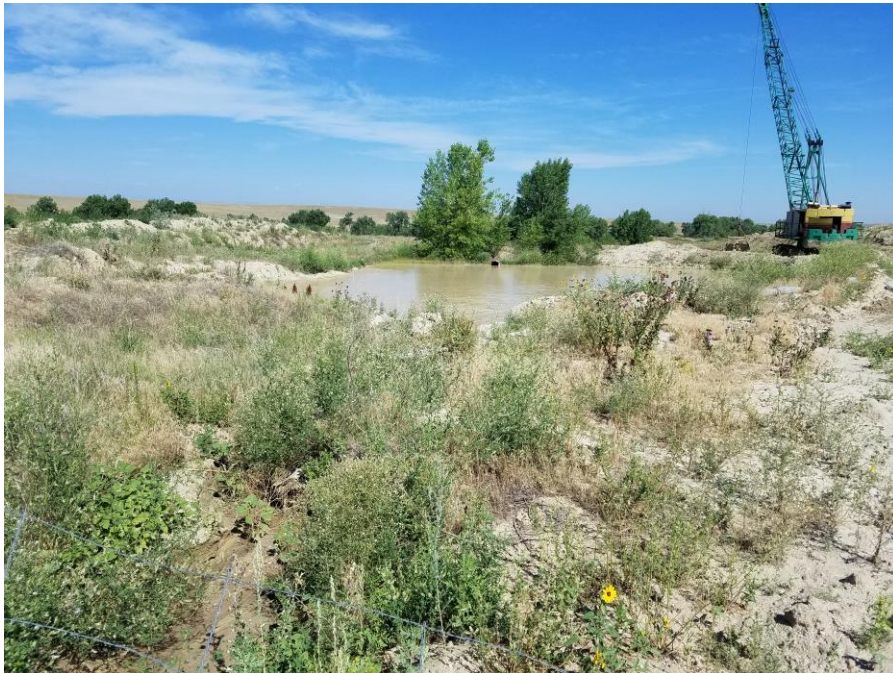
The Division observed the series of four sediment ponds located west of the processing area. This is a closed water system where water from processing flows to the southernmost pond and then travels through the three lower sediment ponds and is then pumped back to the processing area. The final pond in the series does not discharge off-site.

Figure 8. From the south end of the first cell of the sediment ponds west of the processing area.

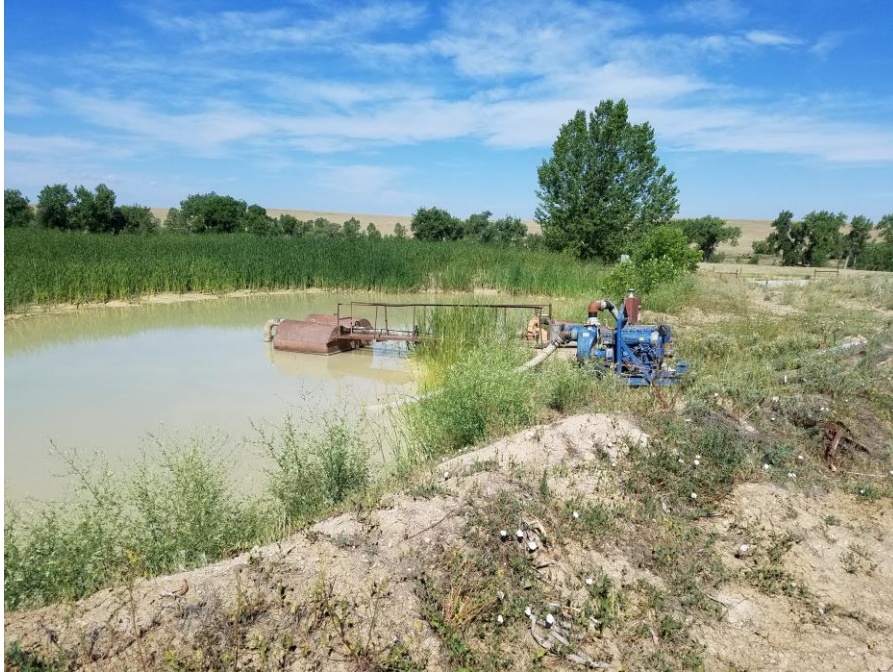
Figure 9. Last cell in the series of sediment ponds. Water pumped back up to the processing facilities.
