**MINERALS PROGRAM INSPECTION REPORT**  
**PHONE: (303) 866-3567**

<b>MINE NAME:</b> Sunnyside Gold Mine	<b>MINE/PROSPECTING ID#:</b> M-1977-378	<b>MINERAL:</b> Lead, zinc, copper, iron	<b>COUNTY:</b> San Juan
<b>INSPECTION TYPE:</b> Multi Person Inspection	<b>INSPECTOR(S):</b> Lucas J. West	<b>INSP. DATE:</b> July 31, 2018	<b>INSP. TIME:</b> 13:36
<b>OPERATOR:</b> Sunnyside Gold Corp	<b>OPERATOR REPRESENTATIVE:</b> Larry Perino	<b>TYPE OF OPERATION:</b> 112 - Hard Rock Regular Operation	
<b>REASON FOR INSPECTION:</b> Memo Of Understanding	<b>BOND CALCULATION TYPE:</b> None	<b>BOND AMOUNT:</b> \$60,534.00	
<b>DATE OF COMPLAINT:</b> NA	<b>POST INSP. CONTACTS:</b> None	<b>JOINT INSP. AGENCY:</b> None	
<b>WEATHER:</b> Clear	<b>INSPECTOR'S SIGNATURE:</b>

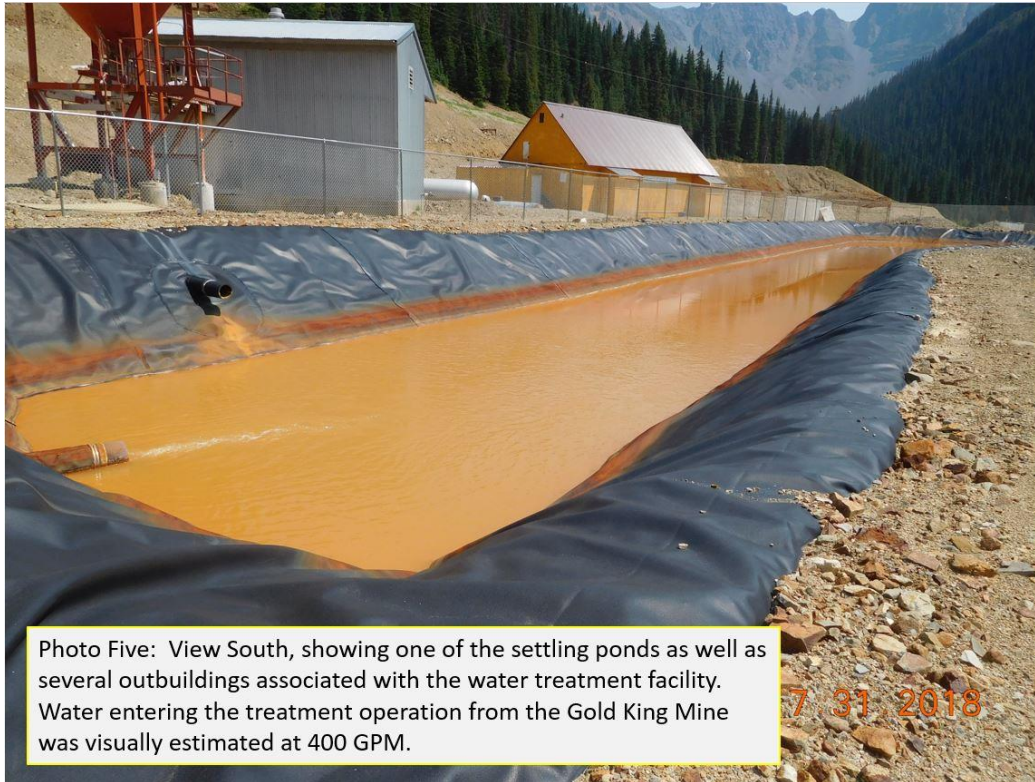
Photo Five: View South, showing one of the settling ponds as well as several outbuildings associated with the water treatment facility. Water entering the treatment operation from the Gold King Mine was visually estimated at 400 GPM.

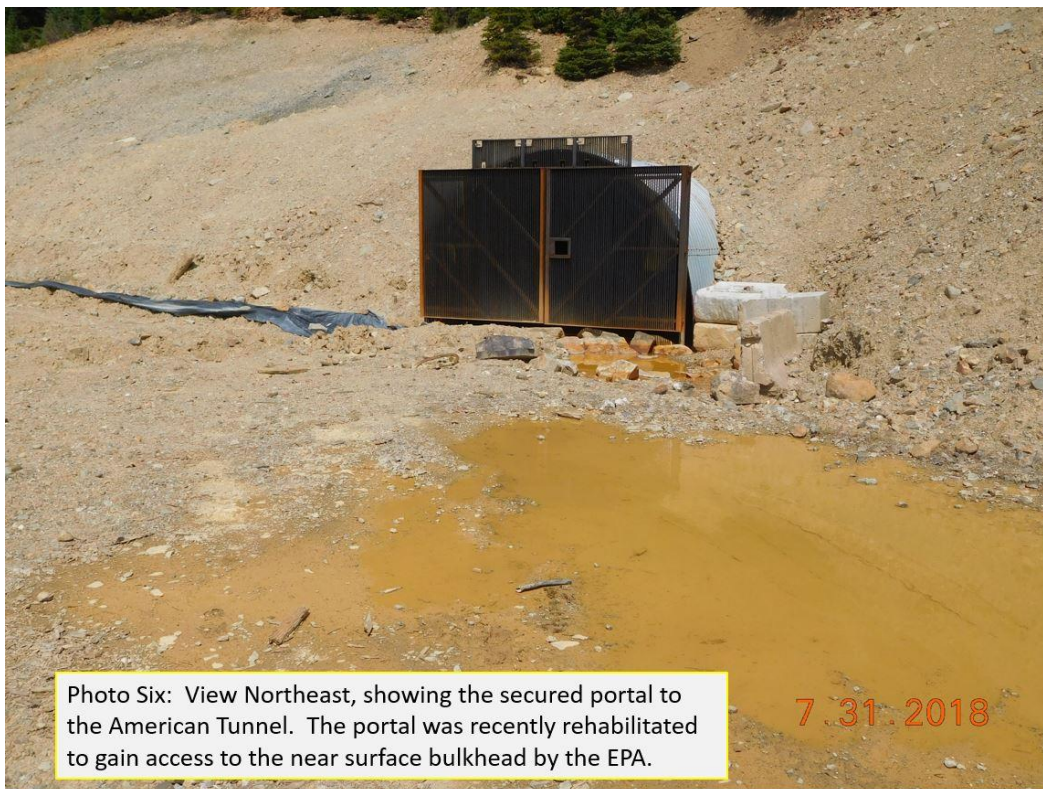
Photo Six: View Northeast, showing the secured portal to the American Tunnel. The portal was recently rehabilitated to gain access to the near surface bulkhead by the EPA.
