**MINERALS PROGRAM INSPECTION REPORT**  
**PHONE: (303) 866-3567**

<b>MINE NAME:</b> Hazeltine Mine	<b>MINE/PROSPECTING ID#:</b> M-2004-031	<b>MINERAL:</b> Sand and gravel	<b>COUNTY:</b> Adams
<b>INSPECTION TYPE:</b> Monitoring	<b>INSPECTOR(S):</b> Jared L. Ebert	<b>INSP. DATE:</b> August 20, 2018	<b>INSP. TIME:</b> 10:30
<b>OPERATOR:</b> Aggregate Industries - WCR, Inc.	<b>OPERATOR REPRESENTATIVE:</b> Joel Bolduc	<b>TYPE OF OPERATION:</b> 112c - Construction Regular Operation	
<b>REASON FOR INSPECTION:</b> Normal I&E Program	<b>BOND CALCULATION TYPE:</b> None	<b>BOND AMOUNT:</b> \$670,602.00	
<b>DATE OF COMPLAINT:</b> NA	<b>POST INSP. CONTACTS:</b> None	<b>JOINT INSP. AGENCY:</b> None	
<b>WEATHER:</b> Clear	<b>INSPECTOR'S SIGNATURE:</b>

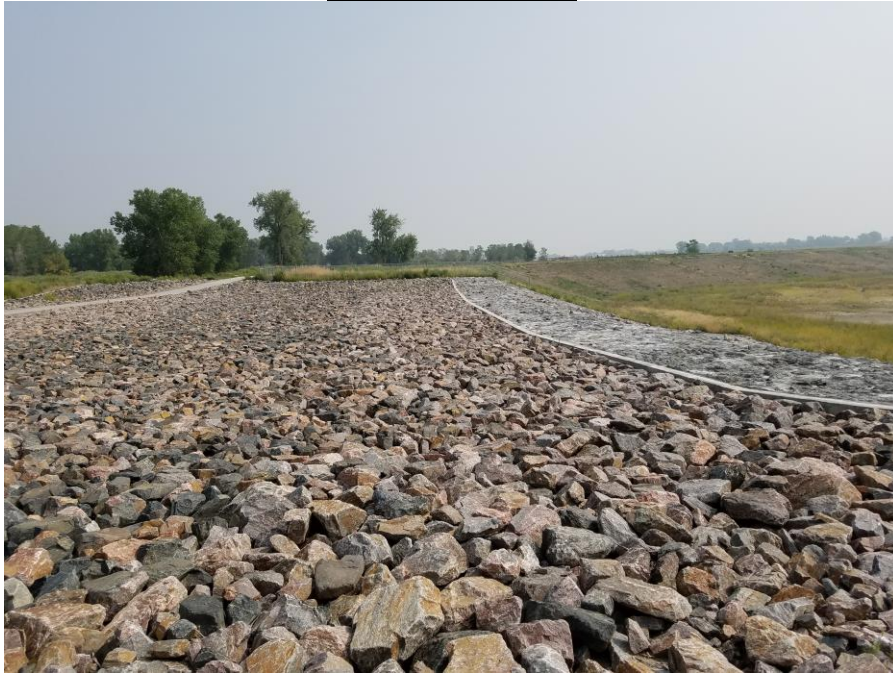
The flood spillway installed at the northwest corner of the pit was observed. No problems were noted.

**Figure 1. Flood control spillway at the northwest corner of the site.**

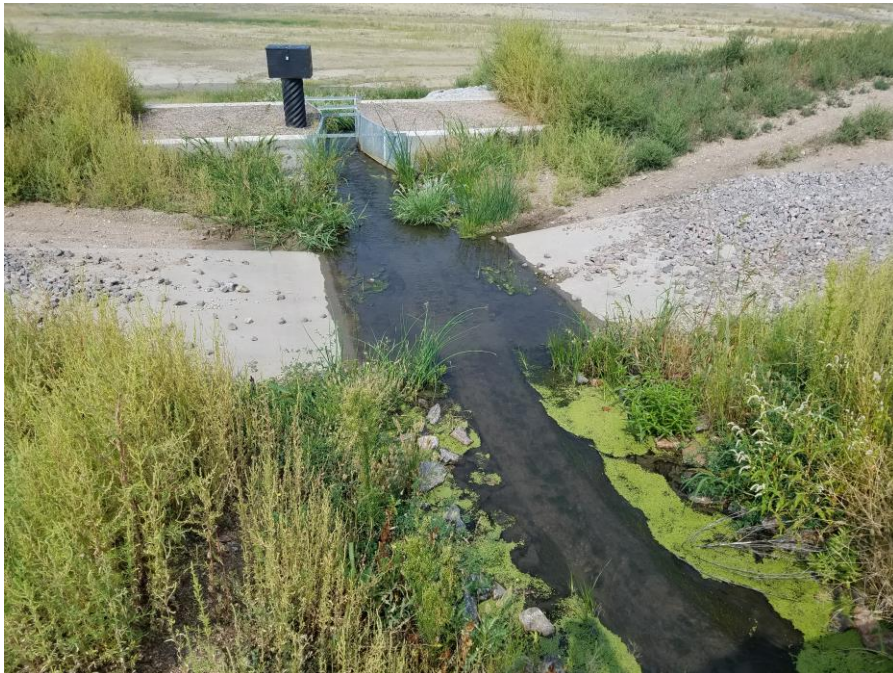
At the time of the inspection, the Orr Drain was open and water was discharging into the pit (Hazeltine Reservoir). Water flows into the pit and pools near the northeast corner where it is pumped from the pit and discharged into the Bull Seep on the north side of the property. AI has excavated deeper "finger drains" or trenches upstream and downstream of the Orr Drain to facilitate the flow of water into the drain. It is likely groundwater and water from the relocated Bull Seep are discharging from the Orr Drain. Based on the second quarter 2018 monitoring well data submitted by AI, the water level in HZMW-2 has lowered to 5040 feet. Water levels in HZMW-11A and 11B do not appear to have substantially changed and are above the pre-slurry wall water level. Mr. Bolduc indicated AI may extend and/or create additional drainage trenches to increase the groundwater drainage from the Orr property. AI as required, should continue to evaluate the groundwater levels in these monitoring wells and take appropriate action to lower the groundwater level. Monitoring well HZMW-2 was accessible during the inspection. However, HZMW 11A and 11B appeared to have been accessed recently but surface water was observed near the casings and the ground was very wet.

**Figure 2. Water discharge from the Orr Drain.**

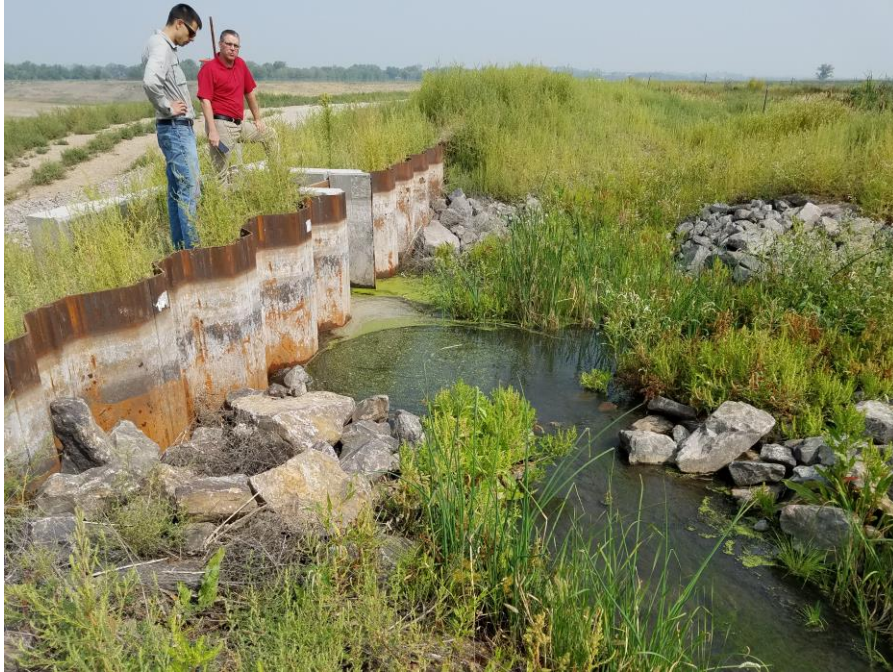
Figure 3. Upstream of the Orr Drain. View of the headwall.

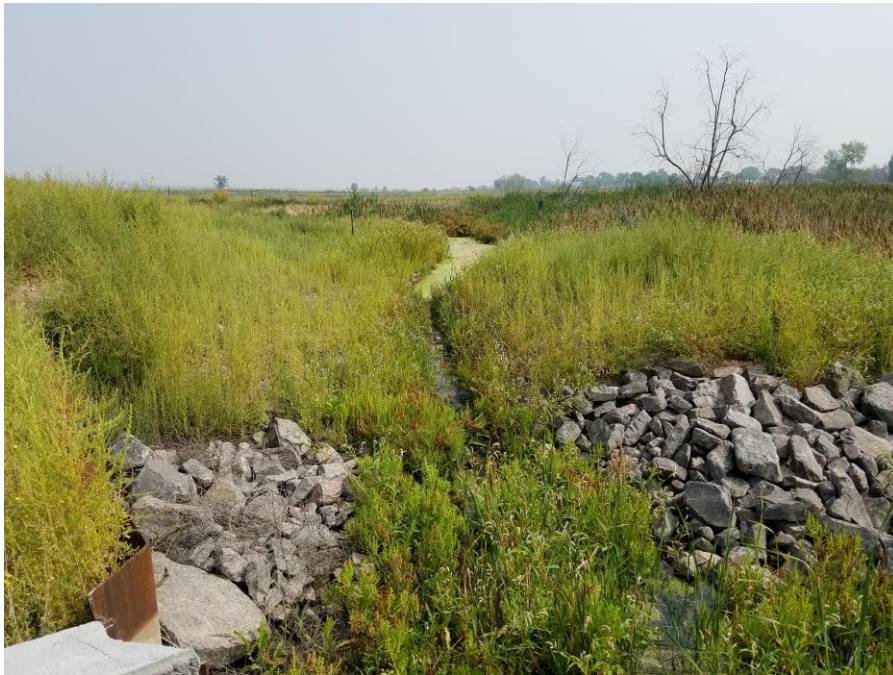
Figure 4. Downstream "Finger Drain" or trench.

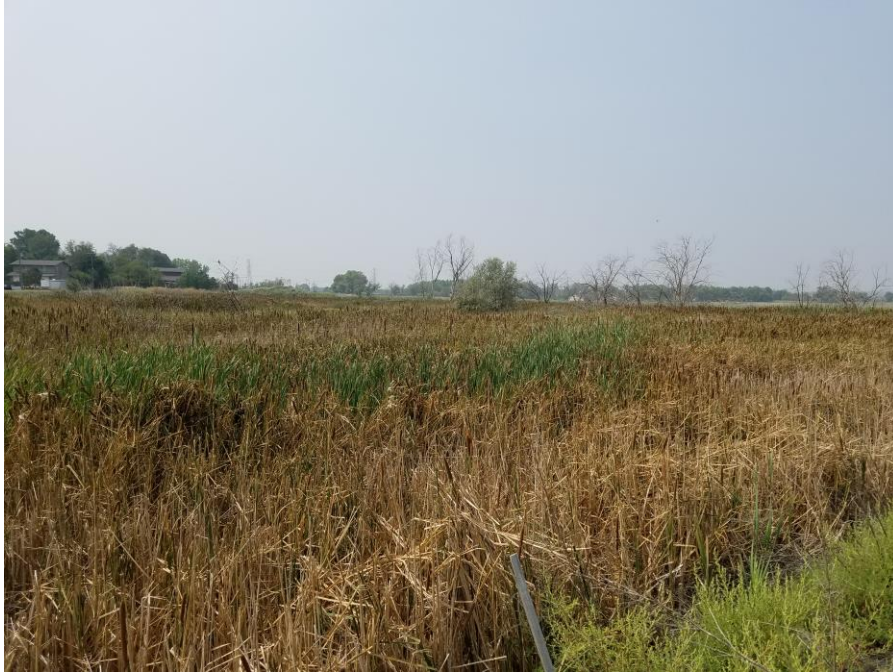
Figure 5. From the north end of the Orr Property looking south.

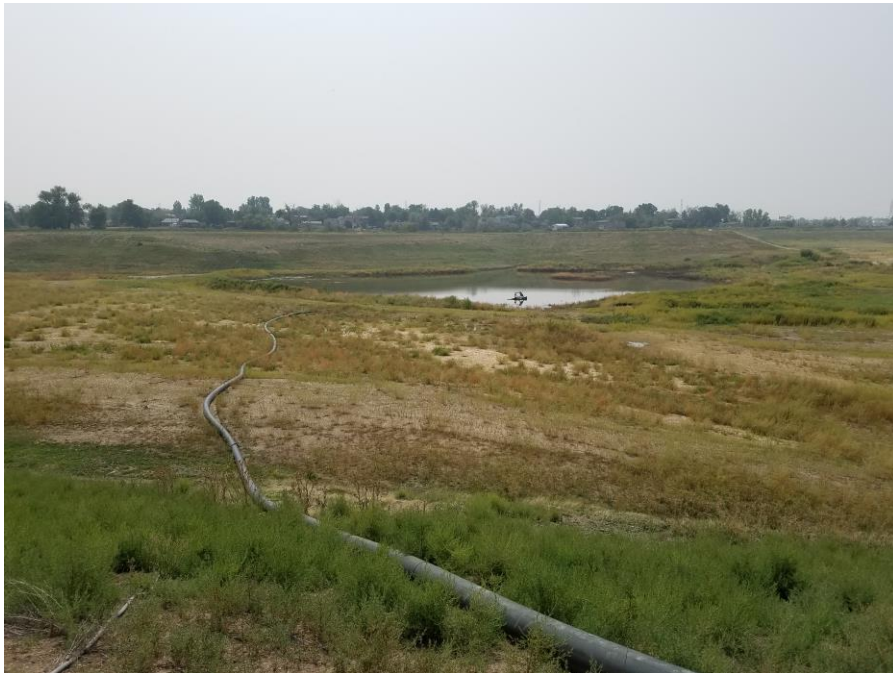
Figure 6. View of the northeast corner of the pit. Pooled water from the Orr Drain and likely recent precipitation.

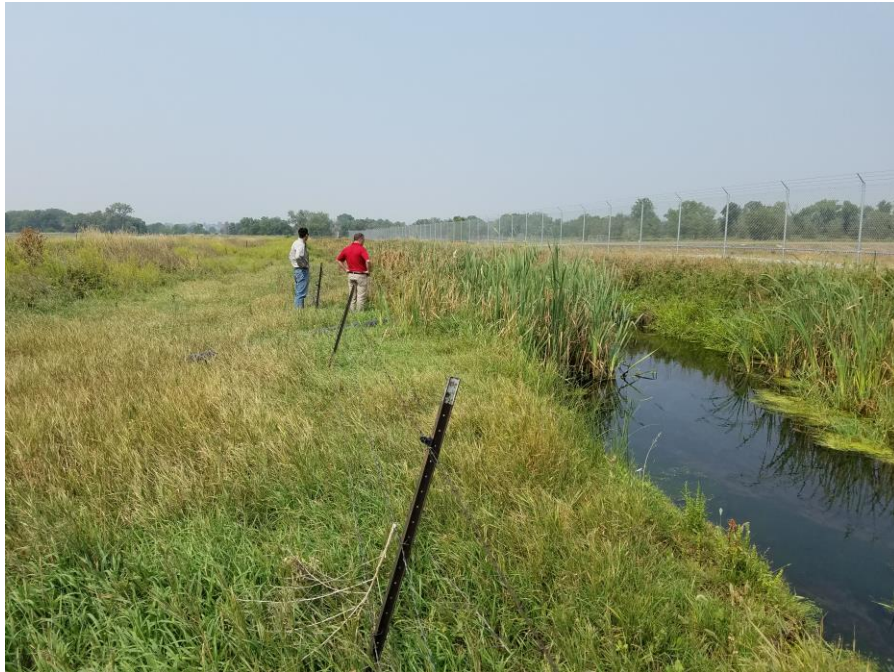
Figure 7. View of the discharge point on the north side of the Hazeltine Mine.

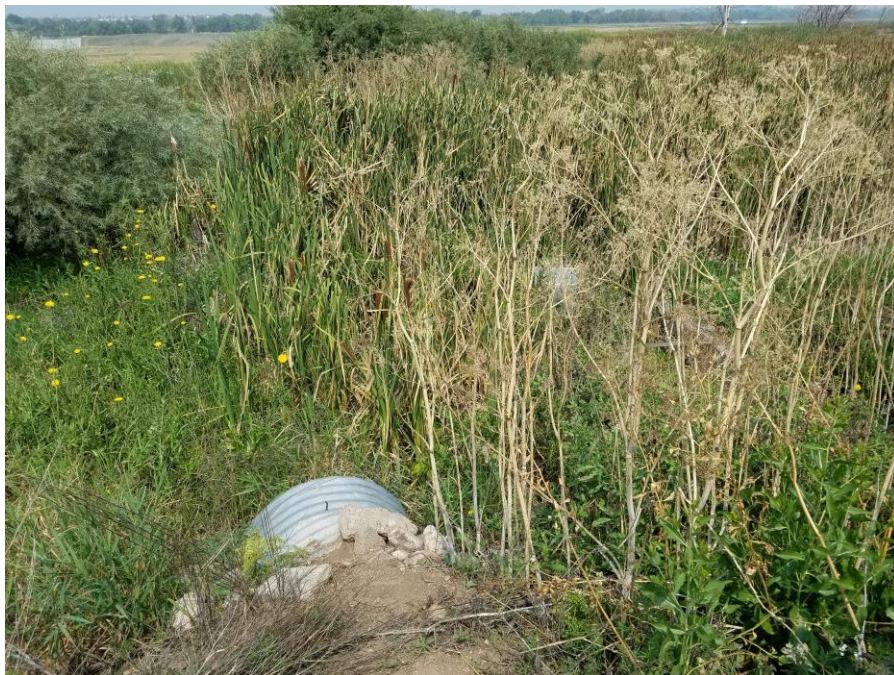
Figure 8. Discharge point of the Fulton Ditch to the Bull Seep, southwest corner of the Orr Property.

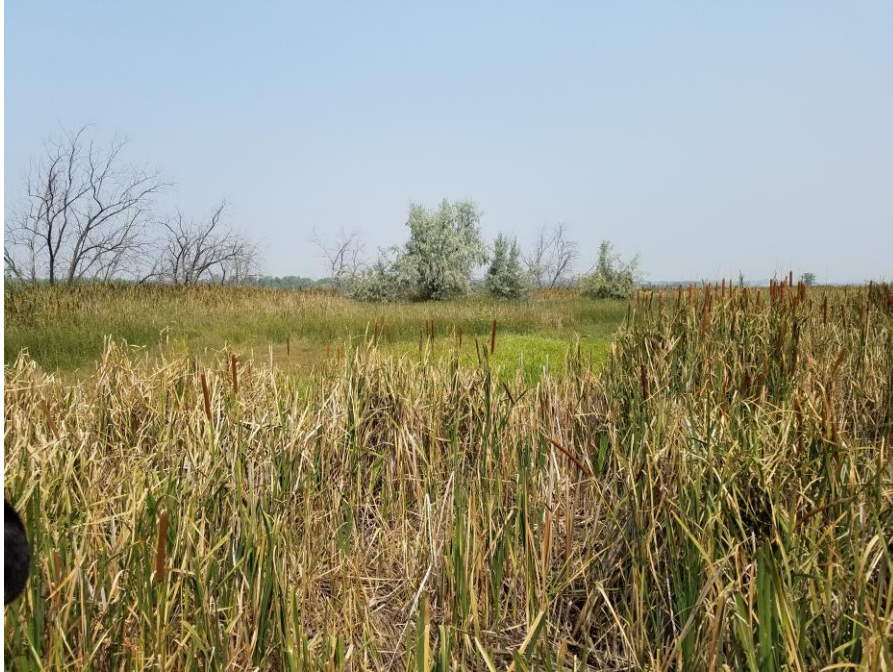
The Orr property was observed. The Fulton Ditch was not open and turned out into the Bull Seep at the gate at the southwest corner of the Orr Property. Previous DRMS inspections have noted a pond of water consistently in the northwest to central part of the Orr property. The surface of this area was relatively dry. Standing water was observed within the cattails that have established throughout the Orr Property. Overall, the surface of the Orr property is dryer than previously observed by the Division, however it is clear the groundwater is still very near the surface on the central, north and east side of the Orr property.

Figure 9. View of the central portion of the Orr property.

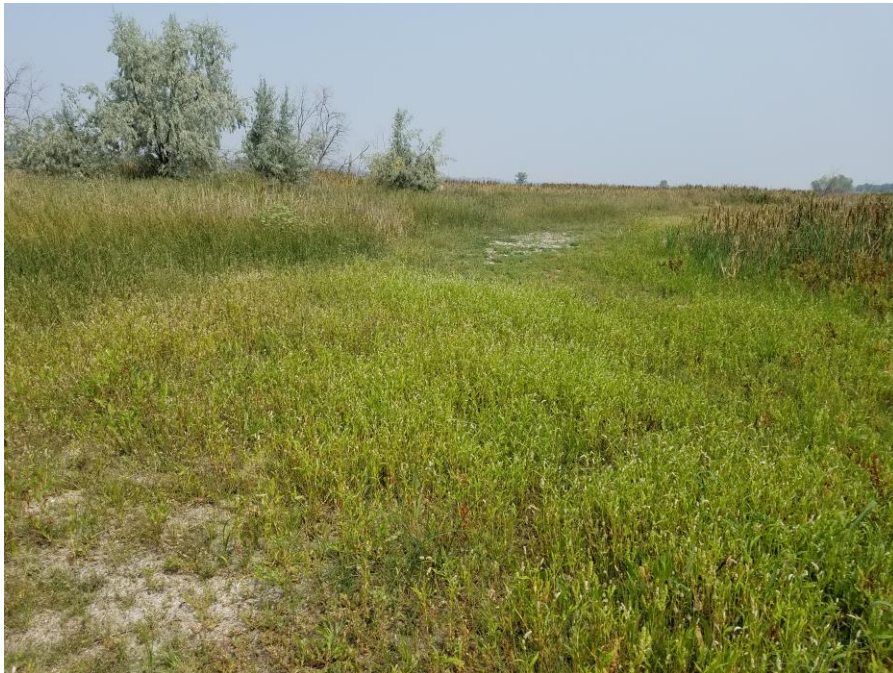
Figure 10. From the center of the Orr property looking north.

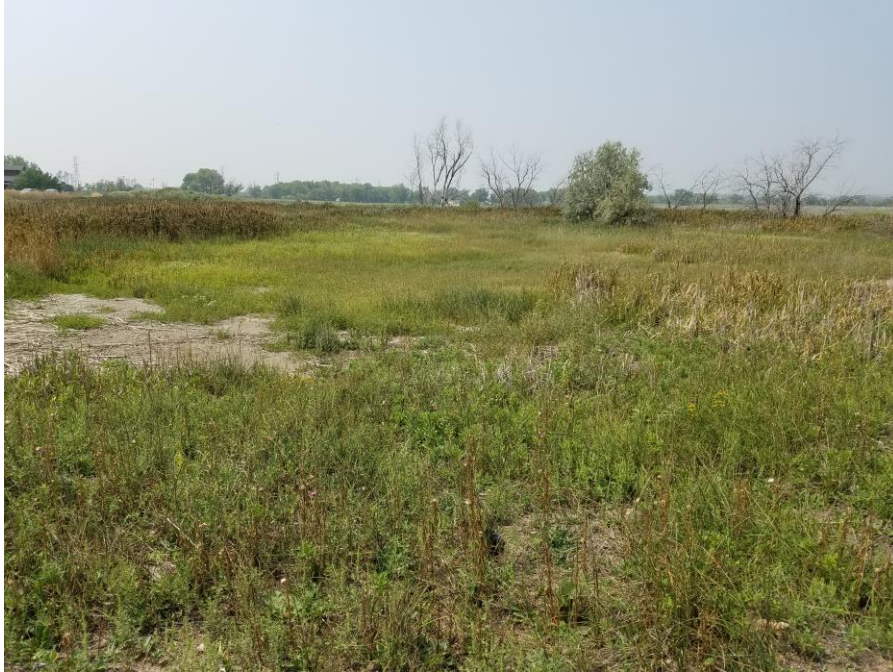
Figure 11. From the north central side of the Orr property looking south.
