COLORADO
Division of Reclamation,
Mining and Safety
Department of Natural Resources

| Permit Number: C-1981-012 Mine Name: New Elk Mine Operator: New Elk Coal Company, LLC Operator Address: Mr. Louis Head 12250 Highway 12 Weston, CO 81091 | County: Las Animas Operation Type: Underground Permit Status: Active Ownership: Private |

| Inspection Start Date: August 22, 2018 Inspection Start Time: 07:40 Inspection End Date: August 23, 2018 Inspection End Time: 07:30 | | Inspection Type: Coal Complete Inspection Inspection Reason: Normal I&E Program Weather: Cloudy | |

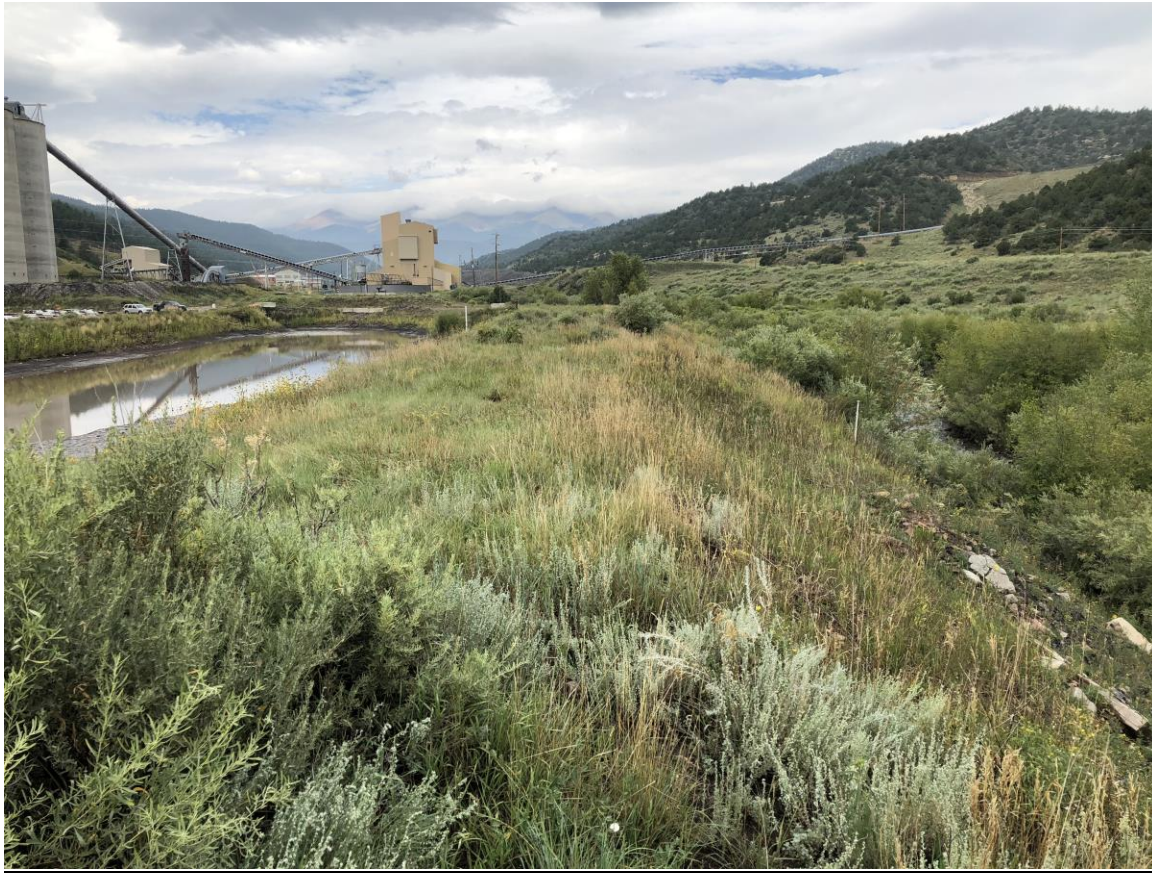
Ponds 001A, 004A, 006A, 007A, and 08 were inspected. None of them were discharging, but all held at least a small amount of water. A large amount of water was in Pond 006A, within approximately four feet from top of embankment. The impounded water in Pond 007A was one to two feet below the lowest row of holes in the primary spillway. No water was seen flowing into the ponds from the pipe and pump systems on site. No significant issues were seen with the embankments or spillways of any ponds, although the top of the Pond 08 dam lacks vegetation.

Pond 007A embankment - river is to the right

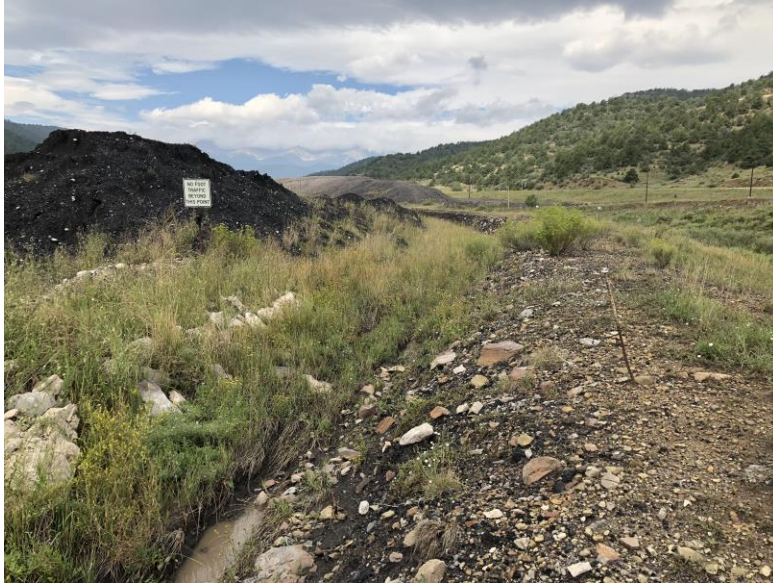
No problems were seen at the coal storage areas. Although a large pile of waste is piled on the north end of the raw coal storage area, an inspection of Ditch D32 indicated that this material is stable. A large amount of sediment from Pond 08 is still on the clean coal storage area. Per Vince Massarotti, this will be moved to the RDA in the autumn of 2018, if weather permits.

Ditch D32 with coal waste on Raw Coal Storage area

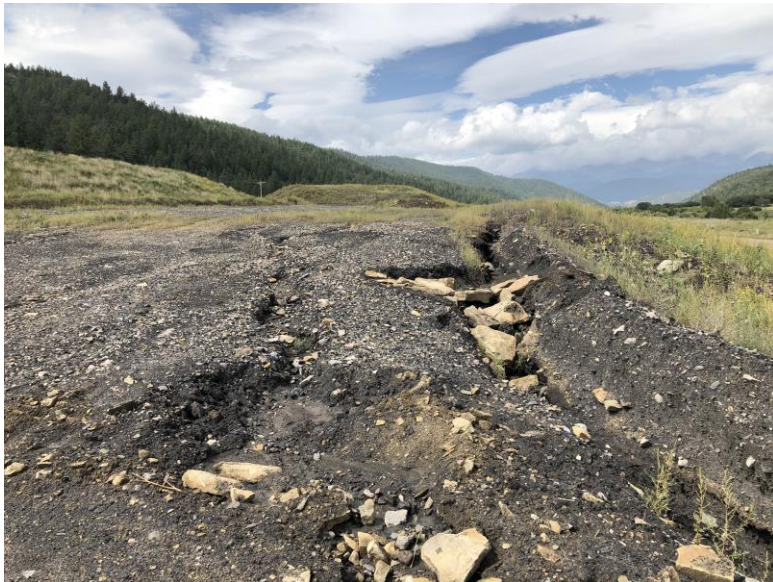
Erosion control at sediment storage area

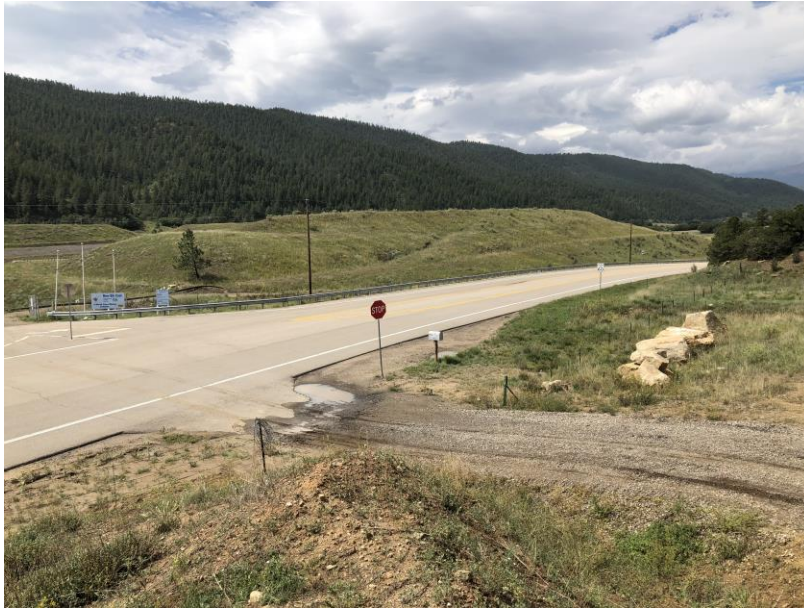
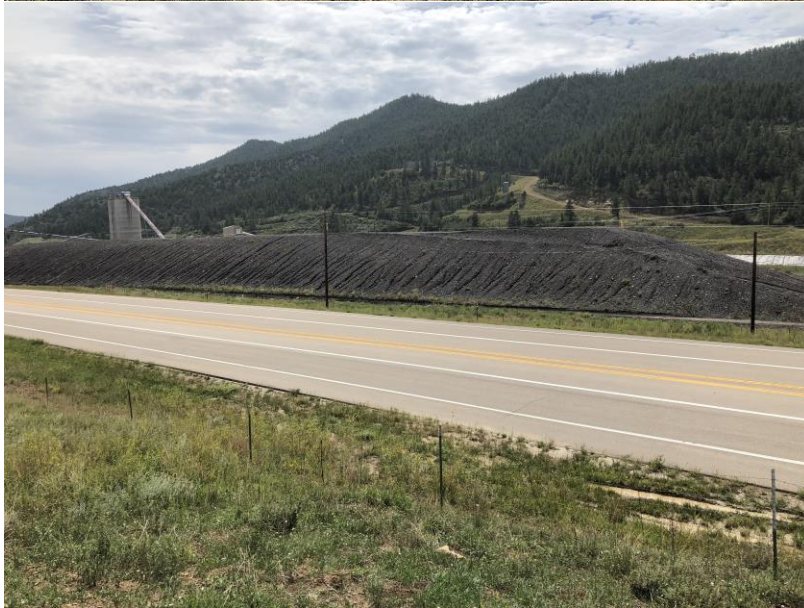
Erosion on DWDA#2 persists. The sump below DWDA#2 did not need immediate maintenance.

No rills were seen on the Development Coal Waste Pile, and the vegetation remains good on this reclaimed area.

Top: Development Coal Waste Pile
Bottom: DWDA#2

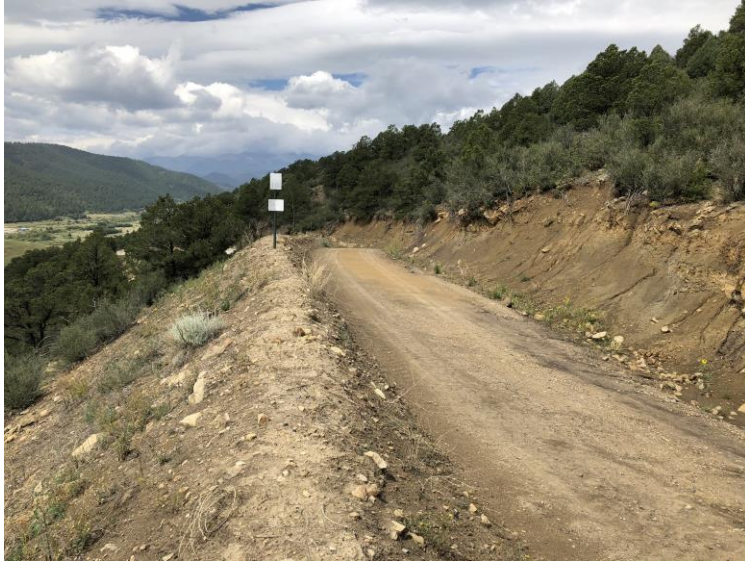
Road to RDA

Cut slope above Ditch D26

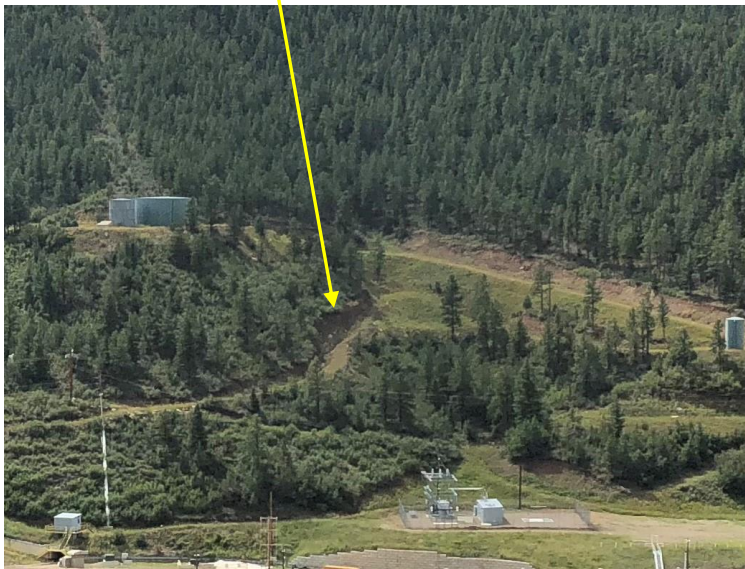
Water tanks and road

Recently placed riprap

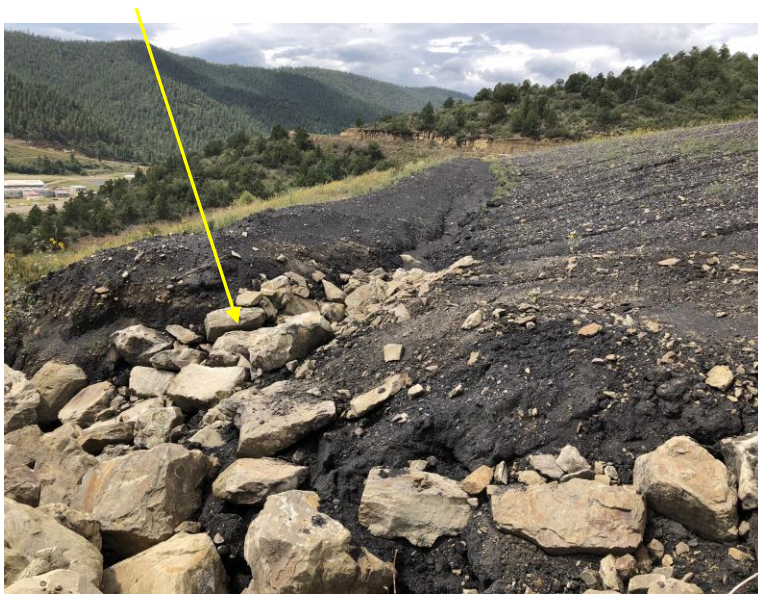
There is good vegetation cover on the majority of the reclaimed portion of the RDA. The ditch between the upper and lower portions of the RDA is in good shape. No problems with the upper portion of the RDA were seen. No signs of blowouts below the clear water ditches were seen.

Interface between upper and lower portion of RDA

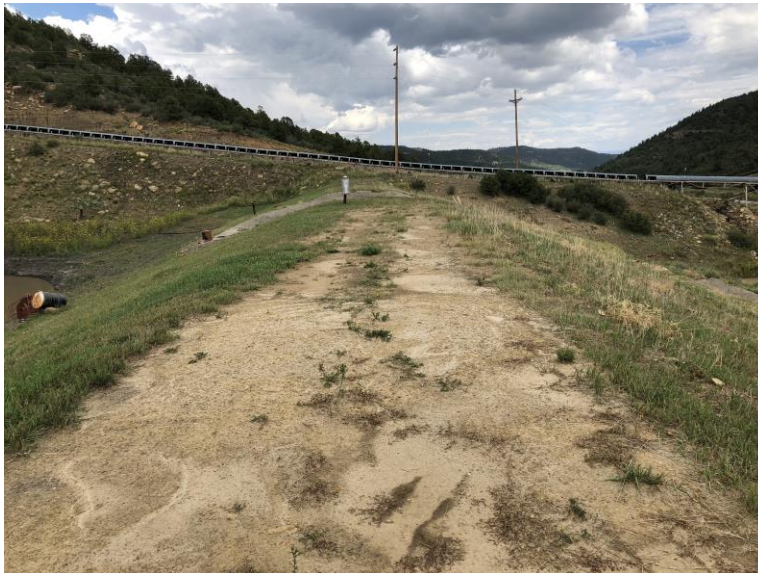
Top of dam for Pond 08

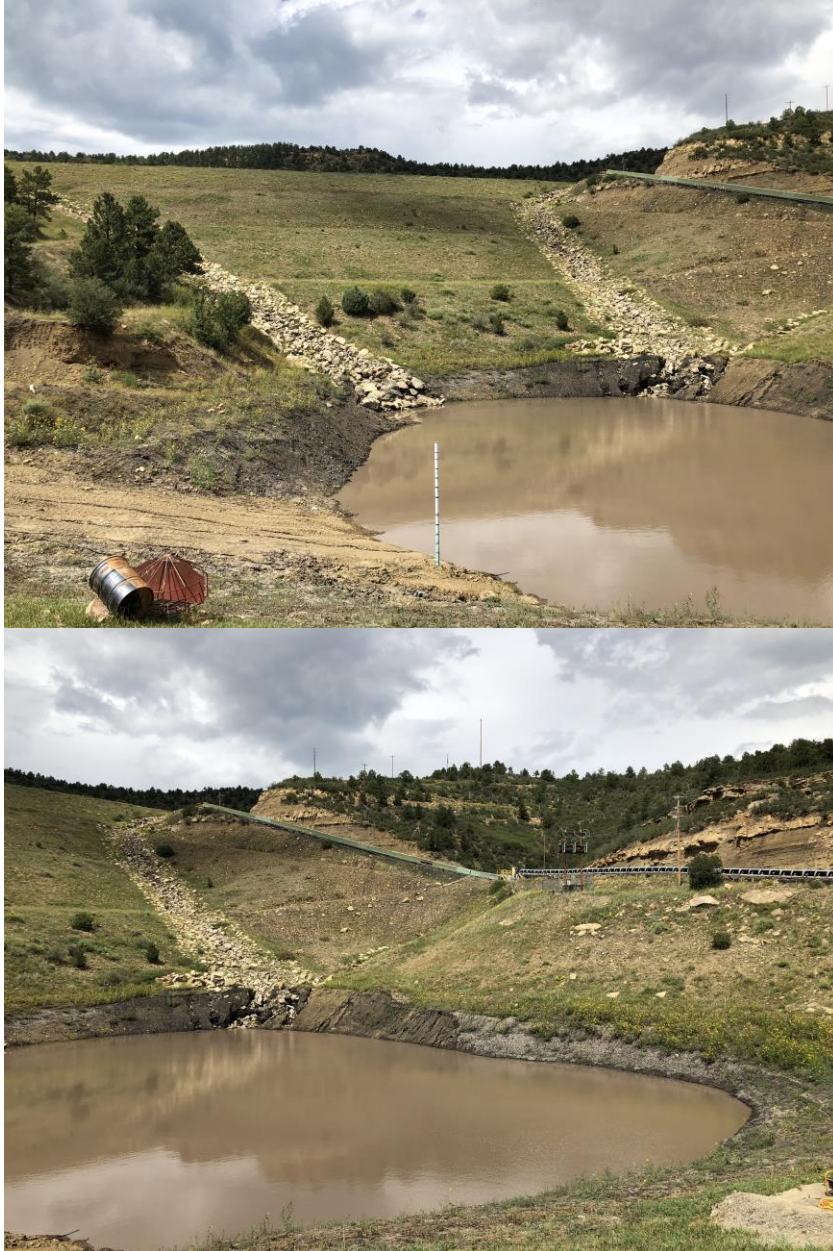
RDA and Pond 08

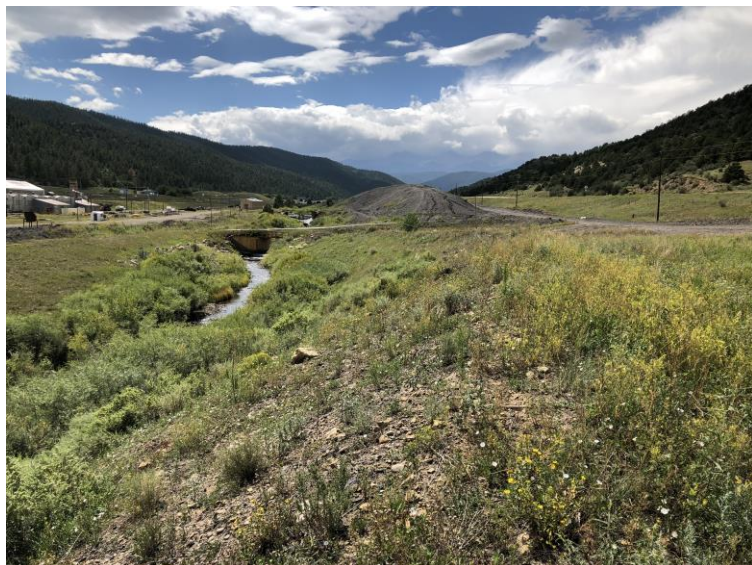
Looking up the river at DWDA#2

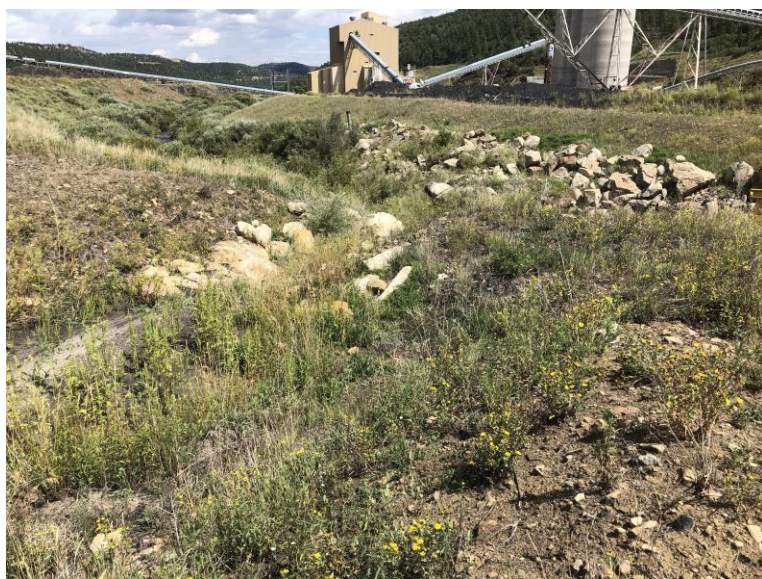
Within the SAE by Pond 007A, BMPs appear to be functioning. There was no discharge from this outfall. No leaks of fluids from equipment were seen within the SAE. No problems were seen with the SAE east of DWDA#2, and the riprap below this area is stable. No problems were seen with the SAE around the slurry injection system.

Outfall below SAE, southeast of DWDA#2

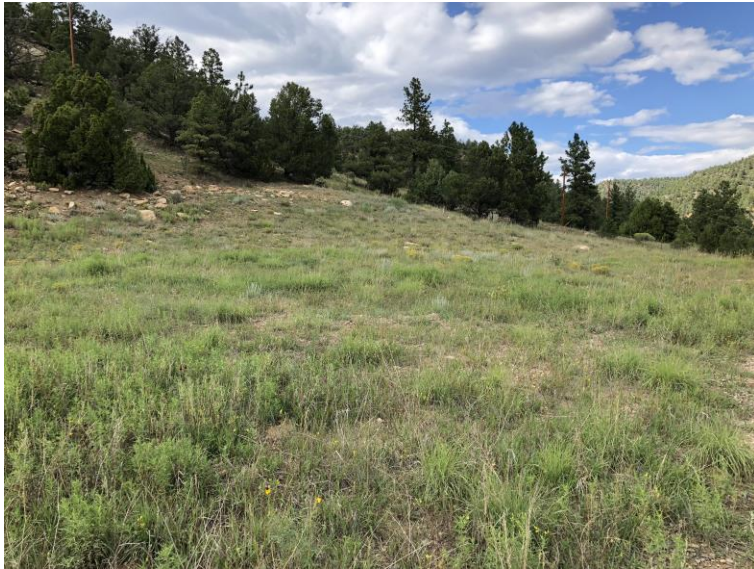
Pad for old North Shaft (was part of Golden Eagle permit)

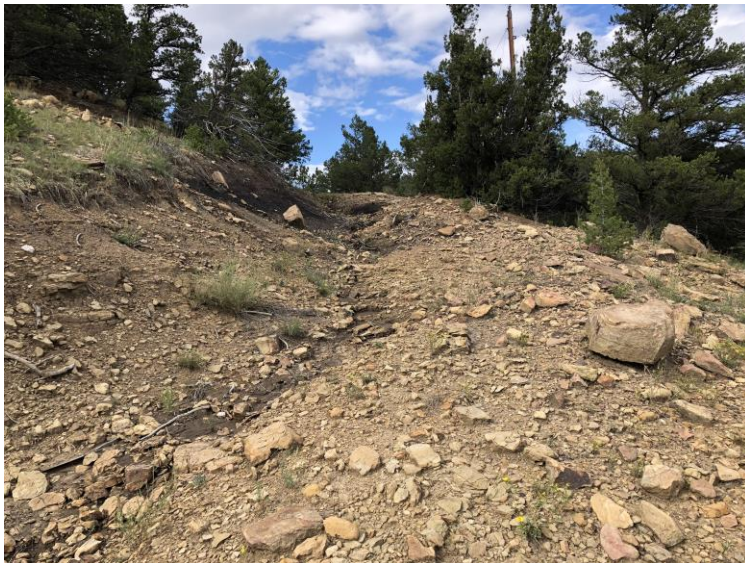
Clear water ditch at old North Shaft site

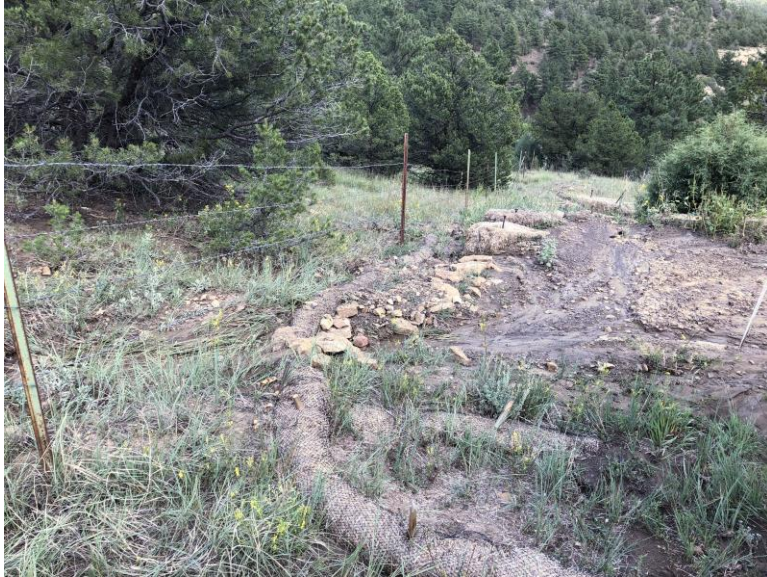
The sediment and erosion BMPs at the former Golden Eagle shaft require considerable maintenance. In particular, there is a large amount of sediment behind a row of straw bales, and this should be removed. The wattles along the fence line are apparently not high enough to divert larger runoff events.

Erosion BMPs in need of maintenance at old North Shaft site

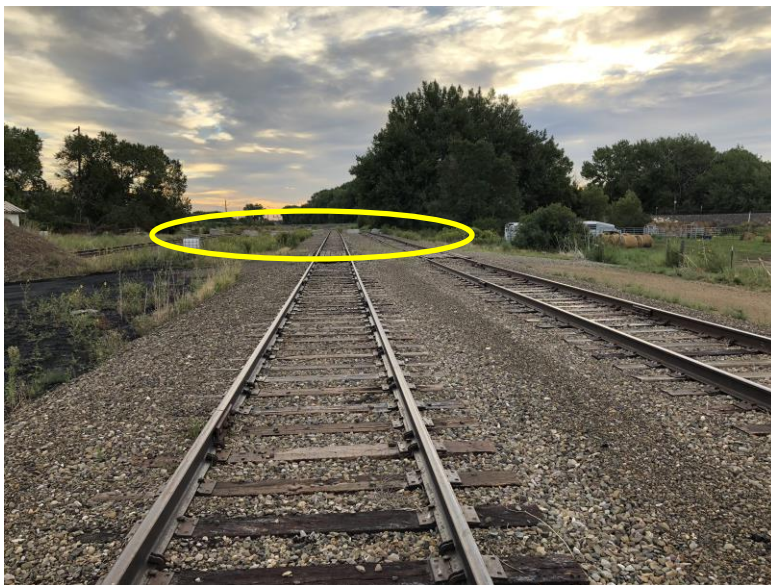
Barriers at east end of Jansen Loadout (circled)
