**MINERALS PROGRAM INSPECTION REPORT**  
**PHONE: (303) 866-3567**

<b>MINE NAME:</b> Gehrman Pit	<b>MINE/PROSPECTING ID#:</b> M-2009-078	<b>MINERAL:</b> Gravel and sand	<b>COUNTY:</b> Moffat
<b>INSPECTION TYPE:</b> Monitoring	<b>INSPECTOR(S):</b> Amy C. Yeldell	<b>INSP. DATE:</b> August 8, 2018	<b>INSP. TIME:</b> 09:00
<b>OPERATOR:</b> Elam Construction, Inc.	<b>OPERATOR REPRESENTATIVE:</b> Tanner Brown	<b>TYPE OF OPERATION:</b> 112c - Construction Regular Operation	
<b>REASON FOR INSPECTION:</b> Normal I&E Program	<b>BOND CALCULATION TYPE:</b> Complete Bond	<b>BOND AMOUNT:</b> \$88,975.00	
<b>DATE OF COMPLAINT:</b> NA	<b>POST INSP. CONTACTS:</b>	<b>JOINT INSP. AGENCY:</b> None	
<b>WEATHER:</b> Clear	<b>INSPECTOR'S SIGNATURE:</b>

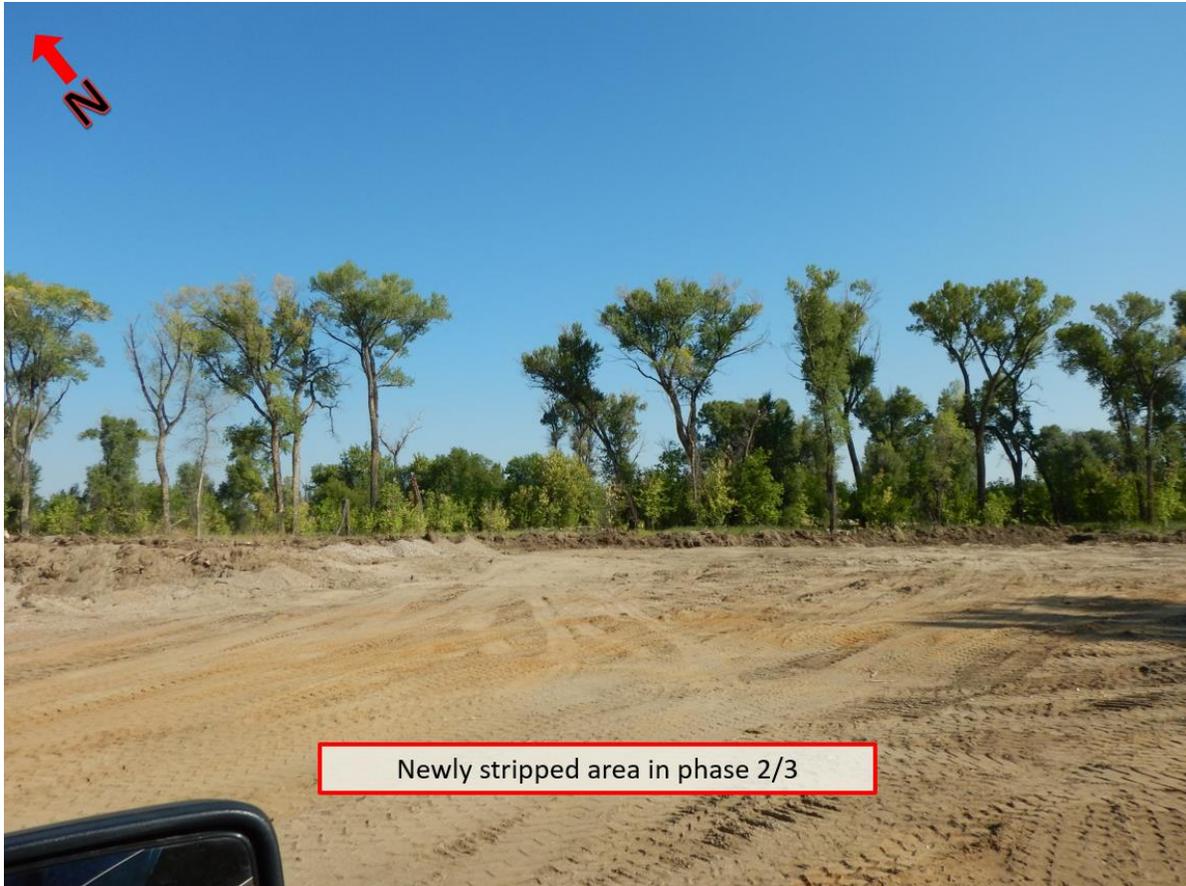
The pit was inactive at the time of the inspection however significant mining progress has been made since the last inspection. Staff estimates that all of phase 2 has been affected. The eastern most acre has been stripped and is ready to be mined. The rest of phase 2 has been mined to a depth of approximately 25 feet. North and south highwalls in phase 2 are sloped at a 1:1. While the eastern active highwall of phase 2 is near vertical. Exterior highwalls will likely be reclaimed this winter leaving the far east highwall active for the next mining season. When overburden and topsoil was stripped in phase 2 the trees were left in the soil material. This excess woody material will make grading for final reclamation more difficult. The permit only allows for a maximum disturbance of 9.6 acres. Given that nearly all of phase 2 is disturbed and not all of phase 1 is reclaimed the operator needs to either reclaim lands or revise the mining plan to allow for a larger area of disturbance prior to affecting more land.

Newly stripped area in phase 2/3

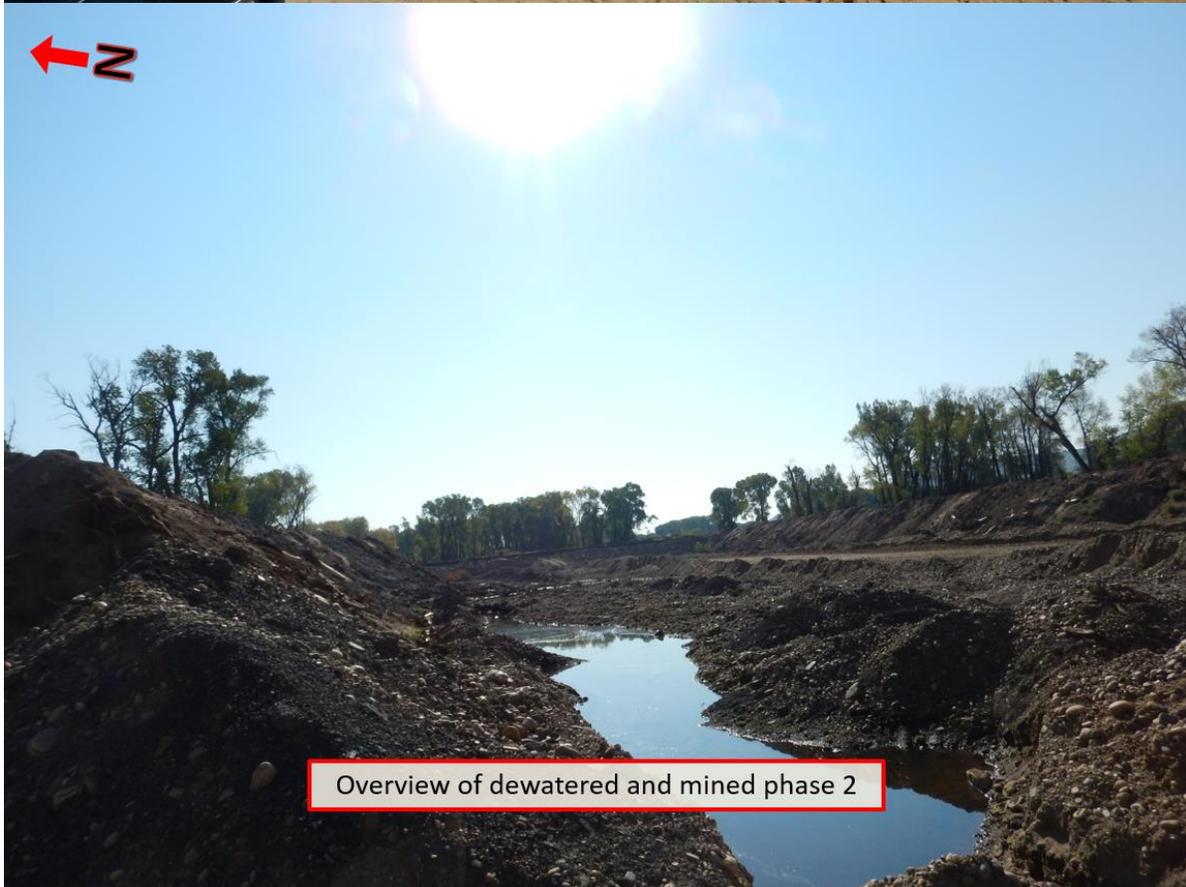
Overview of dewatered and mined phase 2

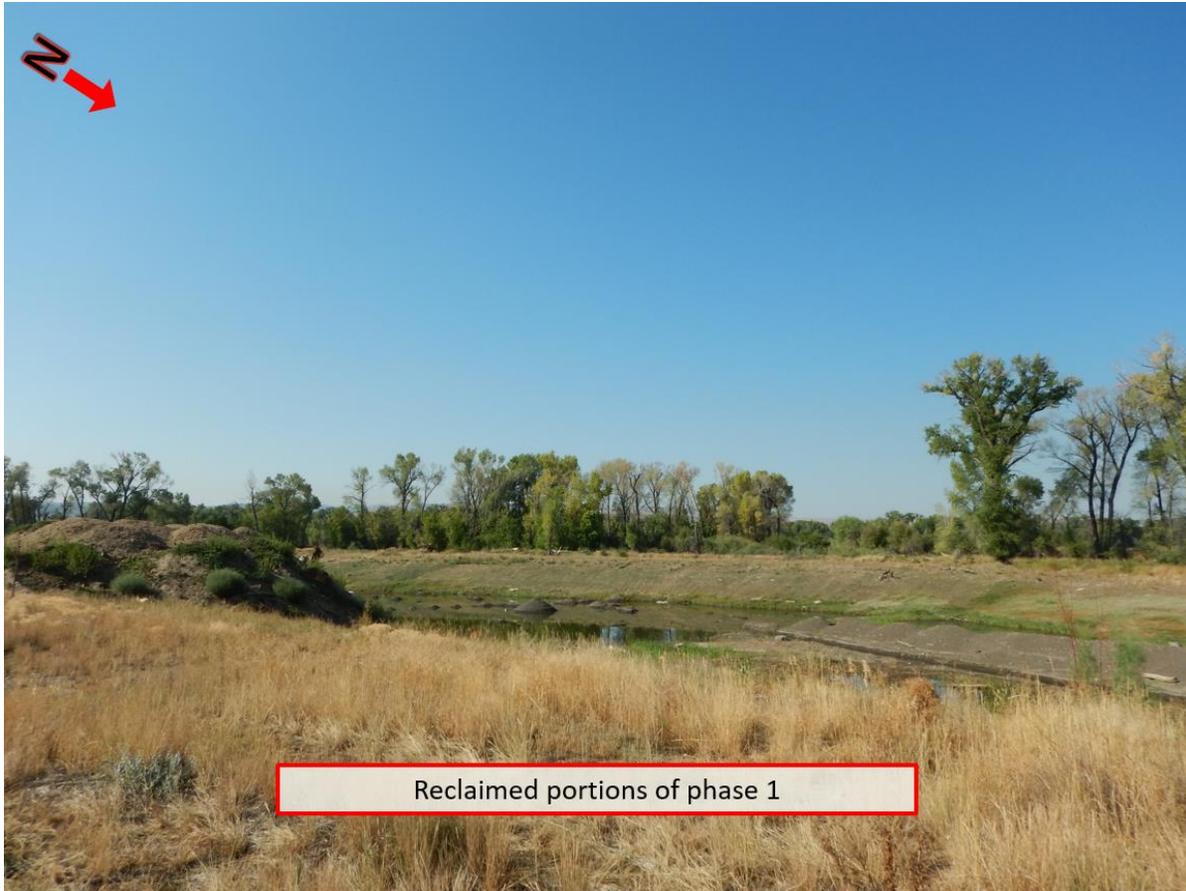
The majority of phase 1 has been reclaimed. South and western slopes have been properly graded and seeded. The lower northeast corner adjacent to phase 2 is being used as a stockpile pad area and will require additional grading prior to seeding. The far north corner of phase 1 has a fuel tank, pump and miscellaneous equipment stored adjacent to where the settling pond was.

Reclaimed portions of phase 1

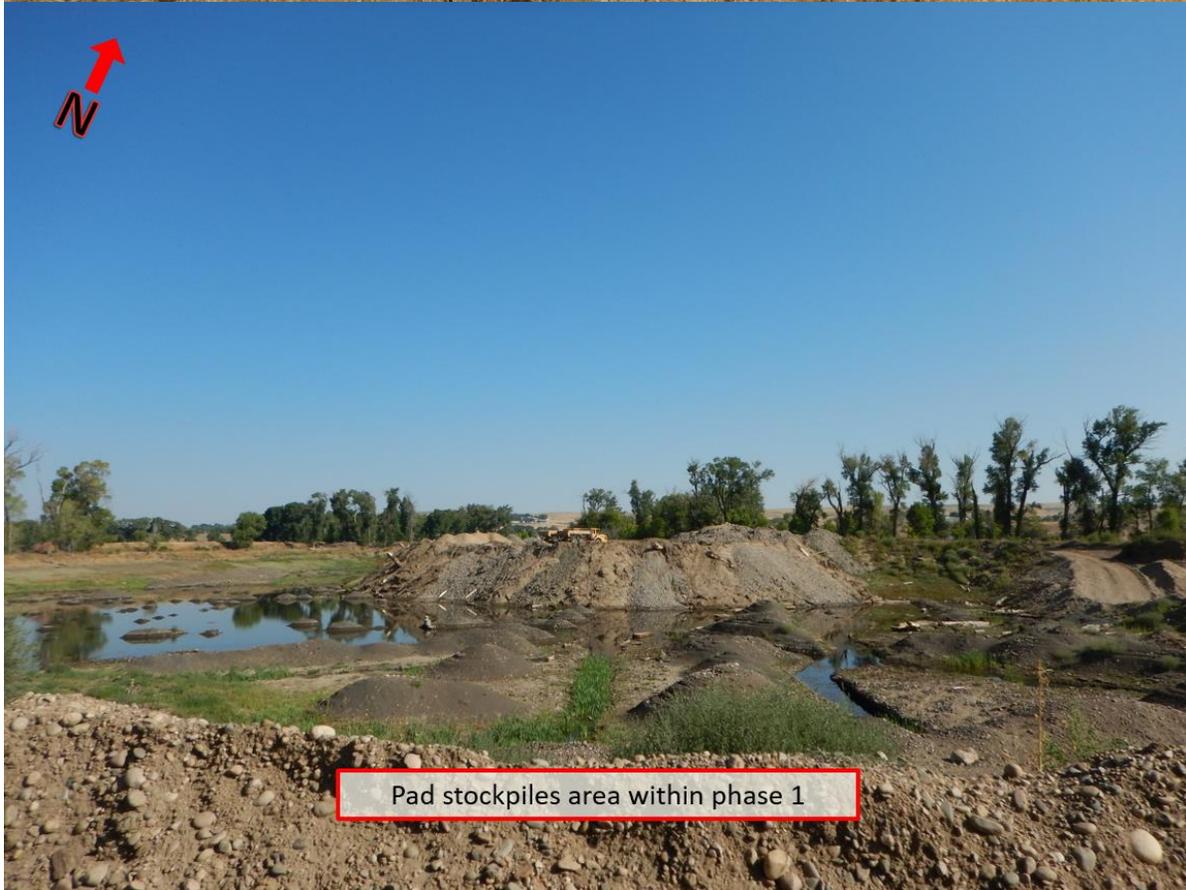
Pad stockpiles area within phase 1
