# MINERALS PROGRAM INSPECTION REPORT PHONE: (303) 866-3567

MINE NAME:	MINE/PROSPECTING ID#:	MINERAL:	COUNTY:	
C & D Farms No. 2	M-1999-043	Sand and gravel	Lincoln	
INSPECTION TYPE:	INSPECTOR(S):	INSP. DATE:	INSP. TIME:	
Surety-Related Inspection	Timothy A. Cazier	August 21, 2018	09:45	
OPERATOR:	OPERATOR REPRESENTATIVE:	TYPE OF OPERATION:		
Lincoln County	Fred Lundy	110c - Construction Limited Impact		
REASON FOR INSPECTION:	BOND CALCULATION TYPE:	BOND AMOUNT:		
Surety Related	None	\$0.00		
DATE OF COMPLAINT:	POST INSP. CONTACTS:	JOINT INSP. AGENCY:		
NA	None	None		
WEATHER:	INSPECTOR'S SIGNATURE:	SIGNATURE DATE:		
Clear (hazy due to smoke)	Thing als	August 27, 2018

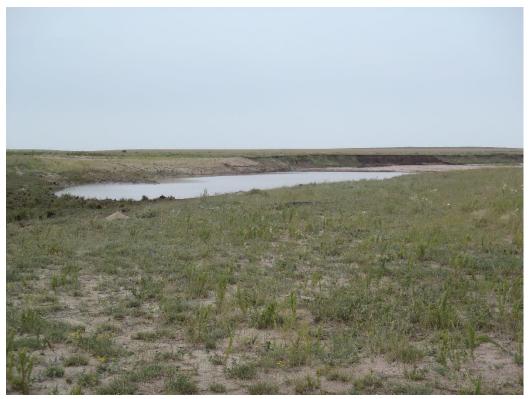
<u>Hydrologic Balance:</u> Standing water was observed in the Arikaree River (see **Photo 1**). Mr. Lundy stated the area had received a lot of rain recently. This was also evidenced by observed standing water in many low-lying areas in that part of Lincoln County driving to a d from the site.

Photo 1. Standing water observed in Arikaree River bottom.

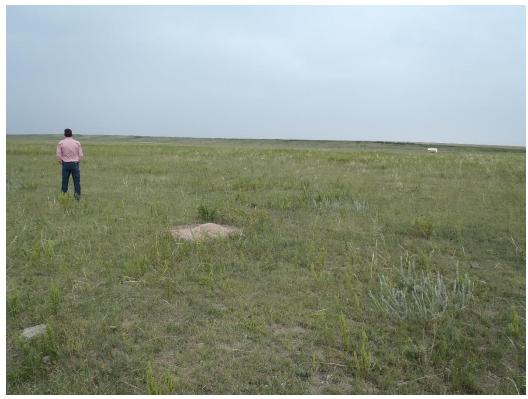
<u>Reclamation Success:</u> No reclamation has been initiated. The area being requested for release had not been disturbed by mining activity (see **Photo 2**), therefore it can be considered for release without reclamation.

Photo 2. View of area requested for release (from SE corner post – looking NNW).

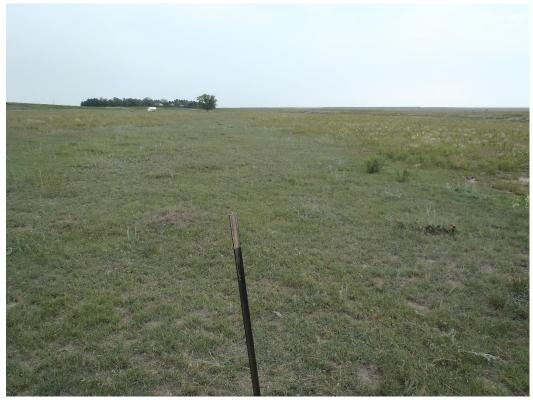
<u>Signs and Markers:</u> The permit sign was properly posted at the entrance off CR46 and boundary markers (see **Photo 3)** were observed to delineate the current and proposed new permit boundary. The position of all 5 boundary markers was provided by Lincoln County with the AM-01 request and observed in the field as shown in the attached <u>post inspection map</u>.

Photo 3. Typical boundary marker (NW corner, looking east).
