**MINERALS PROGRAM INSPECTION REPORT**  
**PHONE: (303) 866-3567**

<b>MINE NAME:</b> Hinkson Site	<b>MINE/PROSPECTING ID#:</b> M-2018-046	<b>MINERAL:</b> Borrow	<b>COUNTY:</b> Ouray
<b>INSPECTION TYPE:</b> Illegal(Unpermitted Operation)	<b>INSPECTOR(S):</b> Travis H. Marshall	<b>INSP. DATE:</b> August 10, 2018	<b>INSP. TIME:</b> 10:00
<b>OPERATOR:</b> Craig Hinkson	<b>OPERATOR REPRESENTATIVE:</b> Craig Hinkson	<b>TYPE OF OPERATION:</b> NM - Not Mining	
<b>REASON FOR INSPECTION:</b> Citizen Complaint	<b>BOND CALCULATION TYPE:</b> None	<b>BOND AMOUNT:</b> No Bond Held	
<b>DATE OF COMPLAINT:</b> NA	<b>POST INSP. CONTACTS:</b> None	<b>JOINT INSP. AGENCY:</b> None	
<b>WEATHER:</b> Clear	<b>INSPECTOR'S SIGNATURE:</b>

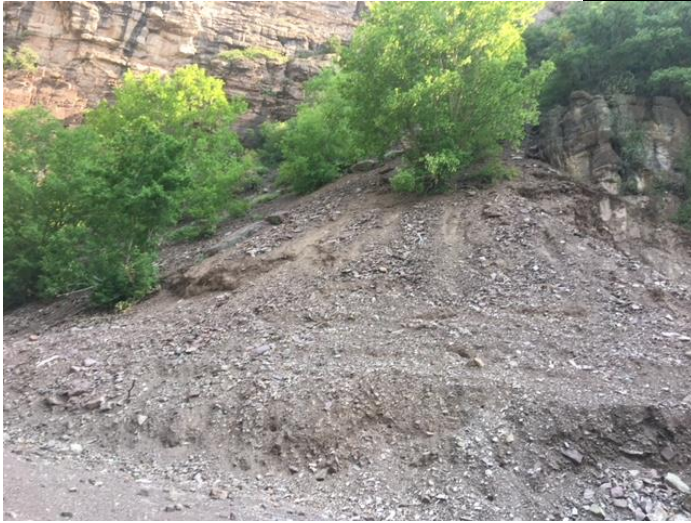
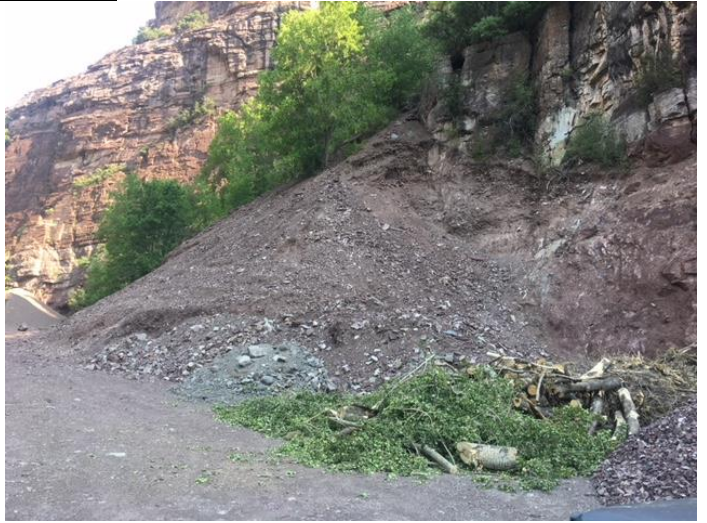
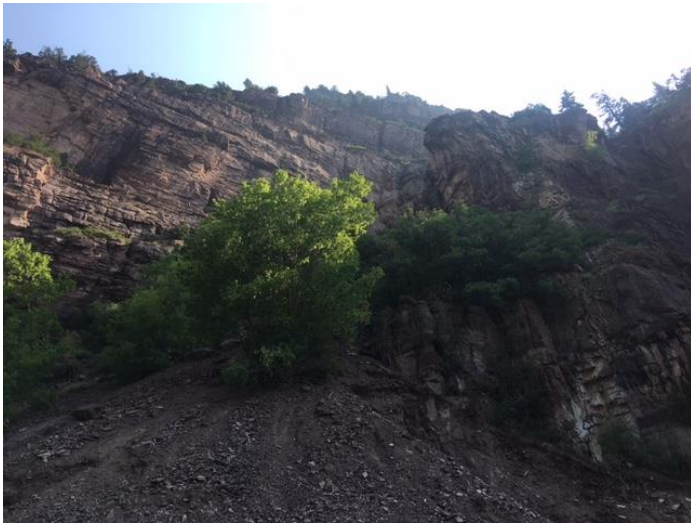
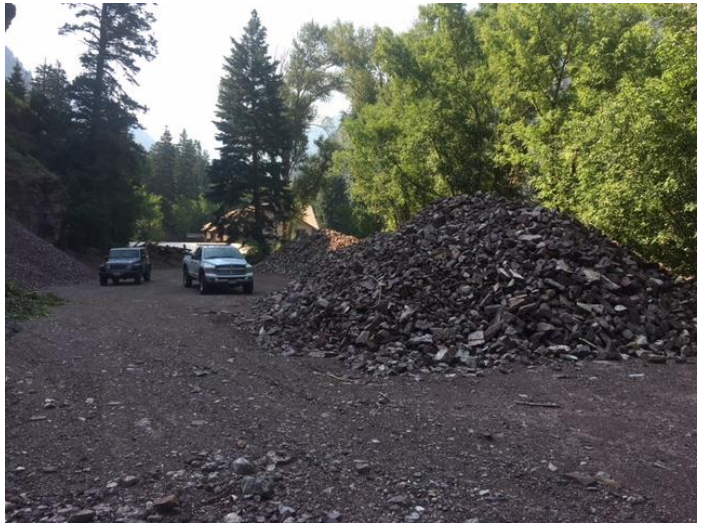
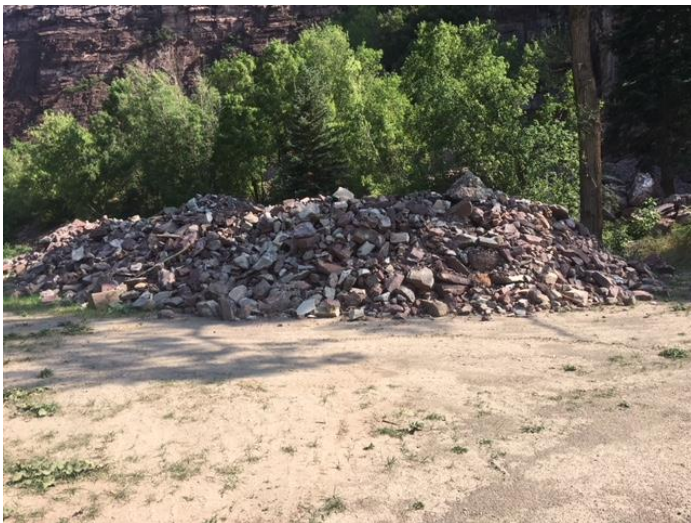
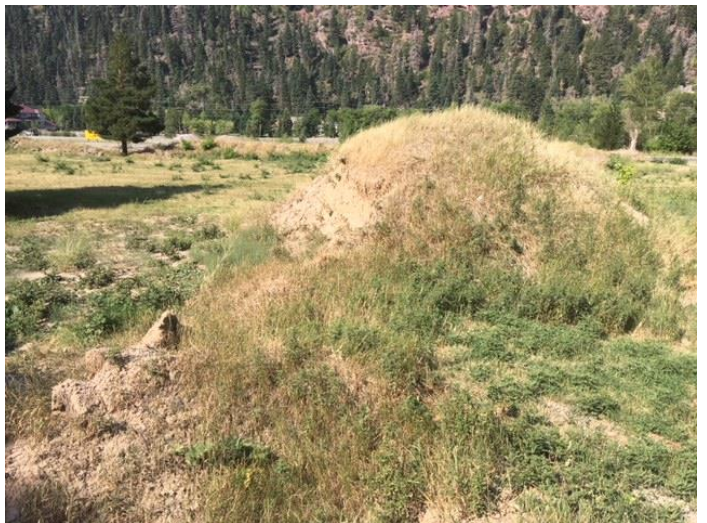
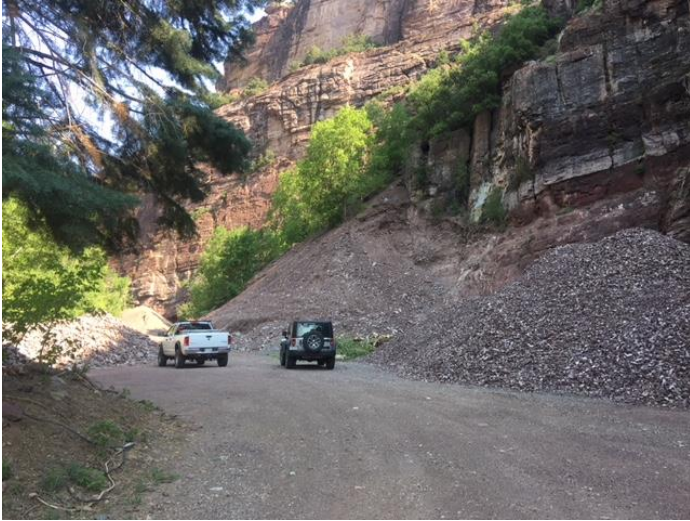
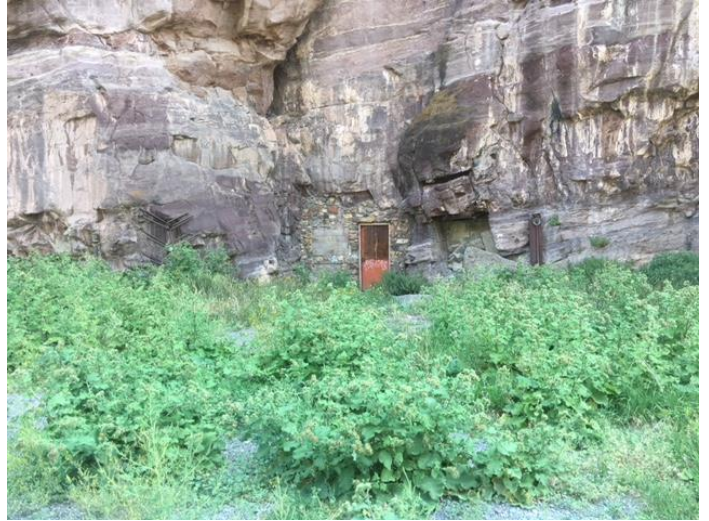
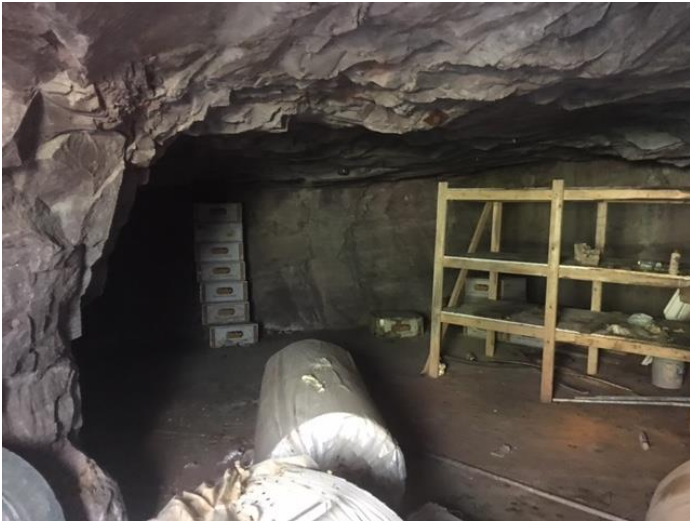
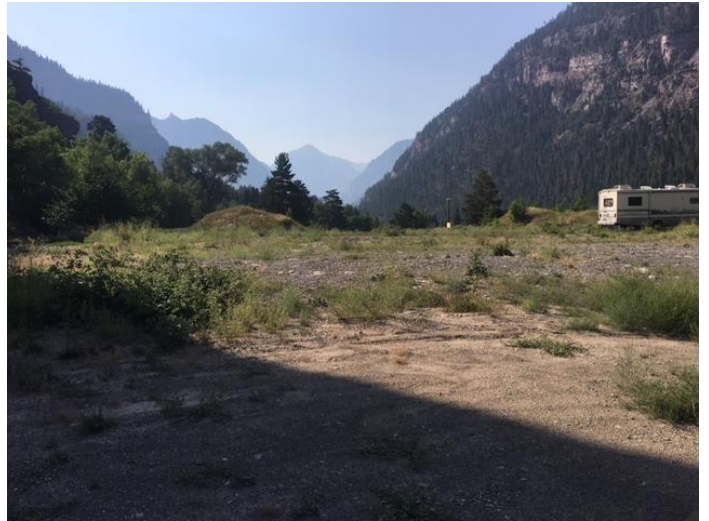
Due to safety issues with Mr. Hinkson's property the activity which was perceived by the complainant as mining was actually storm debris flow and rock fall mitigation and control efforts being conducted by Mr. Hinkson to allow him to use the property in a beneficial way. Mr. Hinkson constructed a wall / berm below the area of concern that would prevent boulders and debris from running out onto the flat area to the west of Highway 550. Mr. Hinkson also removed a large amount of the alluvial fan and intends to use that material to raise the grade of the property to the west of the rock fall control berm.

No evidence of material being hauled off the property was observed during the inspection. Mr. Hinkson denied any material being hauled off the property.
