MINERALS PROGRAM INSPECTION REPORT
PHONE: (303) 866-3567

MINE NAME: Cresson Project	MINE/PROSPECTING ID#: M-1980-244	MINERAL: Gold	COUNTY: Teller
INSPECTION TYPE: Monitoring	INSPECTOR(S): Amy Eschberger, Michael Cunningham, Russ Means	INSP. DATE: June 28, 2018	INSP. TIME: 10:00
OPERATOR: Cripple Creek & Victor Gold Mining Company	OPERATOR REPRESENTATIVE: Justin Bills, Meg Burt	TYPE OF OPERATION: 112d-3 - Designated Mining Operation	
REASON FOR INSPECTION: Normal I&E Program	BOND CALCULATION TYPE: None	BOND AMOUNT: \$208,491,188.00	
DATE OF COMPLAINT: NA	POST INSP. CONTACTS: None	JOINT INSP. AGENCY: None	
WEATHER: Clear	INSPECTOR'S SIGNATURE:

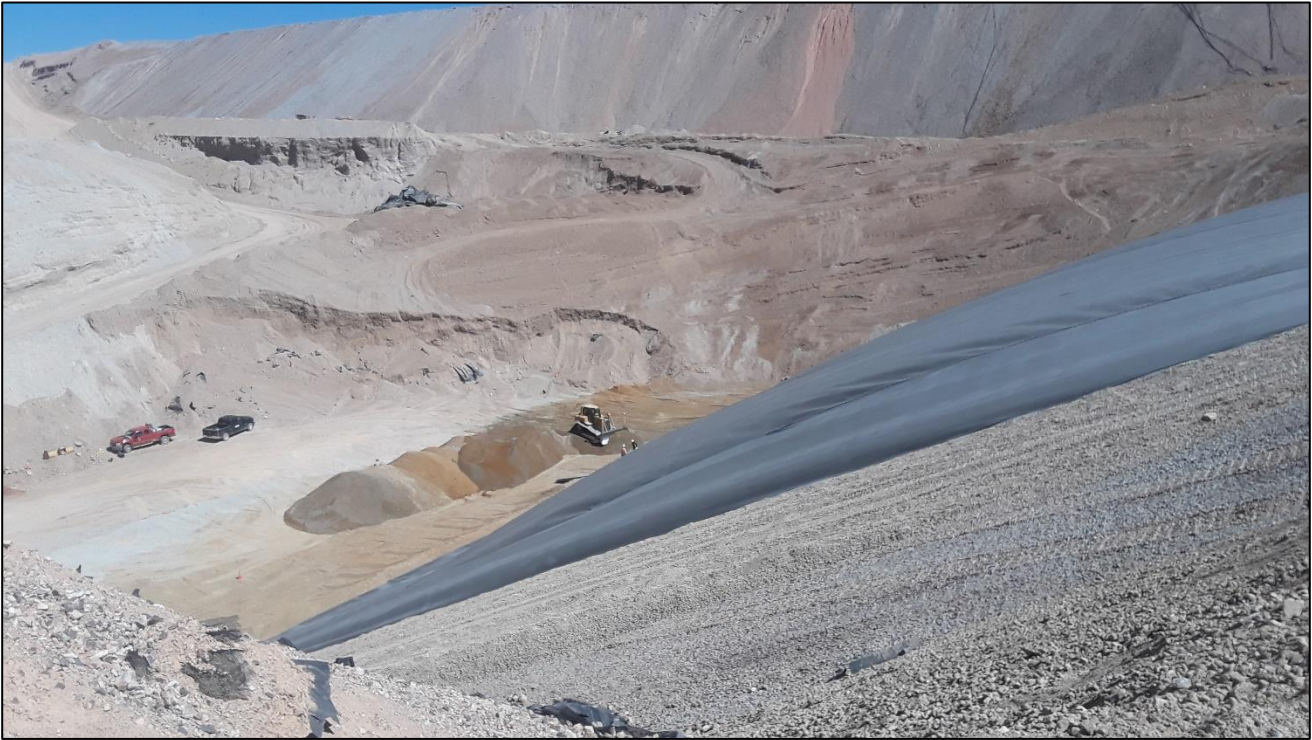
Photo 1. View of liner repair area in SGVLF, showing drain cover fill (DCF) stockpiled at the 9,650 foot bench (below the exposed liner).

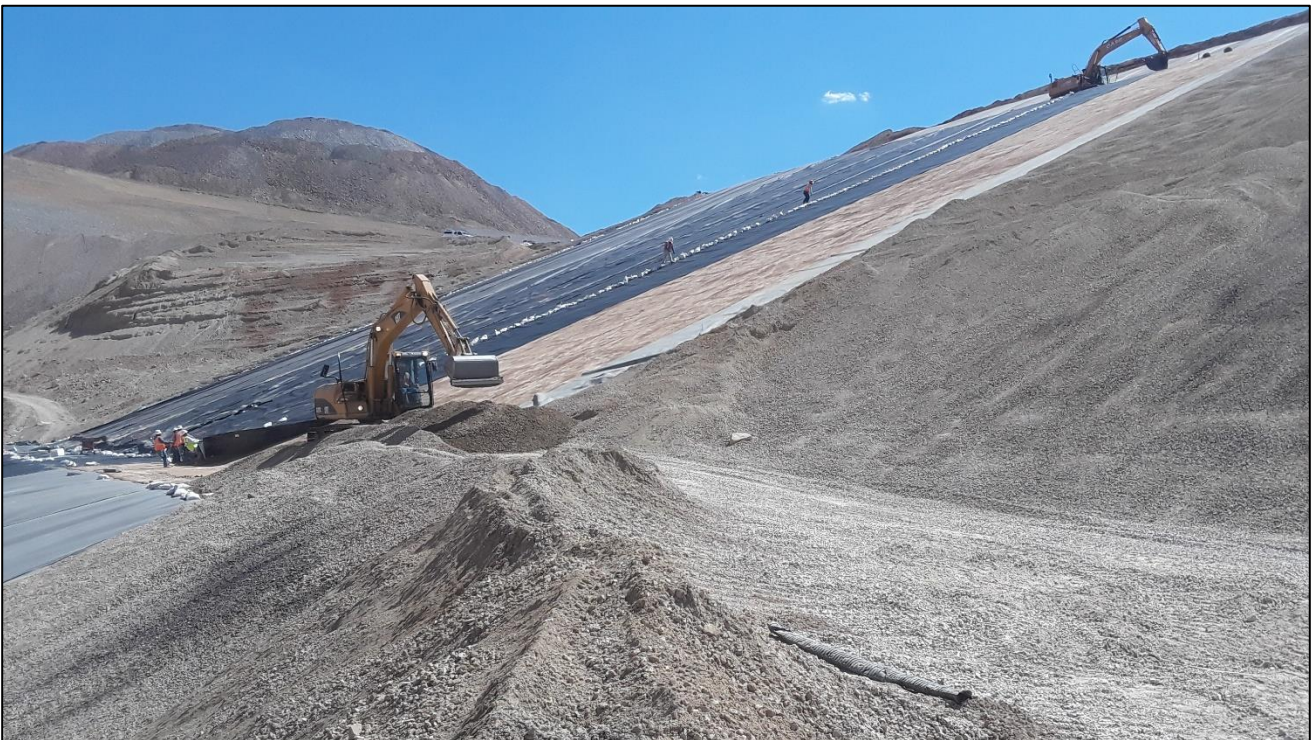
Photo 2. View of liner repair area in SGVLF, showing deployment of liner between the 9,850 foot and 9,750 foot elevations in process during the inspection.

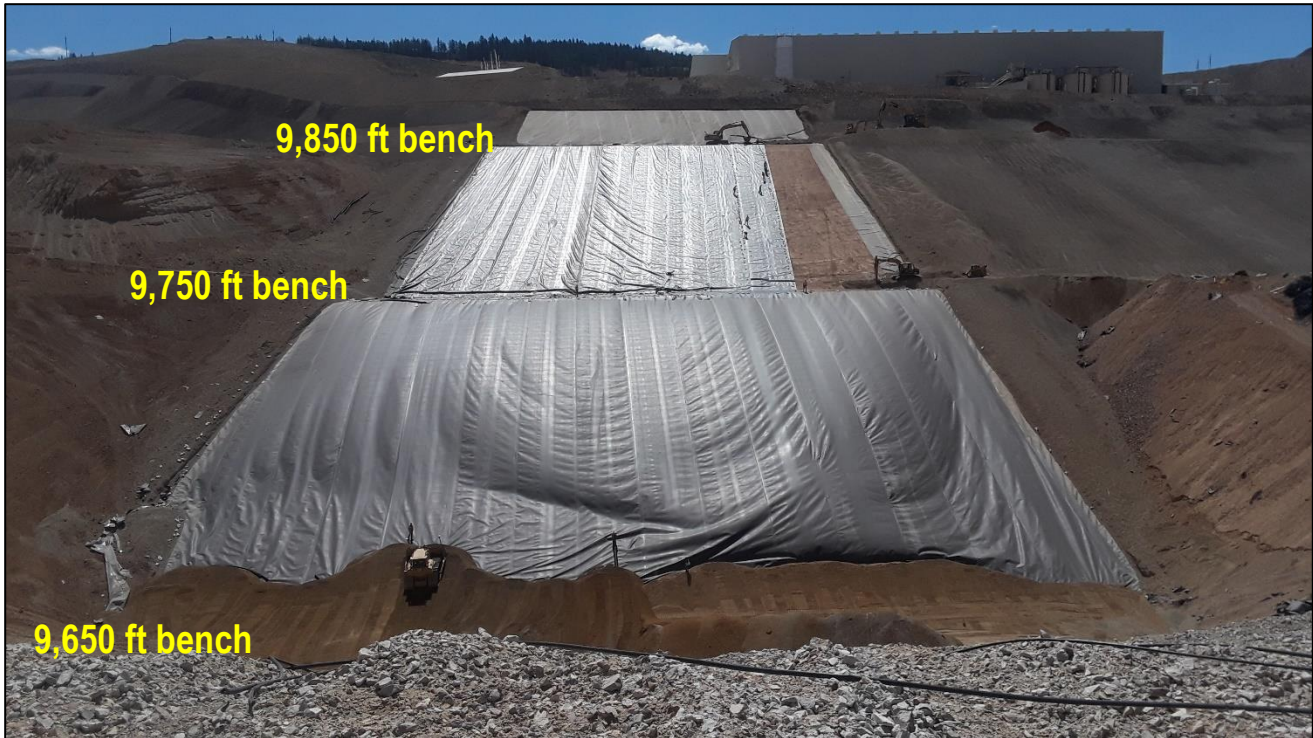
Photo 3. View of liner repair area in SGVLF, showing deployment of liner between the 9,850 foot and 9,750 foot elevations in process, liner between 9,750 foot and 9,650 foot elevations completed, and DCF placement started from 9,650 foot bench.

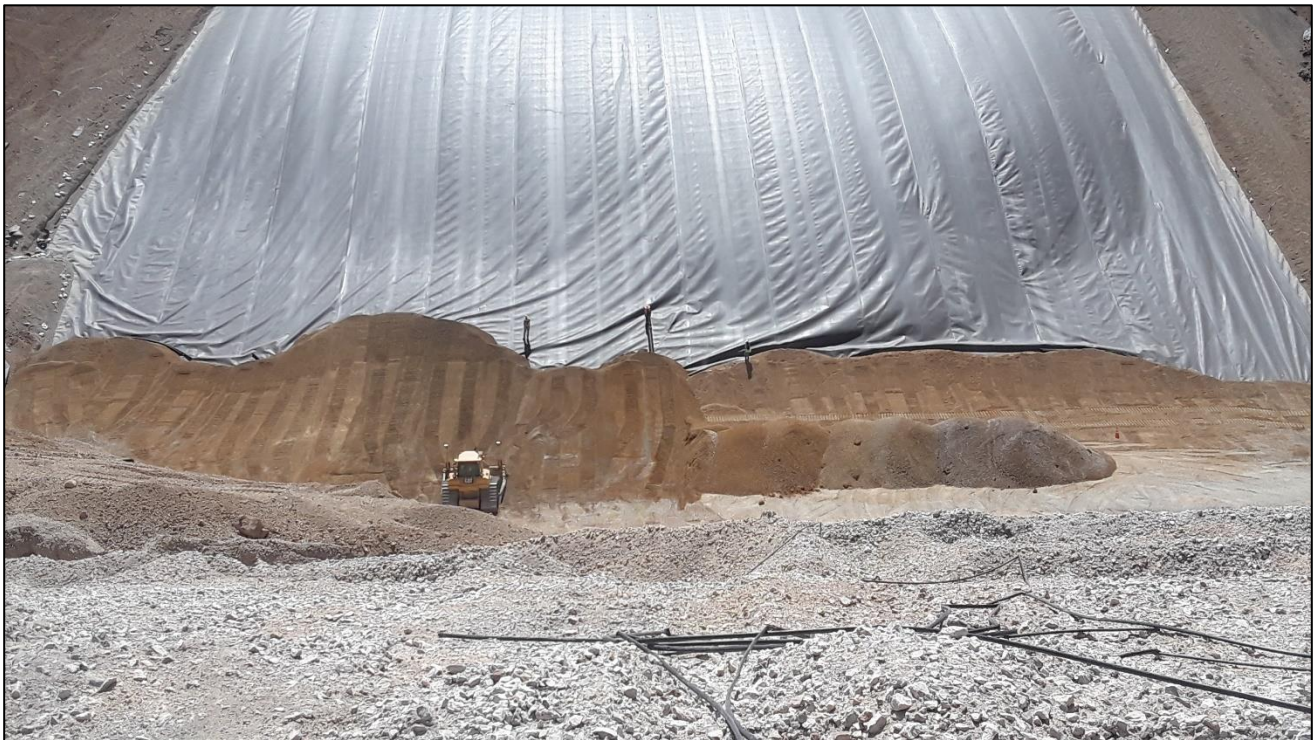
Photo 4. View of liner repair area in SGVLF, showing operation in process of pushing a two-foot lift of DCF up from the 9,650 foot stockpile across the liner using a small dozer.

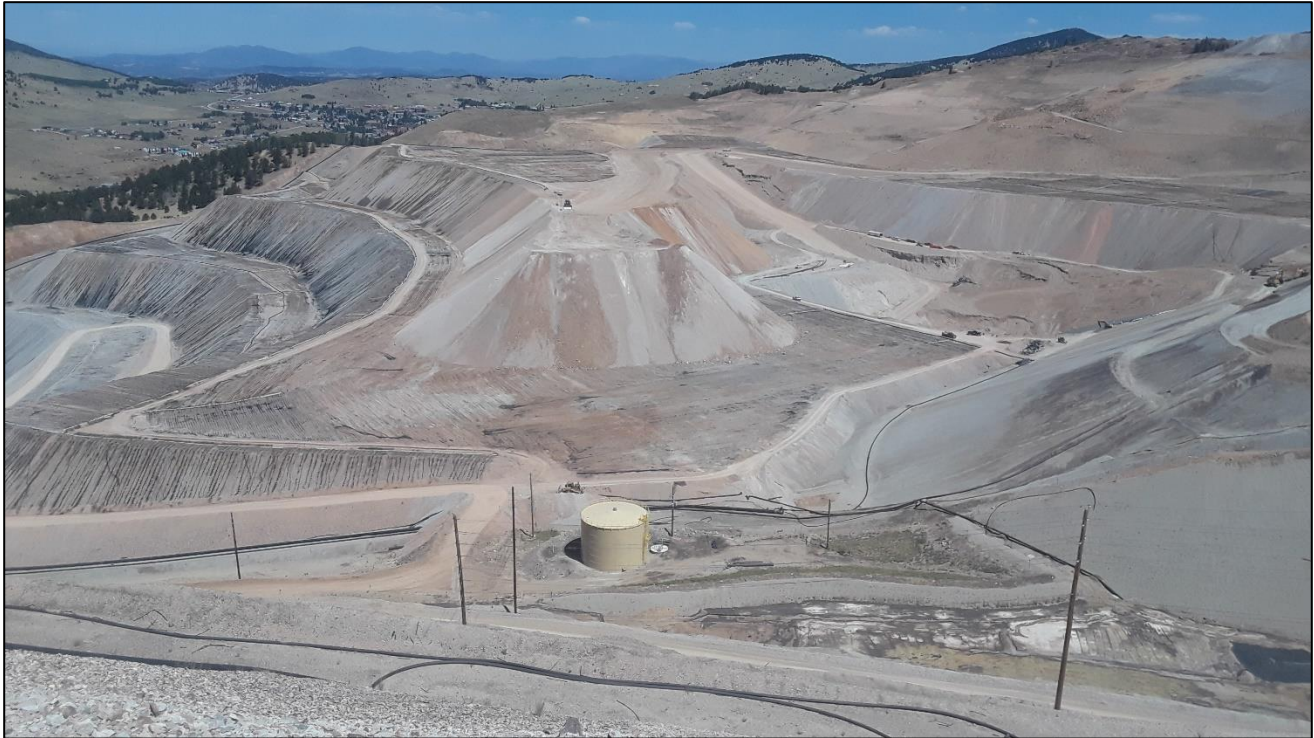
The Division observed the SGVLF (**Photo 5**). The operation is currently advancing the 4th (100 foot) ore lift in the SGVLF. The operation is required to minimize ponding of leaching solution to less than 3 feet by 3 feet in area. This is to prevent the ponds from being a wildlife attractant. No issues with ponded solution were observed on leaching surfaces in the SGVLF. Due to the damaged portion of the SGVLF liner (mentioned above), the operation is required to conduct daily inspections of the facility's Leak Detection System, and report the inspection results to the Division on a monthly basis. This must be done until the Division approves the recertification of the facility. The Division examined Leak Detection Sumps SG-LDS1 (**Photo 6**) and SG-LDS2 (**Photo 7**) during the inspection, and found them both to be dry. No problems were observed.

Photo 5. View looking west across SGVLF. The operation was advancing the 4th (100 foot) ore lift in the facility. No issues with ponded solution were observed on leaching surfaces.

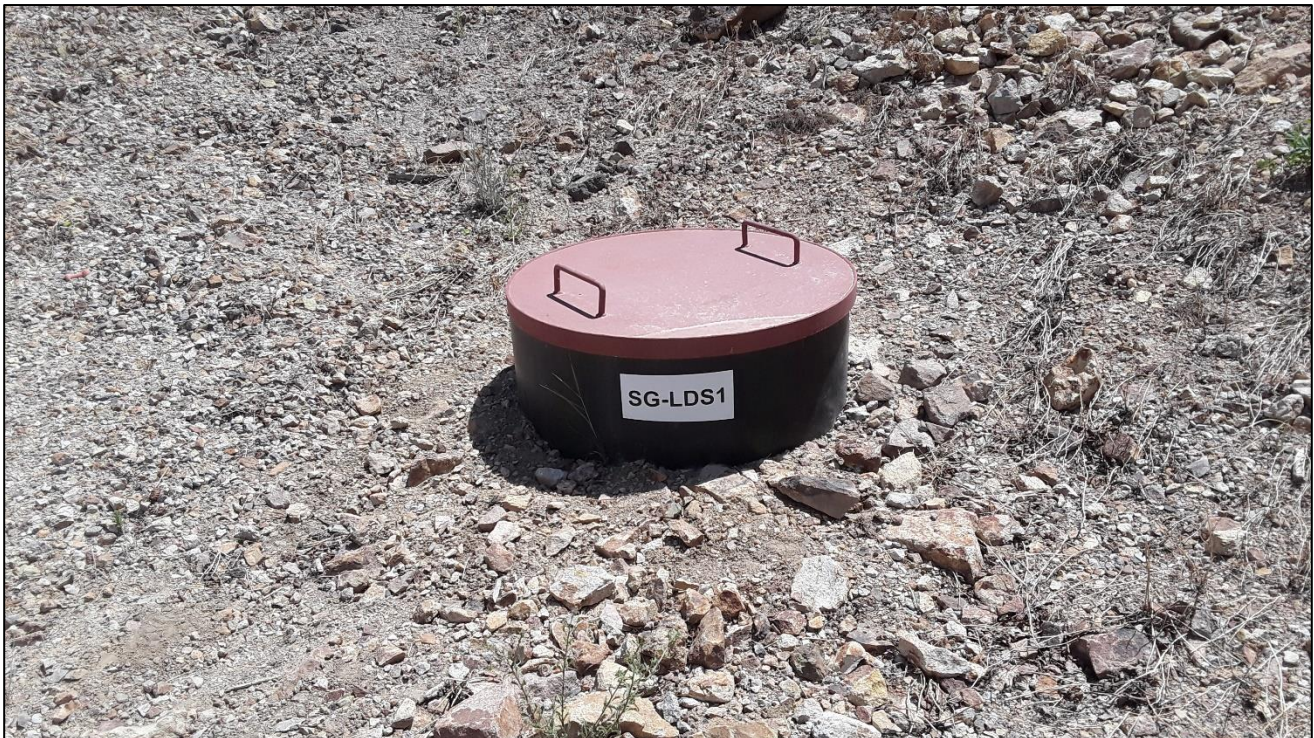
Photo 6. View of SGVLF Leak Detection Sump SG-LDS1, located at southern edge of facility. This sump was observed to be dry during the inspection.

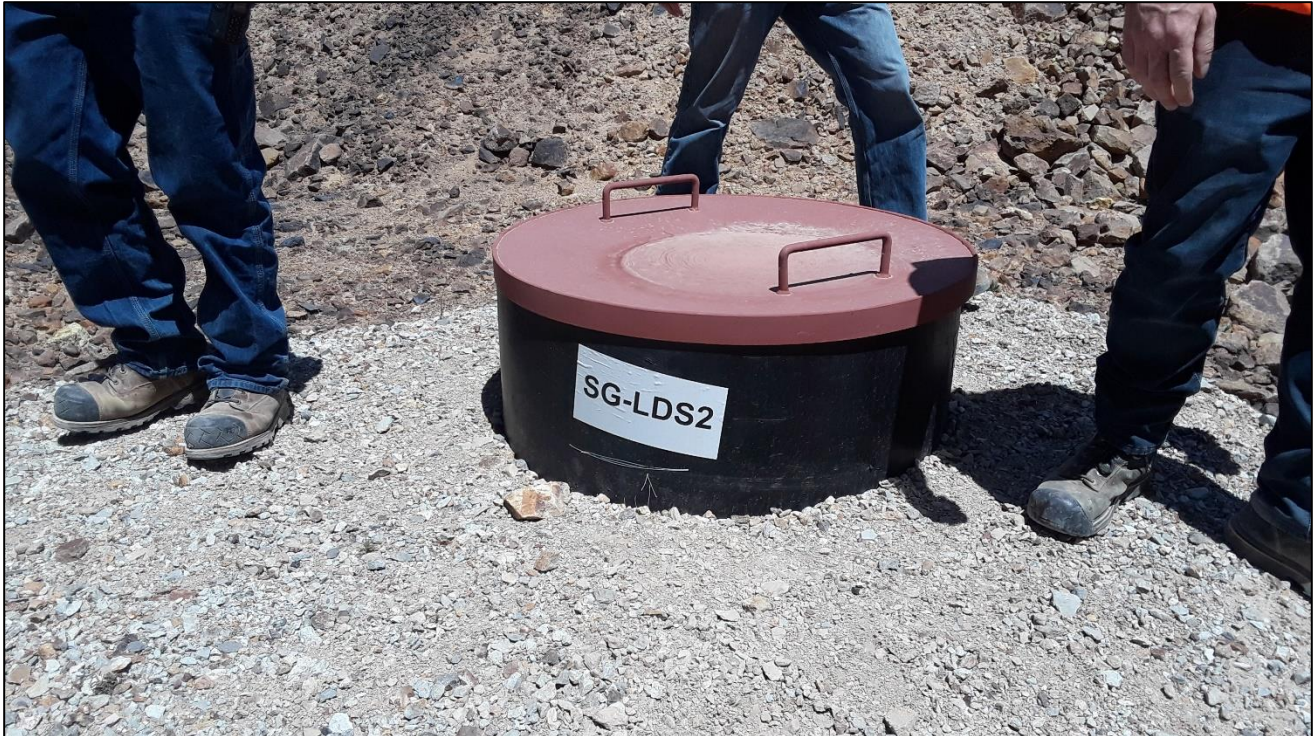
Photo 7. View of SGVLF Leak Detection Sump SG-LDS2, located at the northern edge of the facility. This sump was observed to be dry during the inspection.

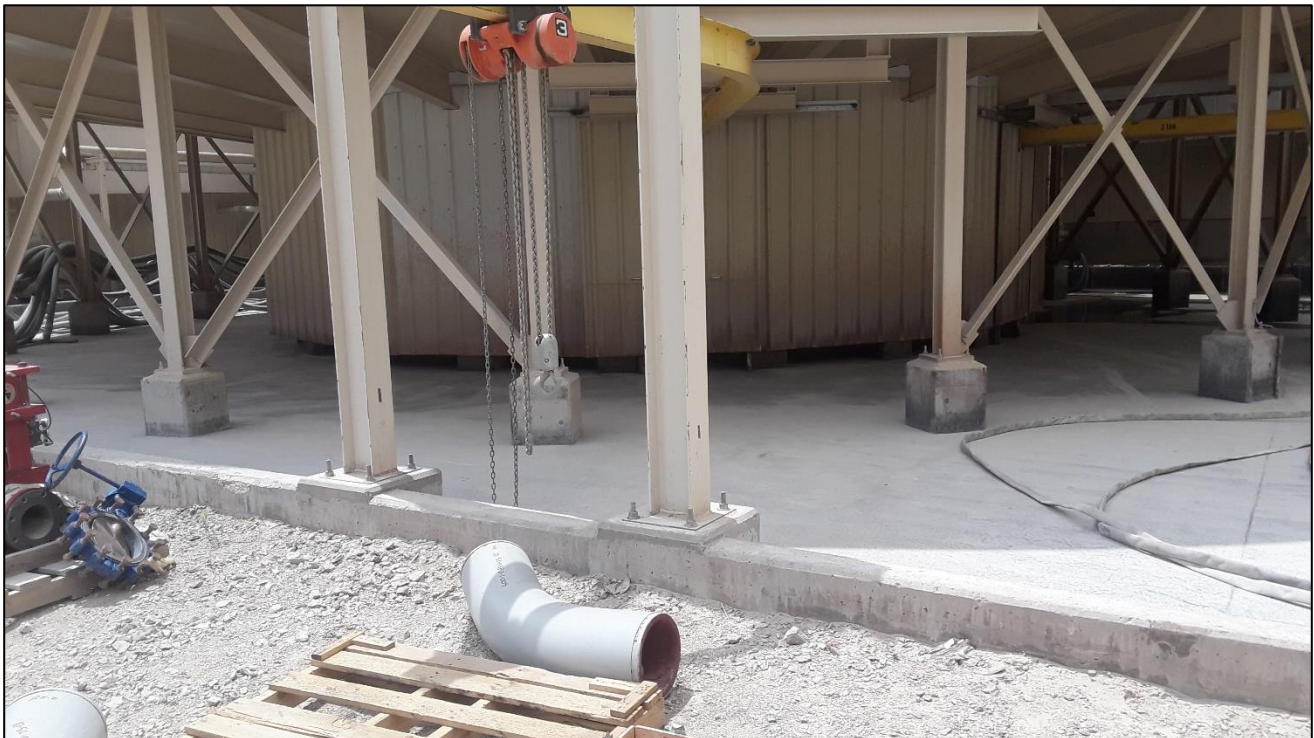
Photo 8. View of secondary containment structure for processed ore thickener tank located on exterior southeastern side of High Grade Mill (HGM). No significant reduction in storage was observed.

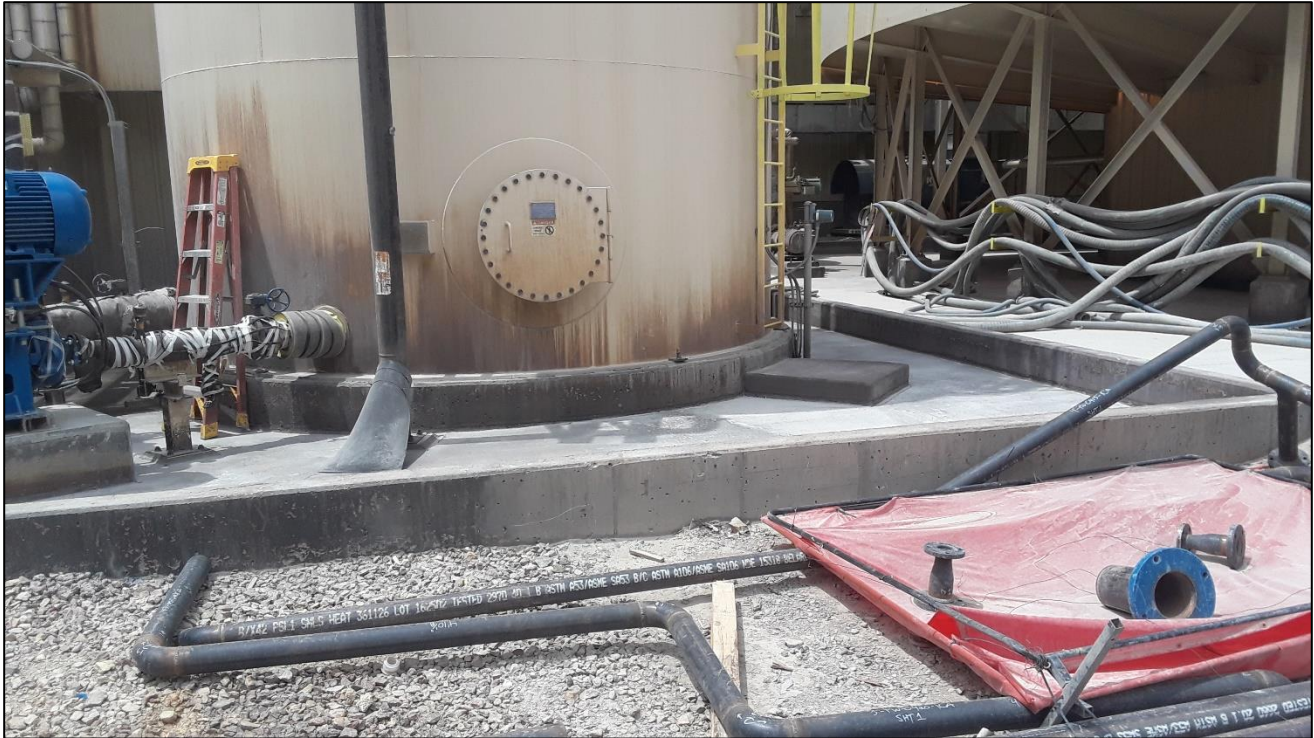
Photo 9. View of secondary containment structure for high pH process water tank located on exterior southeastern side of HGM. No significant reduction in storage was observed.

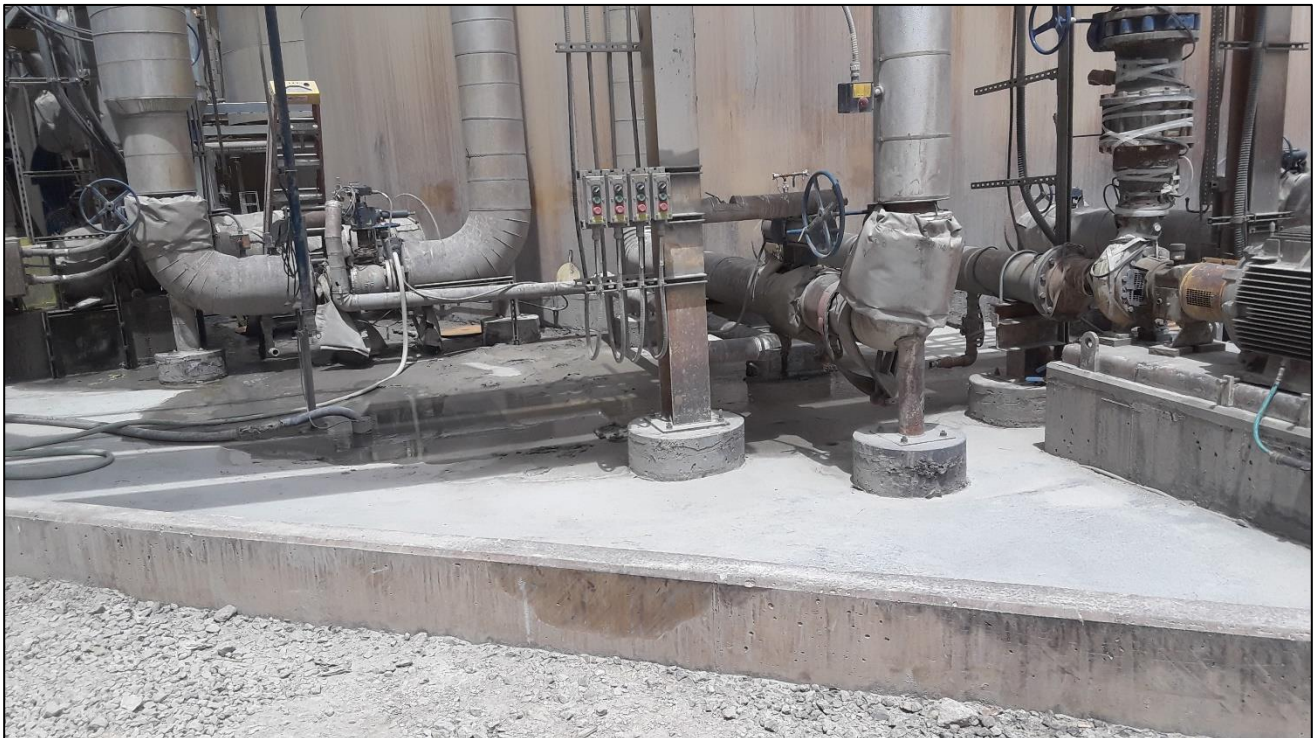
Photo 10. View of secondary containment structure for neutral pH process water tank located on exterior southeastern side of HGM. No significant reduction in storage was observed.

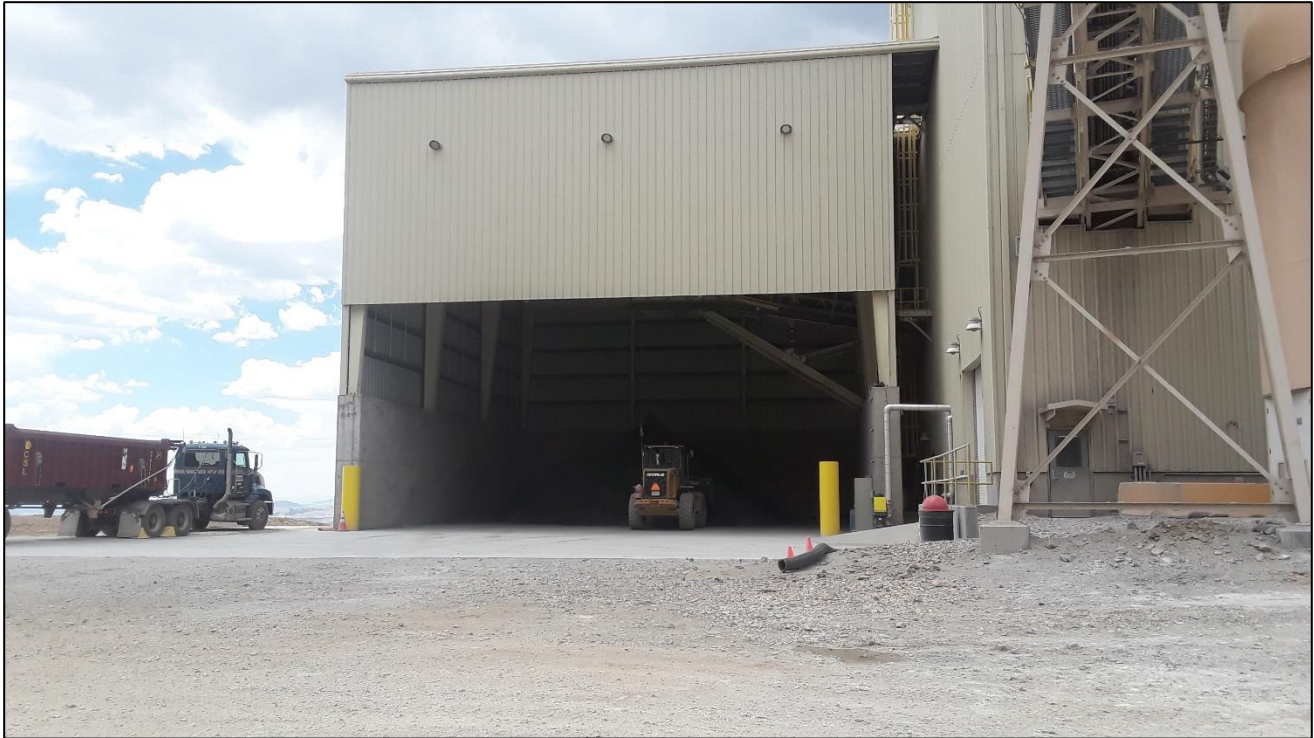
Photo 11. View of concentrate storage building located at southern end of HGM. This building was constructed in 2017 and is designed to store approximately 3,000 cy of concentrate.

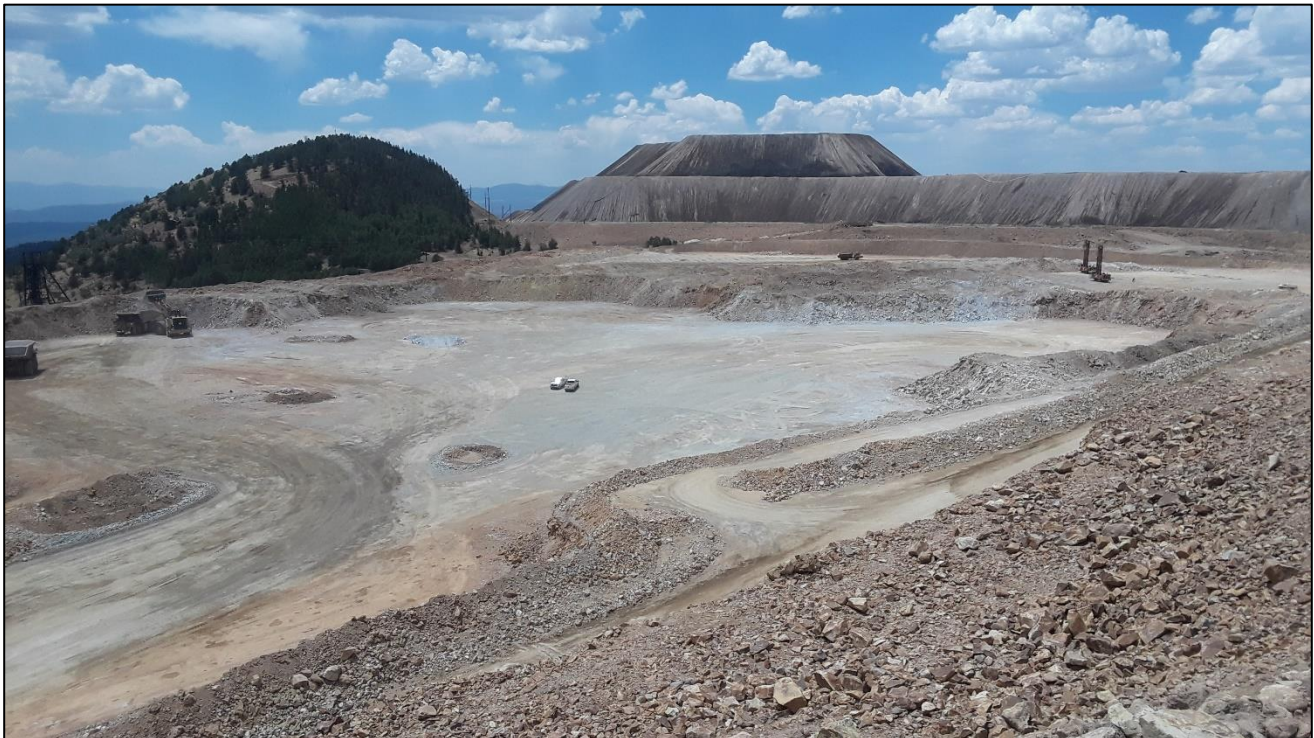
Photo 12. View looking west across South Cresson Mine located between AGVLF and East Cresson Mine.

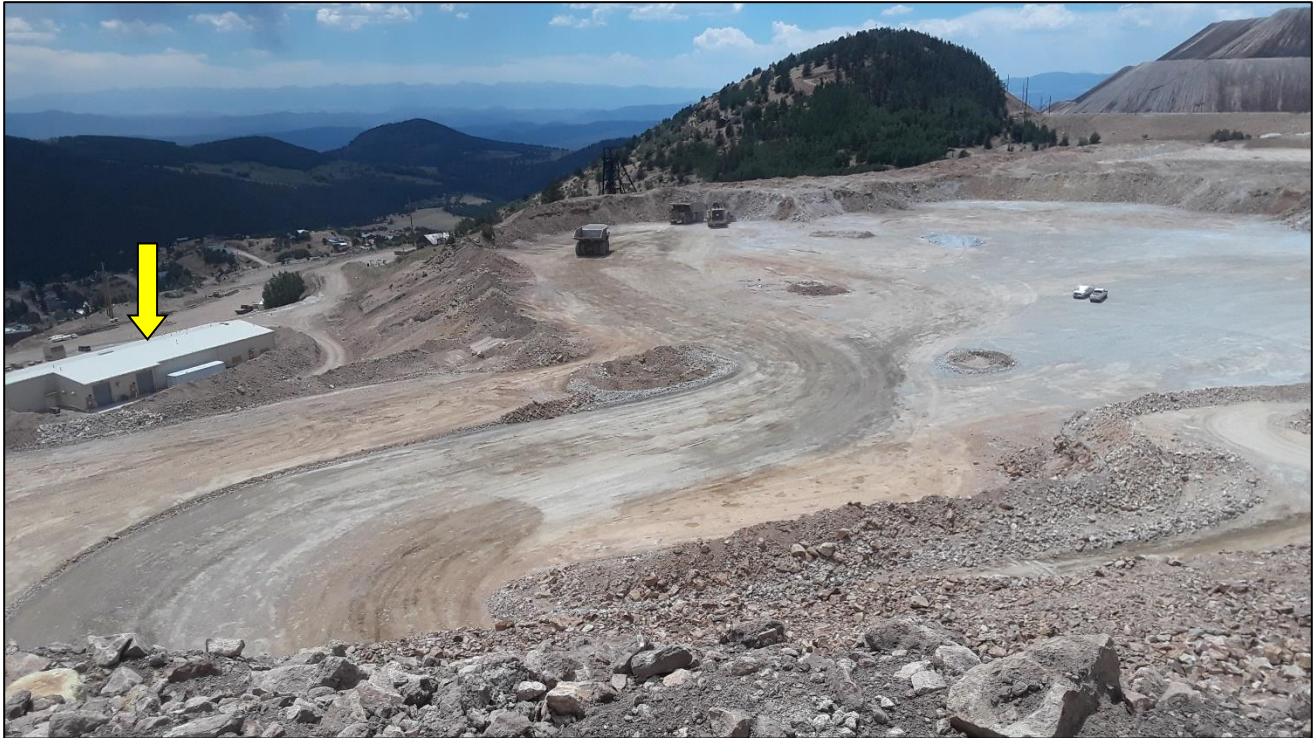
Photo 13. View looking southwest across South Cresson Mine located between AGVLF and East Cresson Mine. Operation was mining southwestern pit wall during inspection. Note Ajax Exploration Building located at southern edge of pit (indicated), which may be removed to allow for pit expansion to the south.

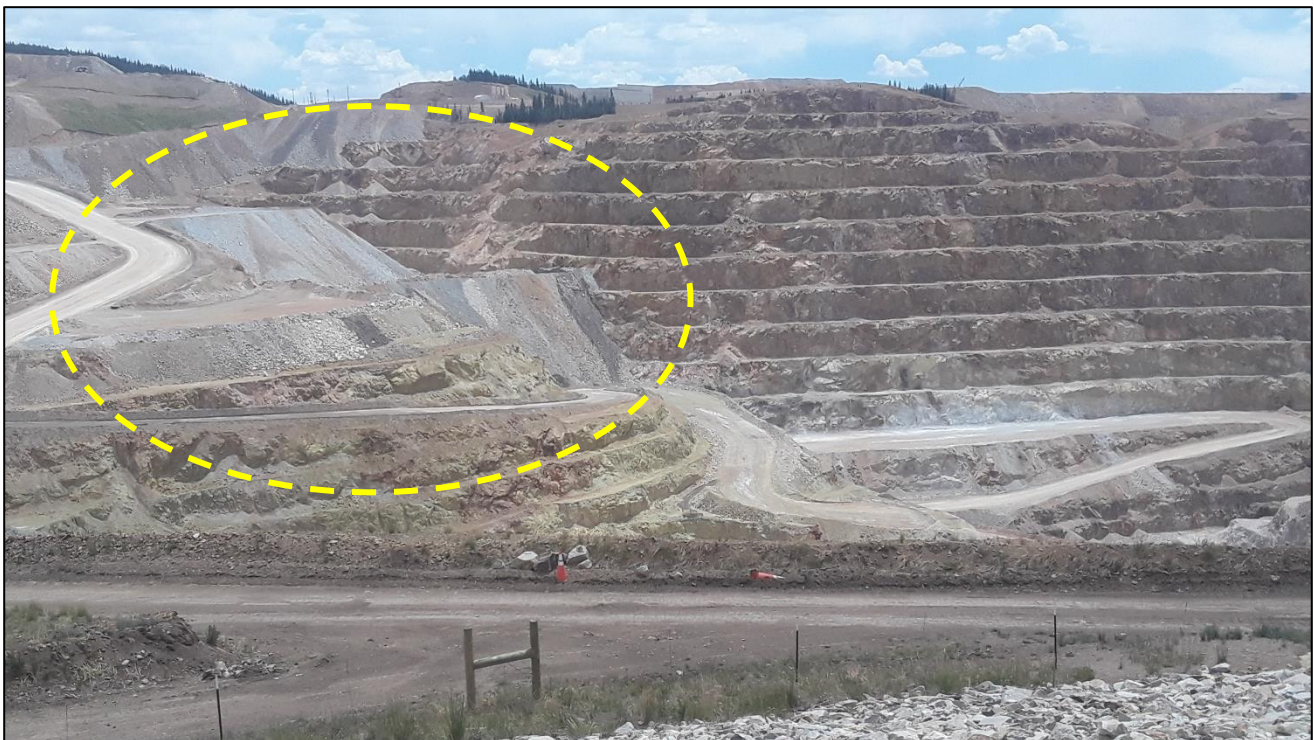
The Division observed the East Cresson Mine (Wildhorse Extension) from the overlook off of County Road 82 (**Photo 14**). The operation has recently begun backfilling the southeastern corner of the pit. The approved reclamation plan for this pit was slightly revised with Technical Revision No. 96 (approved on February 2, 2018), to allow the operation to backfill the pit approximately 280 feet above previously permitted heights. The operation will now backfill portions of the pit to approximate original contour, 10,425 feet above mean sea level. No issues were observed.

Photo 14. View looking south across East Cresson Mine (Wildhorse Extension) located at northern edge of mine site. Operation has begun backfilling southeastern corner of the pit (circled). Approved reclamation plan now calls for backfilling portions of the pit to approximate original contour.

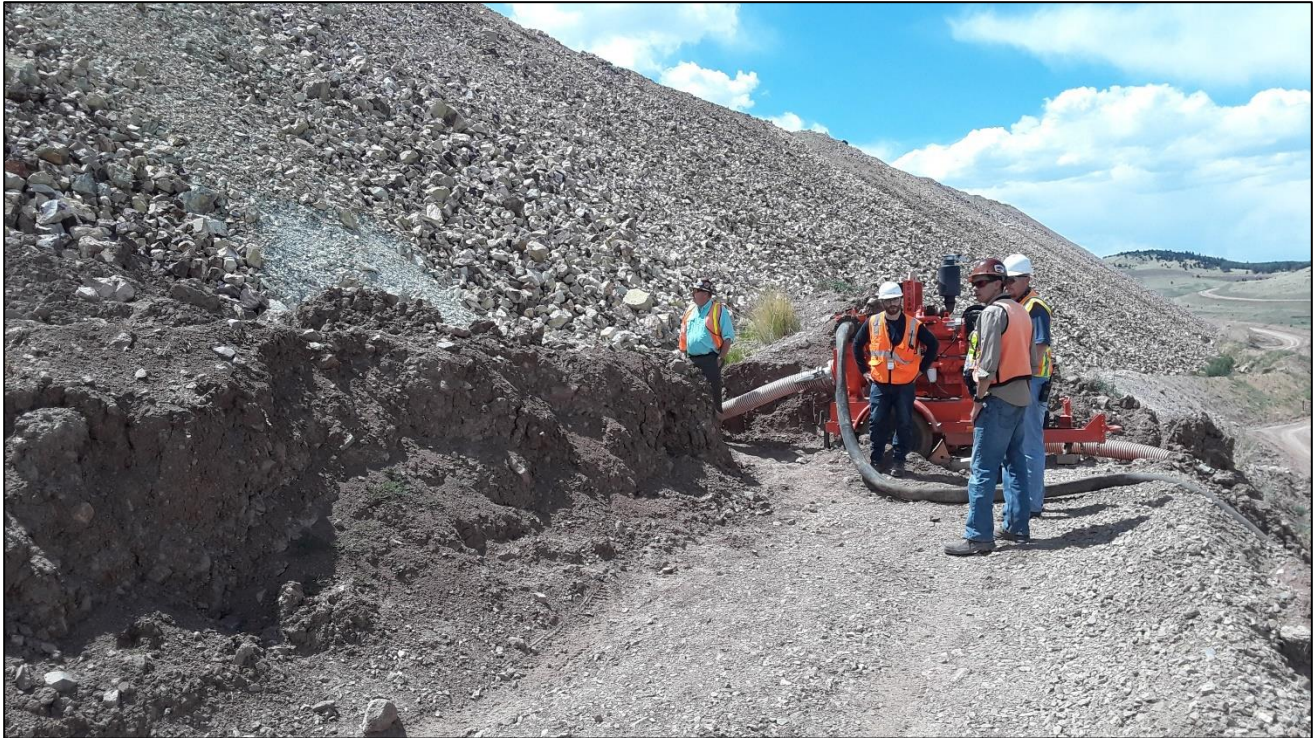
The Division observed the seep location at the eastern toe of the ECOSA (**Photos 15 and 16**). Seep water is retained within a trench constructed at the toe of the ECOSA. The operator has a plan for monitoring the accumulation of water from the seep, and if necessary, conveying the solution from the ECOSA to a lined facility internal to the site. Given the low pH and high metal concentrations of the ECOSA seep water, the Division was concerned about potential impacts to the shallow groundwater system in Grassy Valley. Therefore, the operator submitted Technical Revision No. 97 on May 30, 2018 to install an additional monitoring well (GVMW-25) south of the creek thalweg. The installation of GVMW-25 on the west side of the creek thalweg, downgradient from the ECOSA seep area, should monitor for any potential impacts to shallow groundwater from the seep area.

According to the operator, the seep has been expressing at one location in the ECOSA, typically within 4-5 hours of a rain event, and flowing at a rate of approximately one gallon per minute. The Division observed the trench at the toe of the ECOSA to be dry during the inspection, most likely due to the lack of precipitation in recent weeks. The operator is currently exploring long-term solutions to mitigate the seep for final reclamation.

Photo 15. View looking northwest across eastern toe of the ECOSA at seep location. Any seep water is retained within a trench constructed at the toe of the ECOSA, and if necessary, is pumped from the ECOSA trench to a lined facility internal to the site.

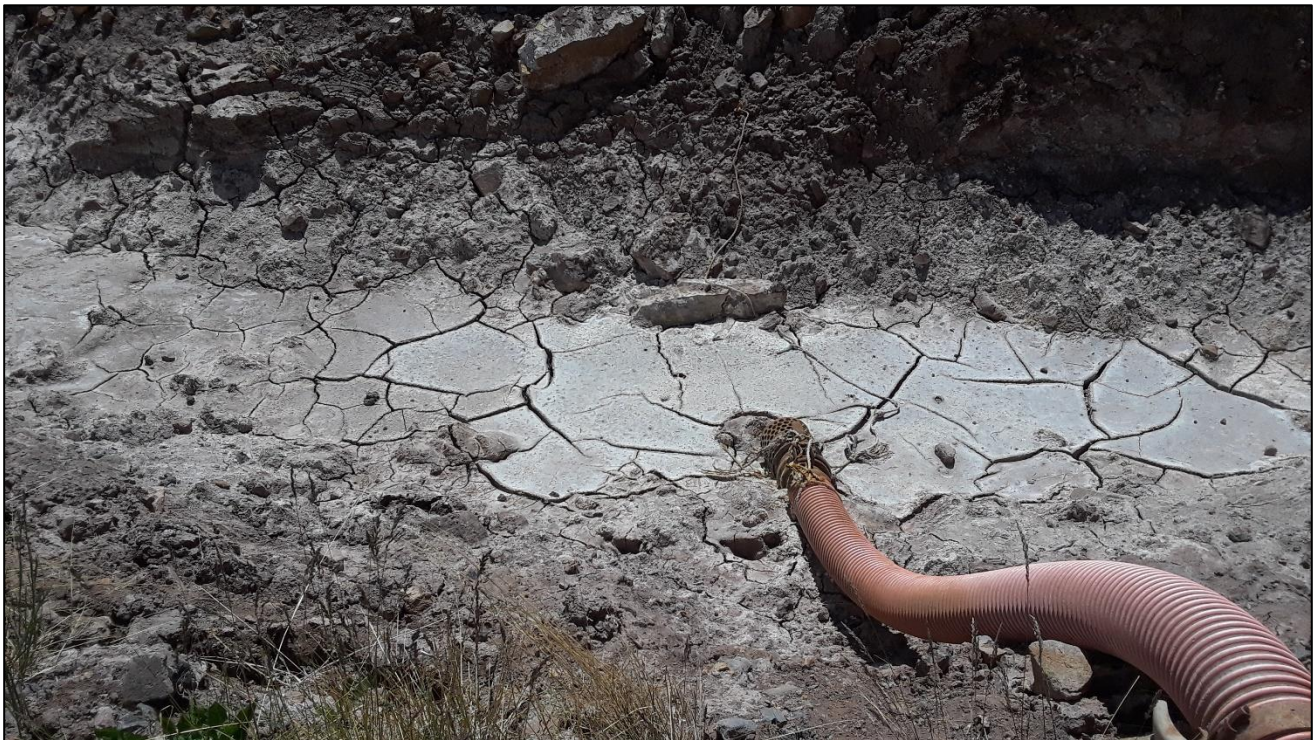
Photo 16. View looking inside trench constructed at toe of ECOSA from which seep water is pumped to a lined facility internal to the site, as necessary. Note trench was dry during the inspection.
