MINERALS PROGRAM INSPECTION REPORT

MINE NAME: Schuler Construction Pit # 1	MINE/PROSPECTING ID#: M-2005-002	MINERAL: Gravel	COUNTY: El Paso
INSPECTION TYPE: Monitoring	INSPECTOR(S): Timothy A. Cazier	INSP. DATE: April 10, 2018	INSP. TIME: 13:05
OPERATOR: Schuler Construction	OPERATOR REPRESENTATIVE: Dave Schuler	TYPE OF OPERATION: 110c - Construction Limited Impact	
REASON FOR INSPECTION: Priority	BOND CALCULATION TYPE: Partial Bond	BOND AMOUNT: \$10,000.00	
DATE OF COMPLAINT: NA	POST INSP. CONTACTS: None	JOINT INSP. AGENCY: None	
WEATHER: Clear	INSPECTOR'S SIGNATURE:

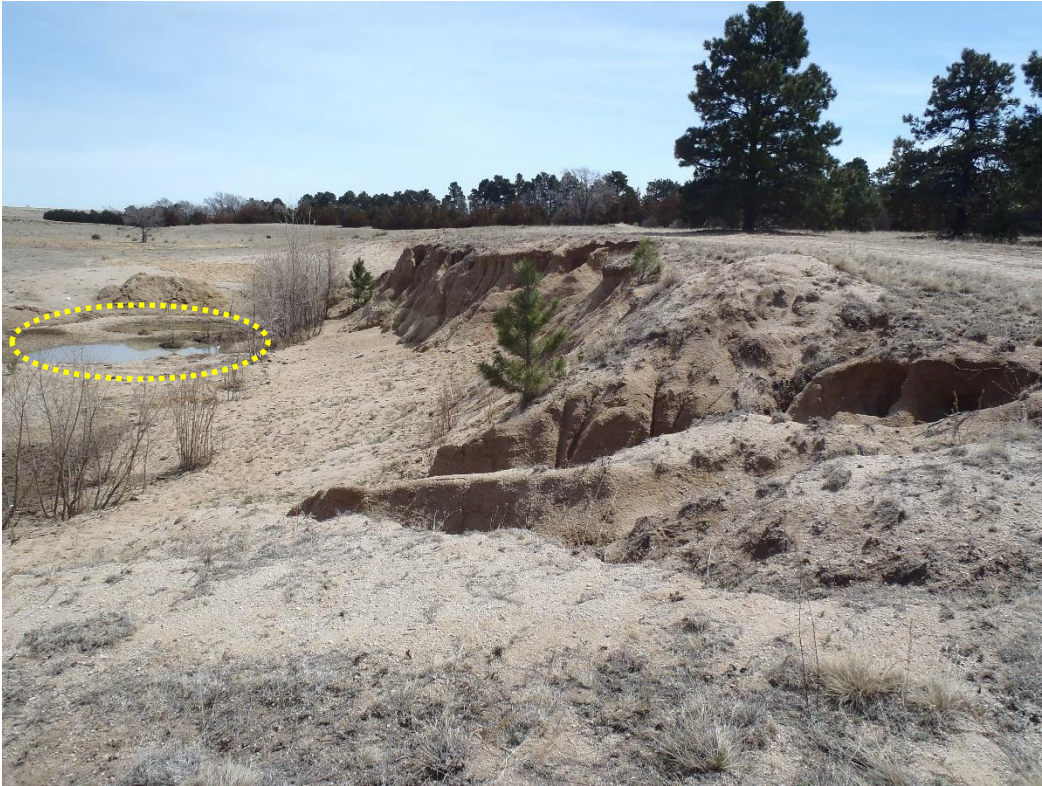
PROBLEM/POSSIBLE VIOLATION No. 2: Problem: Erosion gullies and ruts were observed on-site. This is a problem at this time for failure to protect the affected land from erosion pursuant to C.R.S. 34-32.5-116 (4) (j).

Backfilling and Grading: I discussed the Division's requirement for flattening the highwalls (see **Photo 1**). Mr. Schuler and I agreed there was ample room in the permit boundary to push material down from the top of the highwall to flatten it to the required 3H:1V or flatter. Mr. Schuler indicated he has been having trouble getting a working dozer mobilized to the site to complete the required earthwork.

Gen. Compliance With Mine Plan: The approved Mine Plan (Exhibit C of the permit) indicates the highwalls are to left at 3H:1V or flatter. High walls were near vertical in most areas and estimated to vary between 4 and 10 feet in height (see **Photo 1**) with significant erosion. This is unresolved **PROBLEM/POSSIBLE VIOLATION No. 2**. Mr. Schuler explained the eroded ramp into the pit was part of the previous owner's debris/trash dump which he cleaned up and moved off site.

Sediment Control: As mentioned above, severe erosion is present on the highwall, but appears to be contained in the pit bottom, preventing it from leaving the site for now.

Photo 1. West highwall with erosion gullies and standing water in pit bottom (looking SE).
[Note the permittee has provided evidence of the exposed water being filled in subsequent to this inspection]

CORRECTIVE ACTIONS: The operator shall provide photo documentation to the Division verifying erosion gullies and ruts have been repaired, and that the site has have been reconstructed and stabilized to prevent erosion damage by the corrective action date.

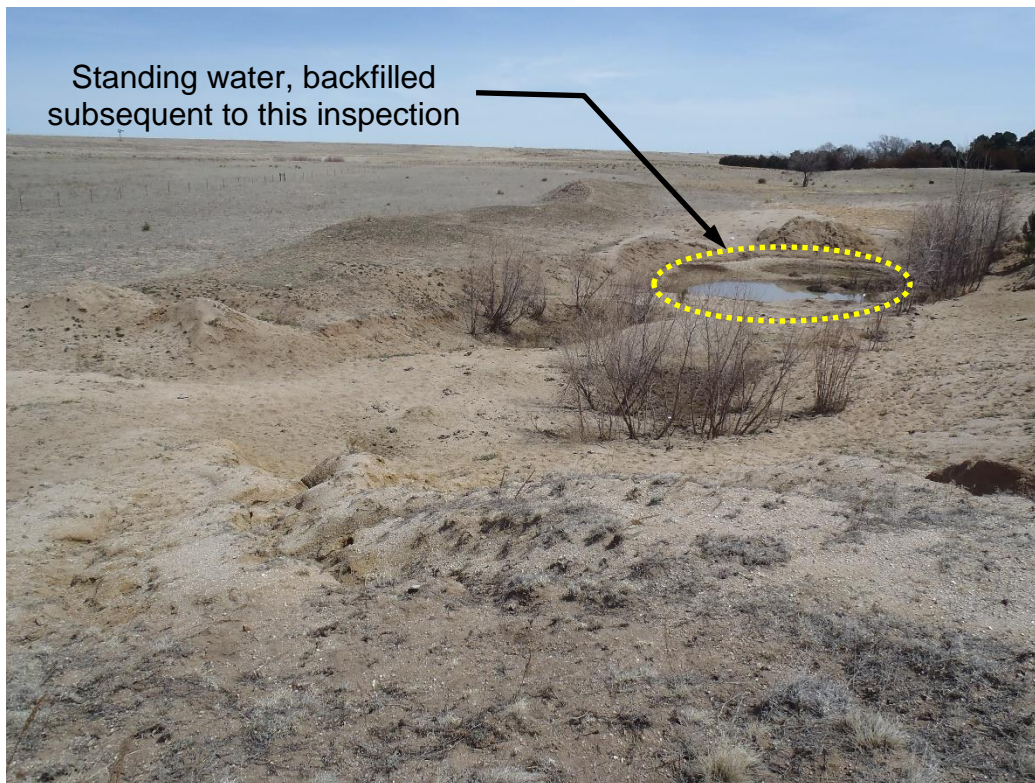
PROBLEM/POSSIBLE VIOLATION No. 1: Problem: The Division has no evidence that the operator has a valid well permit, substitute water supply plan, or approved water augmentation plan for the exposed groundwater at the site. This is a problem related to 34-32.5-116(4)(h) of the Colorado Revised Statutes and 3.1.6(1)(a) of the Construction Materials Rules and Regulations governing injury to existing water rights.

Hydrologic Balance: Standing water was observed in the pit (see **Photo 2**) and was believed to be exposed groundwater. The Permittee provided the Division with photographic evidence of having backfilled the exposed groundwater on August 22, 2018. **PROBLEM/POSSIBLE VIOLATION No. 1** (from the previous inspection) is considered resolved.

Photo 2. Standing water in pit bottom.

CORRECTIVE ACTIONS: The operator shall demonstrate that the operation is in compliance with the Office of the State Engineer, show evidence that the operator is taking measures to bring the site into compliance with the SEO, or backfill the pits to at least two feet above the groundwater surface by the corrective action date specified.

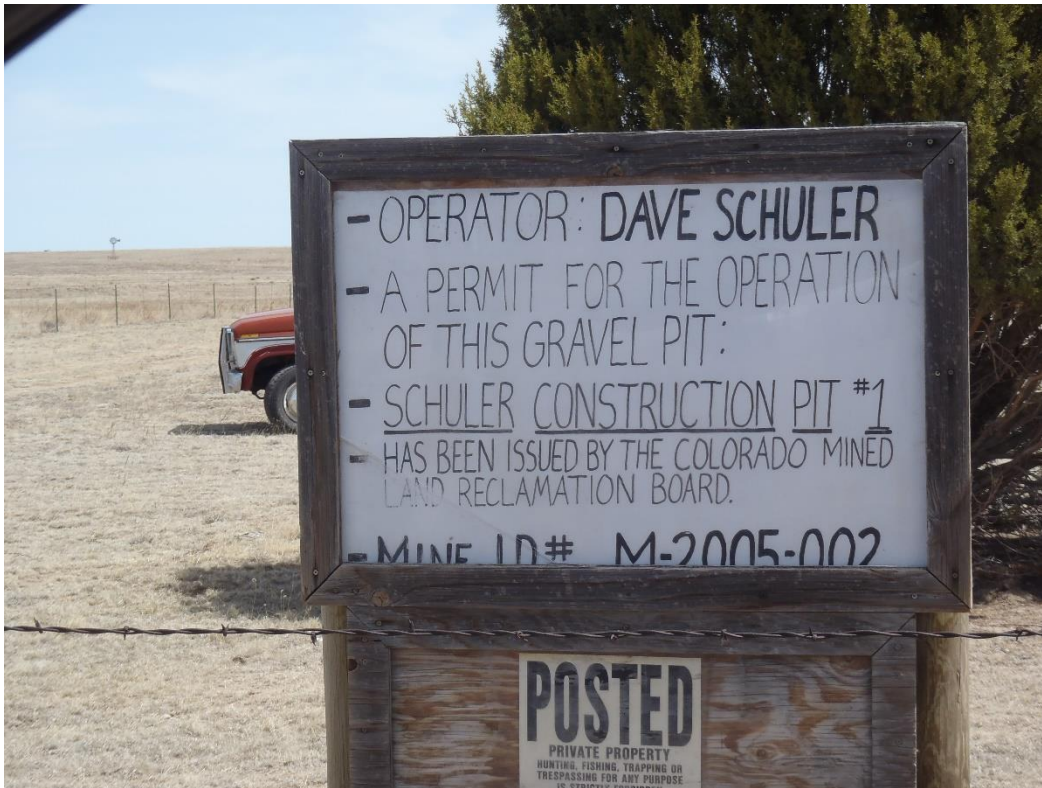
Signs and Markers: The permit sign was properly posted (see **Photo 3**).

Photo 3. Required permit sign at entrance of Ramah Hwy.

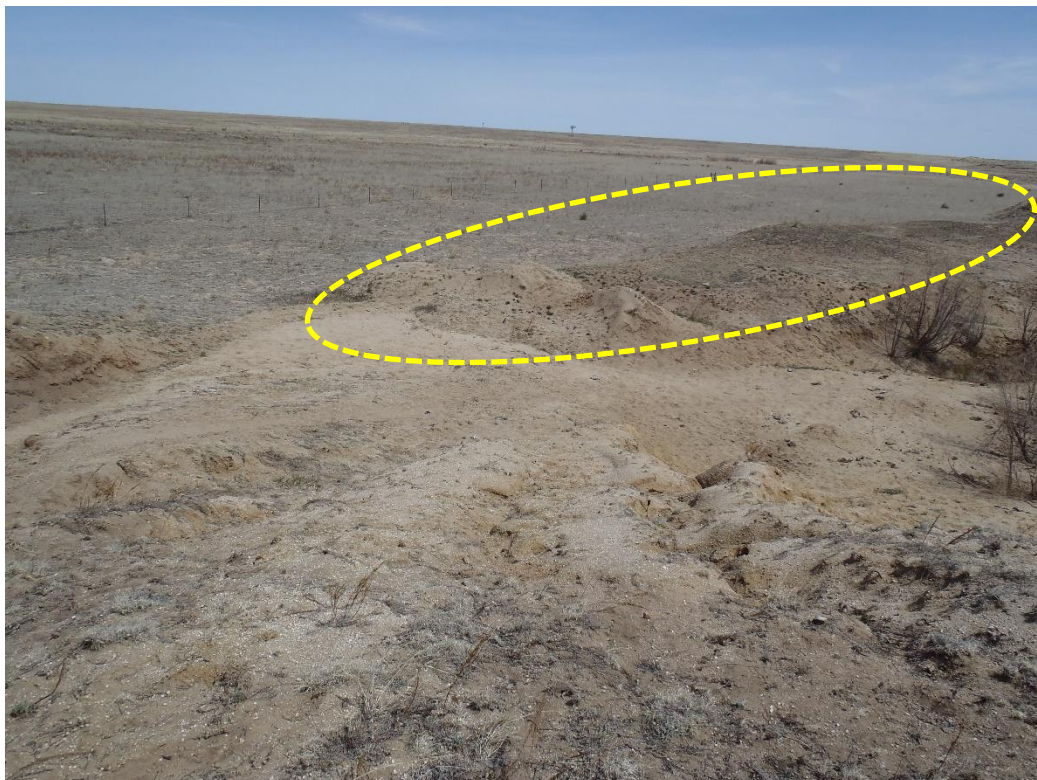
Topsoil: Mr. Schuler indicated the berms on the north side of the excavation (see **Photo 4**) consist of salvaged topsoil.

Photo 4. Berms on the north side of the excavation consisting of salvaged topsoil.
