MINERALS PROGRAM INSPECTION REPORT
PHONE: (303) 866-3567

MINE NAME: Cresson Project	MINE/PROSPECTING ID#: M-1980-244	MINERAL: Gold	COUNTY: Teller
INSPECTION TYPE: Monitoring	INSPECTOR(S): Timothy A. Cazier	INSP. DATE: March 29, 2018	INSP. TIME: 09:00
OPERATOR: Cripple Creek & Victor Gold Mining Company	OPERATOR REPRESENTATIVE: Justin Bills	TYPE OF OPERATION: 112d-3 - Designated Mining Operation	
REASON FOR INSPECTION: Normal I&E Program	BOND CALCULATION TYPE: None	BOND AMOUNT: \$208,491,188.00	
DATE OF COMPLAINT: NA	POST INSP. CONTACTS: None	JOINT INSP. AGENCY: None	
WEATHER: Cloudy	INSPECTOR'S SIGNATURE:

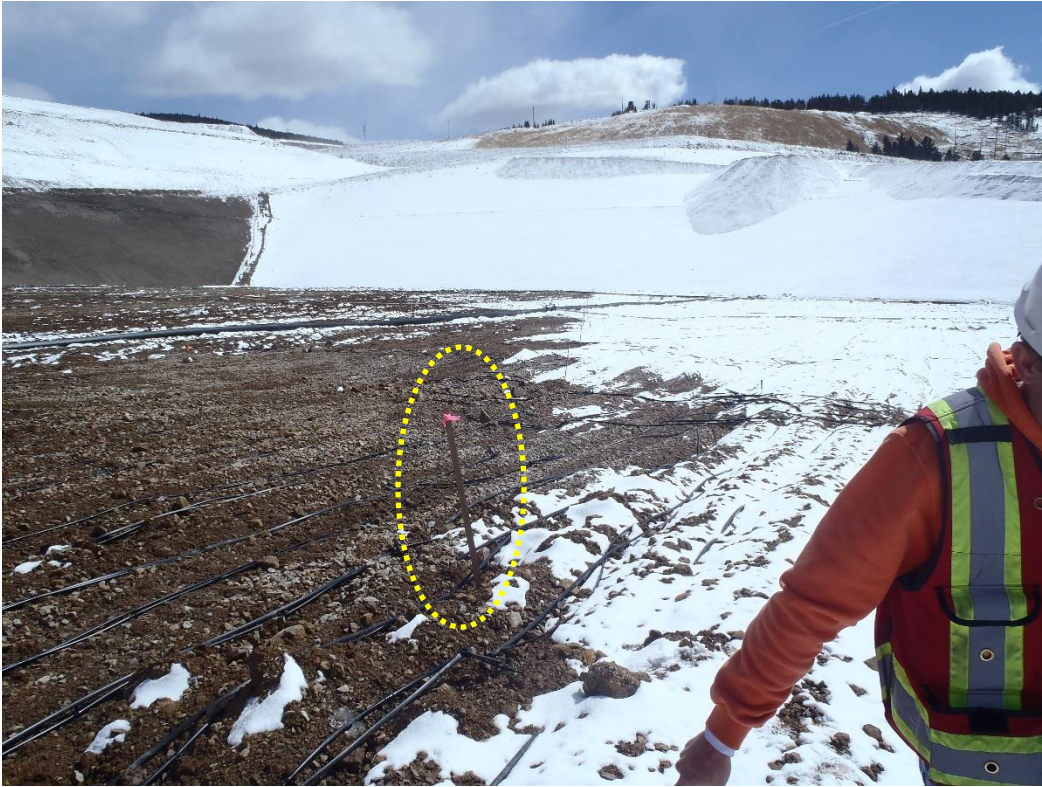
Squaw Gulch Valley Leach Facility (VLF 2) Slide Area: Mr. Jeff Winterton accompanied the Division and Mr. Bills to the area on the east side of the VLF where a slide occurred in December 2017 between the 9850 and 9650 benches. Due to the slide and potential damage (unknown at the time of the inspection) the Division required CC&V to cease leaching within 500 feet of the slide area. The 500-foot limit was observed to be staked out using survey lathe (**Photo 1**) and leach system drip lines were observed to be tied off (**Photo 2**) outside this limit with drip lines dry within the 500-foot limit.

Photo 1. 500-foot leach limit staked out using survey lathe (more stakes beyond).

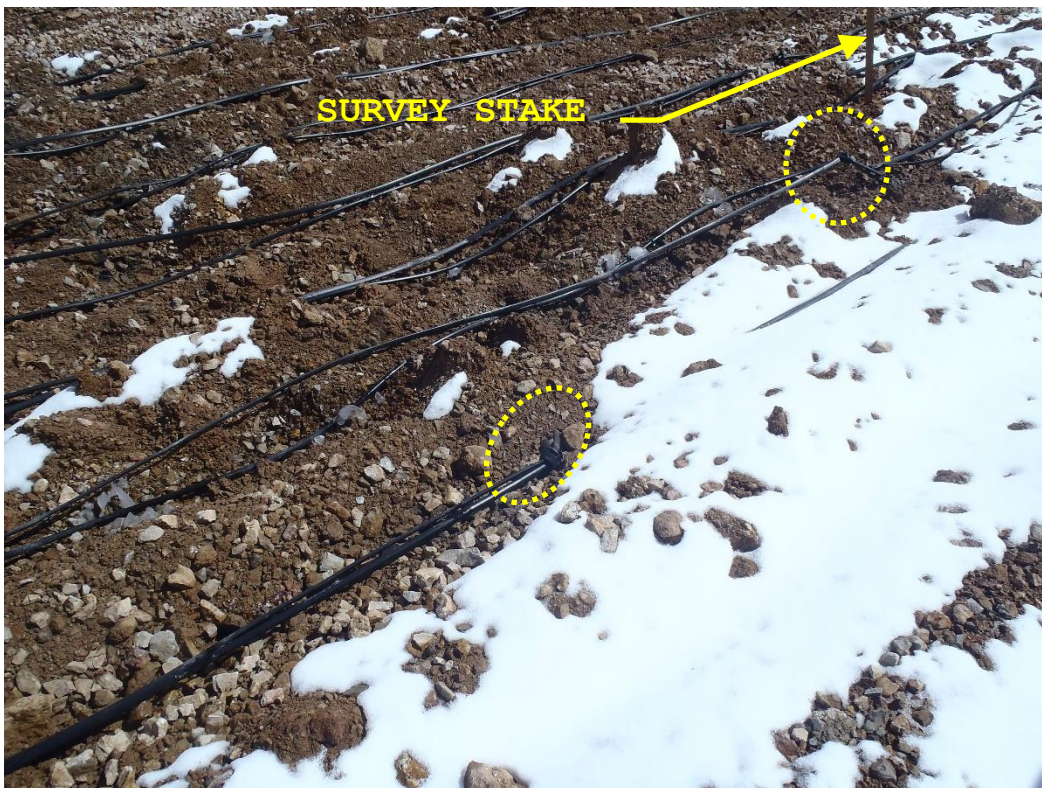
Photo 2. Leach system drip lines tied off at 500-ft limit.

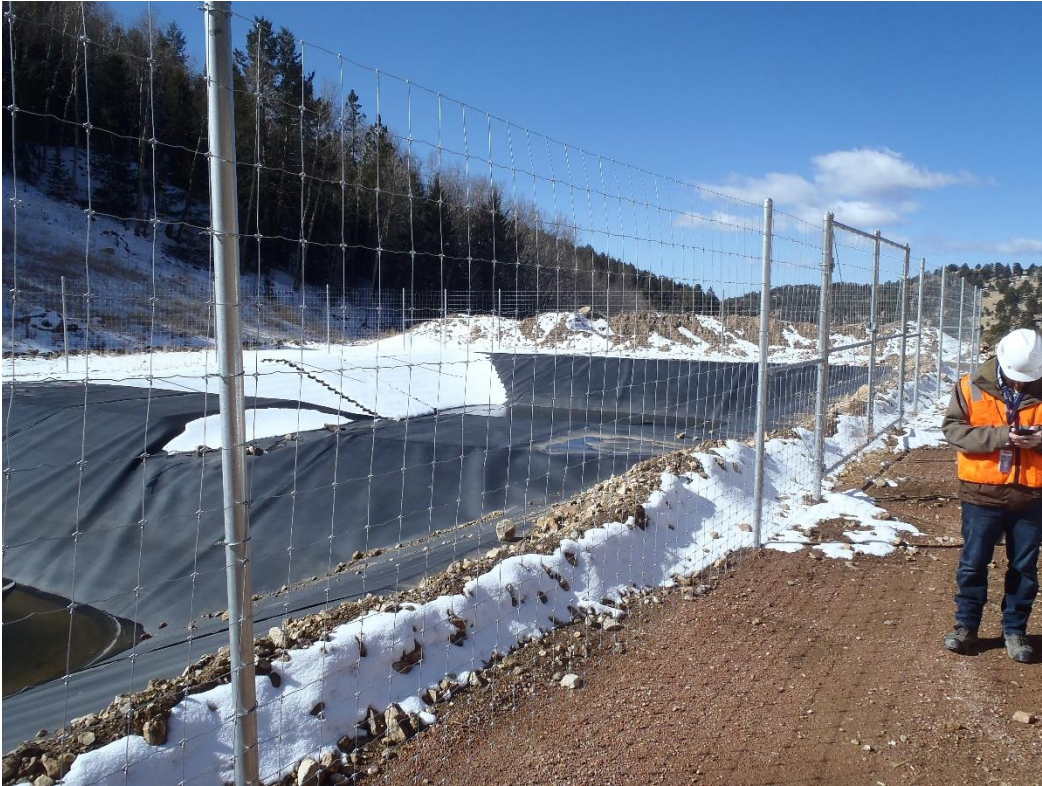
SGVLF Underdrain Ponds: The Division was accompanied by Mr. Dylan Noble to inspect the VLF 2 underdrain ponds. Wildlife fencing around the ponds had been completed (**Photo 3**). Mr. Noble indicated the water observed in the ponds (**Photo 4**) was meteoric. Mr. Noble explained the underdrain pumpback system has two pumps housed in the underdrain sump vault (**Photo 5**). Water levels observed from the two pump level indicators (**Photo 6**) in the vault were 39.4 ft (pump 19) and 41.6 ft (pump 20). Mr. Noble stated the pumps turn on at 50 ft and off at 35 ft.

Photo 3. Wildlife fencing around the VLF 2 underdrain ponds.

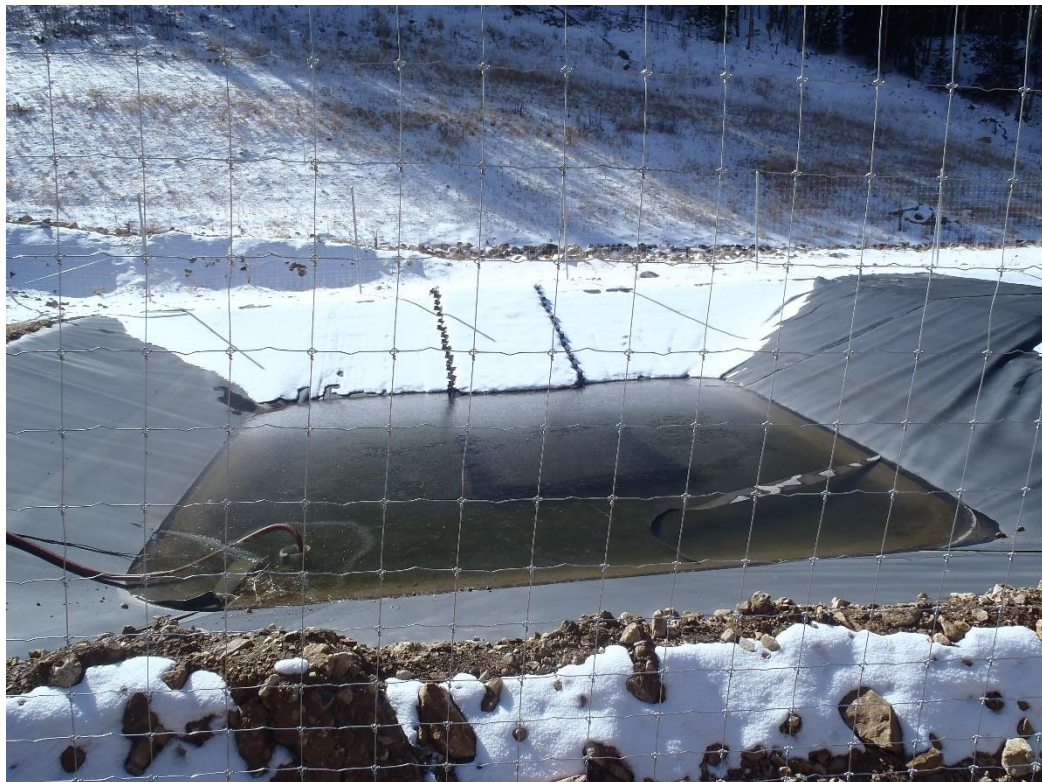
Photo 4. Meteoric water in NE VLF 2 underdrain pond.

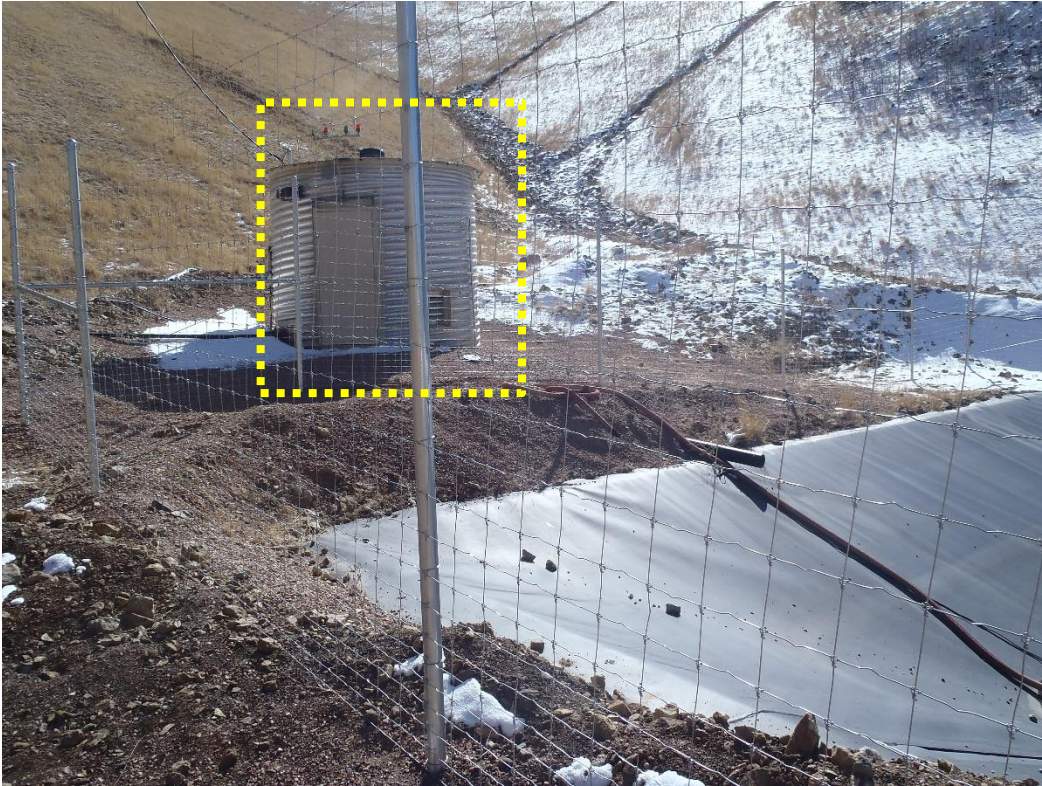
Photo 5. VLF 2 underdrain pump vault.

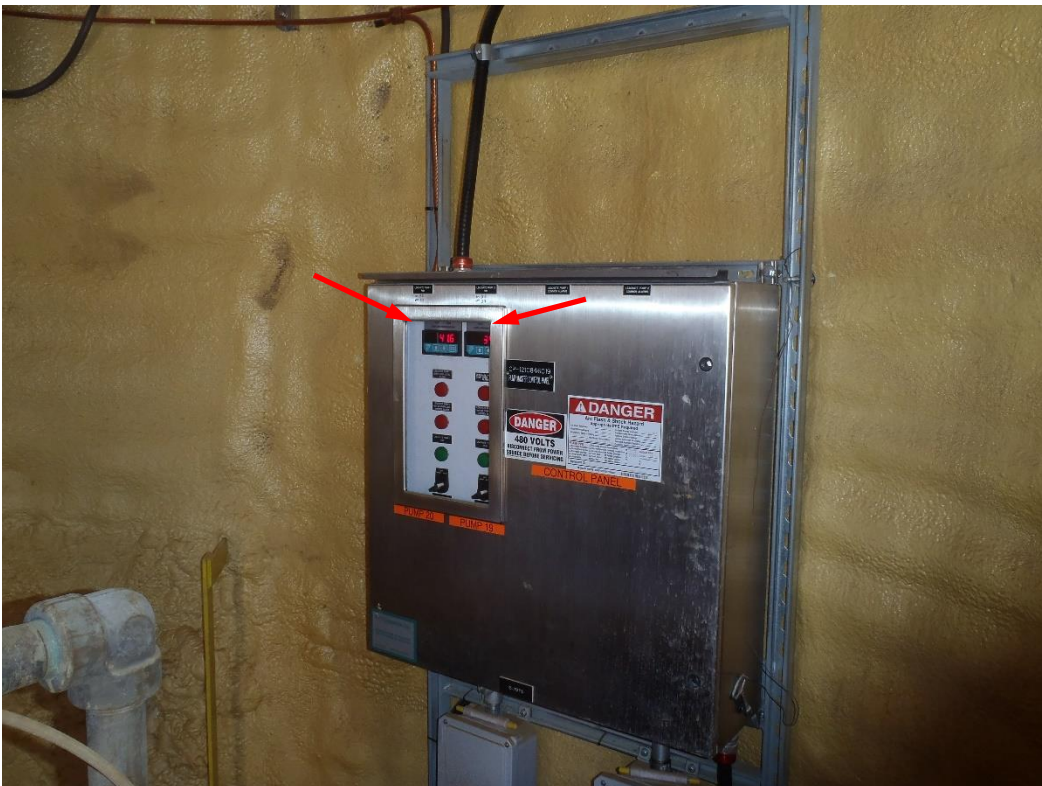
Photo 6. Water level indicators for Pumps 19 & 20 in VLF 2 underdrain sump vault.

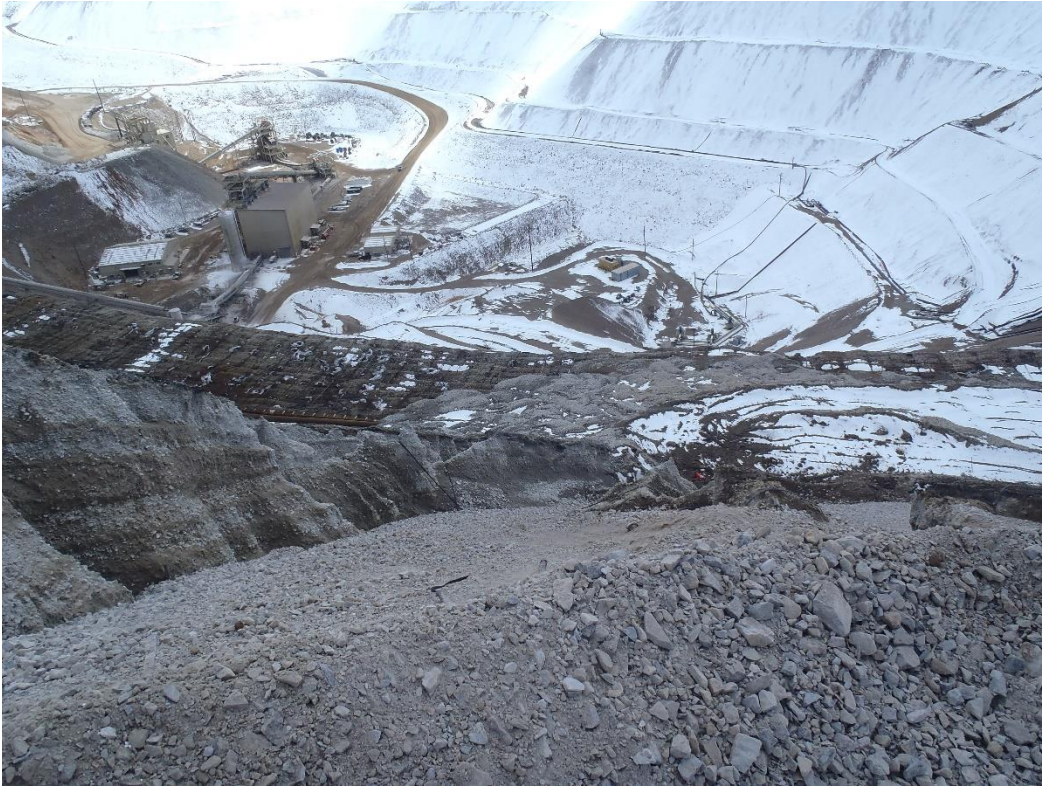
Phase IV Arequa Gulch Valley Leach Facility: Messrs. Will Adams and Laurin Colby accompanied the Division and Mr. Bills to the Phase IV side of the VLF 1 where a leach system header failure (**Photo 7**) occurred on March 19, 2018. Repairs were underway at the time of the inspection. The Division was provided assurances all process solution remained within the VLF liner system and the event did not pose slope stability concern for the VLF.

Photo 7. Erosion feature where a leach system header failure occurred on March 19, 2018.

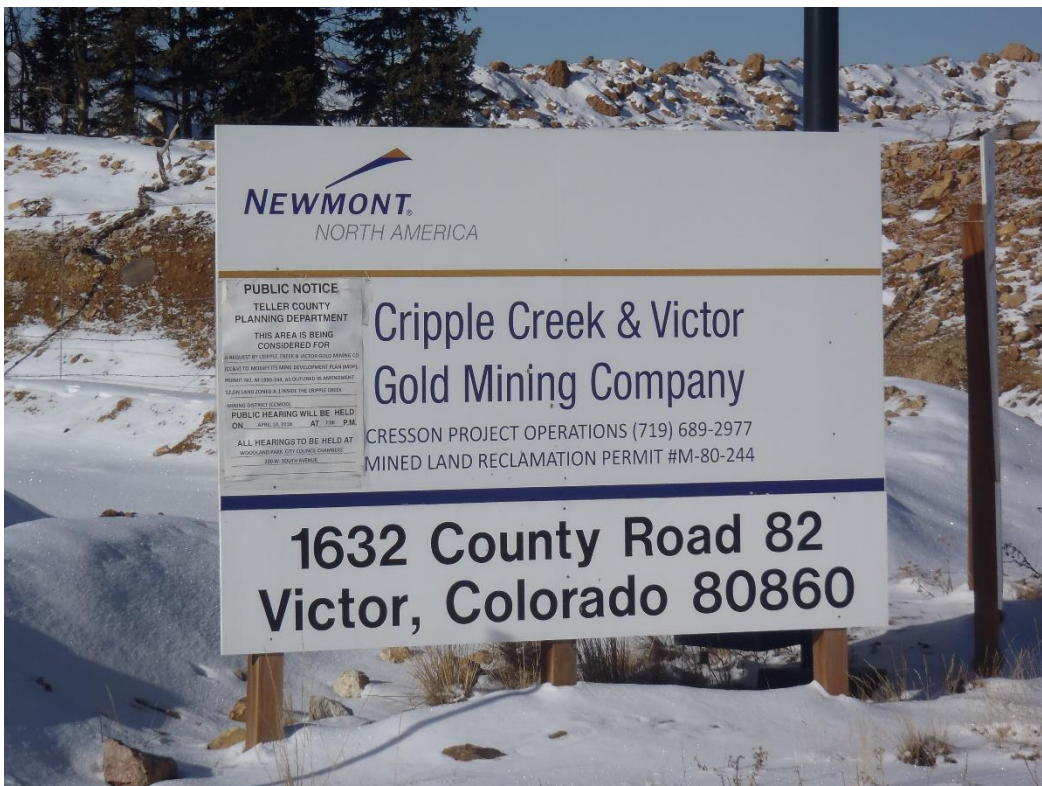
Permit Sign: The permit sign observed at the Ironclad facility entrance meets the requirements of Rule 3.1.12 (Photo 8)

Photo 8. Ironclad entrance permit sign.
