## Bureau of Land Management Colorado River Valley Field Office Minerals Inspection Report

General Information	
<b>Date</b>	8/28/2018
<b>Project Name</b>	Rifle Quarry
<b>Operator</b>	Colorado Lien Company
<b>Serial Number</b>	COC-077876
<b>Project Classification</b>	Plan of Operations
<b>Project Location</b>	T4S R92W Sec15, Garfield County
<b>Inspection Purpose</b>	Reclamation site inspection
<b>Time Period Onsite</b>	1 hour
<b>Attendees</b>	Jessica Lopez Pearce, BLM Geologist
	Amy Yeldell, CO-DRMS Environmental Protection Specialist
	Wally Erickson, CO-DRMS Senior Environmental Protection Specialist

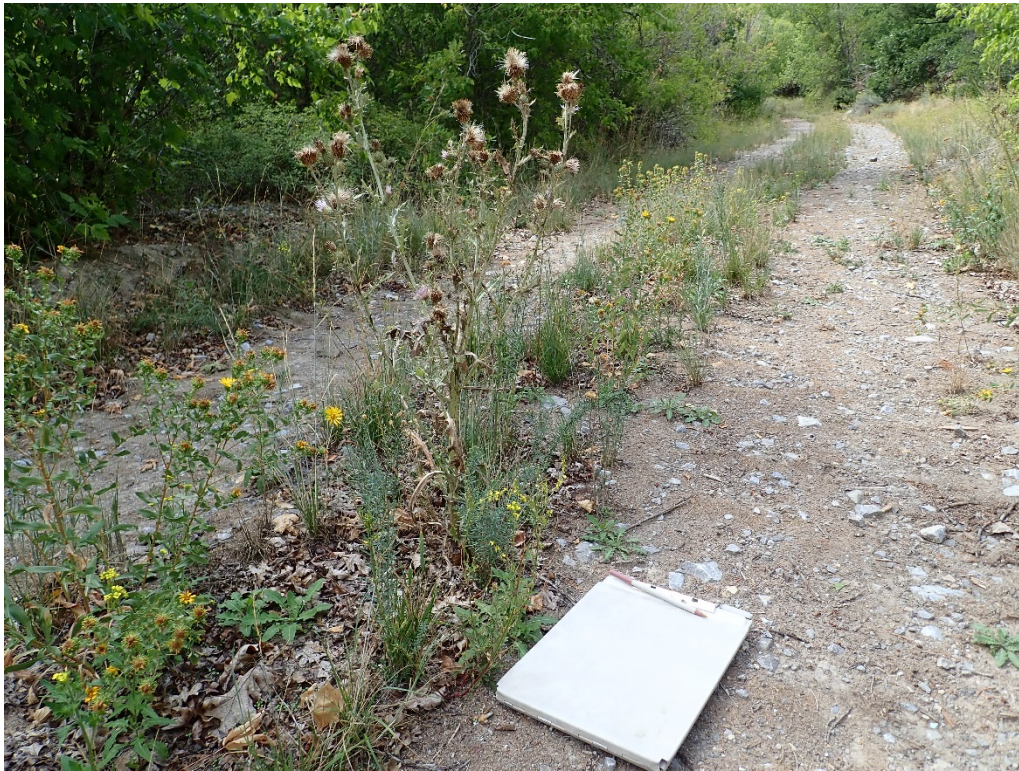
I observed the access road blocked per the Final Reclamation Plan. There was evidence of approved alternative growth media and mulching material (a combination of fish emulsion solids, spent grain solids, spent potato mash solids, mulch, and topsoil) on the surface of the road; however, it appeared to be dried out and washed away in some areas, exposing bare rock and mineral soil. There was significantly more vegetation along the sides and down the middle of the old road than in the wheel ruts. Thistle was observed growing on the access road. Signage was present at the southeast corner of the main quarry area.

Photo 1: Looking west along the barricaded access road. Grasses, forbs, and thistle was observed growing in the middle and along the sides of the road, but there was very little vegetation success within the wheel ruts. Clipboard for scale.

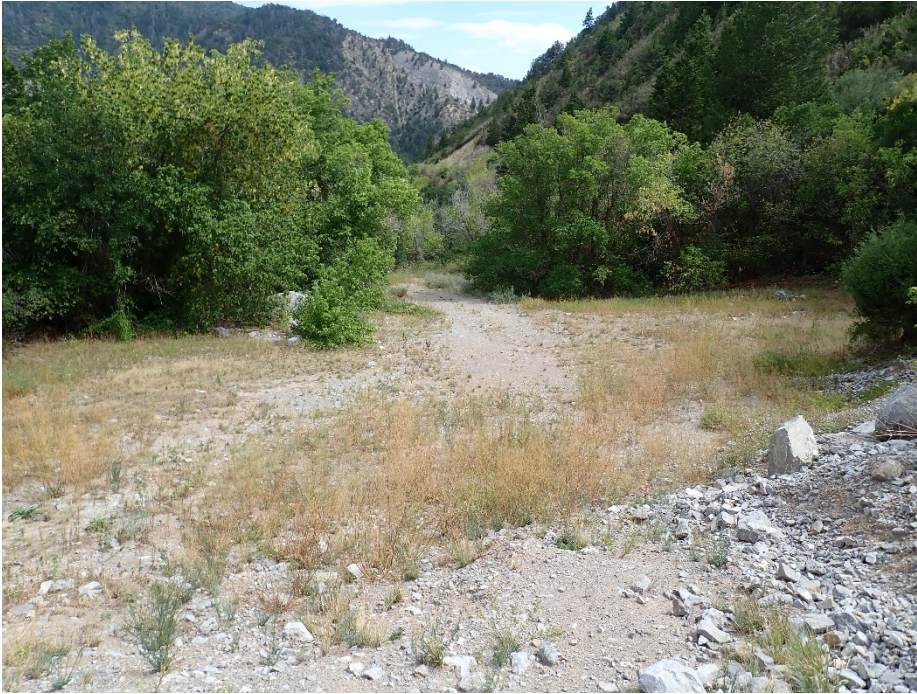
Photo 2: Looking east to the access road from the eastern slope of the quarry. Note the patches of dry vegetation and exposures of bare rock and soil.

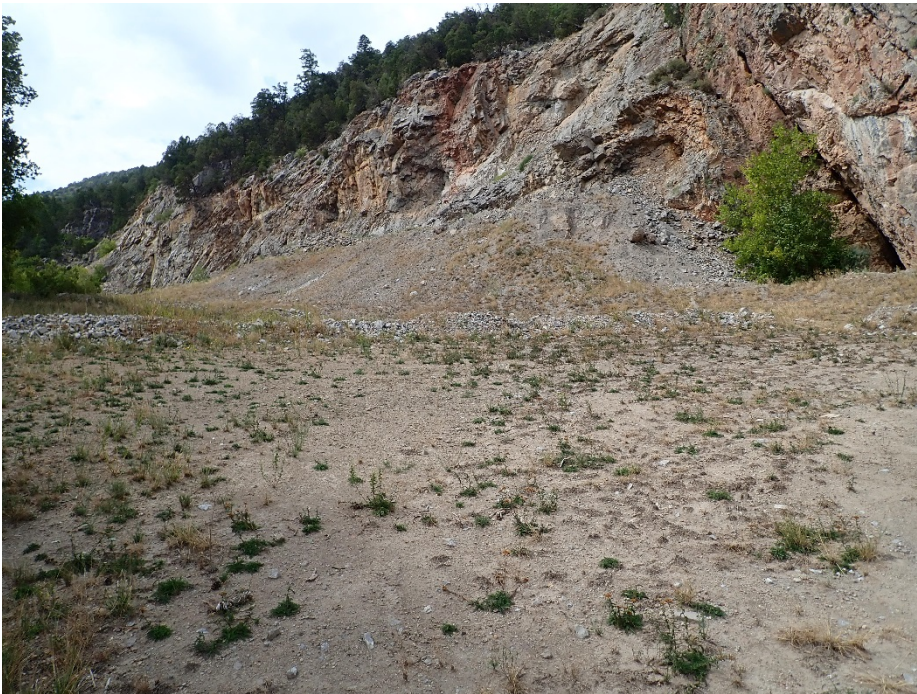
Photo 3: Looking west at the quarry floor. Western Yarrow comprised the majority of the vegetation in the middle of the pit floor. There was abundant bare ground in this area.

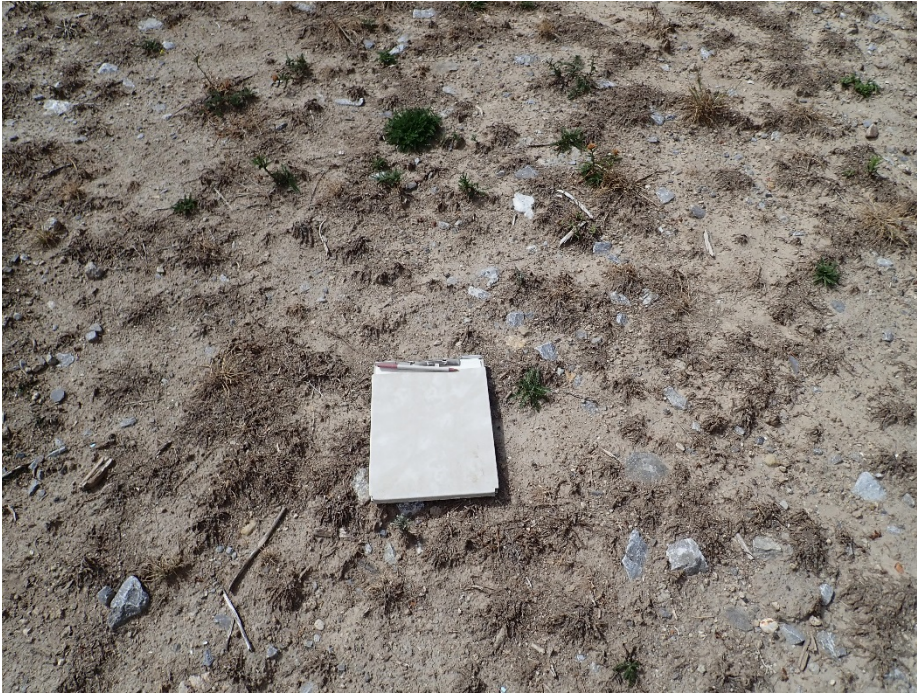
Photo 4: It has been a hot and dry summer; the Western Yarrow was observed drying out and dying on the pit floor. Clipboard for scale.

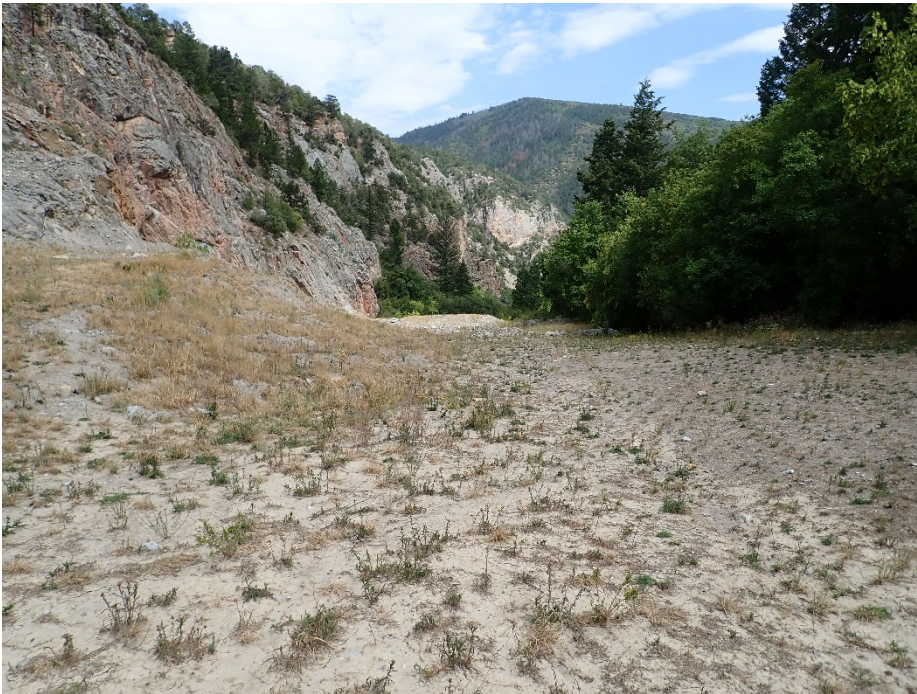
Photo 5: Looking east from the west side of the pit floor. Last year, the grasses were abundant and green on the slope between the upper bench and lower bench. This year, the grasses are dried and brown.

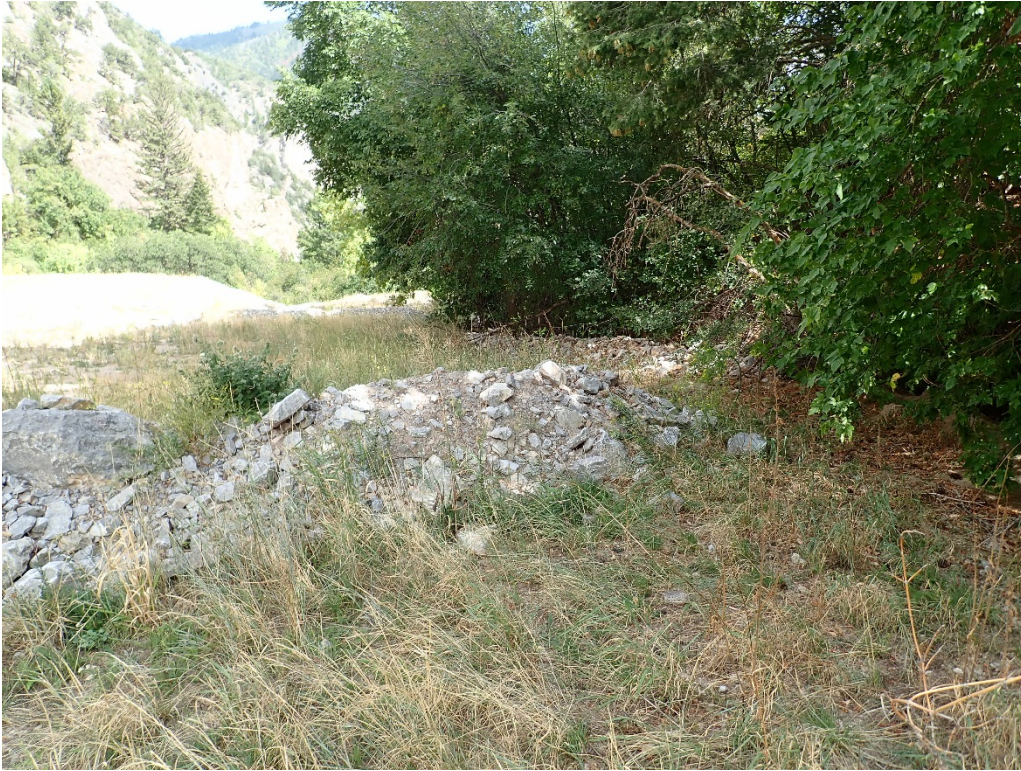
Photo 6: Looking east along the south side of the quarry floor. Grasses and forbs had much higher success in the shade along the southern drainage.
