MINERALS PROGRAM INSPECTION REPORT
PHONE: (303) 866-3567

MINE NAME: Bad Boy Stone	MINE/PROSPECTING ID#: M-1992-108	MINERAL: Dimension stone	COUNTY: Boulder
INSPECTION TYPE: Monitoring	INSPECTOR(S): Amy Eschberger	INSP. DATE: July 11, 2018	INSP. TIME: 13:00
OPERATOR: Bad Boy Stone	OPERATOR REPRESENTATIVE: Raul Vasquez	TYPE OF OPERATION: 110c - Construction Limited Impact	
REASON FOR INSPECTION: Normal I&E Program	BOND CALCULATION TYPE: Partial Bond	BOND AMOUNT: \$5,300.00	
DATE OF COMPLAINT: NA	POST INSP. CONTACTS: None	JOINT INSP. AGENCY: None	
WEATHER: Clear	INSPECTOR'S SIGNATURE:

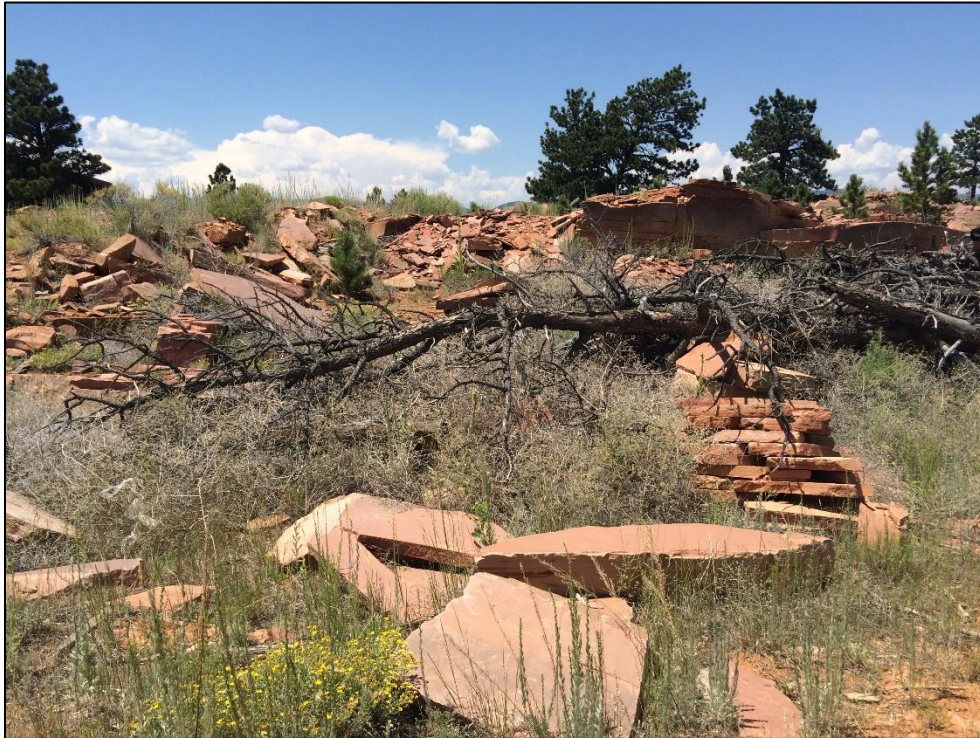
Photo 1. View looking west across south pit area. Large blocks of sandstone scattered across ground will need to be removed from site or used to backfill pits for reclamation. Mine walls will need to be graded to 3H:1V or flatter.

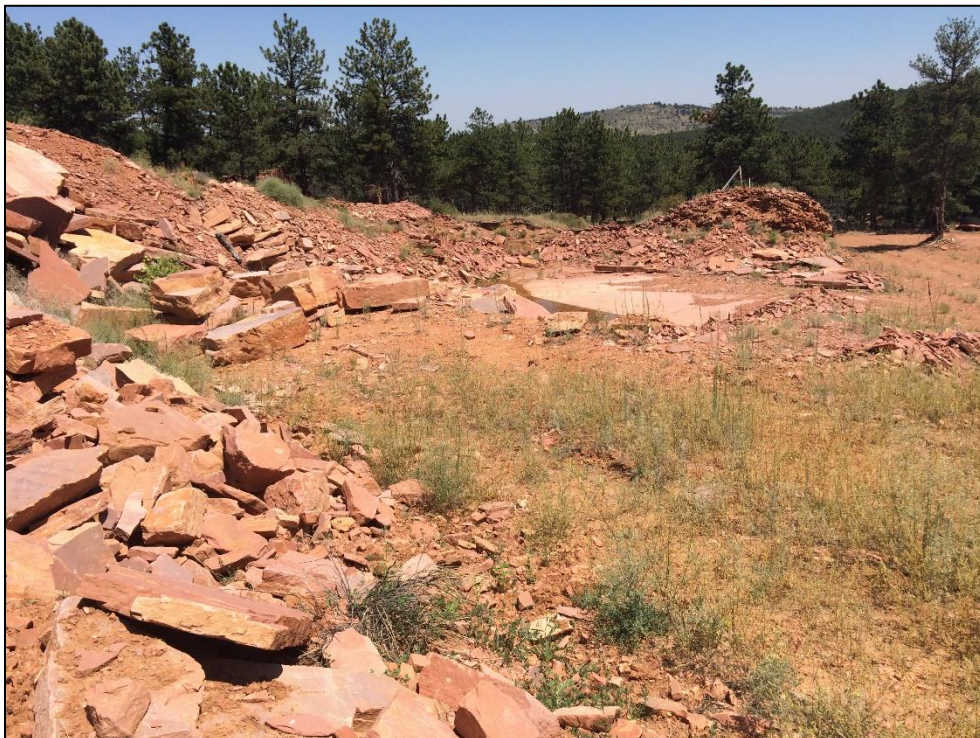
Photo 2. View looking east across south pit area. Loose rocks will need to be pushed into pit and graded out to 3H:1V or flatter for reclamation.

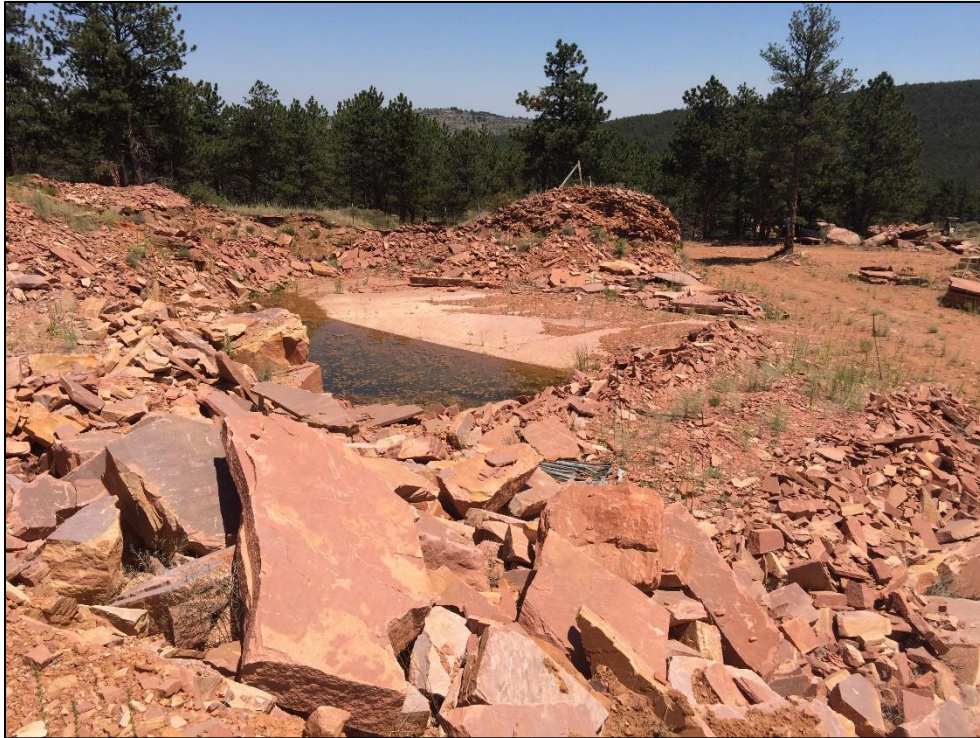
Photo 3. View looking east, showing closer view of south pit shown in Photo 2.

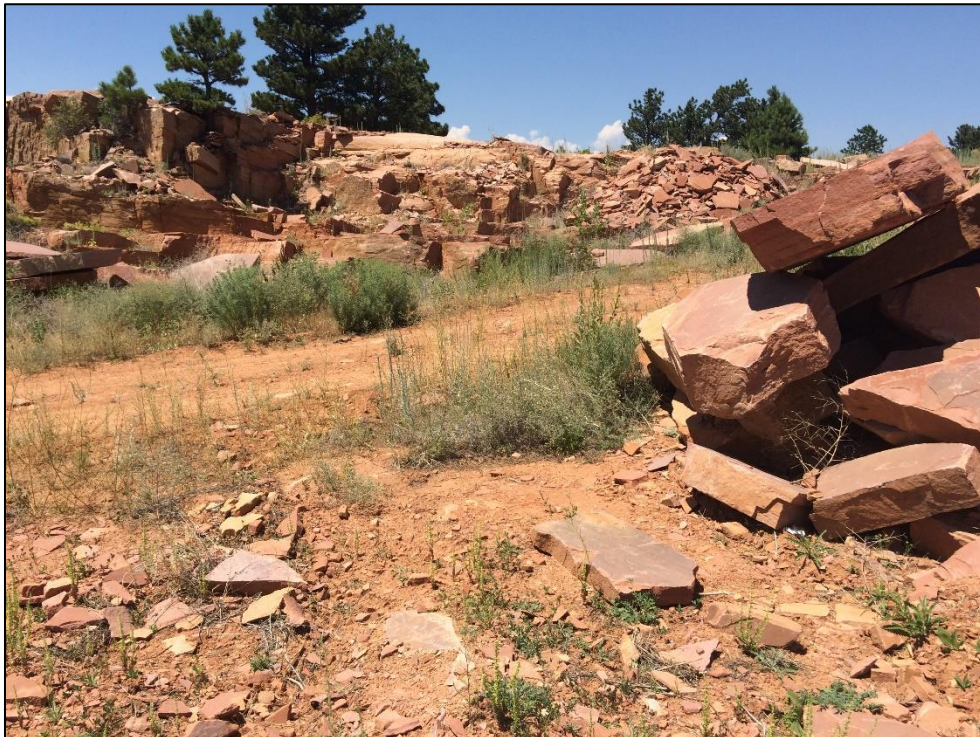
Photo 4. View looking west across south pit area. Loose rocks will need to be pushed into pit and graded out to 3H:1V or flatter for reclamation. Mine walls will need to be graded to 3H:1V or flatter.

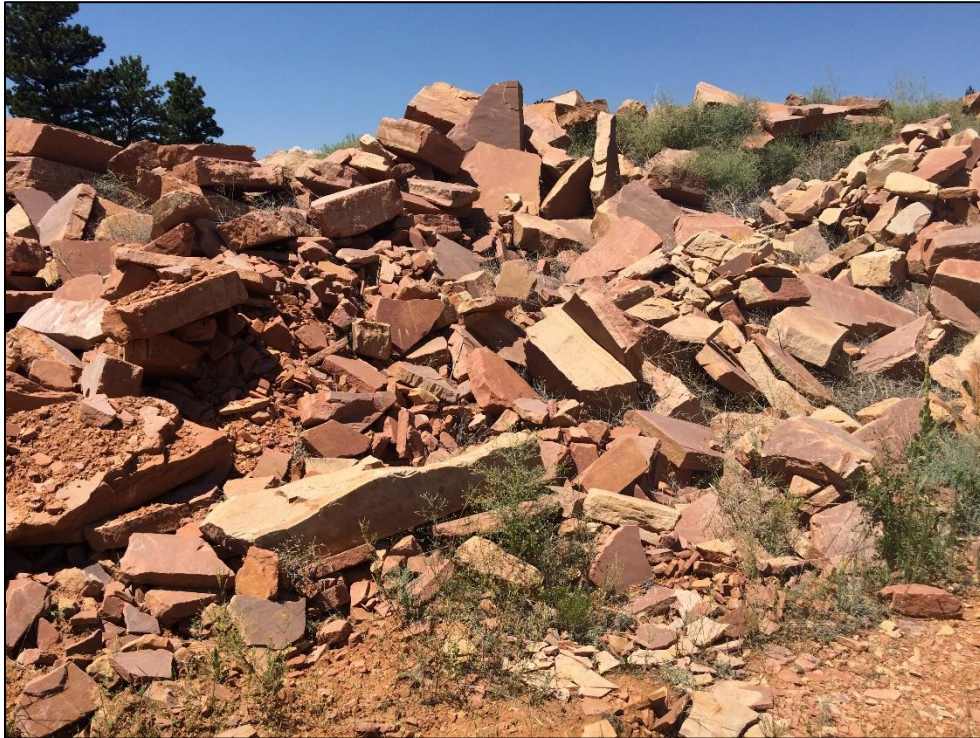
Photo 5. View of rock pile stored in south pit area. This material can be used to backfill the pit for reclamation.

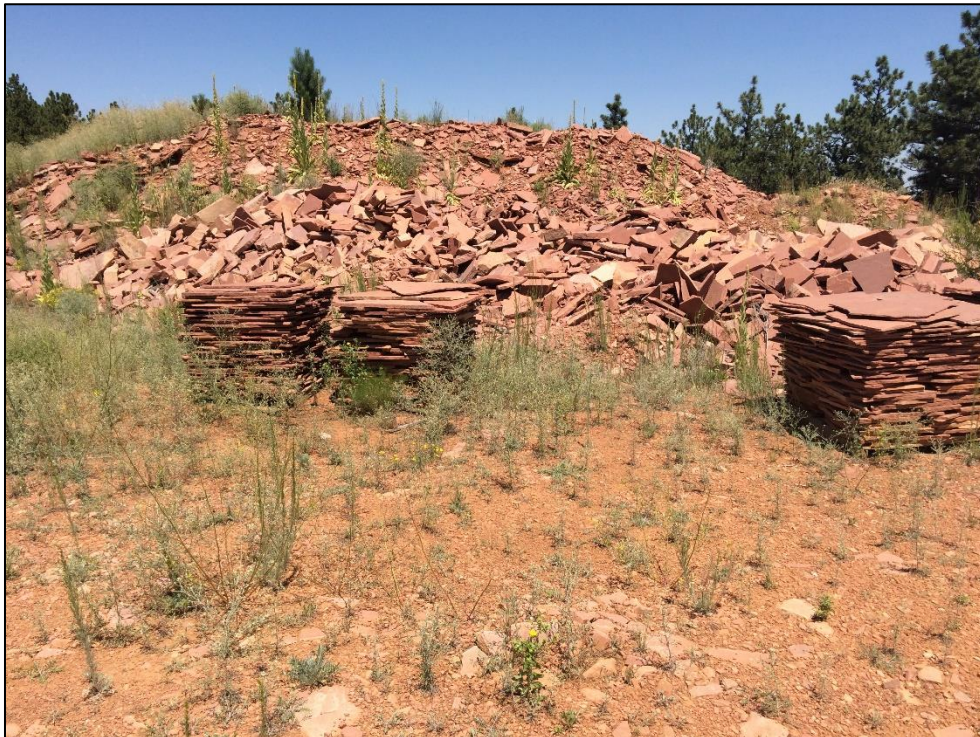
Photo 6. View looking east showing overburden/topsoil stockpile (behind stacked stone) stored at eastern edge of site. This material should be spread across disturbed areas for reclamation.
