MINERALS PROGRAM INSPECTION REPORT

MINE NAME: Cresson Project	MINE/PROSPECTING ID#: M-1980-244	MINERAL: Gold	COUNTY: Teller
INSPECTION TYPE: Monitoring	INSPECTOR(S): Timothy A. Cazier	INSP. DATE: May 23, 2018	INSP. TIME: 10:00
OPERATOR: Cripple Creek & Victor Gold Mining Company	OPERATOR REPRESENTATIVE: Justin Bills	TYPE OF OPERATION: 112d-3 - Designated Mining Operation	
REASON FOR INSPECTION: Normal I&E Program	BOND CALCULATION TYPE: None	BOND AMOUNT: \$208,491,188.00	
DATE OF COMPLAINT: NA	POST INSP. CONTACTS: None	JOINT INSP. AGENCY: None	
WEATHER: Clear	INSPECTOR'S SIGNATURE:

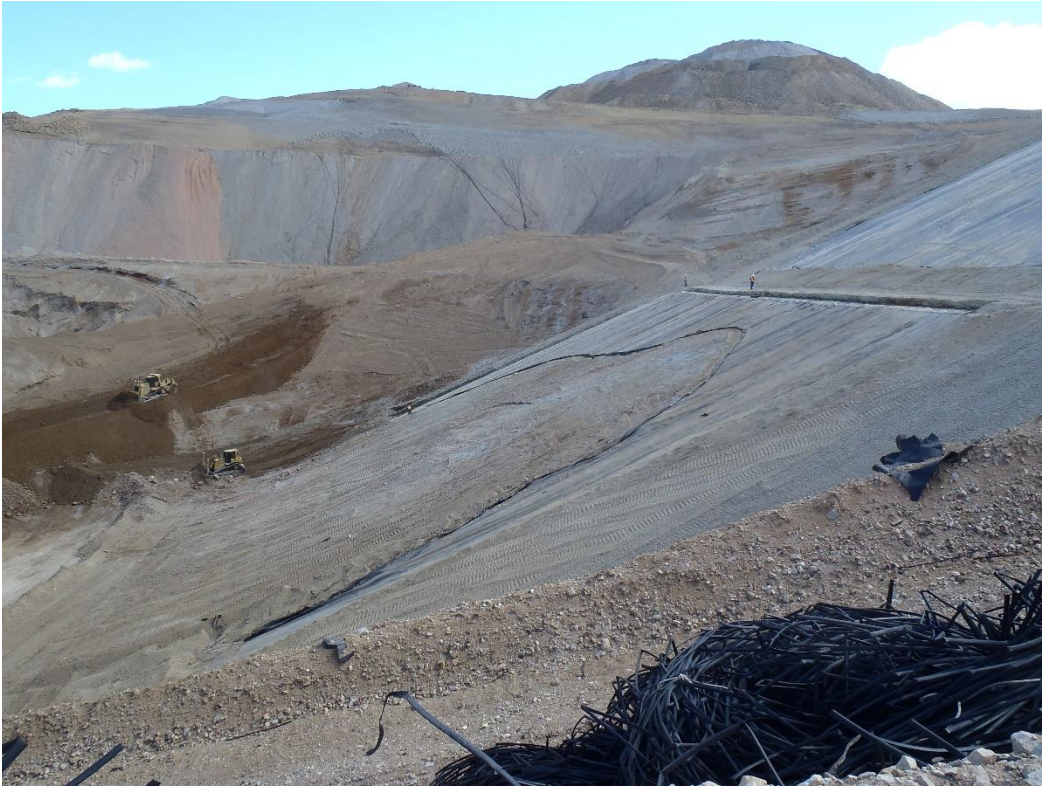
Squaw Gulch Valley Leach Facility (VLF 2) Slide Area: Mr. Laurin Colby and a representative from Ames Construction accompanied the Division and CC&V Environmental Department representatives to the VLF 2 slide area between the 9850 and 9650 benches. Ames construction had cleared the DCF off the extent of the damaged geomembrane plus two geomembrane panel widths on either side of the torn liner (**Photo 1**) below the 9750 bench (**Photo 2**). The geomembrane had been cut to remove the damaged liner and the edges of the remaining geomembrane had been purposely turned up (**Photo 3**) to prevent runoff from above the tear potentially eroding the soil liner fill ("clay" liner) downgradient. The Division was satisfied with the approach taken to determine the extent the damaged liner and discussed the path forward for repair and the required recertification.

Photo 1. Extent of VLF 2 liner damage.

- a) VLF 2 Liner Repair – Ms. Burt committed CC&V to providing weekly update on the liner repair progress.
- b) Division / CC&V meetings – CC&V would like regular meetings with Division staff to discuss ongoing changes and activities at the mine in order to determine what actions might be required from a Division permitting perspective. We agreed on bi-annual meetings with the first to occur in late August 2018 (such a meeting occurred on 8/23/18).

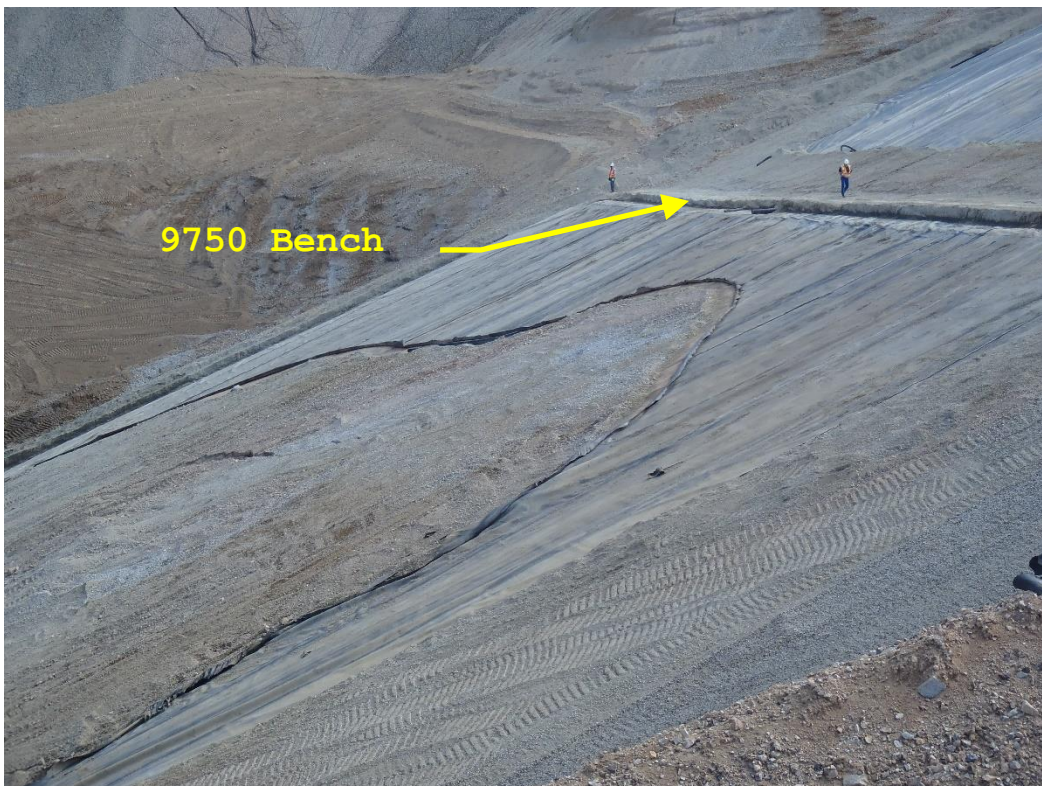
Photo 2. Extent of VLF 2 liner damage, zoomed in.

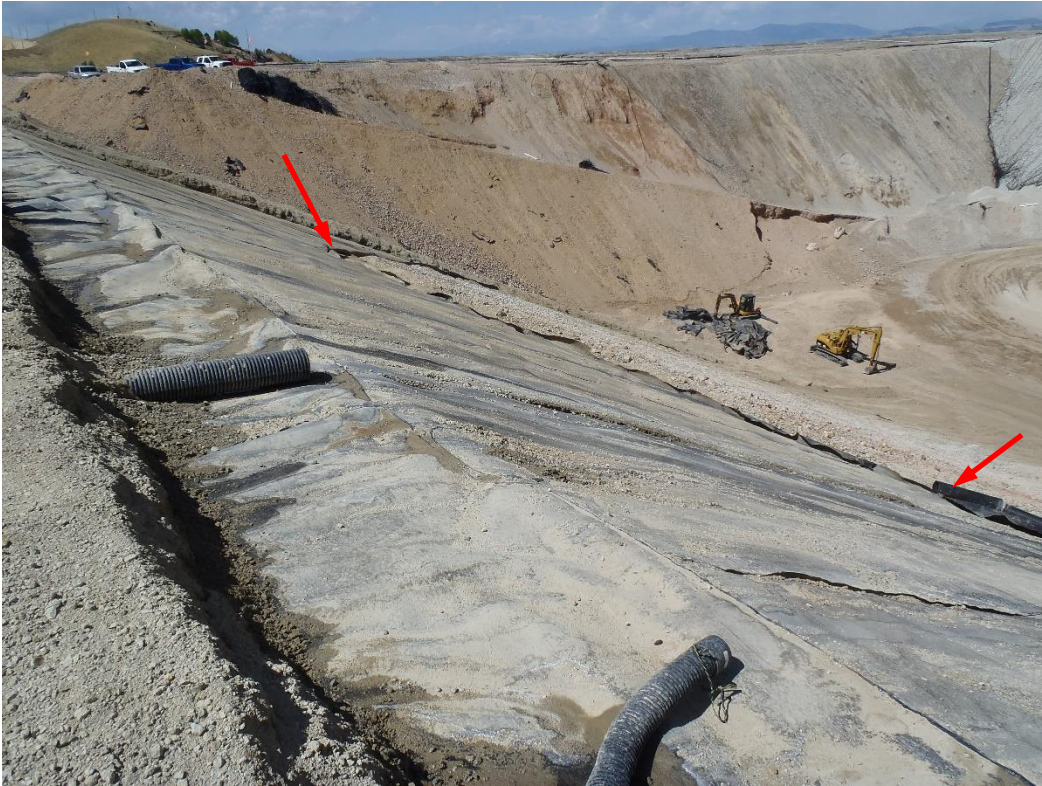
Photo 3. Turned up geomembrane.

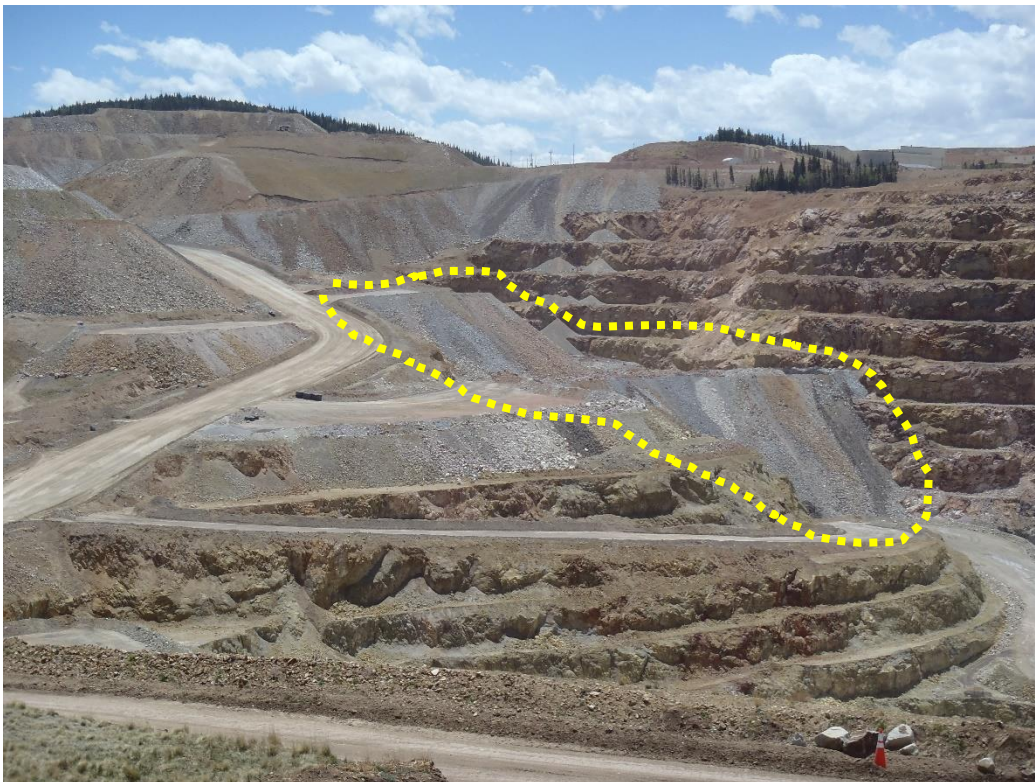
WHEX Pit: The Division was accompanied by Mr. Brian Crawford to observe the progress in backfilling the WHEX Pit. The overlook on CR 82 was used for observation. WHEX Pit backfill had begun from the south end (**Photo 4**).

Photo 4. WHEX Pit backfill.

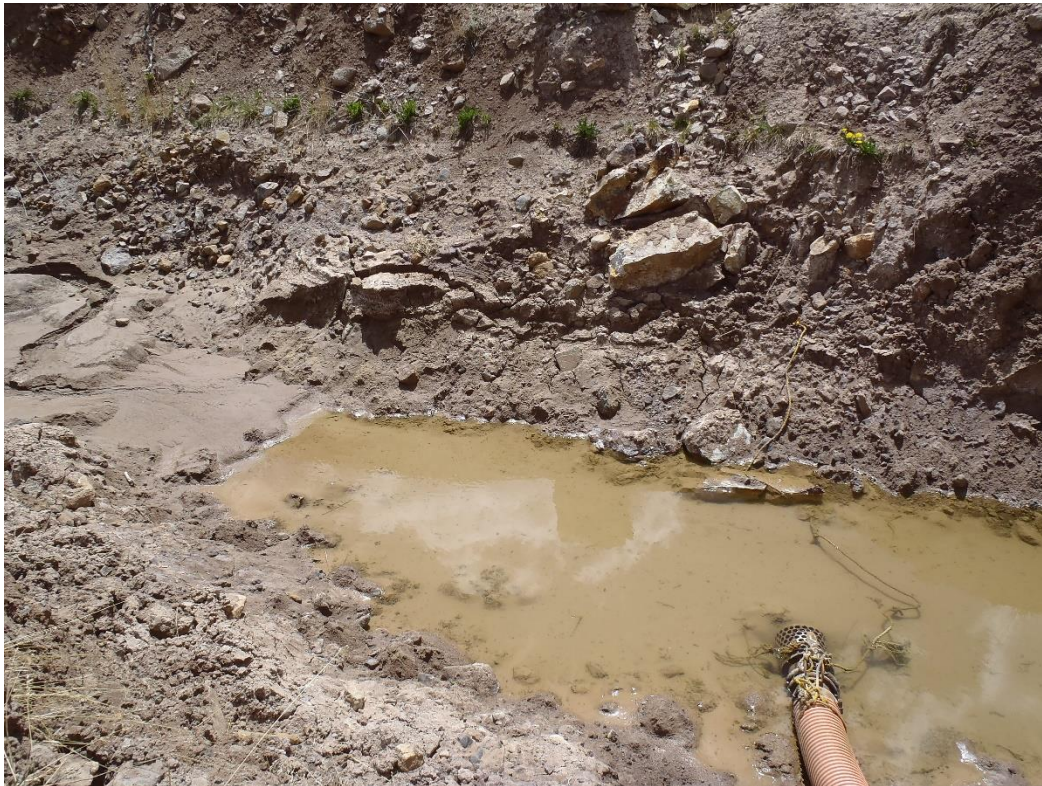
hand held GPS unit (Trimble Juno 3B). The resulting data is shown on the enclosed post inspection map. Mr. Parrat guided the group to the ECOSA seep to help gage the perspective and gradient between the seep and the proposed monitoring well location. The seep pond had some water (**Photo 5**), but there was no inflow observed. The Division concurred the proposed monitoring well location should be adequate for the purpose of investigating potential impact from the ECOSA seep.

Photo 5. ECOSA seep pond (note lack of inflow).

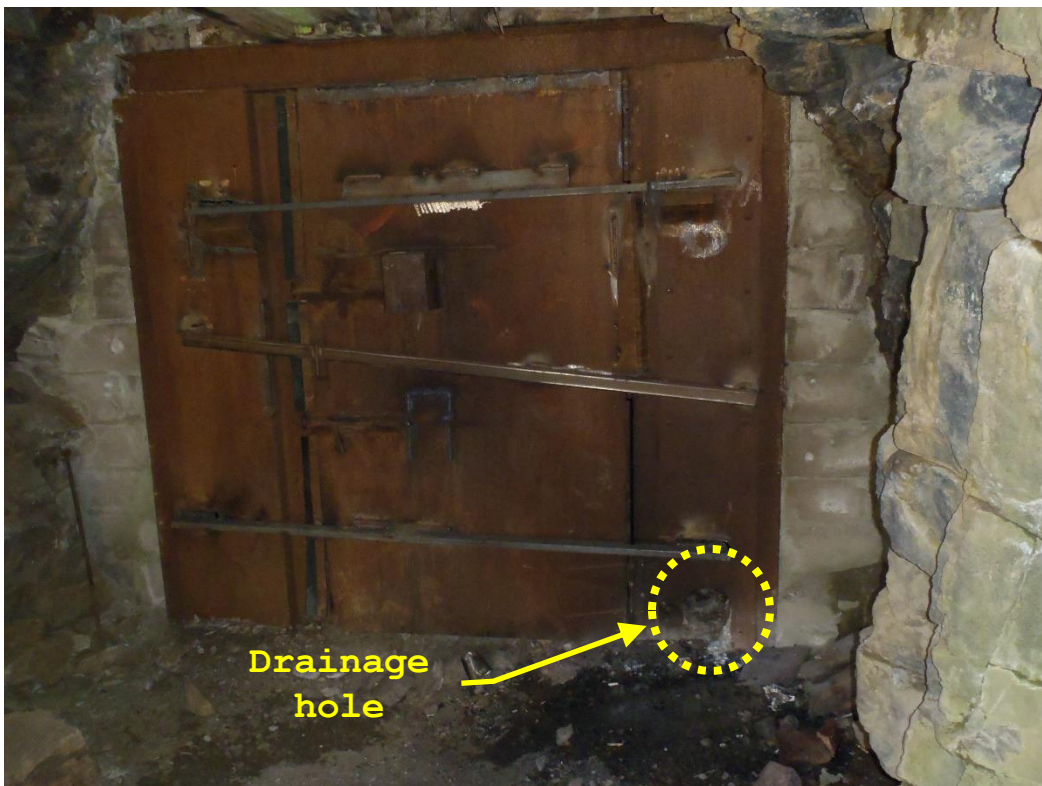
Moffat Tunnel: The Division has received complaints regarding potential impacts to seepage in the Moffat Tunnel partially based on the VLF 2 liner damage (which the Division has no evidence of active leaching in the vicinity of, or upgradient of the compromised liner). The Division is also aware of the legal issue regarding right of entry to the tunnel between some of the complainants and CC&V. The legal status at the time of the inspection prevented entry to the area. The Division went to the tunnel opening unaccompanied by CC&V personnel to observe the status of the adit door/closure. The door appeared secure at the time of the inspection (**Photo 6**). However, there was evidence of the door having been cut with a torch and re-welded likely several times. A six to eight inch diameter hole was observed cut into the lower right corner of the door, presumably to allow water from the tunnel to drain out. No evidence of active discharge from the tunnel was observed.

Photo 6. Moffat tunnel closure door (note lack of discharge).

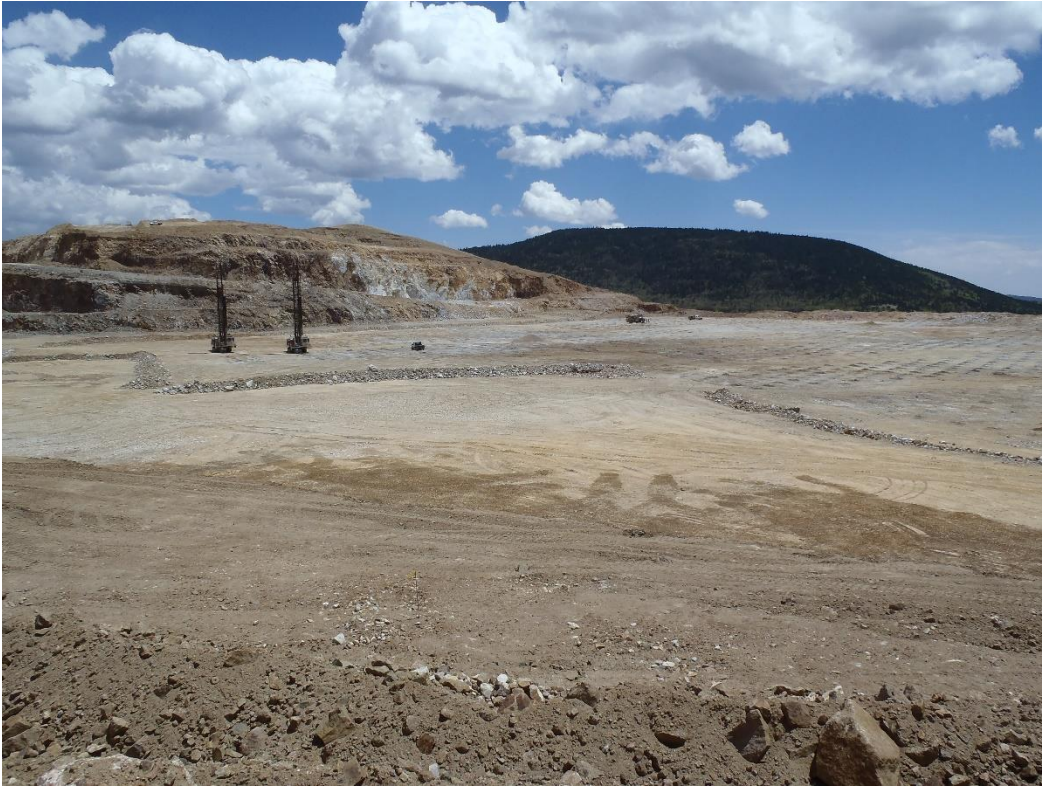
South Cresson Pit area: Mr. Brian Crawford accompanied the Division, Mr. Bills and Ms. Katie Dehlin (CC&V Environmental Department) to developing the South Cresson pit (**Photo 7**). Mr. Crawford stated the typical shot is 20 feet deep with 175 to 200 holes.

Photo 7. Developing South Cresson Pit (looking SE, note blast hole patten on right).
