**MINERALS PROGRAM INSPECTION REPORT**  
**PHONE: (303) 866-3567**

<b>MINE NAME:</b> C-JD-5	<b>MINE/PROSPECTING ID#:</b> M-1977-248	<b>MINERAL:</b> Uranium and vanadium	<b>COUNTY:</b> Montrose
<b>INSPECTION TYPE:</b> Monitoring	<b>INSPECTOR(S):</b> Dustin M. Czapla	<b>INSP. DATE:</b> August 29, 2018	<b>INSP. TIME:</b> 15:30
<b>OPERATOR:</b> Gold Eagle Mining, Inc.	<b>OPERATOR REPRESENTATIVE:</b> None	<b>TYPE OF OPERATION:</b> 112d-1 - Designated Mining Operation	
<b>REASON FOR INSPECTION:</b> Normal I&E Program	<b>BOND CALCULATION TYPE:</b> None	<b>BOND AMOUNT:</b> \$100.00	
<b>DATE OF COMPLAINT:</b> NA	<b>POST INSP. CONTACTS:</b> None	<b>JOINT INSP. AGENCY:</b> No	
<b>WEATHER:</b> Clear	<b>INSPECTOR'S SIGNATURE:</b>

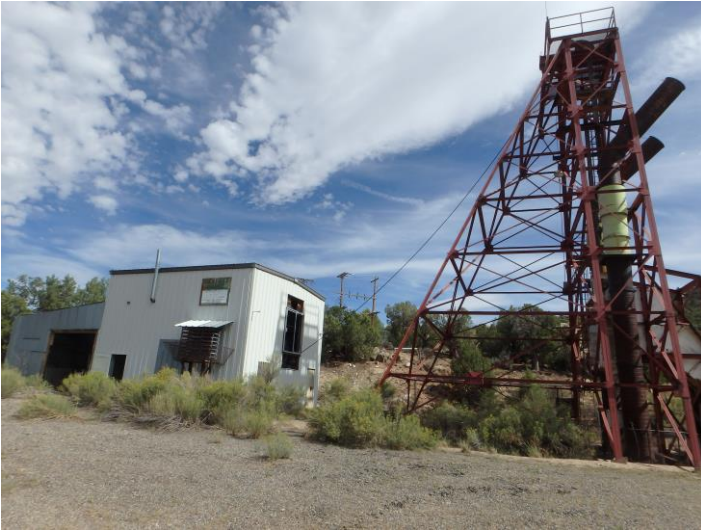
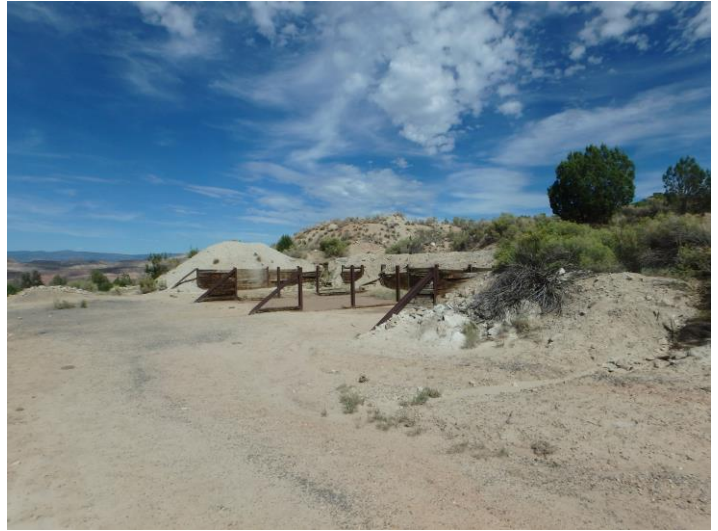
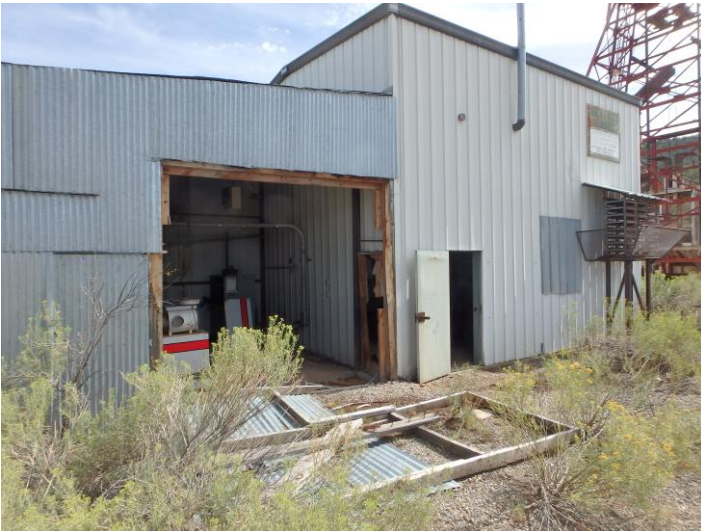
Adequate mine identification signage was posted on the hoist house, visible from the entrance to the mine site.

The mine building and hoist assembly have been damaged by vandalism.
