MINERALS PROGRAM INSPECTION REPORT
PHONE: (303) 866-3567

MINE NAME: CM-25 Mine	MINE/PROSPECTING ID#: M-1977-307	MINERAL: Uranium and vanadium	COUNTY: Montrose
INSPECTION TYPE: Monitoring	INSPECTOR(S): Dustin M. Czaplá	INSP. DATE: August 29, 2018	INSP. TIME: 12:00
OPERATOR: Cotter Corporation	OPERATOR REPRESENTATIVE: Gus Gaviotis, Scott Pottorfs	TYPE OF OPERATION: 110d - Designated Limited Impact	
REASON FOR INSPECTION: Normal I&E Program	BOND CALCULATION TYPE: None	BOND AMOUNT: \$100.00	
DATE OF COMPLAINT: NA	POST INSP. CONTACTS: None	JOINT INSP. AGENCY: D.O.E.	
WEATHER: Clear	INSPECTOR'S SIGNATURE:

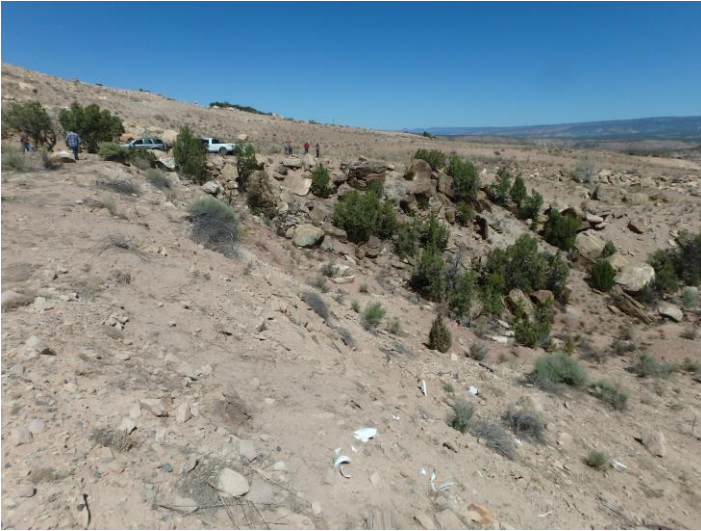
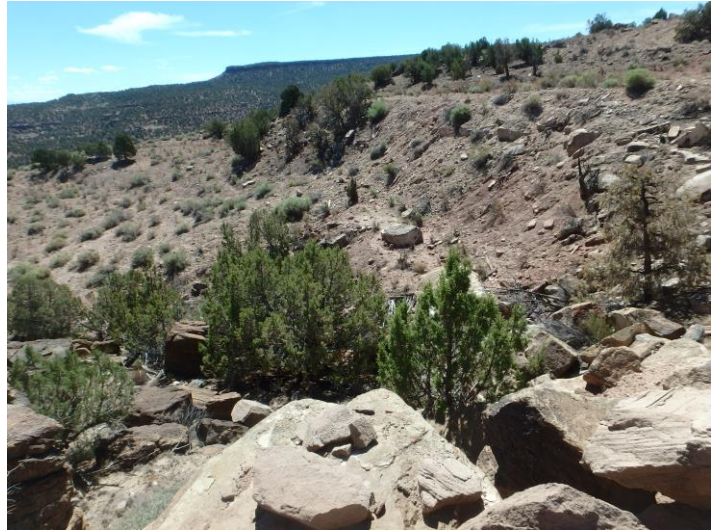
PHOTOGRAPHS

Adequate mine identification signage was noted at the entrance to the site.

According to the operator's annual reports, final reclamation was completed at this site in February, 2003. All reclaimed slopes appeared stable and vegetation is well established over the reclaimed areas.
