MINERALS PROGRAM INSPECTION REPORT
PHONE: (303) 866-3567

MINE NAME: JD-6 Mine	MINE/PROSPECTING ID#: M-1977-310	MINERAL: Uranium and vanadium	COUNTY: Montrose
INSPECTION TYPE: Monitoring	INSPECTOR(S): Dustin M. Czapla	INSP. DATE: August 29, 2018	INSP. TIME: 15:30
OPERATOR: Cotter Corporation	OPERATOR REPRESENTATIVE: Gus Gaviotis, Scott Pottorfs	TYPE OF OPERATION: 110d - Designated Limited Impact	
REASON FOR INSPECTION: Normal I&E Program	BOND CALCULATION TYPE: None	BOND AMOUNT: \$100.00	
DATE OF COMPLAINT: NA	POST INSP. CONTACTS: None	JOINT INSP. AGENCY: D.O.E.	
WEATHER: Clear	INSPECTOR'S SIGNATURE:

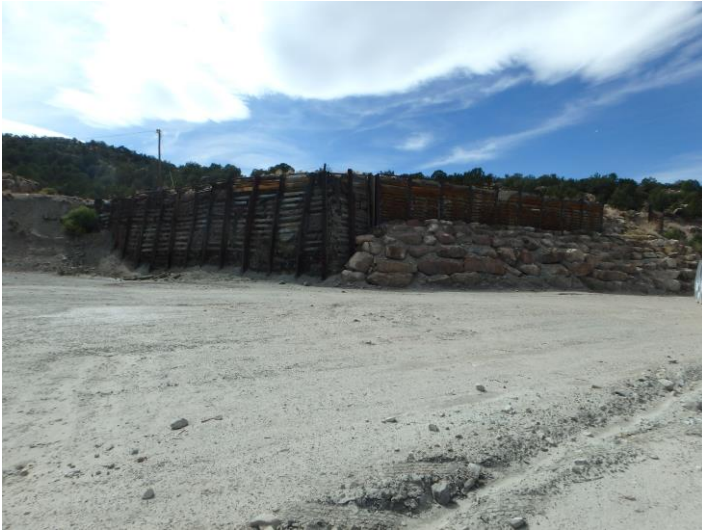
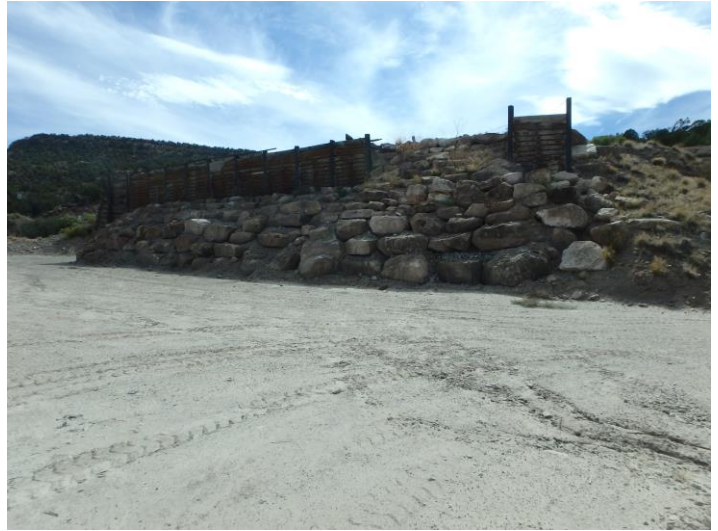
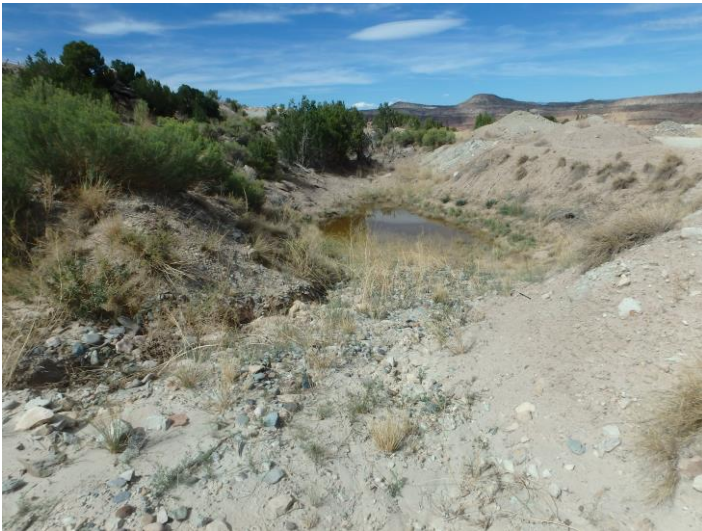
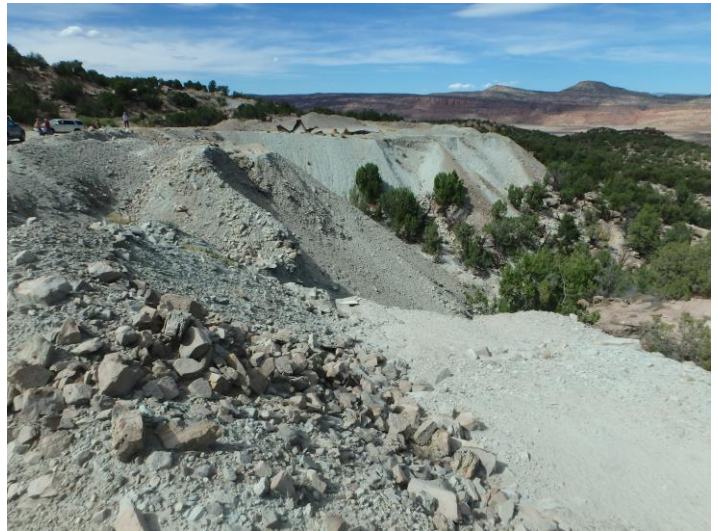
There has been no recent activity at this site. The repaired retaining wall continues to appear stable. Stormwater control structures appear to be maintained and functional.
