MINERALS PROGRAM INSPECTION REPORT PHONE: (303) 866-3567

MINE NAME:	MINE/PROSPECTING ID#:	MINERAL:	COUNTY:	
C-JD-8	M-1984-014	Uranium and vanadium	Montrose	
INSPECTION TYPE:	INSPECTOR(S):	INSP. DATE:	INSP. TIME:	
Monitoring	Dustin M. Czapla	August 29, 2018	16:00	
OPERATOR:	OPERATOR REPRESENTATIVE:	TYPE OF OPERATION:		
Cotter Corporation	Gus Gaviotis, Scott Pottorfs	112d-1 - Designated Mining Operation		
REASON FOR INSPECTION:	BOND CALCULATION TYPE:	BOND AMOUNT:		
Normal I&E Program	None	\$69,950.00		
DATE OF COMPLAINT:	POST INSP. CONTACTS:	JOINT INSP. AGENCY		
NA	None	D.O.E.		
WEATHER:	INSPECTOR'S SIGNATURE:	SIGNATURE DATE:		
Clear	De	September 5, 2018

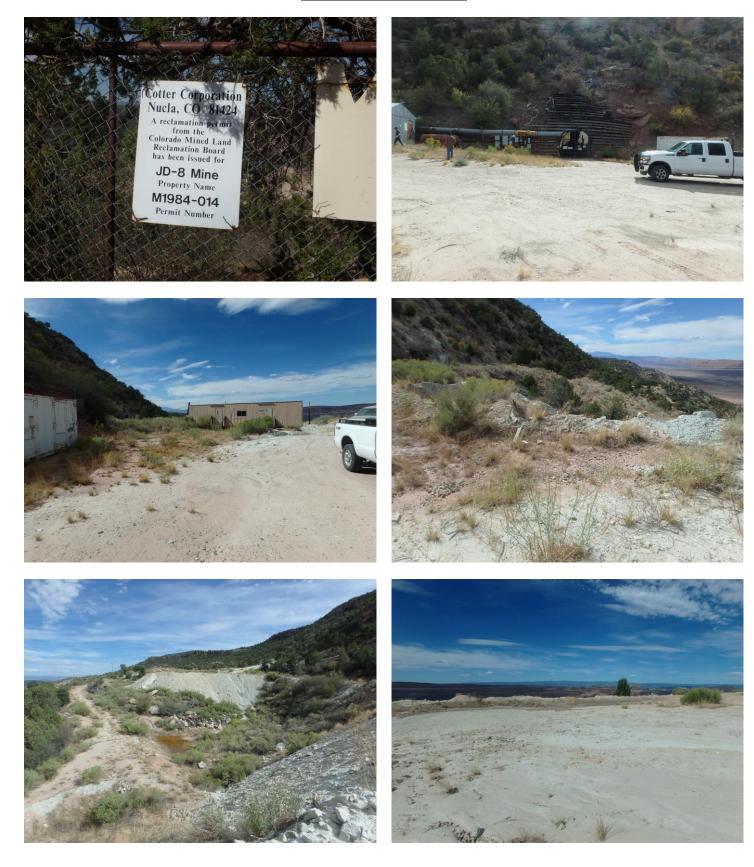
An office building, compressor shed and ventilation system are located on the main mine bench. Unused mining equipment and empty fuel tank have been removed from the site. Stormwater was observed in the retention ponds. Stormwater control structures appeared maintained and functional.
