MINERALS PROGRAM INSPECTION REPORT
PHONE: (303) 866-3567

MINE NAME: May Day Idaho Mine Complex	MINE/PROSPECTING ID#: M-1981-185	MINERAL: Gold and silver	COUNTY: La Plata
INSPECTION TYPE: Monitoring	INSPECTOR(S): Lucas J. West	INSP. DATE: August 7, 2018	INSP. TIME: 08:34
OPERATOR: Sunrise Mining LLC	OPERATOR REPRESENTATIVE: Sara Glinatsis, Jack & Barb Nielson	TYPE OF OPERATION: 112d-2 - Designated Mining Operation	
REASON FOR INSPECTION: Normal I&E Program	BOND CALCULATION TYPE: None	BOND AMOUNT: \$204,562.00	
DATE OF COMPLAINT: NA	POST INSP. CONTACTS: None	JOINT INSP. AGENCY: None	
WEATHER: Clear	INSPECTOR'S SIGNATURE:

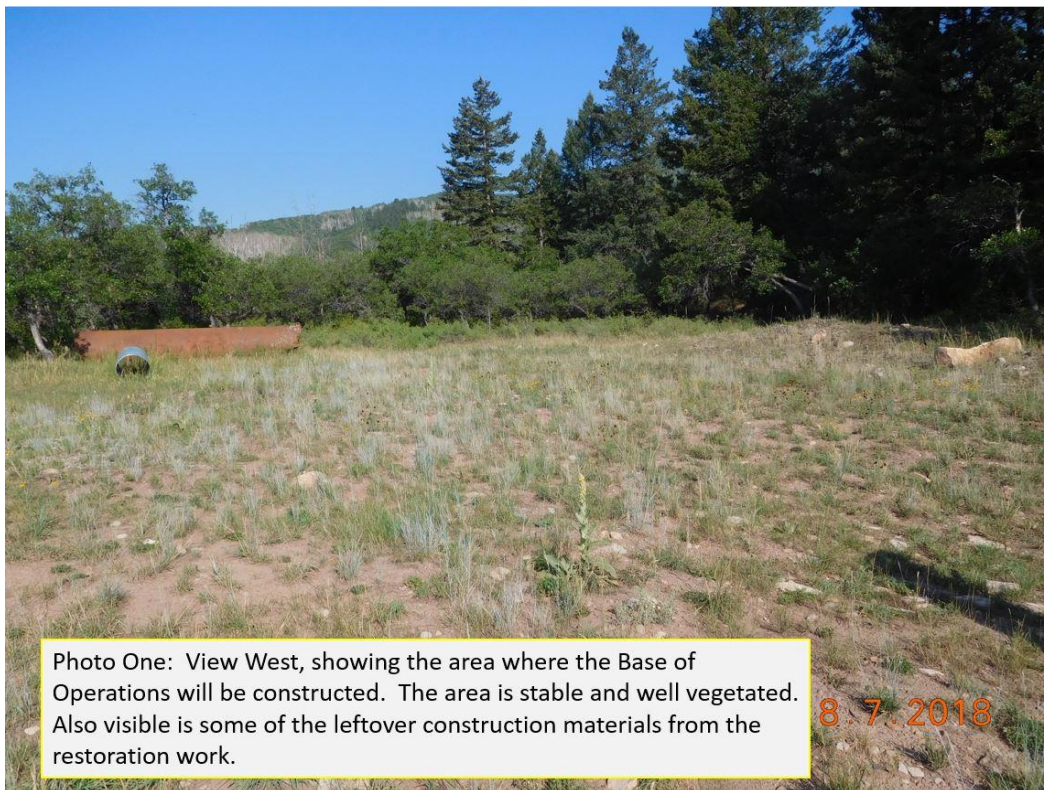
Base of Operations: The Base of Operations area will be the location of the mine offices as well as the lined ore storage pad used to stage ore prior to transport. Construction of these facilities has not begun yet and the area is in the same condition as it was during the previous inspection. Several pieces of leftover materials from construction activities including pieces of culvert and large boulders are located in the area. The area can be seen in Photo One.

Photo One: View West, showing the area where the Base of Operations will be constructed. The area is stable and well vegetated. Also visible is some of the leftover construction materials from the restoration work.

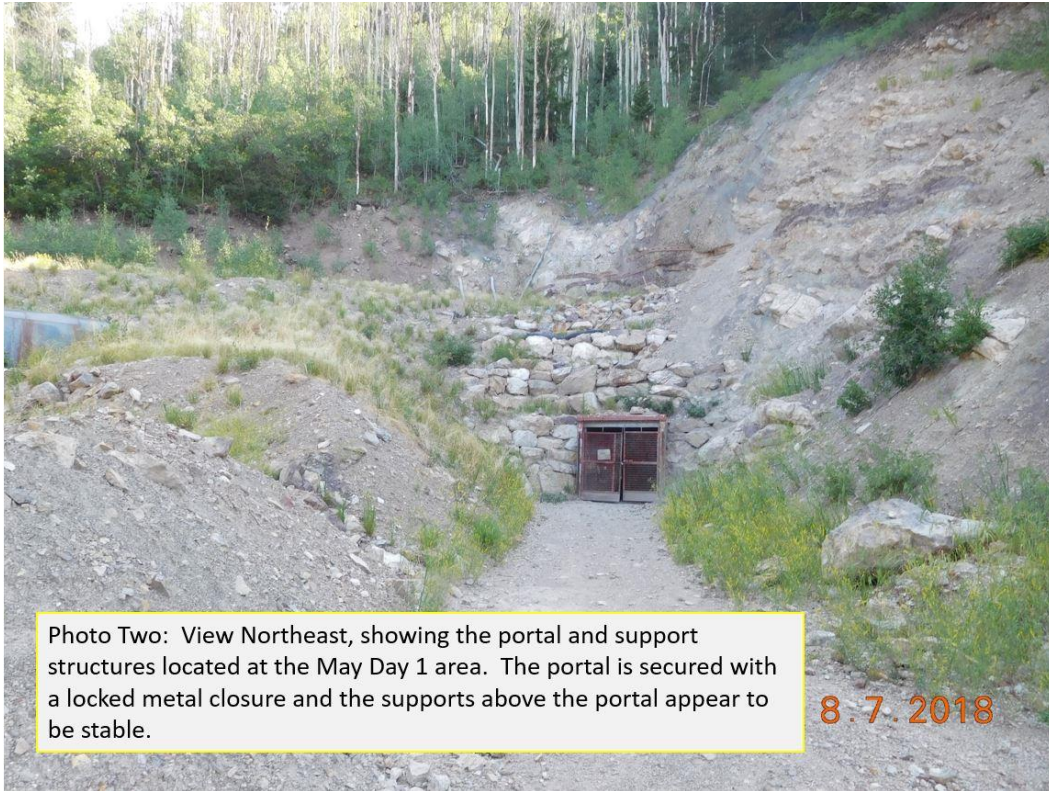
May Day 1 Area: The May Day area is in similar condition from the previous inspections and no significant changes have been made. The portal remains closed with a locked gate, and the surrounding slopes buttressed with the placement of large boulders. The area above the portal has been stabilized with wire mesh and rock bolts. The old mill building was not inspected at this time. Various equipment including an underground loader, several shipping containers and various other mining related debris are still on site. The surface conditions of the area are largely unchanged from the October 2016 Inspection. Photos Two, and Three show the conditions of the May Day 1 Area.

Photo Two: View Northeast, showing the portal and support structures located at the May Day 1 area. The portal is secured with a locked metal closure and the supports above the portal appear to be stable.

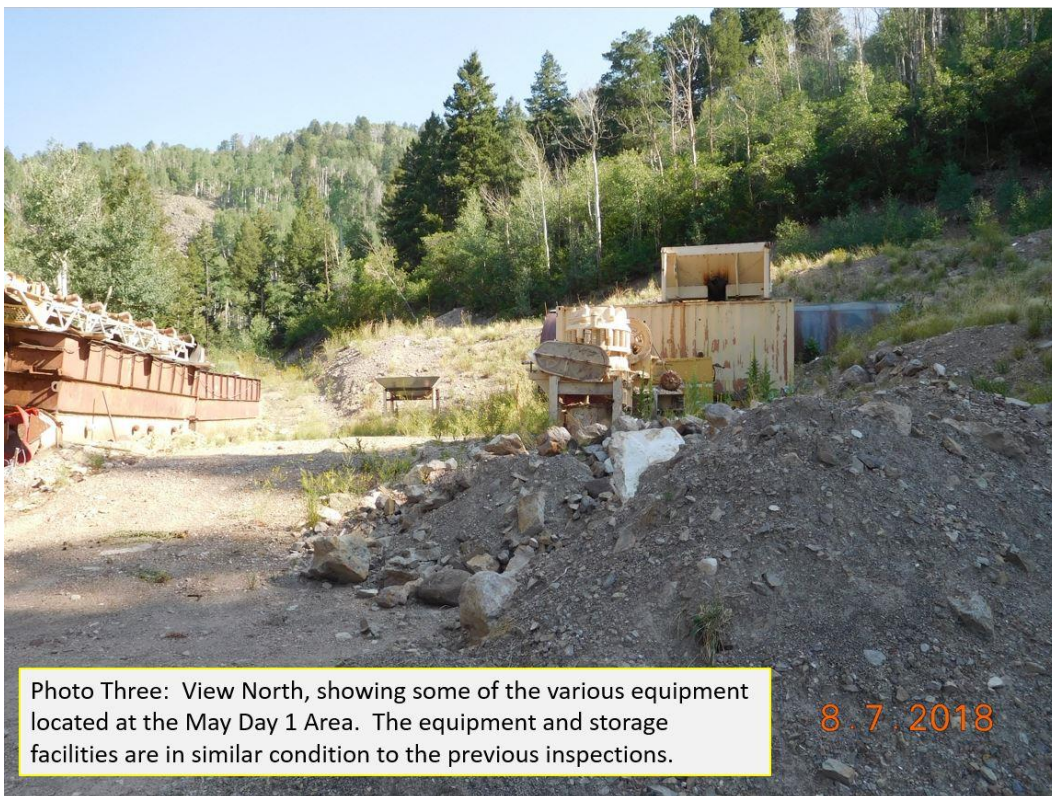
Photo Three: View North, showing some of the various equipment located at the May Day 1 Area. The equipment and storage facilities are in similar condition to the previous inspections.

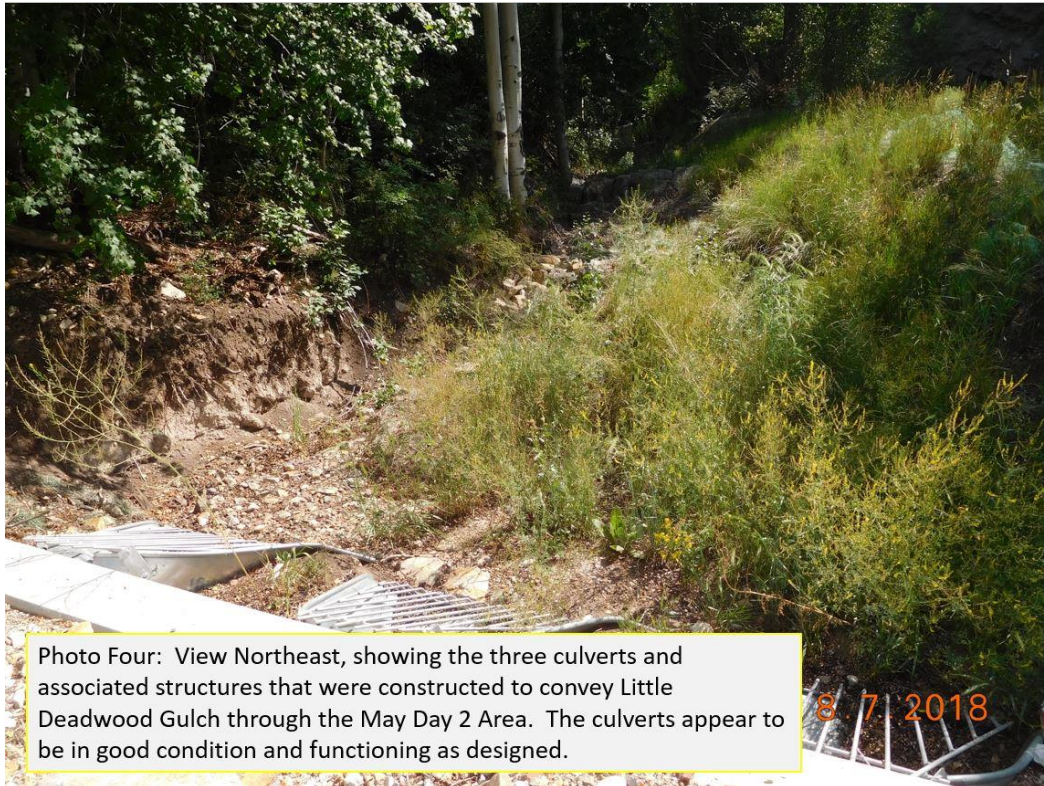
May Day 2 Area: The three culverts, and associated structures that were constructed as part of the restoration of Little Deadwood Gulch appear to be functioning as designed and are in good condition as seen in Photo Four. The outfall of the culverts has been armored to prevent down cutting of the channel immediately downstream of the culverts. Within the channel immediately upstream of the culverts, two water bars have been installed to help dissipate the energy as the stream flow approaches the crossing. The minor erosion of the channel that was noted during the previous inspection has been monitored and addressed. No further erosion in this area was noted. The portal at the May Day 2 Area remains closed. A small waste rock pile was located adjacent to the closure, and was present during the previous inspection. The pile appears to be stable and in good condition.

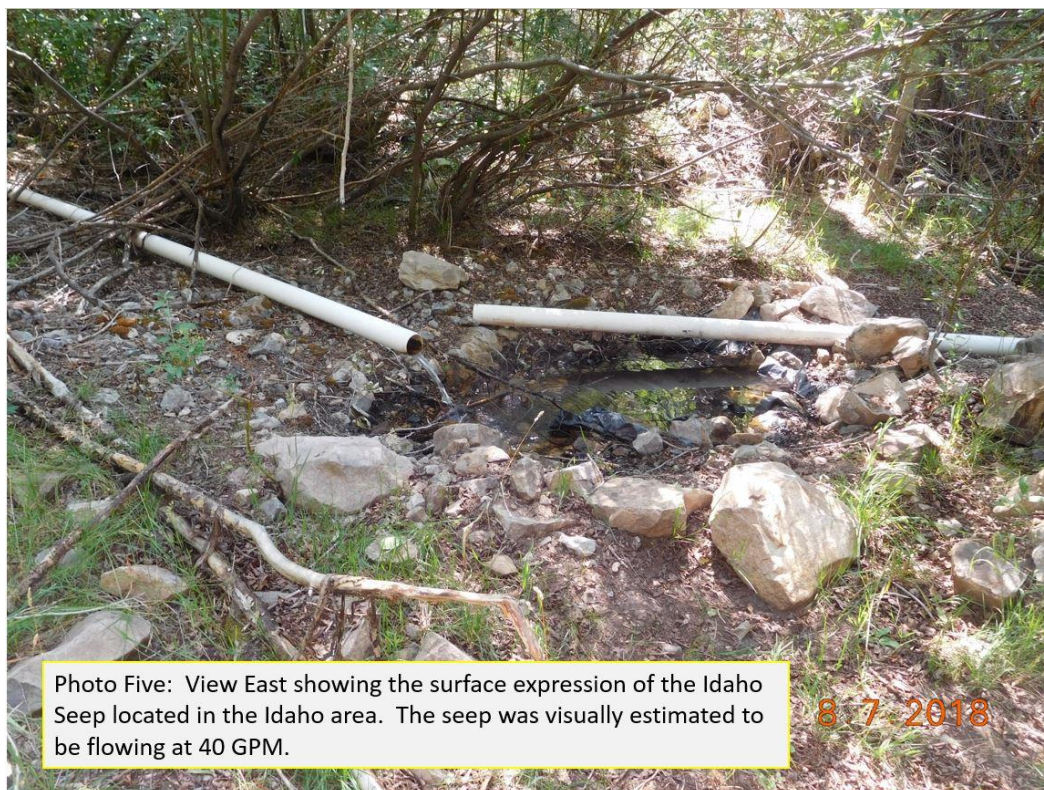
Idaho Area: The Idaho affected area consists of a main pad area, a small office building, shop structure and storage area. The extent of the proposed activity is minimal at the area, however they may be expanded in the future. The structures located at the Idaho area appear to be stable and in good condition. The Idaho spring was observed, as seen in Photo Five, was flowing at approximately 40 Gallons Per Minute.

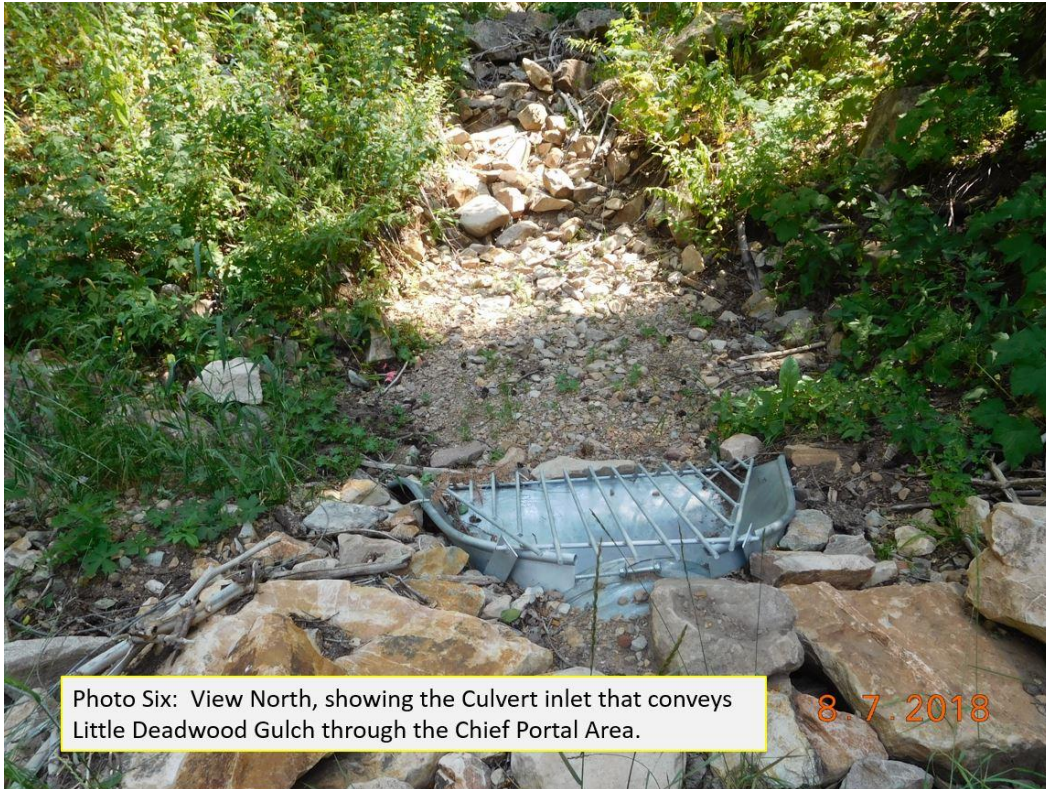
Chief Portal Area: The restoration activities at the Chief Portal Area were completed and inspected in the fall of 2016 and remains in good condition. The Chief Portal is designed to function as a secondary escape way and underground access point. As seen in Photo Six, the culvert in Little Deadwood Gulch has been installed with a grated closure on the inlet to prevent plugging and it appears to be functioning as designed. All backfilled areas appear to be stable and in good condition, no evidence of settling, slumping or subsidence

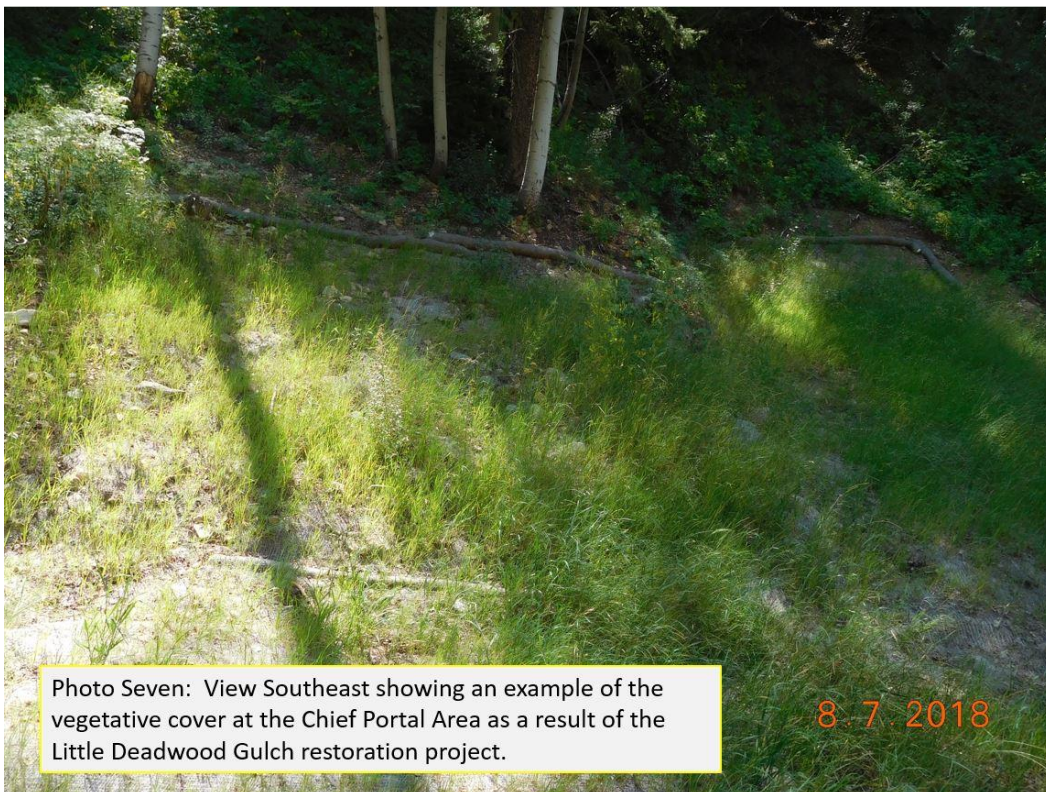
was observed. Areas where the vegetation matting was installed are well vegetated and stable. Photo Seven shows an examples of the vegetative cover in the area. The secondary escape / emergency access has been further buttressed with the restoration of Little Deadwood Gulch. Photo Eight shows the buttressing and secondary escape way. A secondary drain has been installed to allow any water generated from the portal to be conveyed into Little Deadwood Gulch.
