Bureau of Land Management Colorado River Valley Field Office Minerals Inspection Report

General Information	
Date	8/28/2018
Project Name	Mid-Continent Limestone Quarry
Operator	RMR Aggregates, Inc.
Serial Number	COC-074205
Project Classification	Plan of Operations
Project Location	T5S R89W Sec36, Garfield County
Inspection Purpose	Regular site inspection (per 43 CFR 3809.600 (a))
Time Period Onsite	3 hours
Attendees	Jessica Lopez Pearce, BLM Geologist
	Bobby Wagner, RMR Aggregates, Inc. Vice President
	Justin Olin, RMR Aggregates, Inc. Mine Superintendent
	Wally Erickson, CO-DRMS Senior Environmental Protection Specialist
	Amy Yeldell, CO-DRMS Environmental Protection Specialist

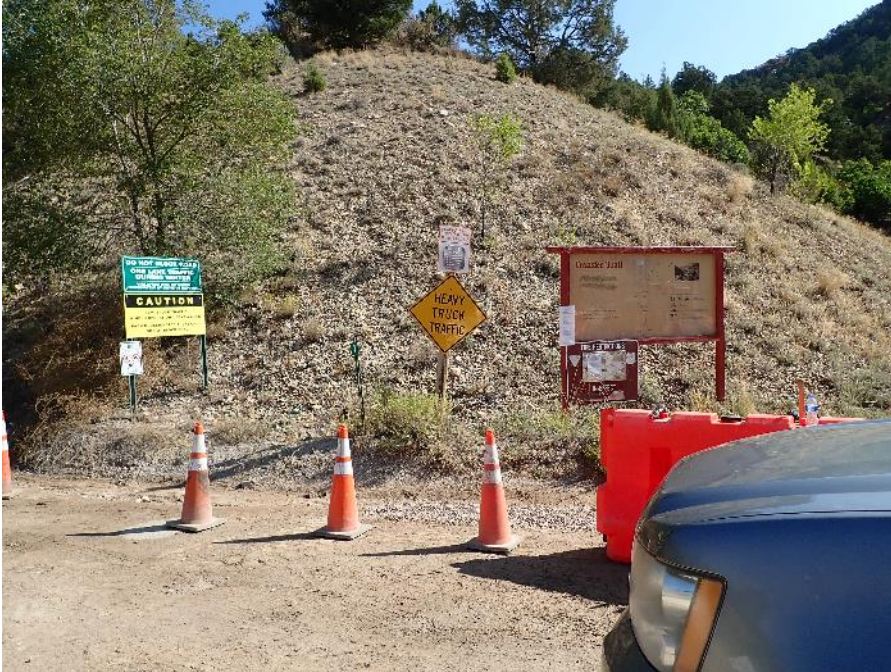
My inspection began on the access road to the quarry, Transfer Trail. At the intersection of Traver Trail and Transfer Trail, I observed a construction zone unrelated to the Mid-Continent Quarry and a yellow and black sign that stated: "Caution. Semi Truck Traffic. Mine in Operation 7 Days A Week. Park in Designated Areas Only. Do Not Block Road." As I drove up Transfer Trail to the quarry, I observed six "Heavy Truck Traffic" signs at various points along the road. Per the January 14, 2011 BLM letter to previous operator CalX regarding parking and access on Transfer Trail: "CalX will install a metal sign at the intersection of Transfer Trail Road and Traver Trail Road. The sign will be approximately 2 feet by 4 feet in size and will read: Caution, Semi Truck Traffic, Mine in Operation 7 Days a Week, Park in Designated Areas Only, Do Not Block Road." The 2011 letter further states: "CalX will install "Heavy Truck Traffic" signs at multiple points along Transfer Trail Road." These requirements are satisfied.

Photo 1. A "Heavy Truck Traffic" sign and the required caution signage is present at the intersection of Traver Trail and Transfer Trail.

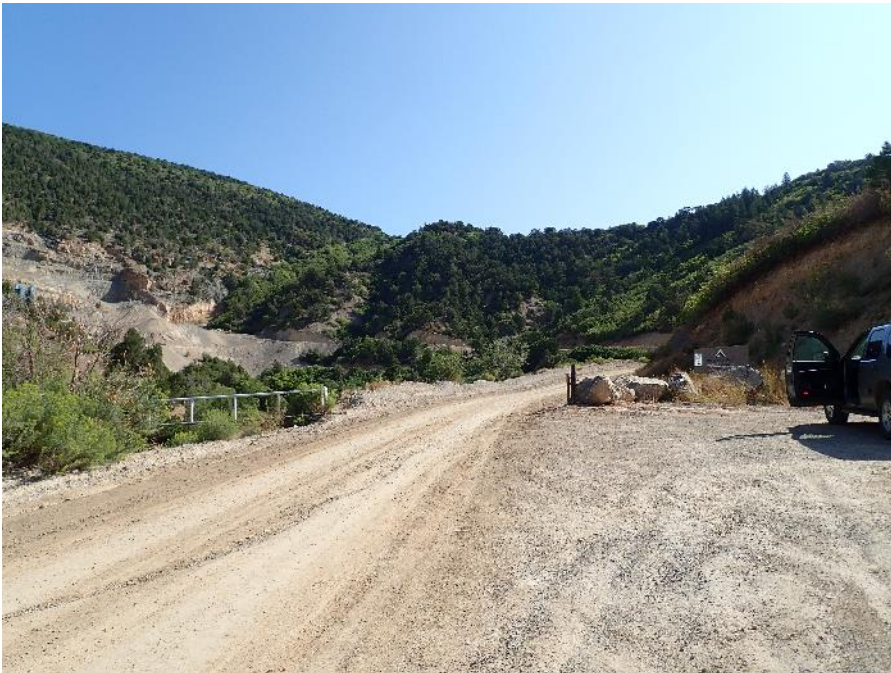
At the entrance gate to the operation, I observed a Rocky Mountain Resources sign and an open gate. Both sides of the gate were installed. There was a stormwater spillway at the gate as well. The gate, a scale shack, and a scale were approved under 43 CFR 3809 in a BLM letter dated November 20, 1986 which states: "The installation of a gate, scales, and scale shack is approved subject to item 3b(3) of the reclamation plan submitted by Mid-Continent Resources, Inc." The sign and gate were recently granted an occupancy authorization under 43 CFR 3715 in a letter dated January 9, 2017. The scale and scale shack that were previously located at the gate were not present, having been removed between my April 12, 2016 and January 30, 2017 inspections. Haul trucks are currently weighed on a digital scale located on the south side of the mill building.

Photo 2. At entrance gate, looking northeast to gate and RMR sign.

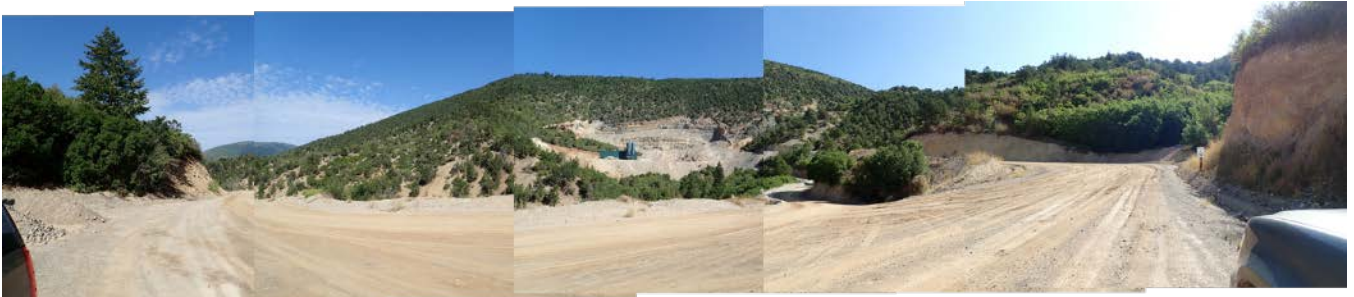
Photo 3. Looking north to Lower Road and Middle Road junction photopoint.

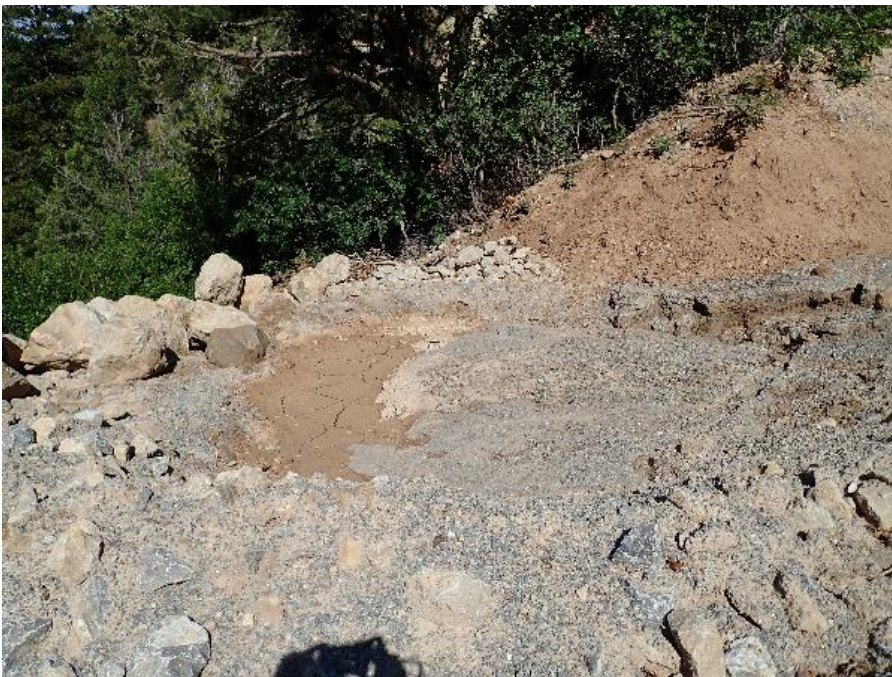
I drove into the quarry on the lower access road and took photos at the photopoint established at the junction between the middle road and the lower road. There was a stormwater detention and spillway structure halfway along the lower road.

Photo 4. Looking east to sediment and stormwater control feature along the Lower Road.

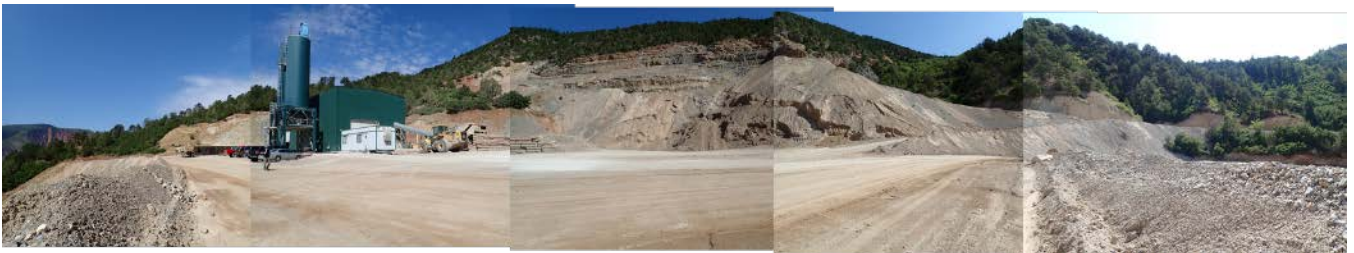
As noted in my March 12, 2016 inspection report and observed during subsequent inspections as well as this inspection, portions of the Mid-Continent Quarry operations including the currently existing mill bench are located outside of the approved 1989 Plan of Operations Modification permit boundary. Records of approvals for the permitted boundary vary between the BLM and DRMS. The Mid-Continent Quarry operations are currently considered to be within the DRMS-approved permit boundary. DRMS permit boundary markers were observed at various locations surrounding the area of surface disturbance. On June 3, 1992, DRMS approved Amendment 2, which extended the permit boundary and increased the permitted area from 15.7 acres to 34.4 acres (other DRMS records state a permitted boundary of 32.78 acres) in order to include an area affected by crusher fines washout from the lower bench of the quarry. There is no record of approval for this proposal in BLM records. On March 8, 2018, DRMS subsequently updated its records with Administrative Revision 1 (AD-1), which corrects the existing permit boundary to 38 acres. BLM records reflect an approved permit area of 15.7 acres in the text of the Plan of Operations from the 1989 Amendment 1 (although the map included in the amendment shows the acreage to be approximately 24 acres), which was approved by the BLM on July 21, 1989. When measured by aerial imagery in ArcGIS, the currently disturbed area is calculated to be approximately 23 acres.

Photo 5. Looking west, north, and east from the mill bench photopoint.

- Any proposed Plan of Operations Modification must include a permit boundary increase in order to create consistency between BLM and DRMS authorizations. Alternatively, the operator may reclaim surface disturbance to within the BLM-approved permit boundary.

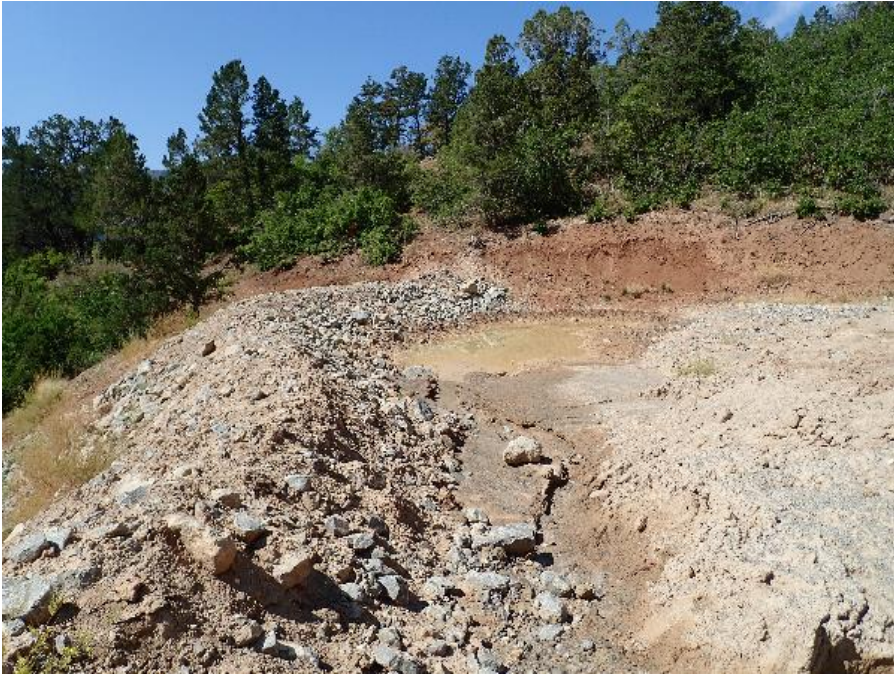
A stormwater retention pond is located on the southwestern side of the mill bench. The retention pond contained water during my visit. The most recent precipitation event was in the early morning of August 27, 2018. Stormwater management is briefly addressed in the 1982 Plan of Operations and 1989 Plan of Operations modification:

Per 43 CFR 3809.420(b)(5): “all operators shall comply with applicable Federal and state water quality standards, including the Federal Water Pollution Control Act, as amended (30 U.S.C. 1151 et seq.).” The 2015 Colorado River Valley Field Office Resource Management Plan, Appendix K – Best Management Practices (BMPs) and Conservation Measures states: “MIN-17: Before activities take place, every pad, access road, or facility site will have an approved surface drainage plan (storm water management plan) for establishing positive management of surface water drainage, to reduce erosion and sediment transport. The drainage plan will include adaptive BMPs, monitoring, maintenance and reporting. BMPs may include run-on/run-off controls such as surface pocking or revegetation, ditches or berms, basins, and other control methods to reduce erosion. Pre-construction drainage BMPs will be installed as appropriate.” The BMPs also state: “MIN-24: As detailed in the site plan for surface/storm water management, drainage from disturbed areas will be confined or directed to minimize erosion, particularly within 100 feet of all drainages. No runoff, including that from roads, will be allowed to flow into intermittent or perennial waterways without first passing through sediment-trapping mechanisms such as vegetation, anchored bales or catchments.”

Photo 6. Looking southwest to the sediment/stormwater detention feature on the mill bench.

- A comprehensive water management plan will be required in any future Plan of Operations modification (43 CFR 3809.401((b)(2)(iii))).
- The operator must perform noxious weed eradication per the 1989 Plan of Operations Modification.

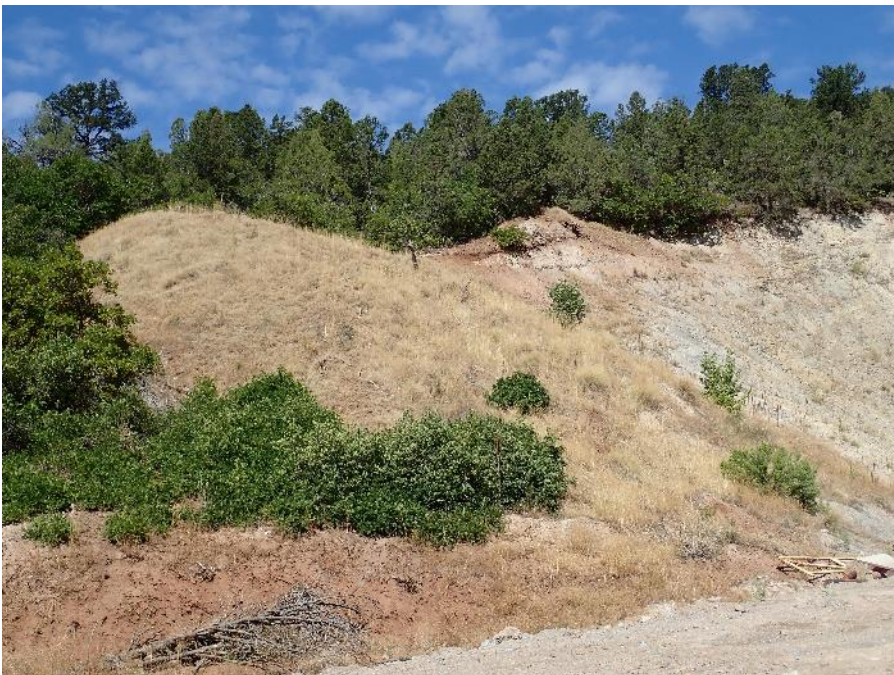
Topsoil is stored on the far western side of the mill bench. As in past inspections, the soil stockpile appeared to be at approximately 2:1 slope and the quantity inadequate for future site reclamation. According to the stipulations included in BLM’s approval of the Plan of Operations modification dated July 21, 1989: “The stored topsoil will be graded to a slope of approximately 4:1 to prevent erosion and to facilitate seeding and establishment of grasses.”

Several live mullein were observed growing on and around the topsoil stockpile. Thistle was observed growing north and south the stockpile as well. RMR had hired Native Habitat to spray the weeds in fall 2017. The weeds present require attention again. The July 21, 1989 Plan of Operations Modification authorization states: “5. The operator is responsible for eradication of noxious weeds on all disturbed areas during ongoing operations and through completion of reclamation.” The 2015 Colorado River Valley Field Office Resource Management Plan, Appendix K – Best Management Practices (BMPs) and Conservation Measures states: “WEED-17: Inspect and document all ground-disturbing activities in noxious weed infested areas for at least three growing seasons following completion of the project. For ongoing projects, continue to monitor until reasonably certain that no weeds are present. Plan for follow-up treatments based on inspection results.”

Photo 7. Looking west the topsoil stockpile on the mill bench.

- Regrade topsoil stockpile to the 4:1 slope as stated in the 1989 Plan of Operations modification (Amendment 1) or include the current topsoil conditions in a proposed Plan of Operations modification.

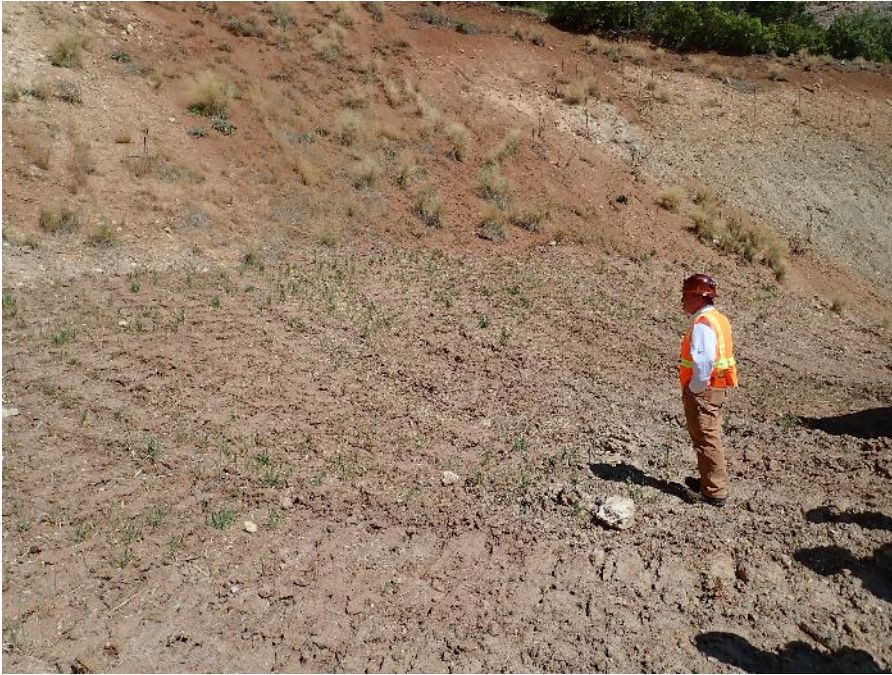
I observed a reclamation test plot on the northwest corner of the mill bench, north of the boneyard. RMR stated that the test plot was established in the late spring 2018. The plot consists of 3 inches of topsoil over crusher fines; it was seeded, hand-mulched, and tracked with a dozer. The soils within the test plot were very hard and had a crust on top. Grass establishment did not have a high level of success.

Photo 8. Looking north to the reclamation test plot on the northwest corner of the mill bench.

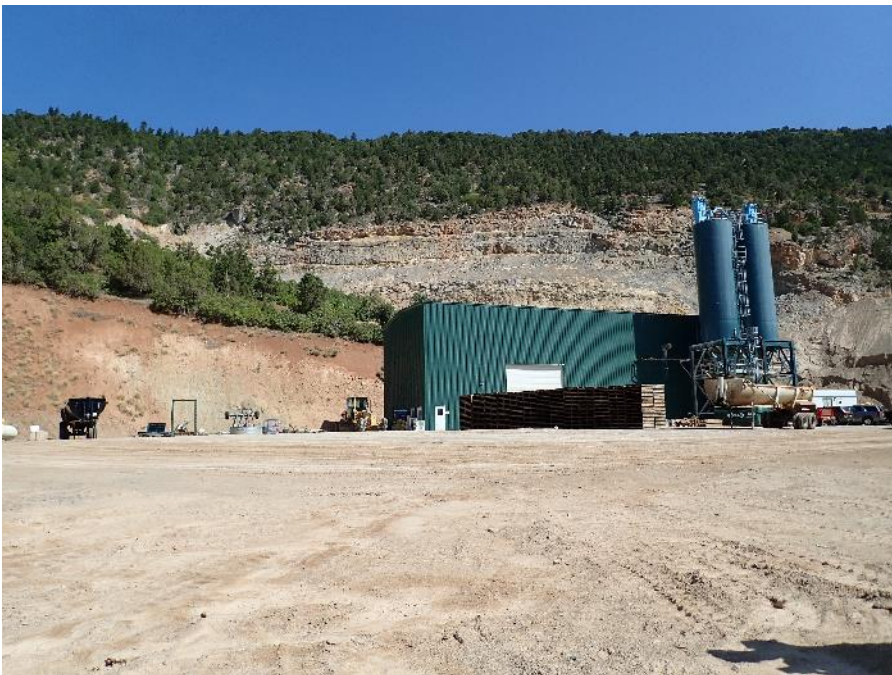
Within the mill building, containers of lubricants were stored on spill pallets. The 2015 CRVFO RMP – Appendix K BMPs state: “MIN-7: Project materials which could be a hazard to public health, safety or resource value will be stored in appropriate secondary containment. No oil or lubricants will be drained onto the ground surface.” The mill facility was approved in BLM correspondence dated June 15, 2009. Per 43 CFR 3809.420 (b) (13): “During all operations, the operator shall maintain his or her structures, equipment, and other facilities in a safe and orderly manner.”

Photo 9. Looking north at mill facility from the southwest corner of the mill bench.

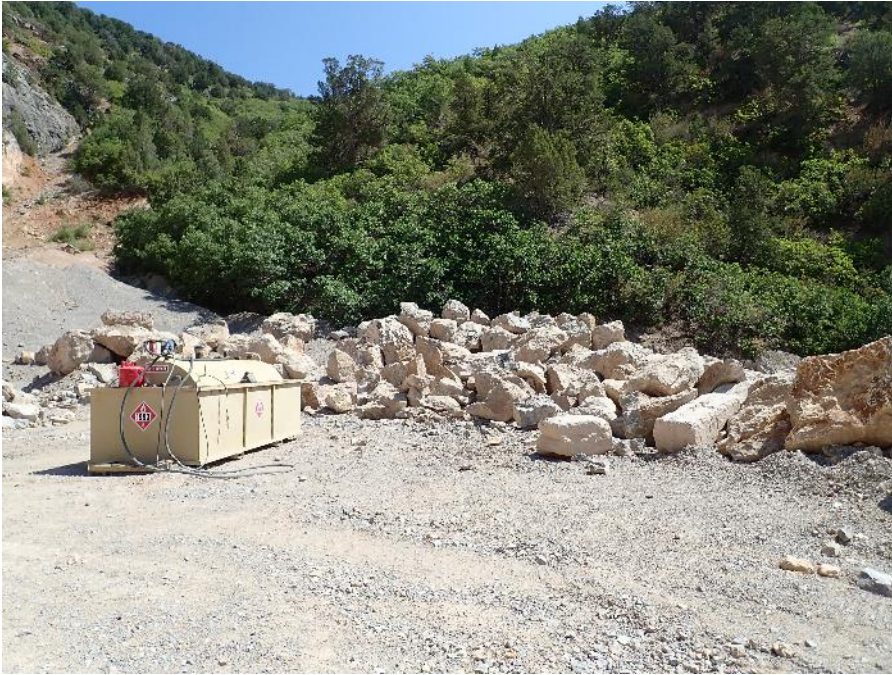
While walking up to the east side of the production bench, I observed three small benches/landings. The lowest landing contained scrap wood. The middle landing contained a personal vehicle, a dozer with a ripper, and a storage container. The upper landing contained boulder storage and a large diesel tank with secondary containment.

Photo 10. Looking east at a diesel tank with secondary containment and a boulder stockpile on the top landing on the east side of the crusher bench.

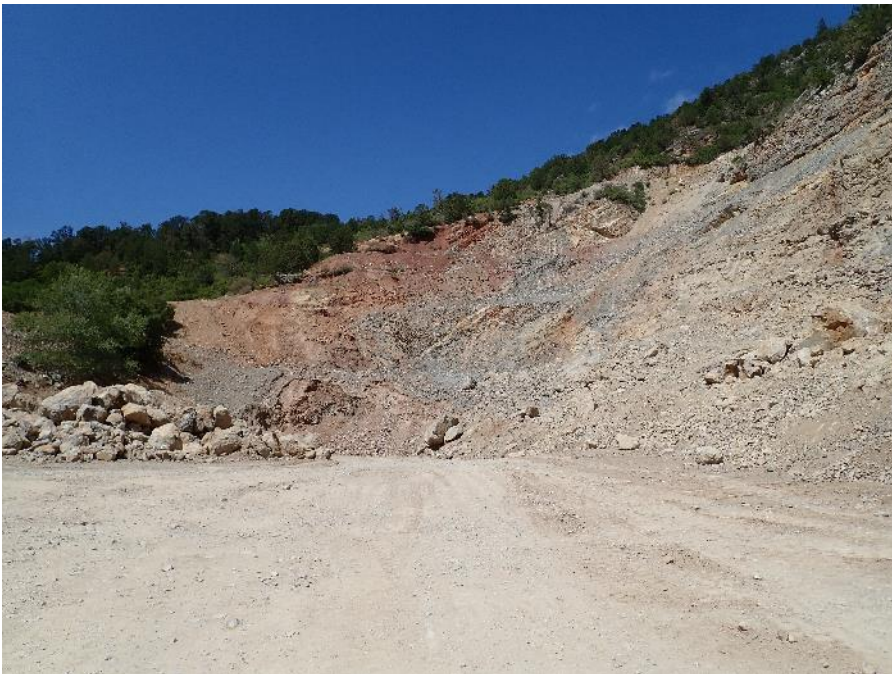
There are currently two main mine benches within the quarry. The lowest mine bench is separated from the production bench by a 30-40' tall slope of fractured rock. The lowest mine bench is approximately 600 feet long and 20 feet wide, with a 70 foot tall highwall above it. The western portion of the quarry has an additional small bench between the lowest and second bench that narrows and terminates to the east. The second mine bench is approximately 600 feet long and 20 feet wide, with a 50 foot tall highwall above it. The uppermost mine bench narrows and terminates to the east. There is an additional upper mine bench in development on the far west side of the quarry.

Photo 11. Looking west from the crusher bench to the mine benches.

- Redesign the quarry highwall and mine benches to conform with the 1982 Plan of Operations and 1989 Plan of Operations modification or provide an updated mining plan and mine bench design in a proposed Plan of Operations modification to reflect the current mine operations.

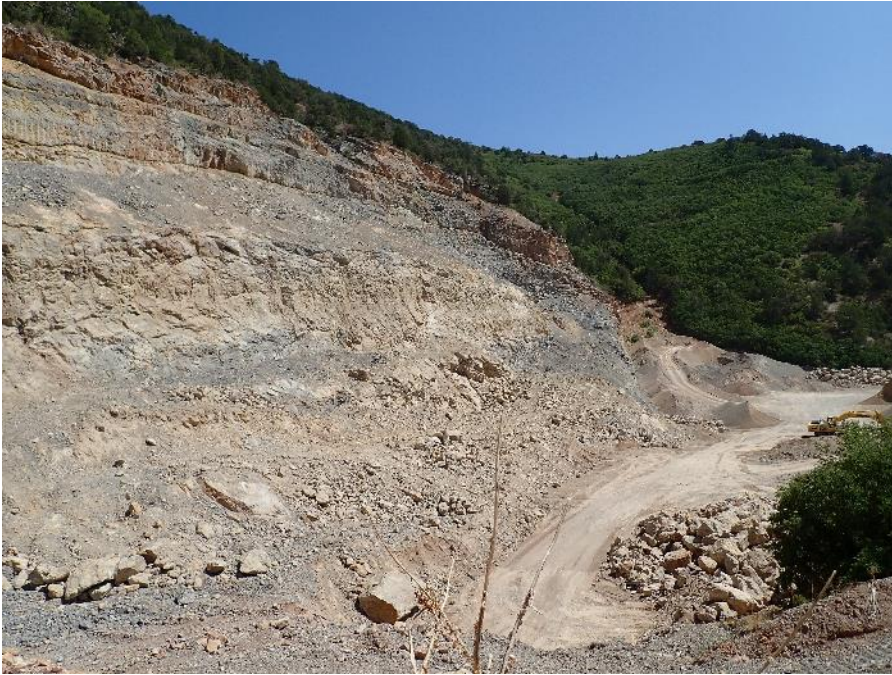
Photo 12. Looking east to the quarry's mine benches (left) and crusher bench (right).

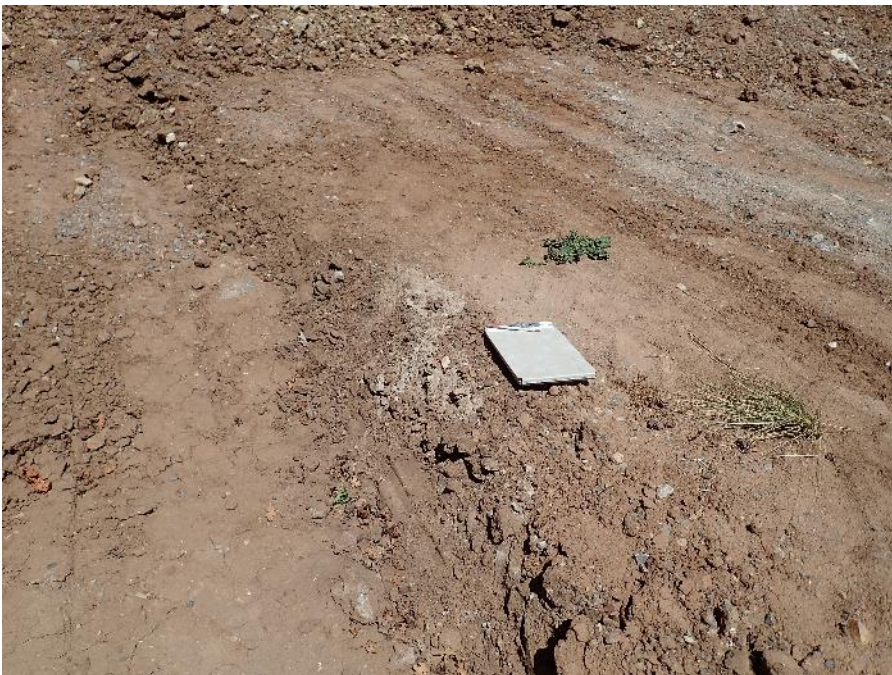
During this inspection, we visited two of the reclaimed 2016 exploratory drill holes; drill holes #5 and 6. Surface evidence of the remaining four holes (drill holes #1, 2, 3, and 4) have been obliterated by subsequent blasting operations. Drill hole #6, located on the western access to the upper mine benches, is no longer visible. The drill hole and pad was located in the road and subsequent grading operations have removed traces of this drill site. Only light colored cuttings that contrast with the surrounding overburden provide evidence of past drilling at this site. Drill hole #5, located on the access to the upper-most mine bench, has a larger volume of dark grey cuttings remaining on the surface. All six drill holes were located within existing disturbance. RMR stated that water was not encountered during drilling operations for any of the six holes.

Photo 13. Looking north to drill hole #6 on the mine bench access road. Clipboard for scale. Note thistle to the north of the clipboard.

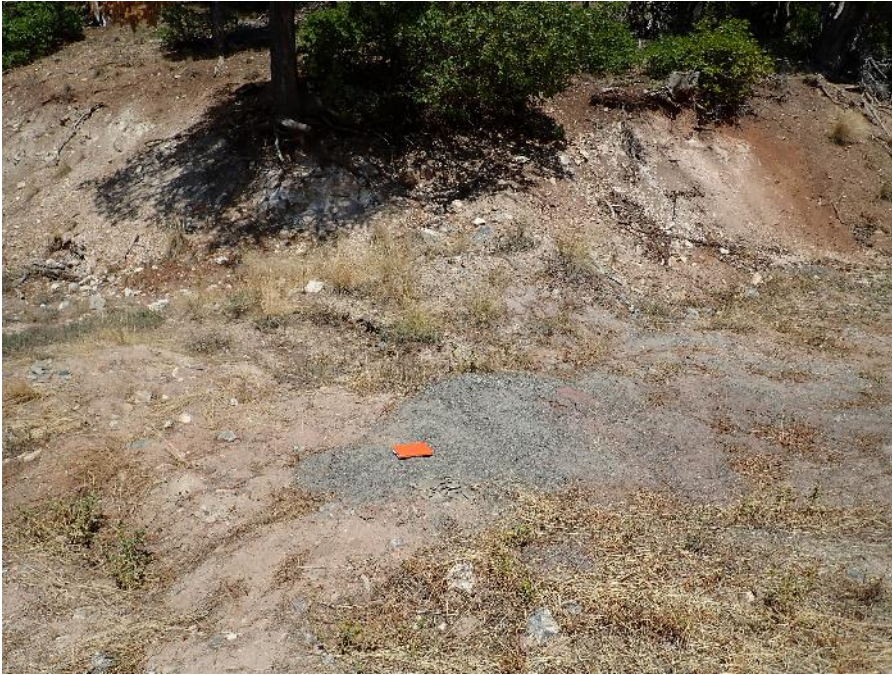
Photo 14. Looking north to drill hole #5. Notebook for scale.
