**MINERALS PROGRAM INSPECTION REPORT**  
**PHONE: (303) 866-3567**

<b>MINE NAME:</b> Cresson Project	<b>MINE/PROSPECTING ID#:</b> M-1980-244	<b>MINERAL:</b> Gold	<b>COUNTY:</b> Teller
<b>INSPECTION TYPE:</b> Monitoring	<b>INSPECTOR(S):</b> Timothy A. Cazier	<b>INSP. DATE:</b> June 11, 2018	<b>INSP. TIME:</b> 12:40
<b>OPERATOR:</b> Cripple Creek & Victor Gold Mining Company	<b>OPERATOR REPRESENTATIVE:</b> Justin Bills	<b>TYPE OF OPERATION:</b> 112d-3 - Designated Mining Operation	
<b>REASON FOR INSPECTION:</b> Priority	<b>BOND CALCULATION TYPE:</b> None	<b>BOND AMOUNT:</b> \$208,491,188.00	
<b>DATE OF COMPLAINT:</b> NA	<b>POST INSP. CONTACTS:</b> None	<b>JOINT INSP. AGENCY:</b> None	
<b>WEATHER:</b> Clear	<b>INSPECTOR'S SIGNATURE:</b>

The Division conducted a priority monitoring inspection of the site on June 11, 2018. Mr. Justin Bills represented CC&V during the inspection. Tim Cazier represented the Division. The purpose of this inspection was to observe the liner repair progress in the Squaw Gulch Valley Leach Facility (SGVLF, a.k.a. VLF 2) slide area.

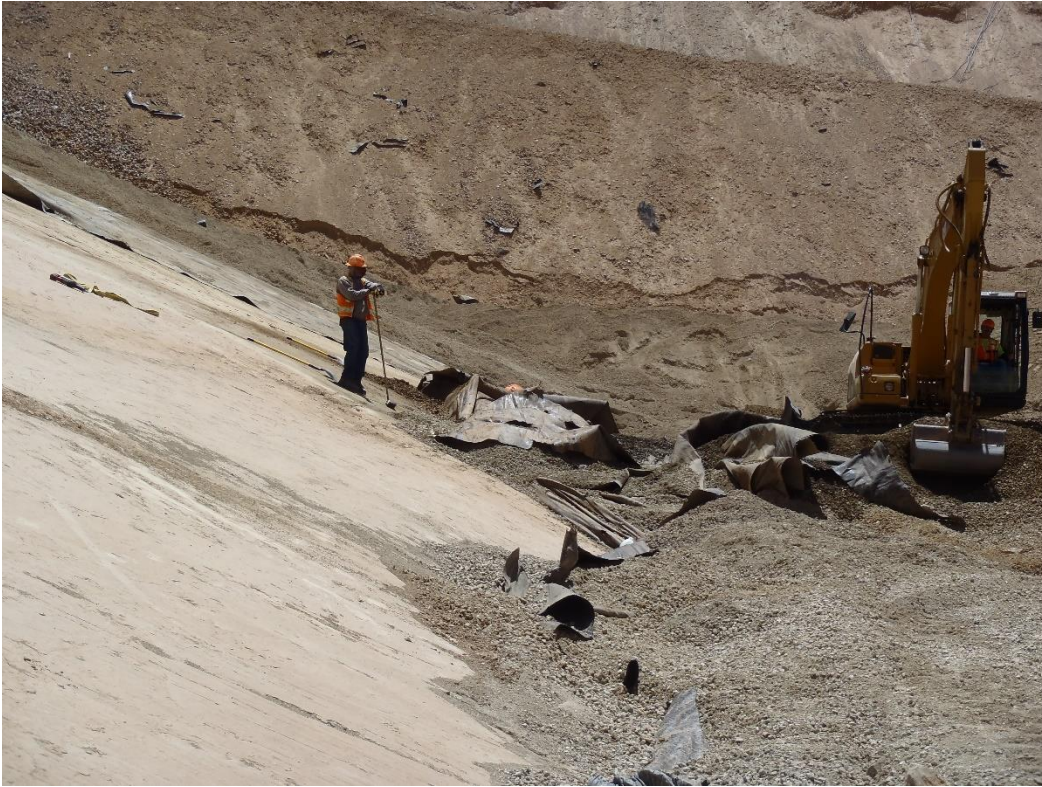
Squaw Gulch Valley Leach Facility (VLF 2) Slide Area: Progress and plans for verifying the extent of the liner damage were discussed with Ames Construction representatives (Ben and Kevin). All but the very bottom (near the 9650 elevation, **Photo 1**) of the damaged geomembrane had been exposed (**Photo 2**). In addition, DCF had been removed from the geomembrane above the slide area below both the 9950 and 9850 benches (**Photo 3**). Ames personnel were observed checking the soil liner fill (SLF/"clay") thickness (**Photo 4**) below the 9750 bench on a 50-foot grid marked with orange paint (**Photo 5**). Ames representatives indicated the SLF thickness exceeded the required 12-inch minimum thickness at all locations checked at the time of the inspection. Kevin stated the exposed SLF was well compacted and very moist to point of near saturation and that the SLF was being watered daily to keep the moisture optimal. Ames used an excavator mounted roller compactor (**Photo 6**) to work the SLF on a daily basis. The Division observed the SLF near the 9650 bench where it appeared to be in good condition (**Photo 7**).

Photo 1. Bottom of VLF 2 liner damage still being uncovered (near 9650 bench).

Ames representatives explained they intended to remove all the damaged geomembrane panels between the 9750 and 9650 benches, plus two panels on either side of the damaged panels. The third geomembrane panel on either side of the damaged area would remain. New panels were to be installed to replace the damaged panels and the two adjoining panels slated for removal. The plan was to start cutting away these panels on the day following the inspection.

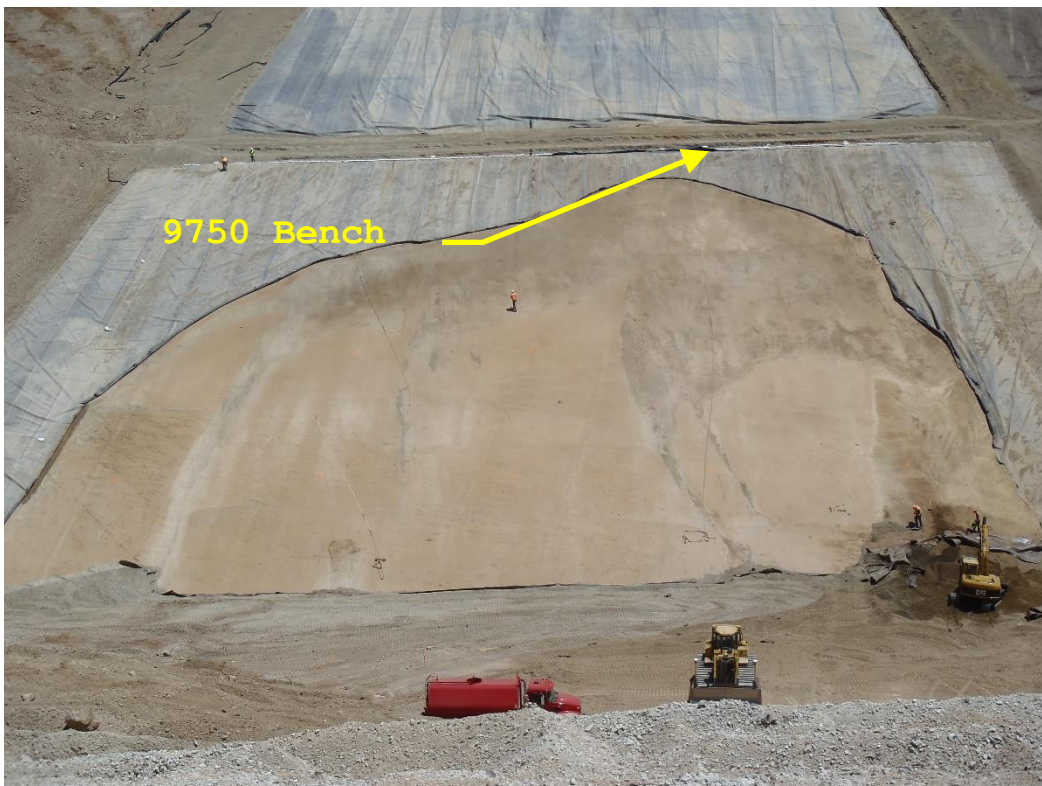
Photo 2. Extent of VLF 2 liner damage, zoomed in.

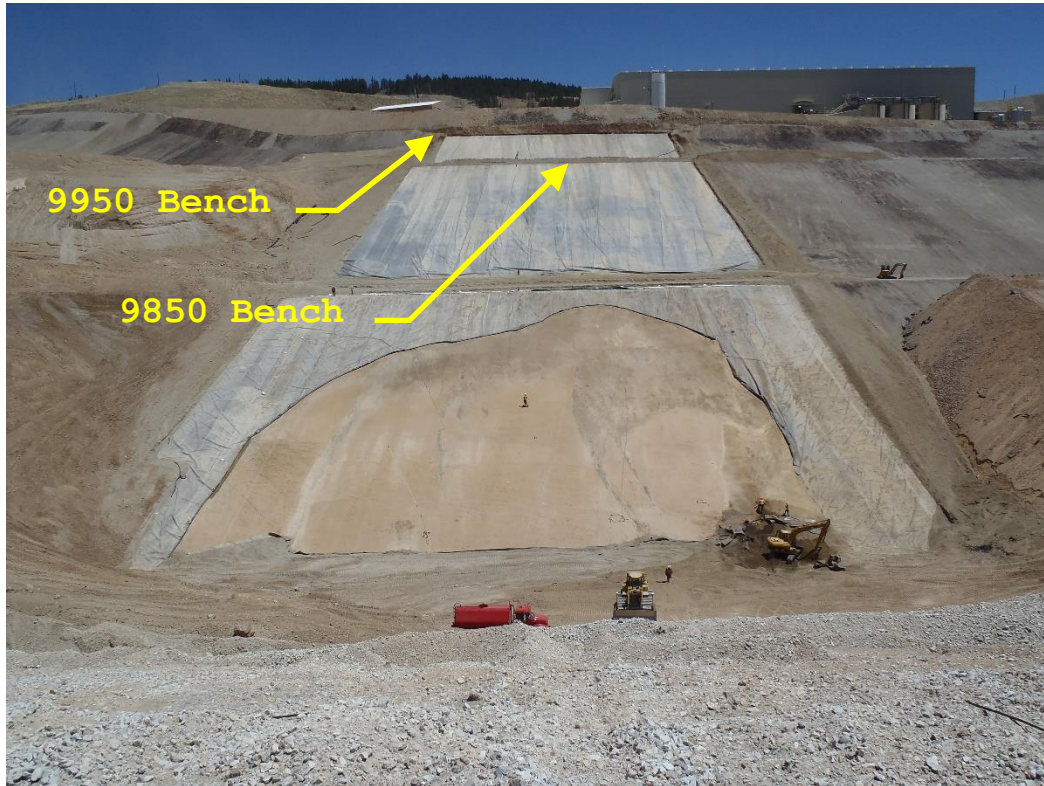
Photo 3. DCF removed from geomembrane above the slide area below both the 9950 and 9850 benches.

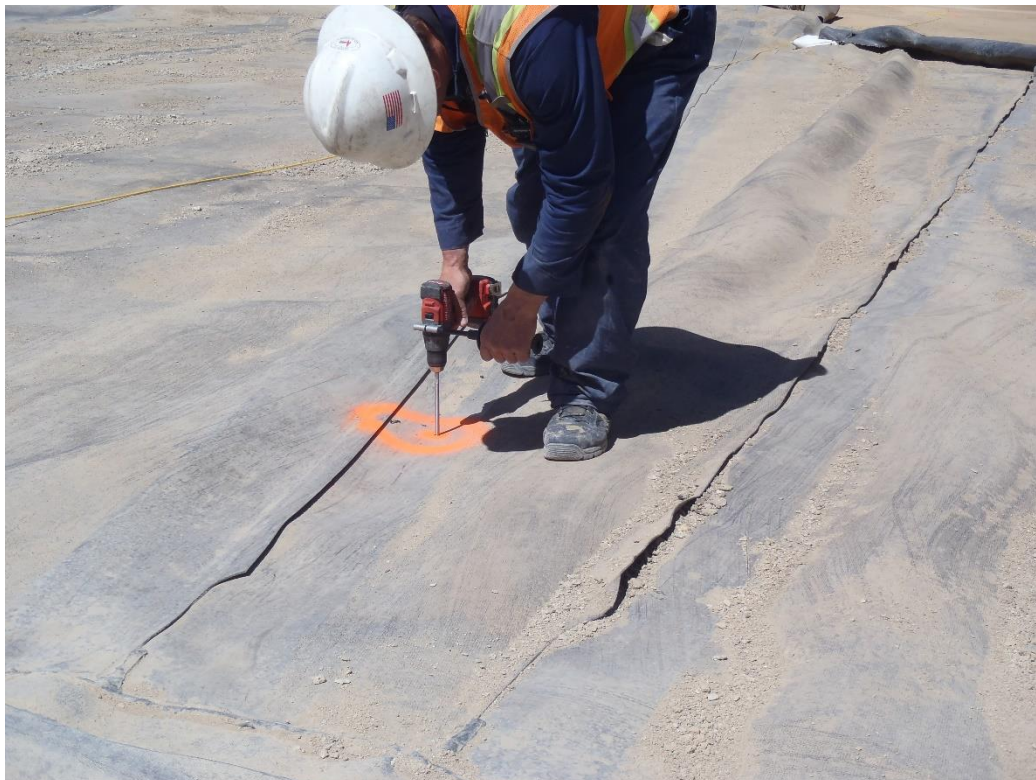
Photo 4. Checking soil liner fill (SLF/"clay") thickness.

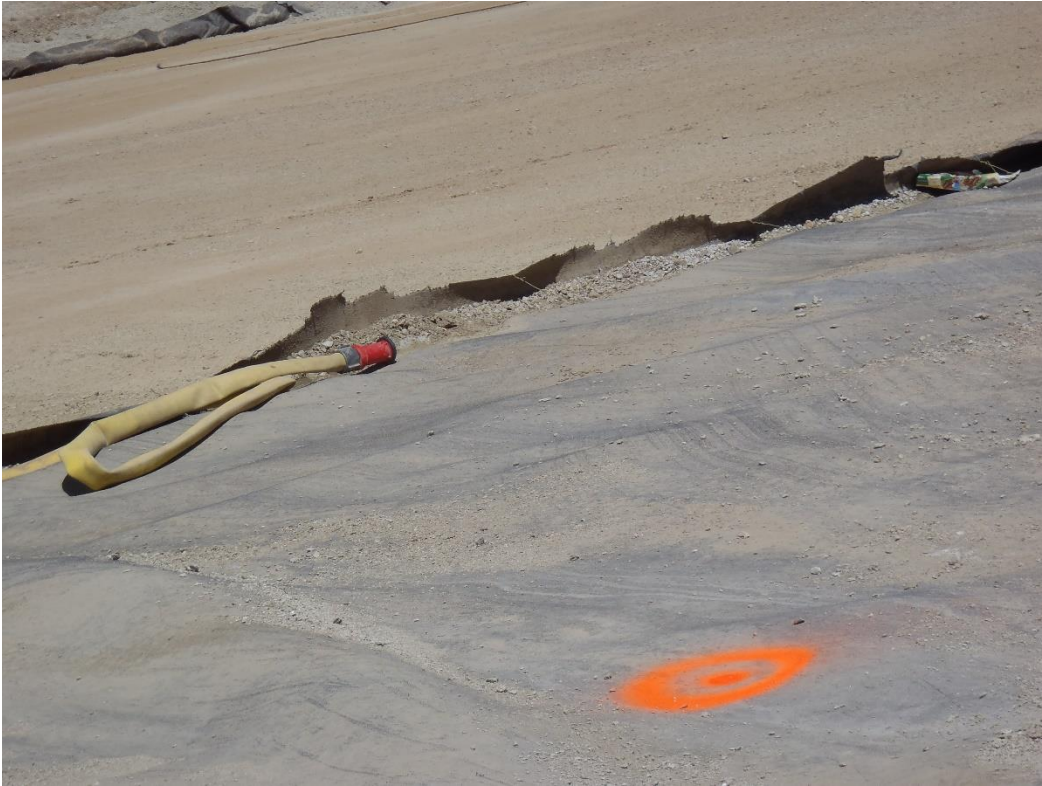
Photo 5. Orange paint marking a sample point on a 50-ft grid.

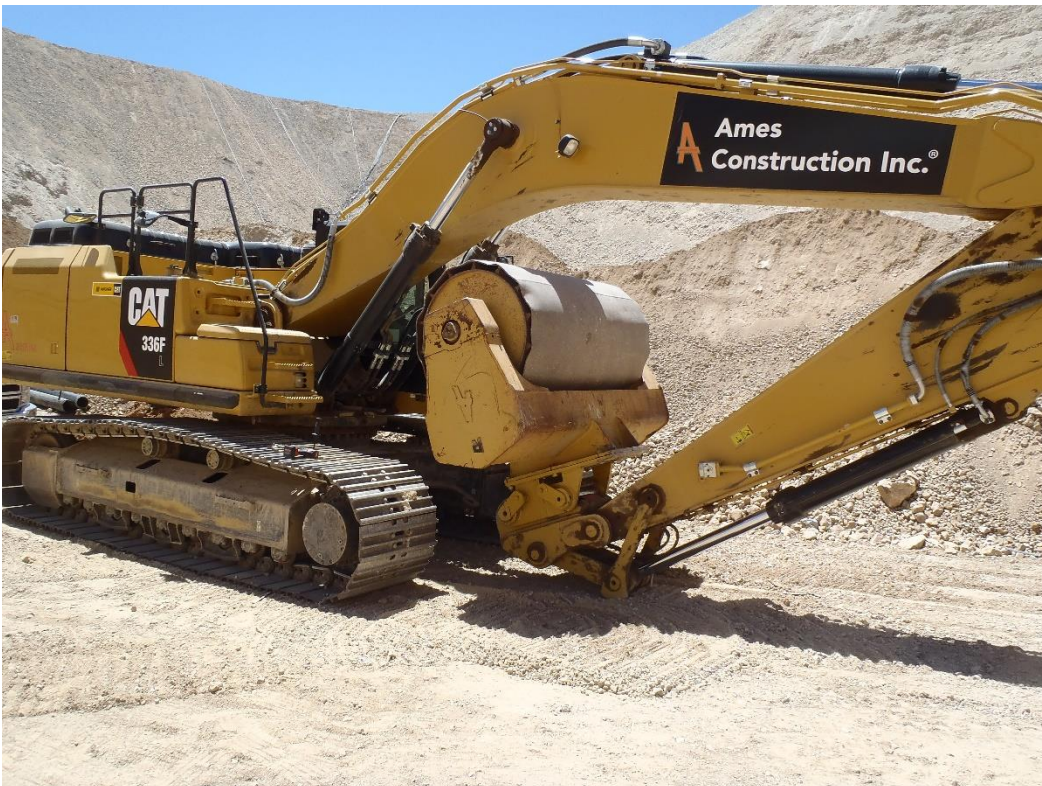
Photo 6. Excavator mounted roller compactor.

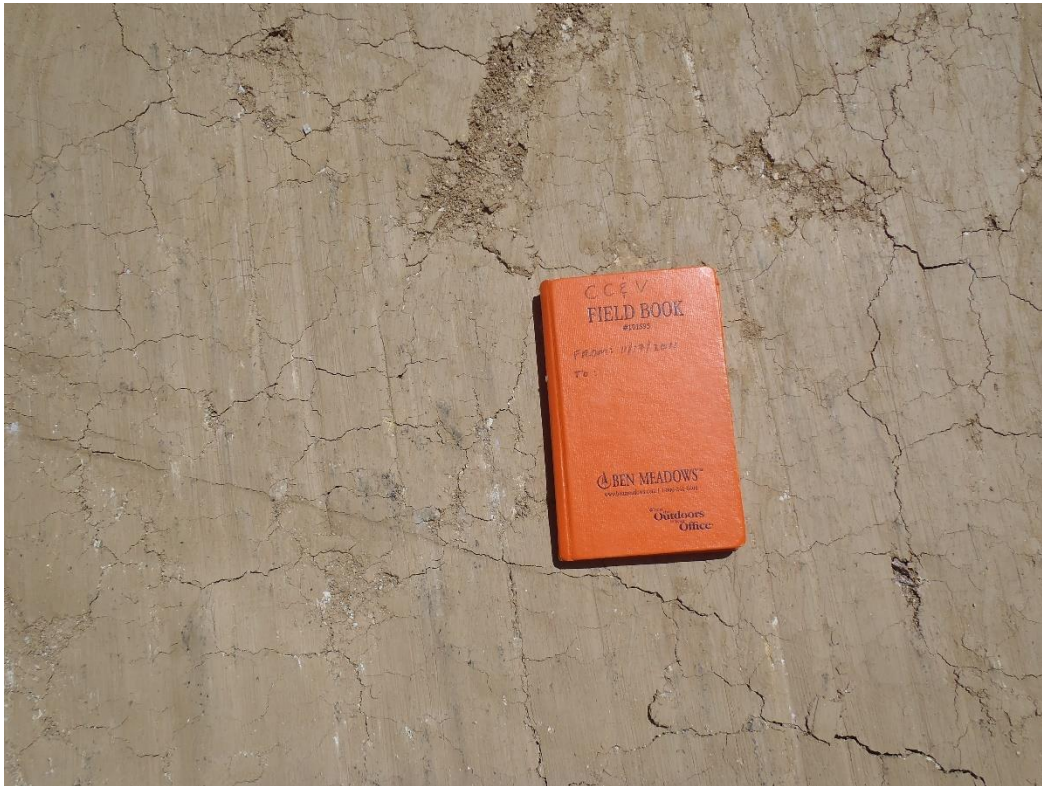
Photo 7. SLF surface near 9650 bench.
