MINERALS PROGRAM INSPECTION REPORT

MINE NAME: Henderson Mine	MINE/PROSPECTING ID#: M-1977-342	MINERAL: Molybdenum	COUNTY: Clear Creek, Grand
INSPECTION TYPE: Monitoring	INSPECTOR(S): Peter S. Hays	INSP. DATE: August 30, 2018	INSP. TIME: 09:30
OPERATOR: Climax Molybdenum Company	OPERATOR REPRESENTATIVE: Aaron Hilshorst	TYPE OF OPERATION: 112d-3 - Designated Mining Operation	
REASON FOR INSPECTION: Normal I&E Program	BOND CALCULATION TYPE: None	BOND AMOUNT: \$37,993,785.00	
DATE OF COMPLAINT: NA	POST INSP. CONTACTS: None	JOINT INSP. AGENCY: None	
WEATHER: Clear	INSPECTOR'S SIGNATURE:

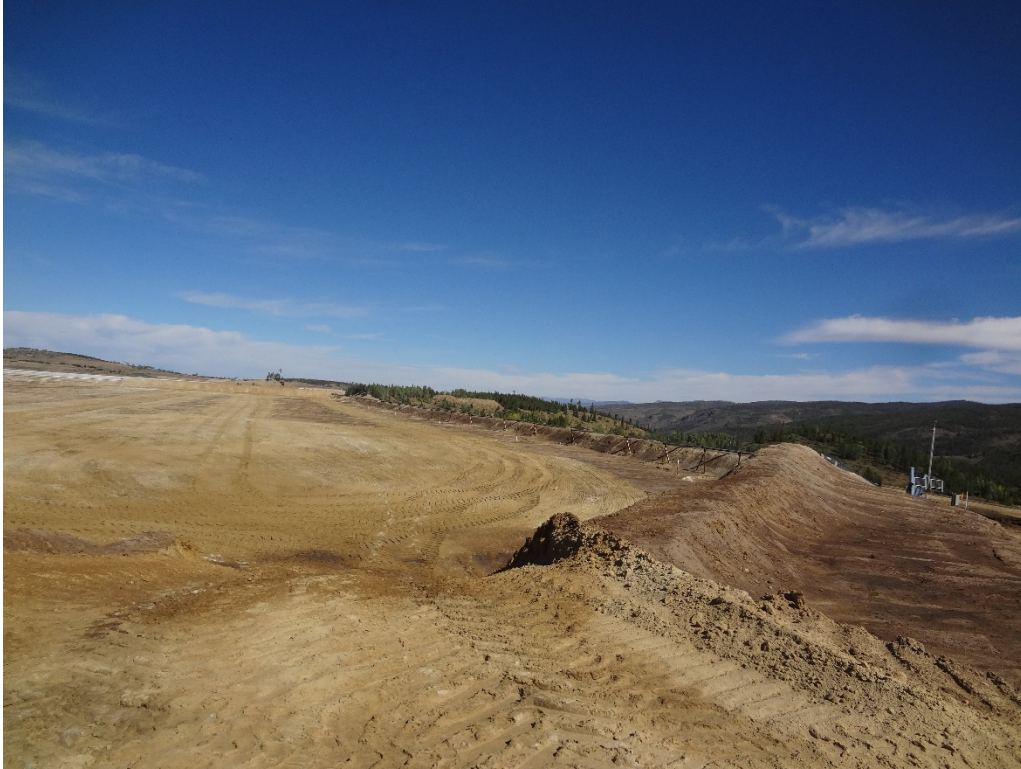
View of 3-Dam crest from south end looking north

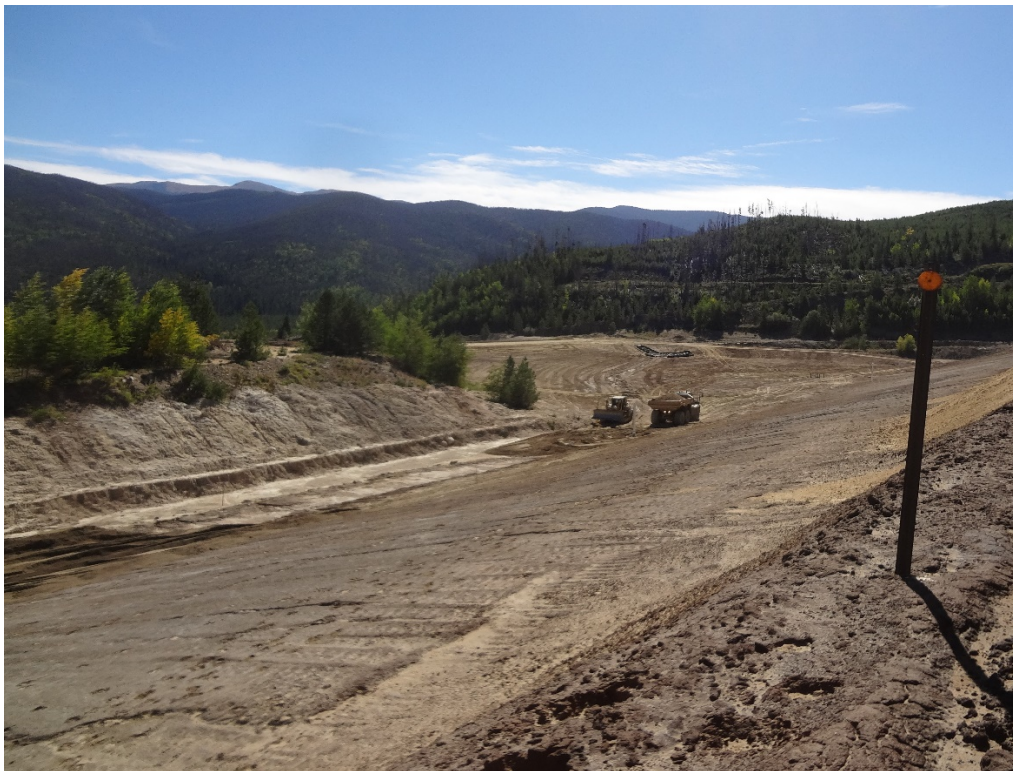
The 3 Dam Buttress Project– Stage 1 was approved by the Division as TR-29 on April 4, 2018. The placement of filter sand on the north stepback area were observed during the inspection. The filter sand was placed in two (2), nine (9) inches lifts for a total depth of 1.5 feet. The installation of the filter sand on the north and south toe areas and on the north stepback area were complete. The placement and compaction of the tailing sand on the north and south toe areas was complete. The slopes of the toe buttress areas will be finish graded soon. The tailings material was placed and compacted in 1 foot lifts. Compaction was achieved by the haul trucks and verified by a proof roll test. The toe drains affected by the toe buttress were extended 75 feet to daylight at the new toe of slope. Three (3) new piezometers were installed in the stepback area to monitor the phreatic surface during construction of the buttress.

View of filter sand placement on the south side of the 3-Dam stepback looking south

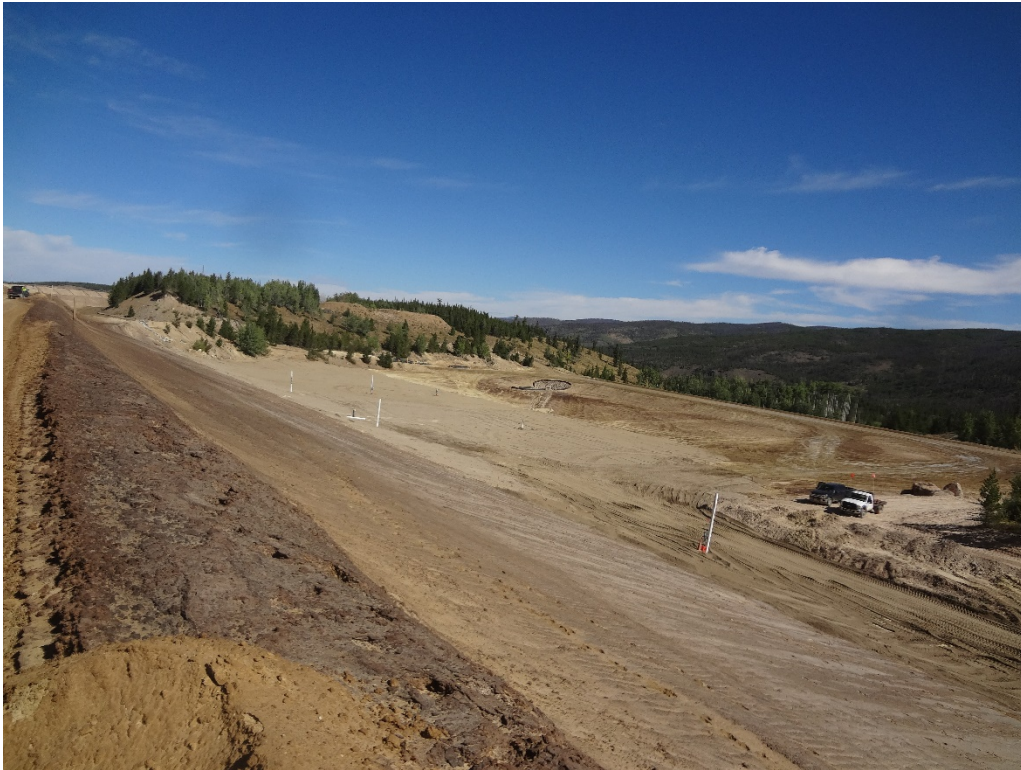
View of completed filter sand placement on the north side of the 3-Dam stepback looking north

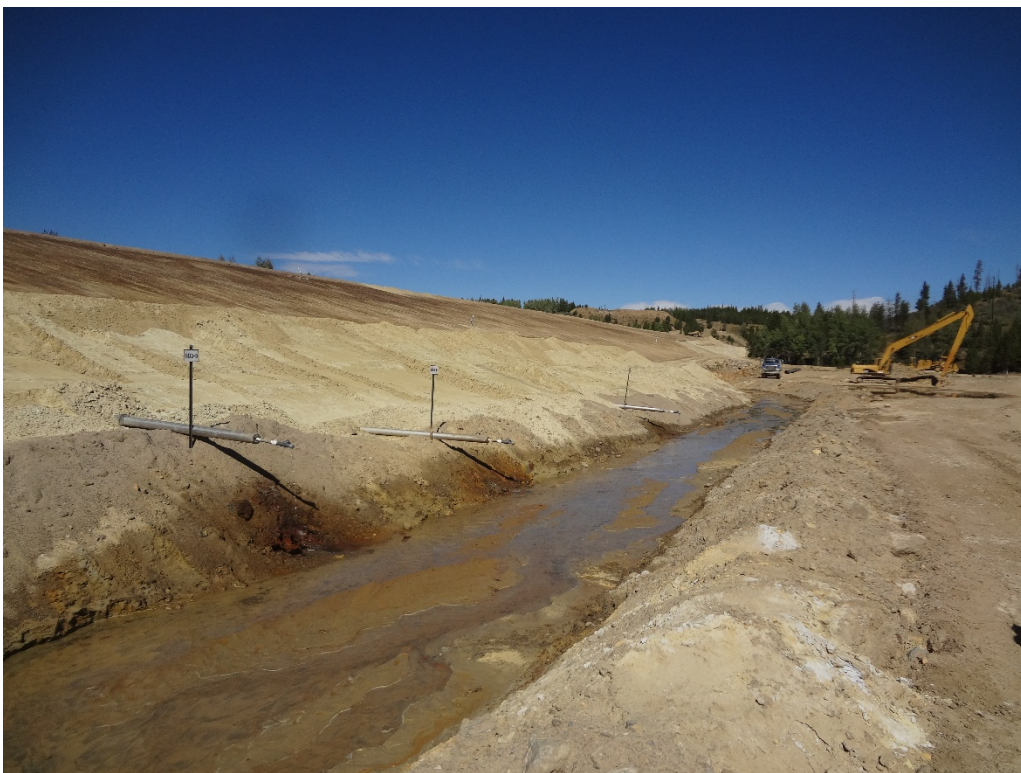
The toes of 1-Dam and 3-Dam were observed for the flow of water from the foundation and horizontal drains. The foundation drains under the impoundments were discussed and several of the active drains were observed. Henderson reported five (5) new toe drains are planned for installation this fall.

View of extended toe drains at the south toe of 3-Dam

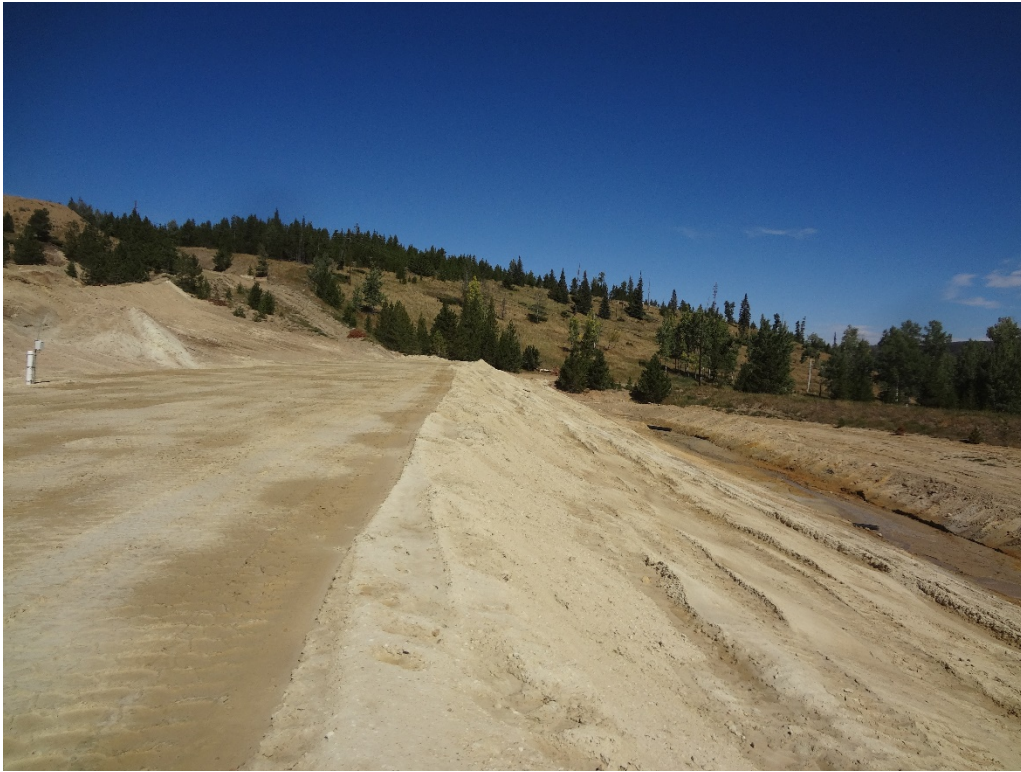
View of completed tailings sand placement at the north toe of 3-Dam

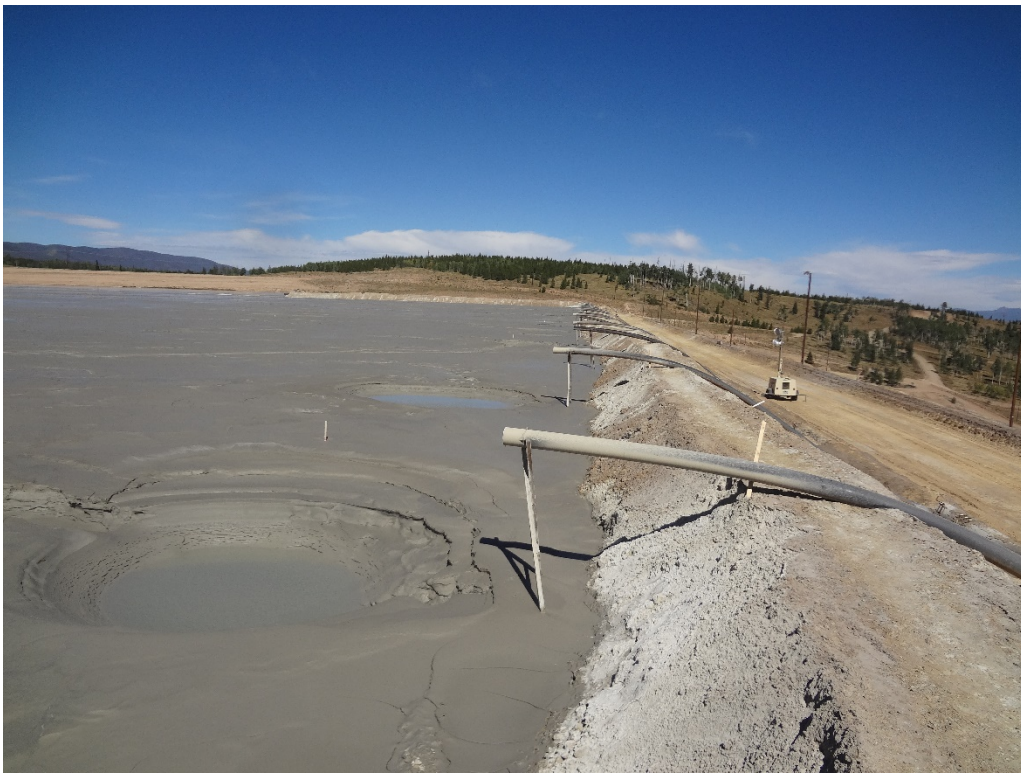
The road adjacent to the TDL was driven to observe the condition of the line and drop towers. No recent problems or repairs of the TDL have been reported by Henderson. Tailings deposition in the 3-Dam cells is scheduled for this fall and will consist of one 1.5 foot deposition. Tailings deposition in the 1-Dam cells have occurred as planned from south to north. The spigot deposition of tailings ended the previous day in Cells 7 and 8 on 1-Dam, which were observed during the inspection. The impoundment water pool location is estimated by Henderson based on monuments located in the impoundment. A minimum 500 foot beach offset from the crest of the impoundment is required by AECOM. A minimum 1,000 foot offset is required by Henderson. The beach distance was reported at 2,800 feet during the inspection.

View of tailings deposition in Cell 8 of 1-Dam looking north

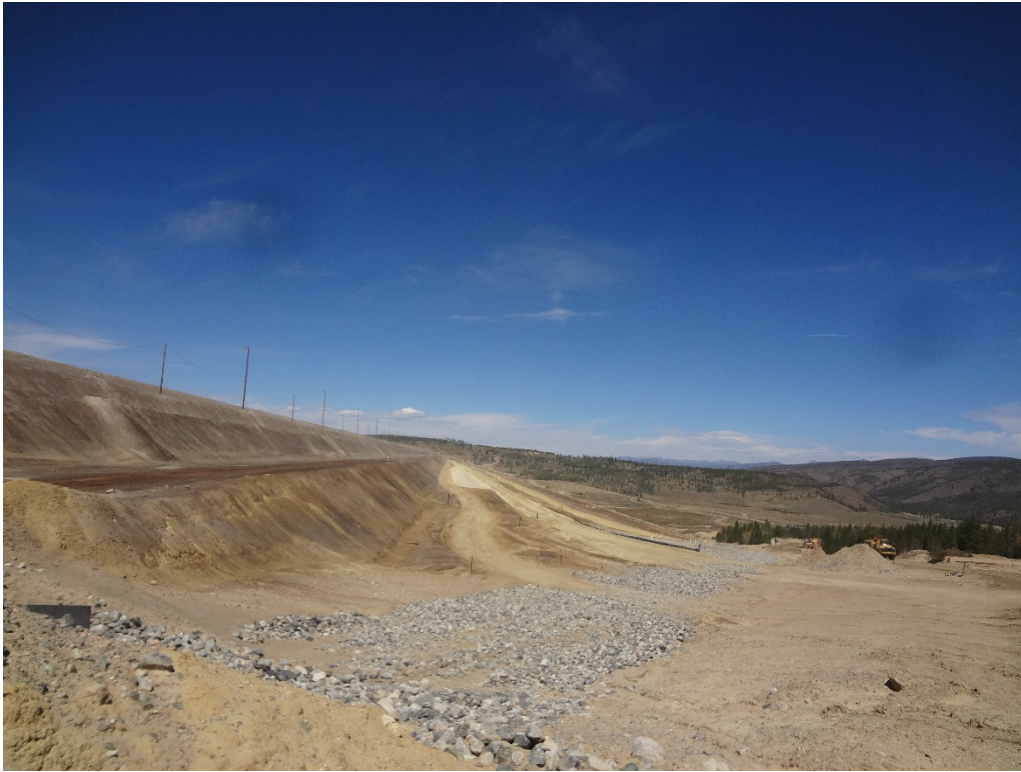
The source of the buttress project tailings sand from the inter-benches between Benches F and G on 1-Dam was observed during the inspection. The removal of the inter-benches will allow Henderson to grade the slope between the F and G benches at a 4H:1V slope. The inter-bench between Benches A and B were regraded by Henderson in the last few months.

View of the removal of the inter-benches on 1-Dam

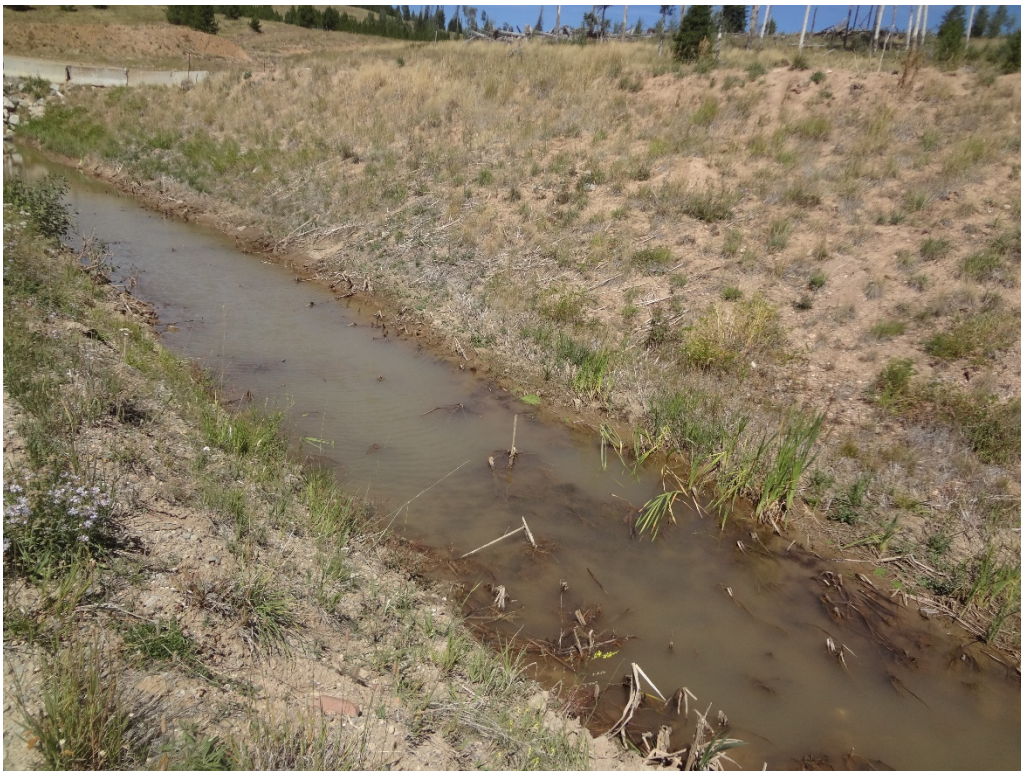
The return water system was observed to verify the pond elevation and the pumping flow rate. The Ultimate Canal was inspected from north to south during the inspection. Henderson chemically treated and mechanically removed several areas of cattails in the canal to maintain the proper function of the canal since the last DRMS inspection of the canal.

View of mechanically removed cattails in the ultimate canal
