**PERMIT INFORMATION**

<b>Permit Number:</b> C-1981-035 <b>Mine Name:</b> King Coal Mine <b>Operator:</b> GCC Energy, LLC <b>Operator Address:</b> Mr. Tom Bird 6473 County Road 120 Hesperus, CO 81326	<b>County:</b> La Plata <b>Operation Type:</b> Underground <b>Permit Status:</b> Active <b>Ownership:</b> Federal
	<b>Operator Representative Present:</b>  None
<b>Operator Representative Signature: (Field Issuance Only)</b>

**INSPECTION INFORMATION**

<b>Inspection Start Date:</b> August 20, 2018 <b>Inspection Start Time:</b> 11:53 <b>Inspection End Date:</b> August 20, 2018 <b>Inspection End Time:</b> 11:54		<b>Inspection Type:</b> Aerial Inspection <b>Inspection Reason:</b> Normal I&E Program <b>Weather:</b> Clear	
<b>Joint Inspection Agency:</b>  None		<b>Joint Inspection Contacts:</b>  	
<b>Post Inspection Agency:</b>  None		<b>Post Inspection Contacts:</b>  	
<b>Inspector(s):</b>  Brock F. Bowles	<b>Inspector's Signature:</b>

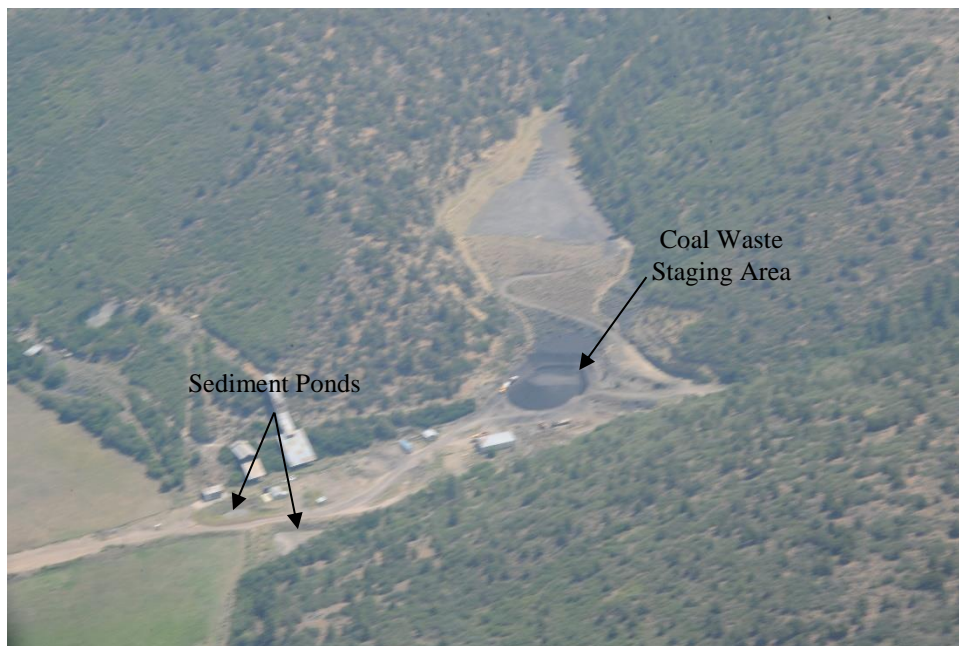
Photo 1 – King I Area Sediment Ponds and Waste Pile

King I - The east and west sediment pond do not appear to contain water (photo 1).

King I - Coal waste was being staged at the toe of the coal waste pile (photo 1).

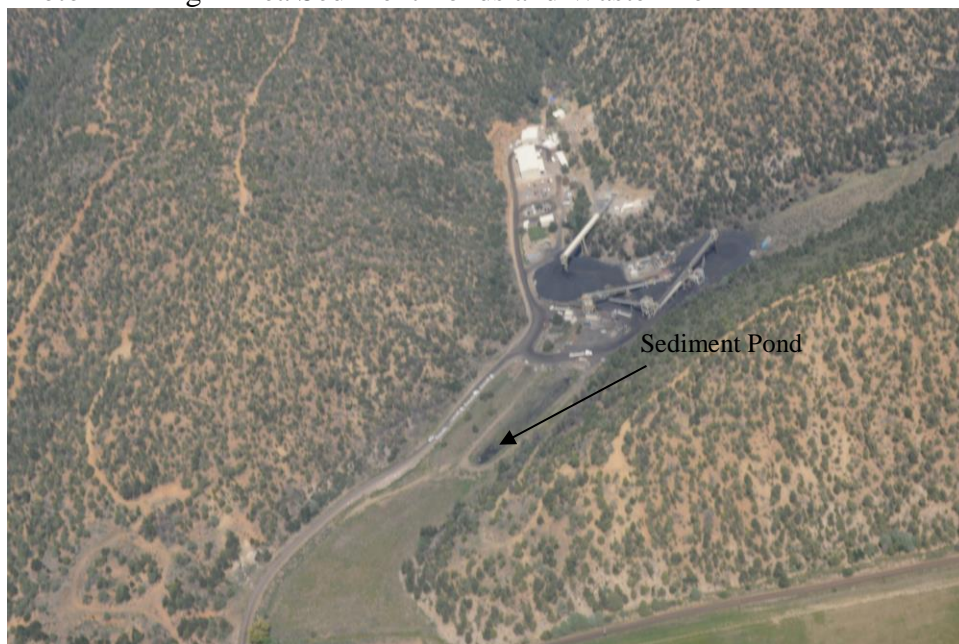
Photo 2 – King II Area Mine

King II - The sediment pond appears to contain a small amount of water (photo 2).
