## TR100 VLF2 Recertification (9750-9900)

Attachment 2:  
Record of Construction Report  
VLF2 Recertification Project  
Subgrade and Geomembrane 9750' – 9900' Elevations

## **VLF2 RECERTIFICATION PROJECT RECORD OF CONSTRUCTION REPORT FOR SUBGRADE AND GEOMEMBRANE 9750' – 9900' ELEVATIONS**

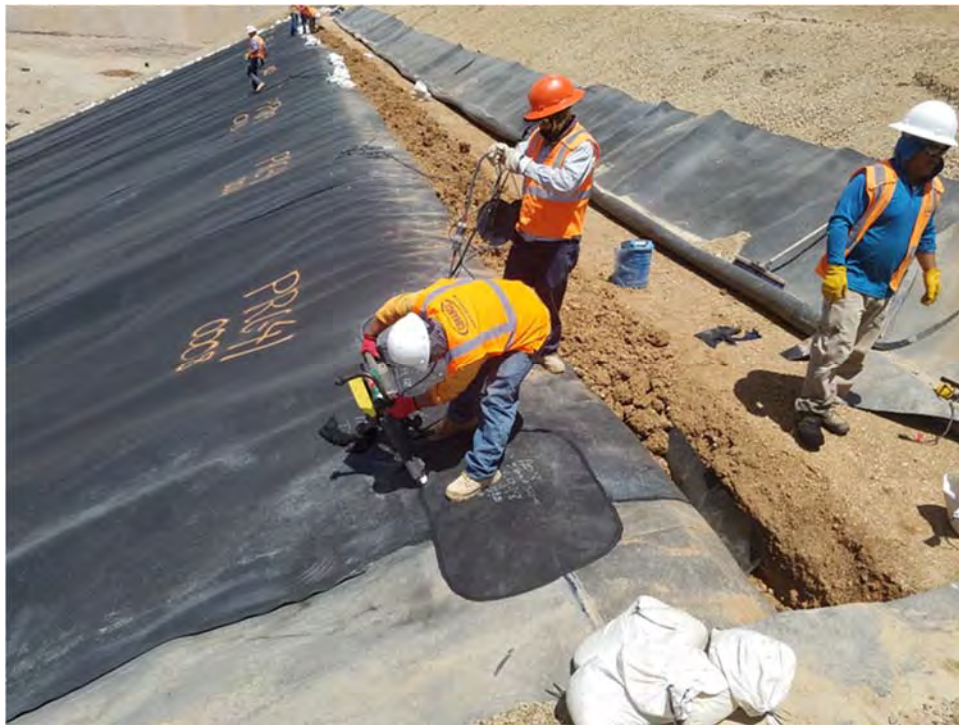
**Repair Activities**

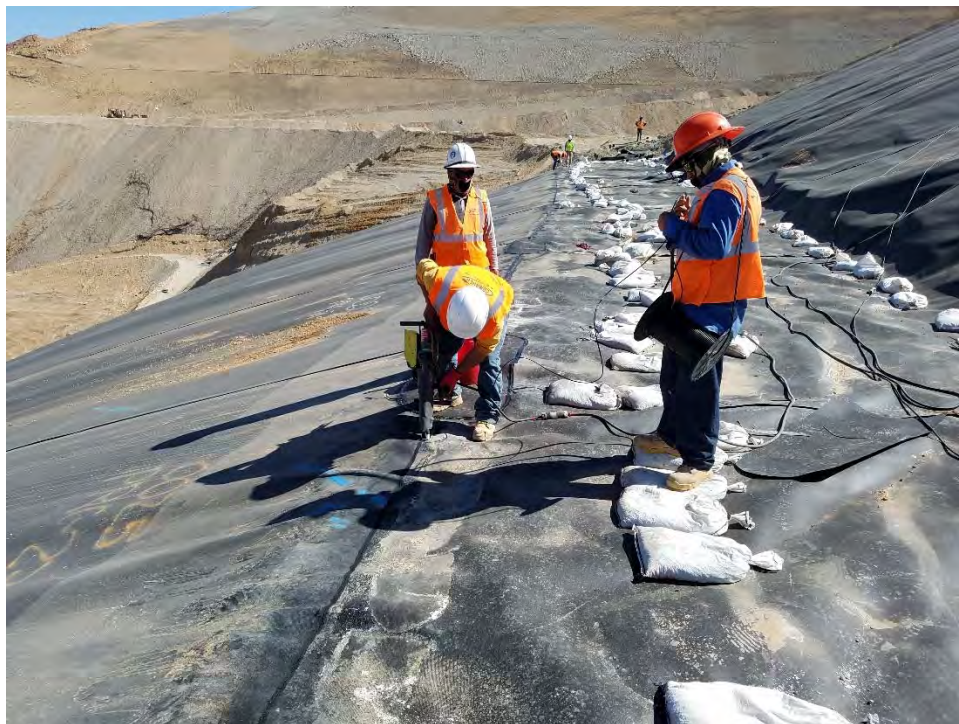
**Exrtusion Seaming and Repairs Performed**

Approximately 357 linear feet of extrusion seaming on tie-in was performed using one extrusion machine/operator combination. One destructive testing sample was marked during extrusion seaming. Repairs were performed during the shift, but not vacuum tested. Tomorrow, extrusion seaming will be completed and the repairs.

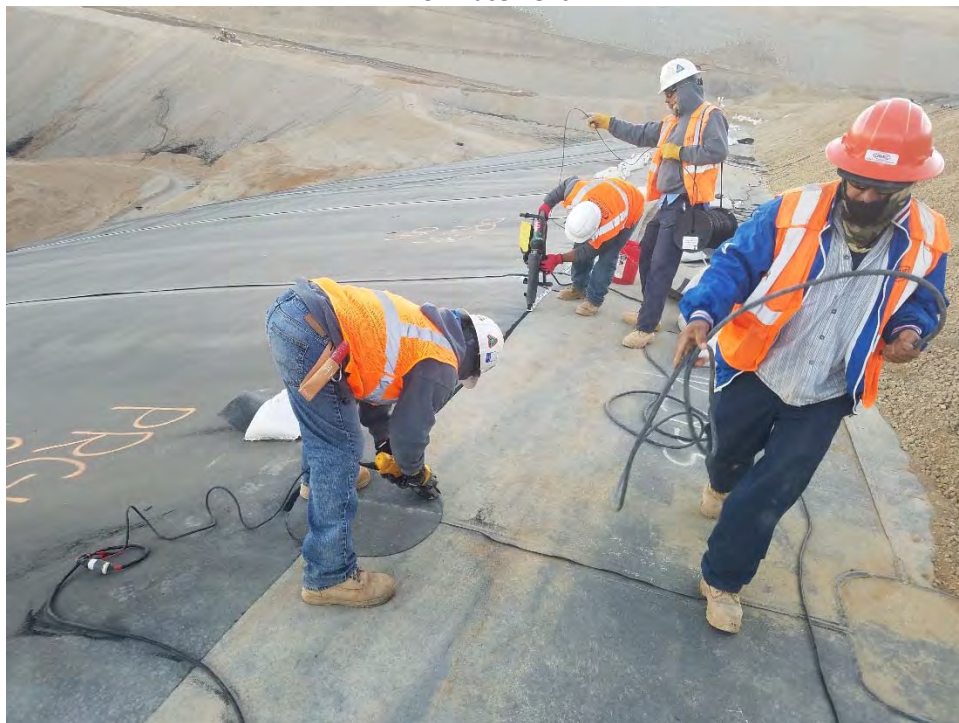
**Extrusion Seaming and Repairs Performed**

Repairs were performed using the extrusion welding method. A total of 46 linear feet of extrusion seaming was completed. All repairs and extrusion welded seams were vacuum tested during the shift. All the destructive testing was performed and met project specifications.

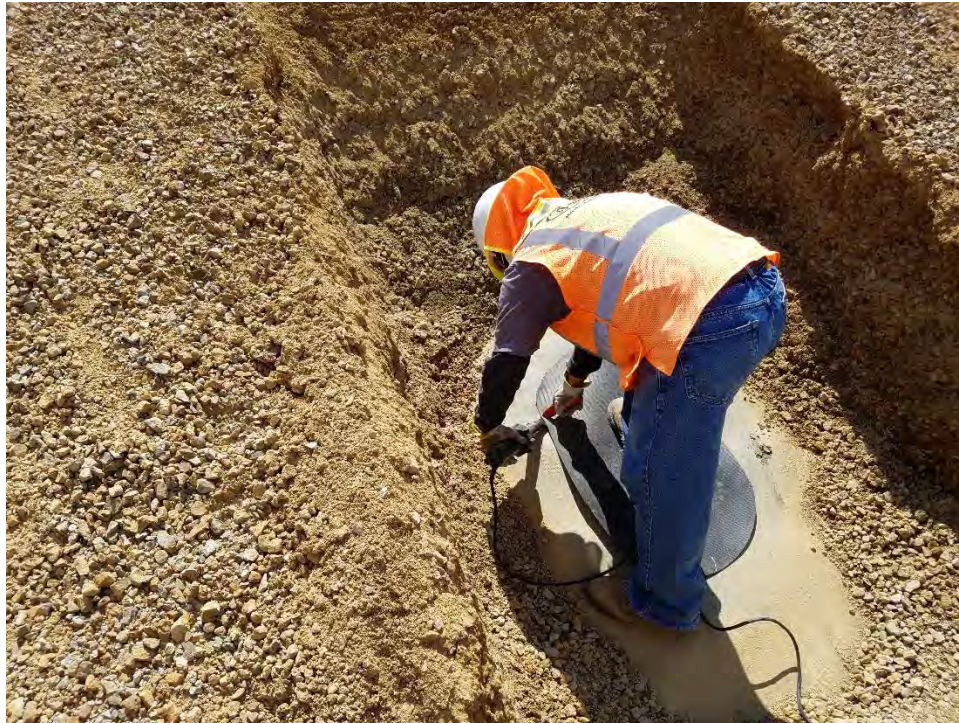
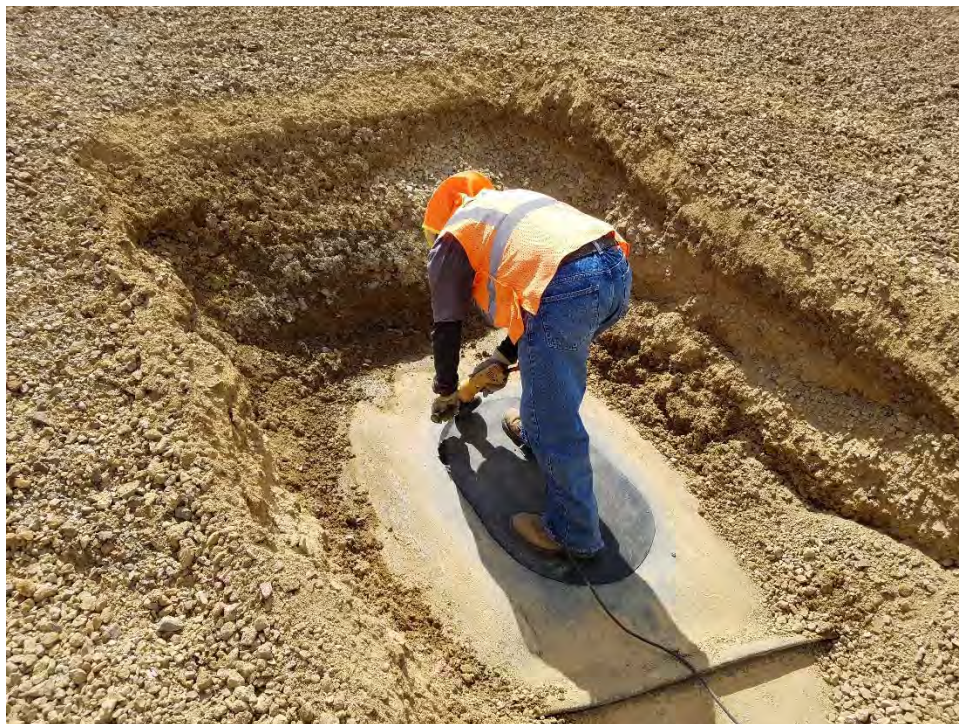
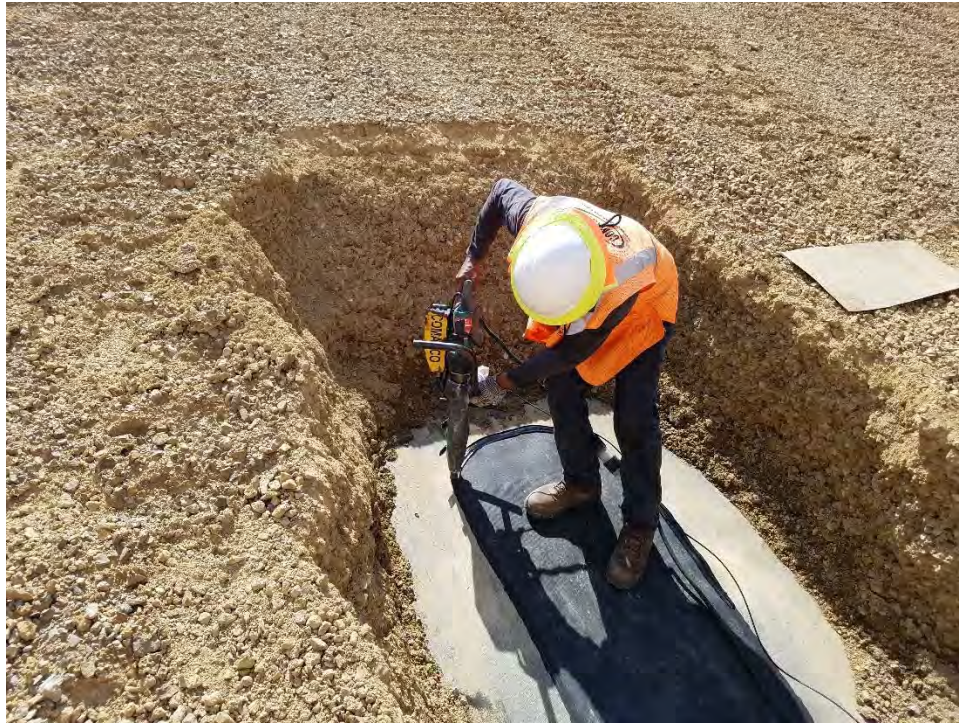
**Repair Activities**

Comanco cut the geomembrane to expose the SLF for density tests. After the tests were complete, Comanco repaired the geomembrane at each test hole location. Repairs were performed using the extrusion welding method in accordance with the technical specifications. Vacuum testing was not performed during the shift and will be performed on July 21, 2018 prior to backfilling test holes.

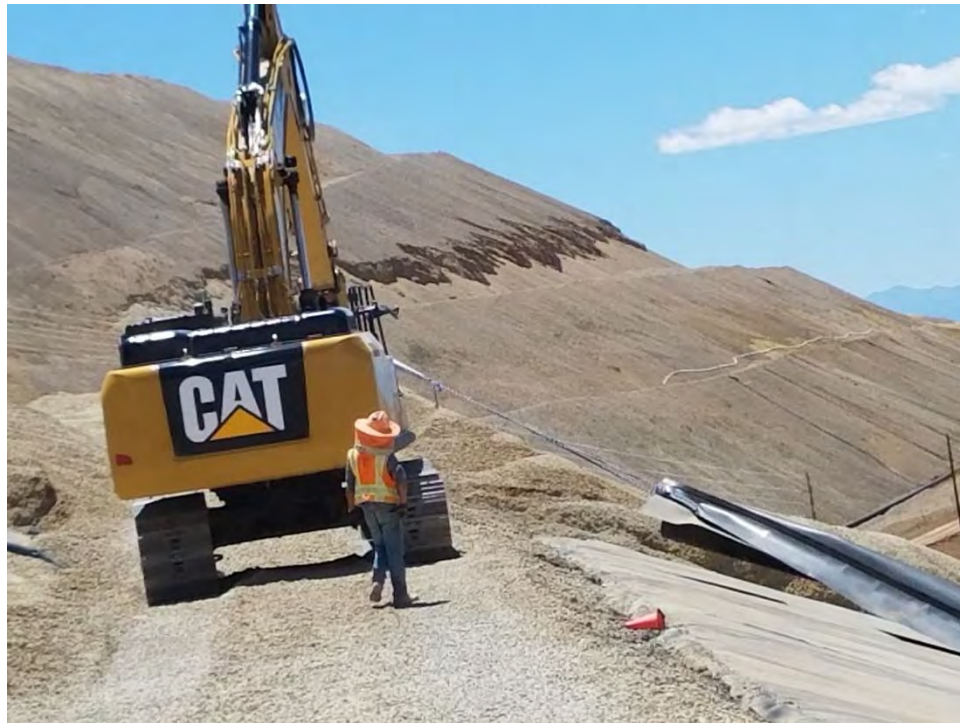
**Geomembrane Removal**

After the geomembrane was exposed and the damaged area was identified, it was removed using a CAT track mounted excavator. The removed geomembrane was discarded into roll off trash receptacles and removed from site.

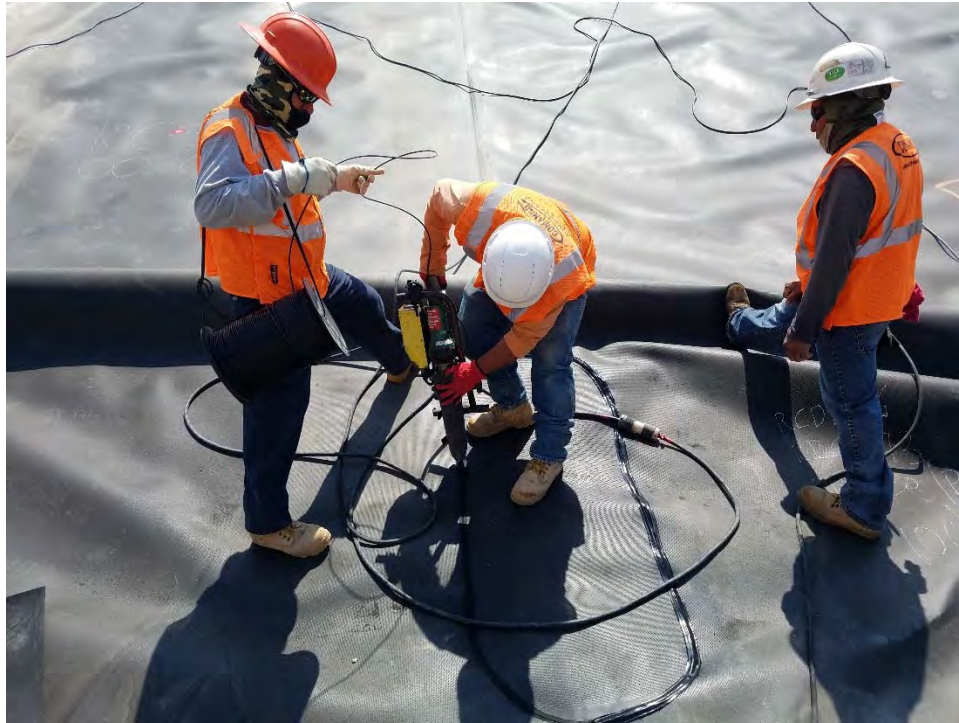
**Repair Activities**

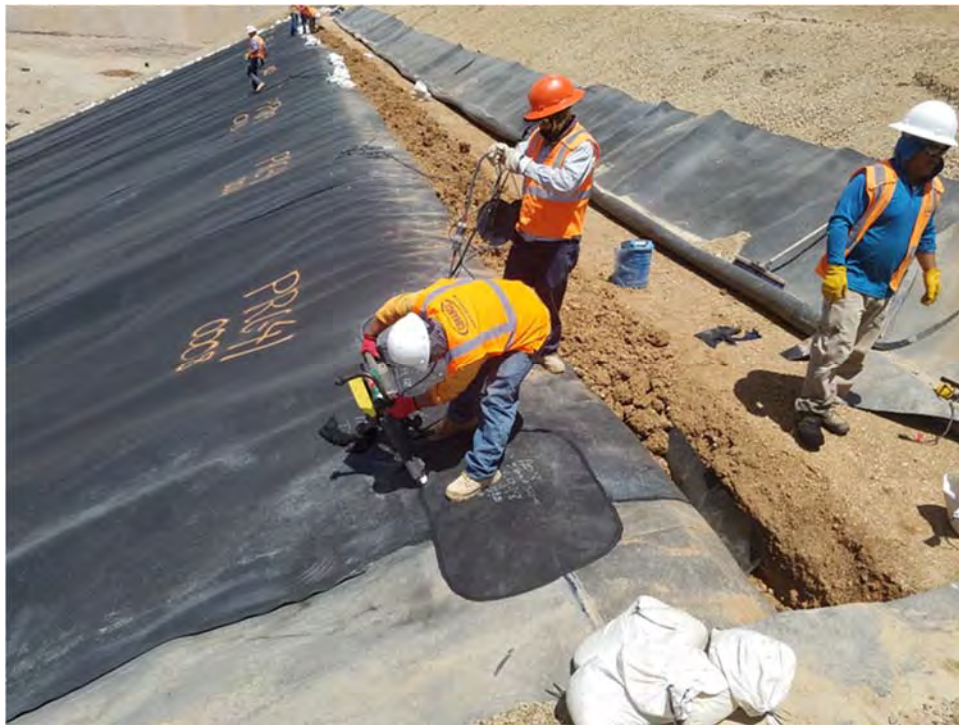
**Repair Activities**

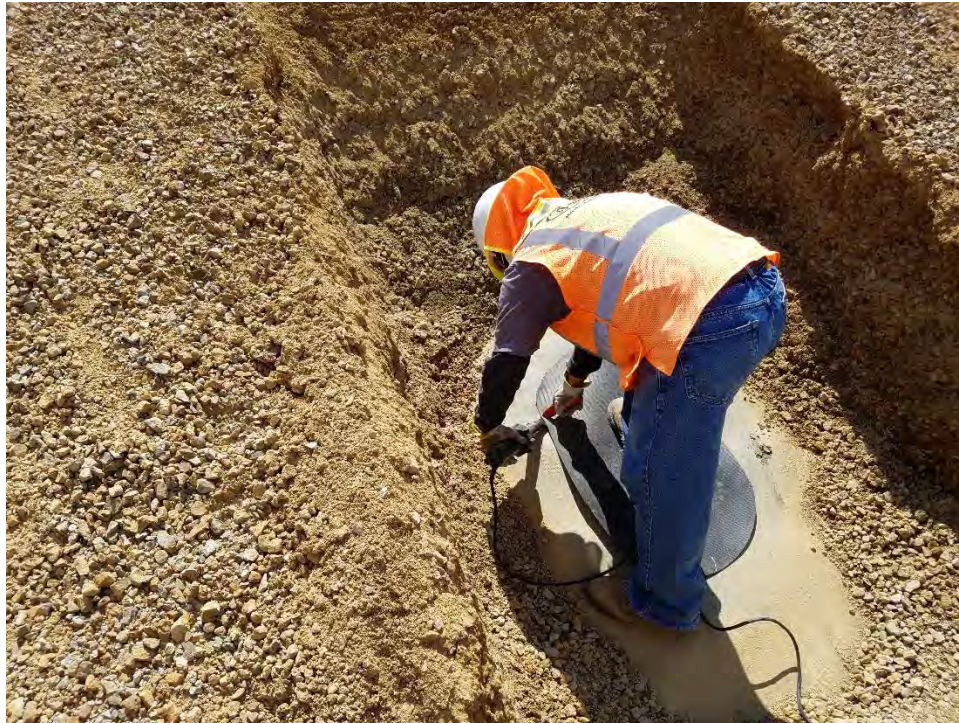
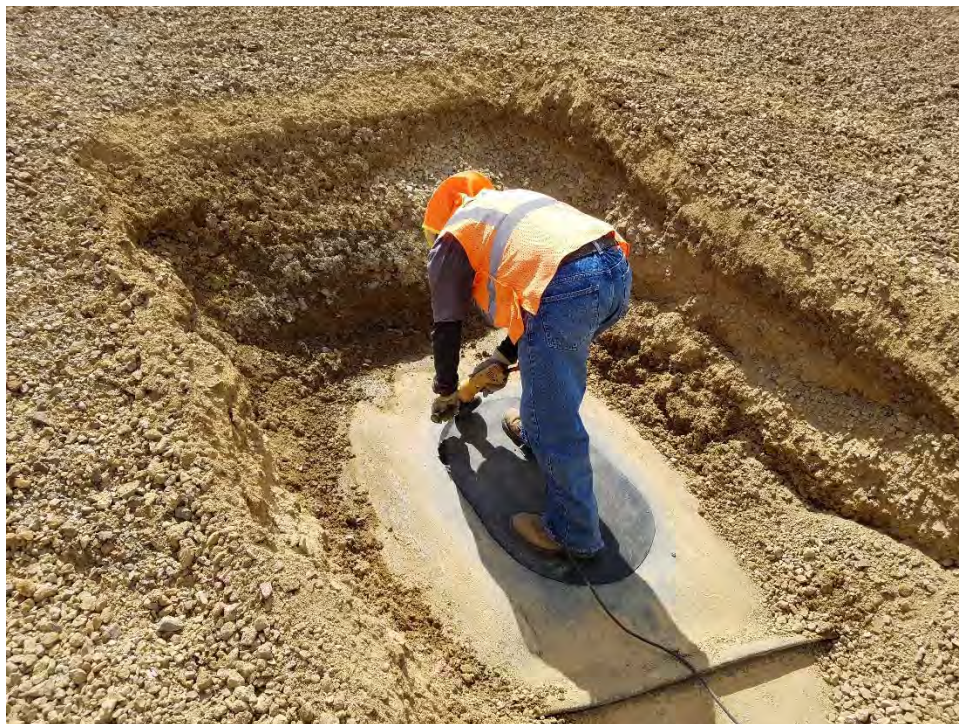
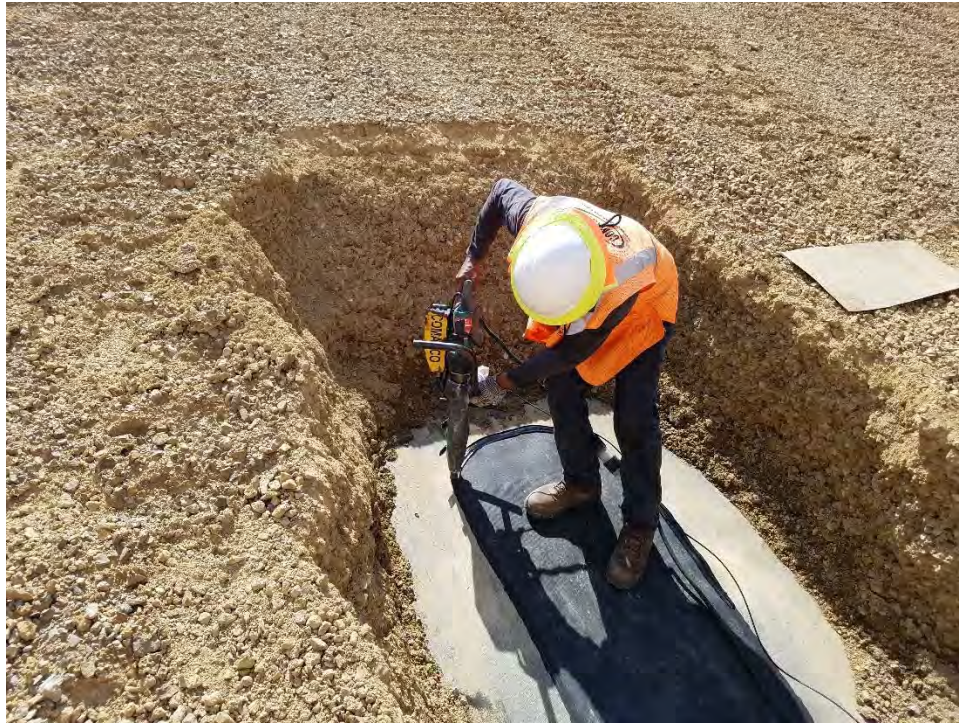
**Repair Activities**
