**MINERALS PROGRAM INSPECTION REPORT**  
**PHONE: (303) 866-3567**

<b>MINE NAME:</b> Nahcolite Project	<b>MINE/PROSPECTING ID#:</b> M-1983-194	<b>MINERAL:</b> Carbonates	<b>COUNTY:</b> Rio Blanco
<b>INSPECTION TYPE:</b> Monitoring	<b>INSPECTOR(S):</b> Amy C. Yeldell	<b>INSP. DATE:</b> August 21, 2018	<b>INSP. TIME:</b> 10:45
<b>OPERATOR:</b> Natural Soda LLC	<b>OPERATOR REPRESENTATIVE:</b> Kirk Daehling	<b>TYPE OF OPERATION:</b> 112d-3 - Designated Mining Operation	
<b>REASON FOR INSPECTION:</b> Normal I&E Program	<b>BOND CALCULATION TYPE:</b> None	<b>BOND AMOUNT:</b> \$4,158,340.68	
<b>DATE OF COMPLAINT:</b> NA	<b>POST INSP. CONTACTS:</b> None	<b>JOINT INSP. AGENCY:</b> None	
<b>WEATHER:</b> Cloudy	<b>INSPECTOR'S SIGNATURE:</b>

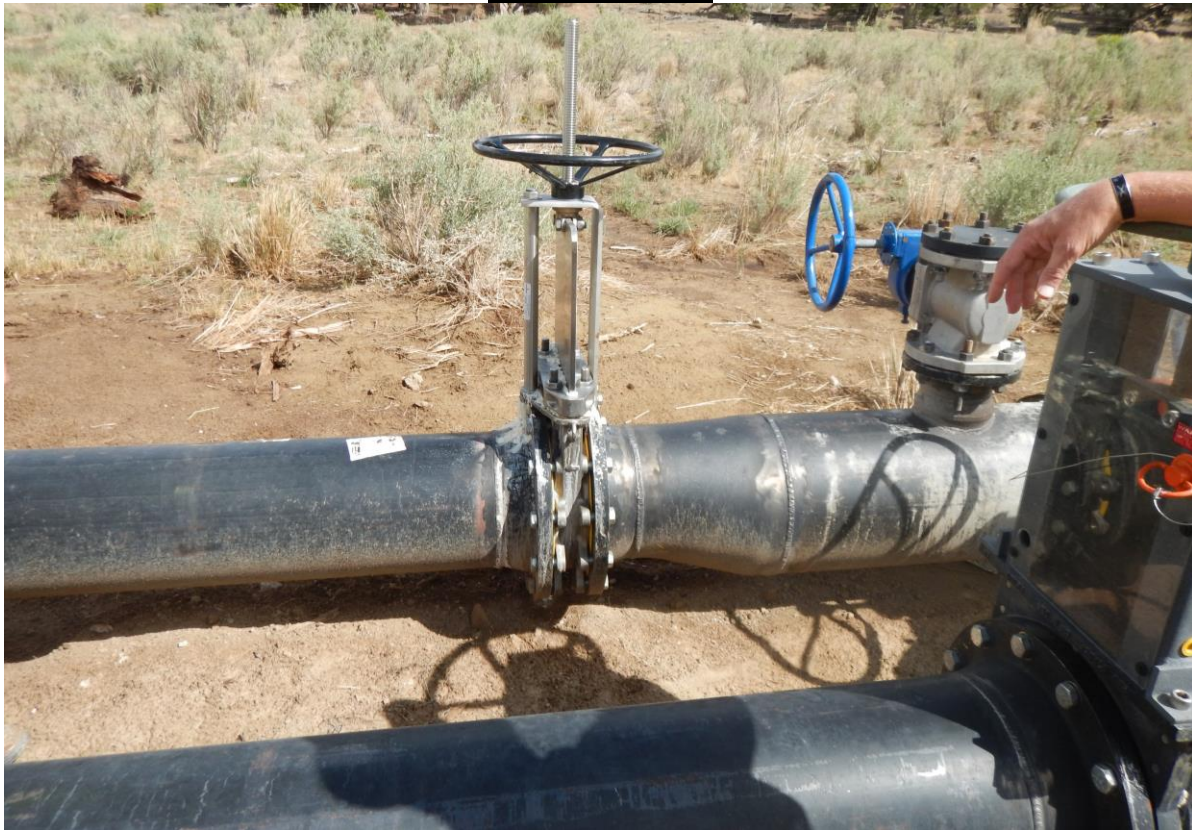
Subsurface subsidence monitoring well 15H-SSMW was observed on the 4-3H(V) pad. This pad has been interim reclaimed however successful vegetation has not completely been established. The Division was able to observe the pipeline adjacent to this pad where the January 2, 2018 spill occurred. This undesirable event occurred where the pipeline size was being increased and a valve that joined the two sections of pipe leaked. The leak has since been fixed. A coating of brine is still evident from where the barn liquor initially leaked. This white coating may make it difficult to see a future leak since the pipeline is already discolored. Cleaning the pipe after a leak may make identifying future leaks easier as a new white stain would be more alarming than trying to distinguish if an existing discoloration has increased in size.

White coating on pipe, evidence of previous spill.

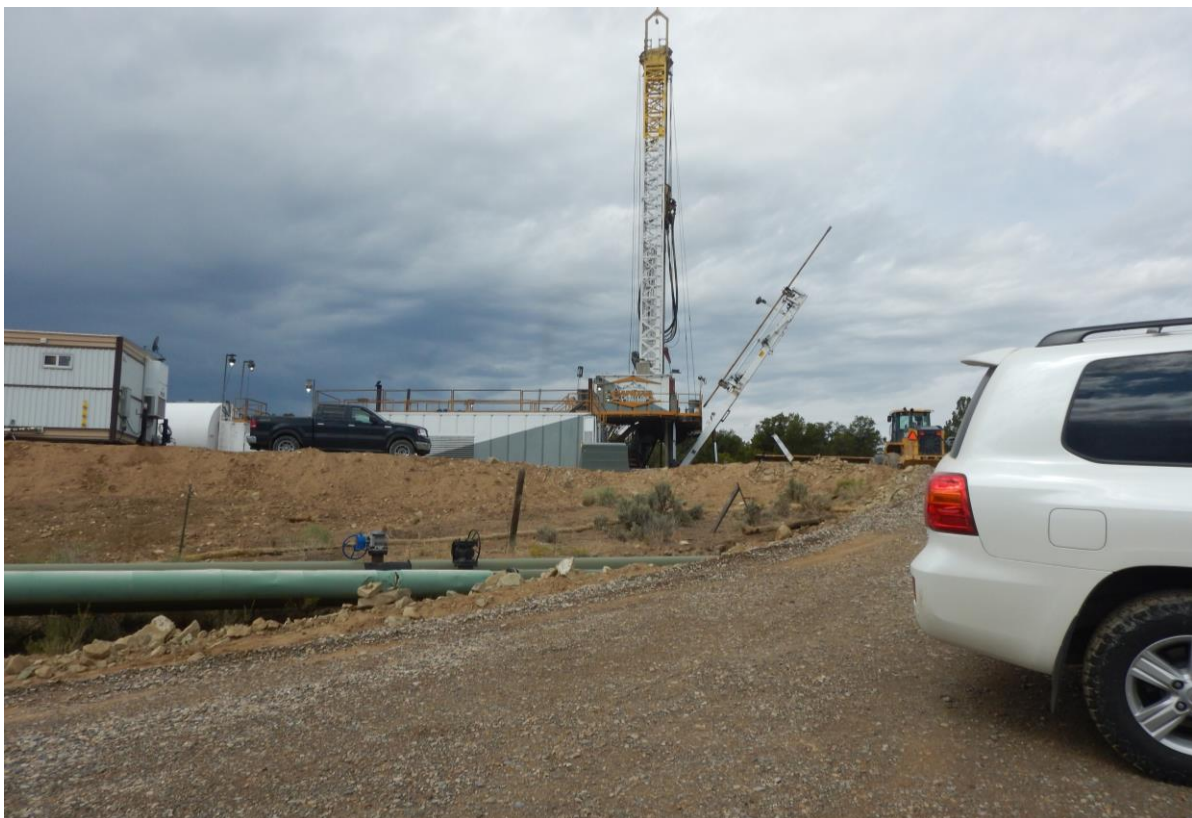
Drilling has begun on the new 13H-IR well. The rig was observed in operation tripping pipe at the time of the inspection. The new well is on the pre-existing 12H-IR pad.

Overview of 12H-IR pad where new well 13HIR is being drilled

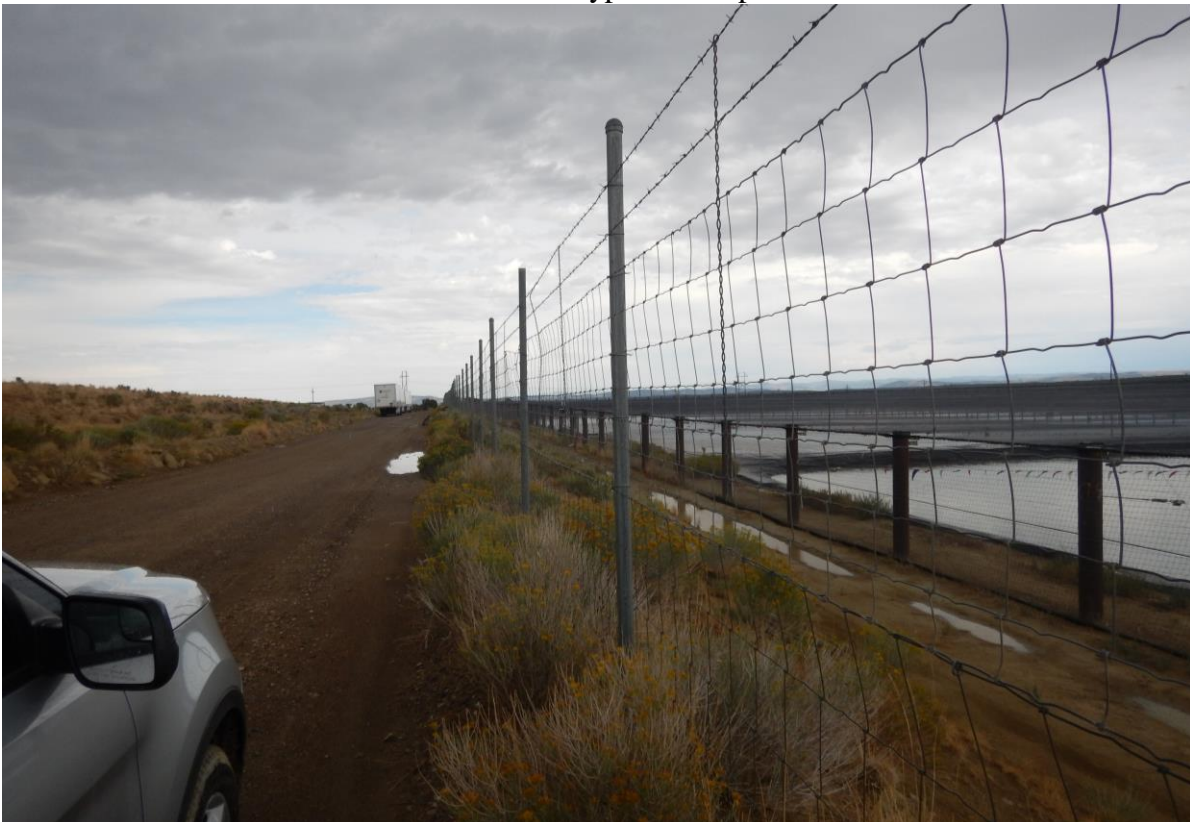
The evaporation pond was observed and discussed. Mr. Dushane explained the squawk box noise deterrent for birds. The Division heard the sound and it appeared to be effective. Next season the net covering the evaporation pond will need to be replaced.

Evaporation pond, game exclusion fencing as well as bird netting to help protect wildlife
