**COLORADO**Division of Reclamation,
Mining and Safety

MINERALS PROGRAM INSPECTION REPORT**PHONE: (303) 866-3567**

MINE NAME: San Luis Project	MINE/PROSPECTING ID#: M-1988-112	MINERAL: Gold and silver	COUNTY: Costilla
INSPECTION TYPE: Monitoring	INSPECTOR(S): Lucas J. West	INSP. DATE: August 14, 2018	INSP. TIME: 10:05
OPERATOR: Battle Mountain Resources, Inc.	OPERATOR REPRESENTATIVE: Julio Madrid, Melissa Chalona	TYPE OF OPERATION: 112d-3 - Designated Mining Operation	
REASON FOR INSPECTION: Normal I&E Program	BOND CALCULATION TYPE: None	BOND AMOUNT: \$7,400,000.00	
DATE OF COMPLAINT: NA	POST INSP. CONTACTS: None	JOINT INSP. AGENCY: None	
WEATHER: Clear	INSPECTOR'S SIGNATURE:

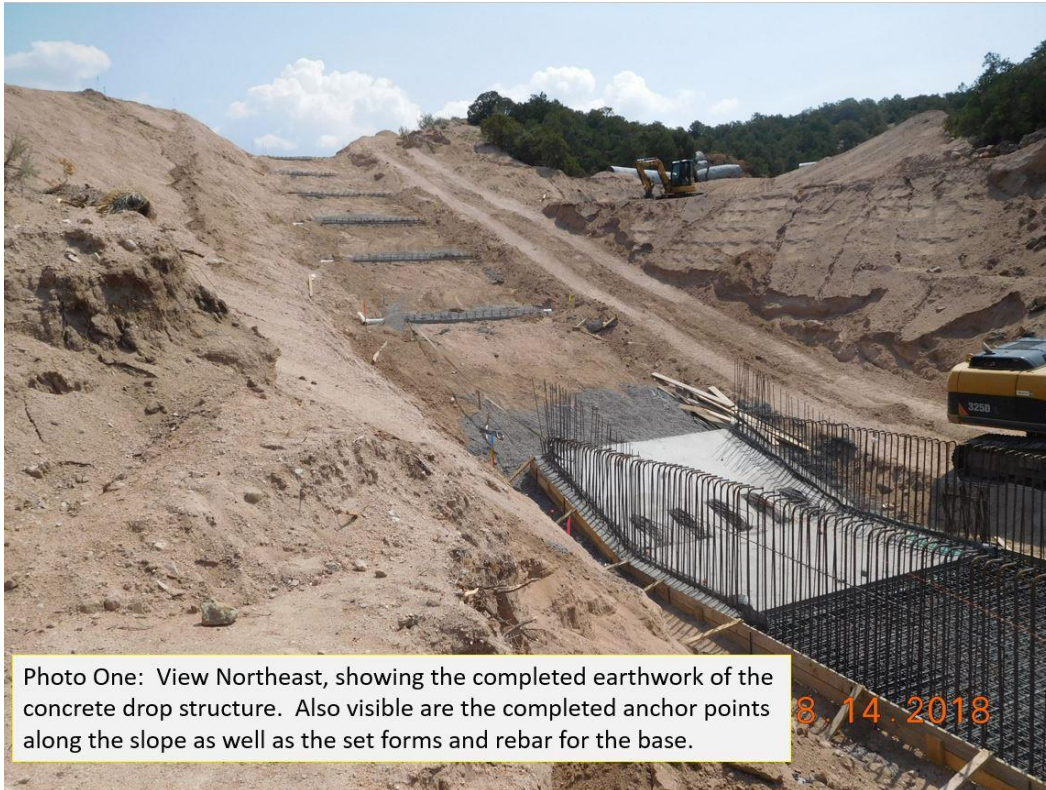
The main focus of this inspection was to monitor the construction of the new concrete drop structure located adjacent to the tailings dam. All grading and earthwork for the drop structure has been completed and appears to be stable and in good condition. The anchor points along the structure as well as two sections of concrete have been formed and poured. Crews were in the process of setting and tying in the re-bar for the next two sections to be poured. The current progress of the structure can be seen in Photos One through Three. All conditions of the construction appear to be stable and in good condition and the progress appears to be progressing as designed.

Photo One: View Northeast, showing the completed earthwork of the concrete drop structure. Also visible are the completed anchor points along the slope as well as the set forms and rebar for the base.

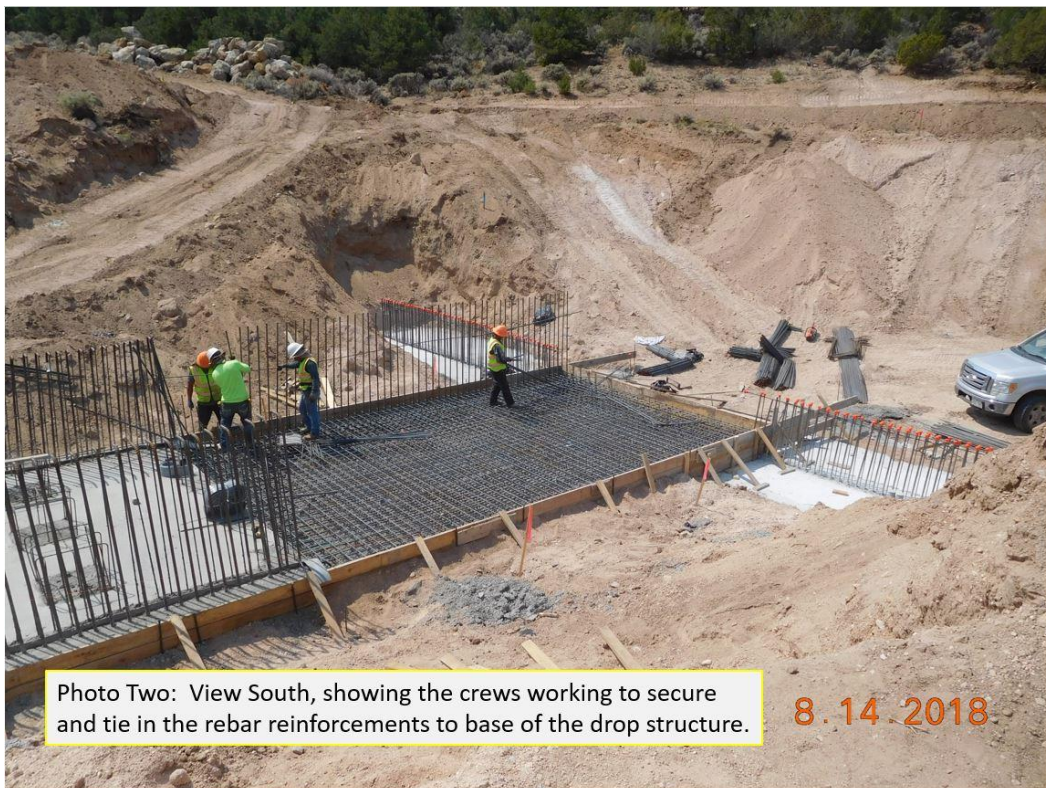
Photo Two: View South, showing the crews working to secure and tie in the rebar reinforcements to base of the drop structure.

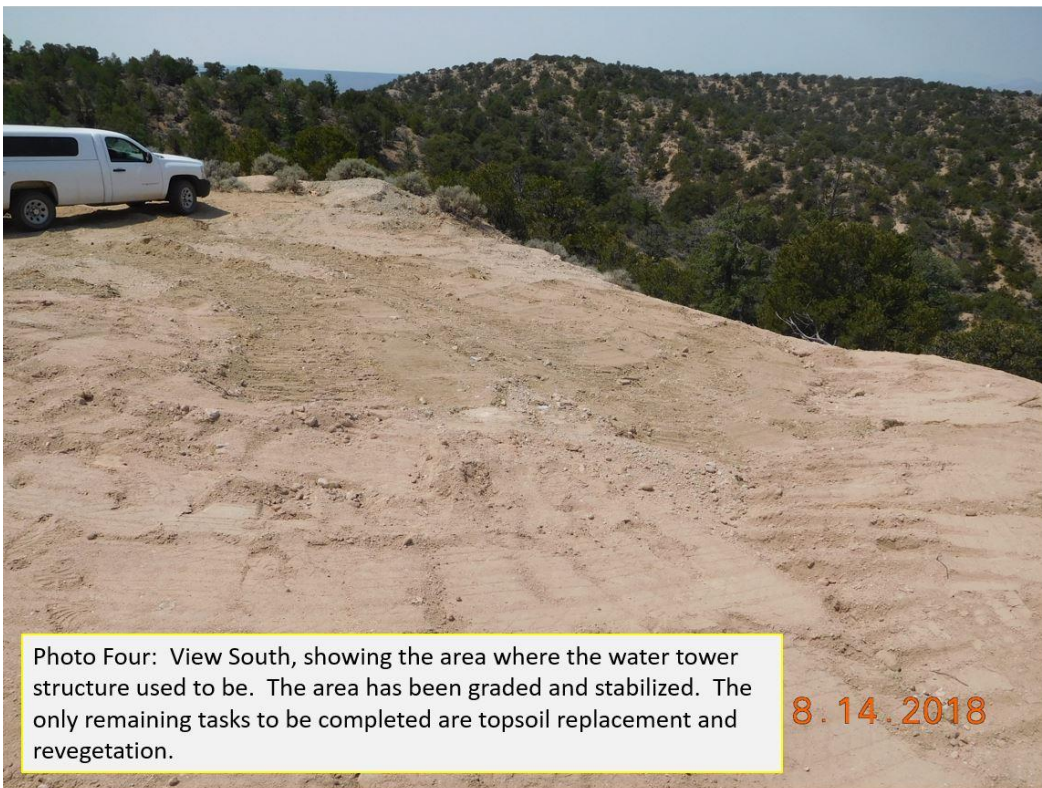
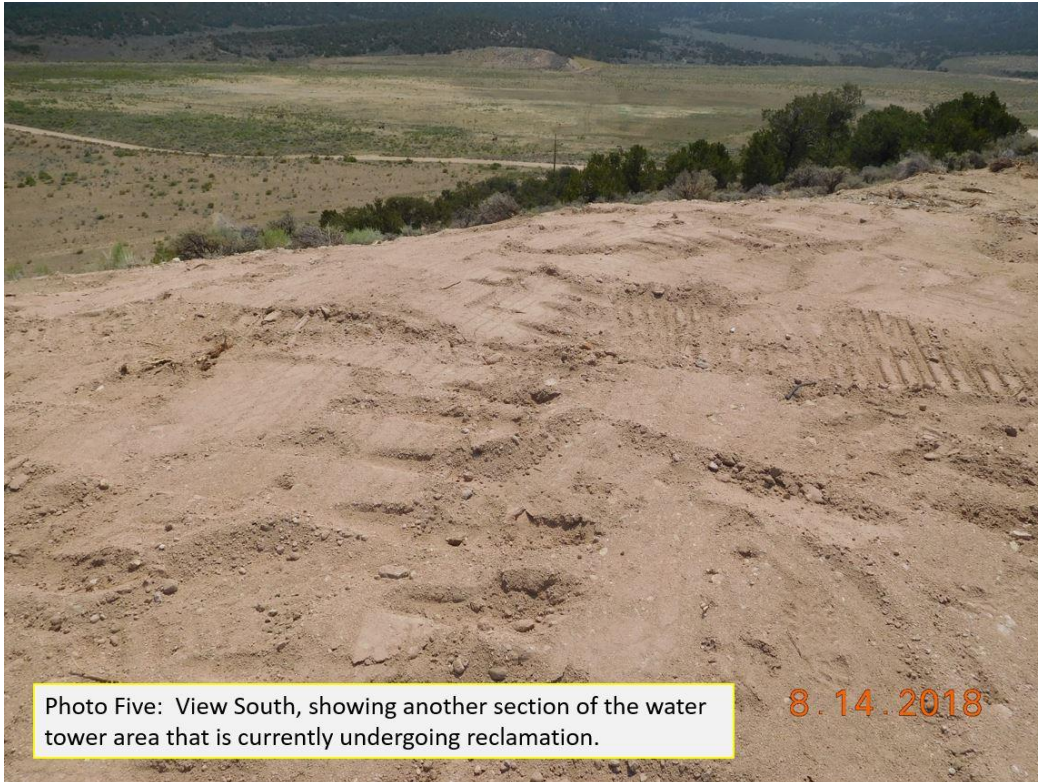
Other areas of the permitted area were inspected for upcoming and ongoing reclamation tasks. Those areas include the water tower and facility, areas along the access road that can be reclaimed and storm water control structures located on site. The condition of the water tower area can be seen in Photos Four and Five. The remaining tasks that remain to be completed is, final cleanup and topsoil with revegetation.
