MINERALS PROGRAM INSPECTION REPORT**PHONE: (303) 866-3567**

MINE NAME: Klondike Pit	MINE/PROSPECTING ID#: M-1981-220	MINERAL: Sand and gravel	COUNTY: San Miguel
INSPECTION TYPE: Monitoring	INSPECTOR(S): Lucas J. West	INSP. DATE: August 23, 2018	INSP. TIME: 11:45
OPERATOR: San Miguel County	OPERATOR REPRESENTATIVE: None	TYPE OF OPERATION: 112c - Construction Regular Operation	
REASON FOR INSPECTION: Normal I&E Program	BOND CALCULATION TYPE: None	BOND AMOUNT: \$0.00	
DATE OF COMPLAINT: NA	POST INSP. CONTACTS: None	JOINT INSP. AGENCY: None	
WEATHER: Clear	INSPECTOR'S SIGNATURE:

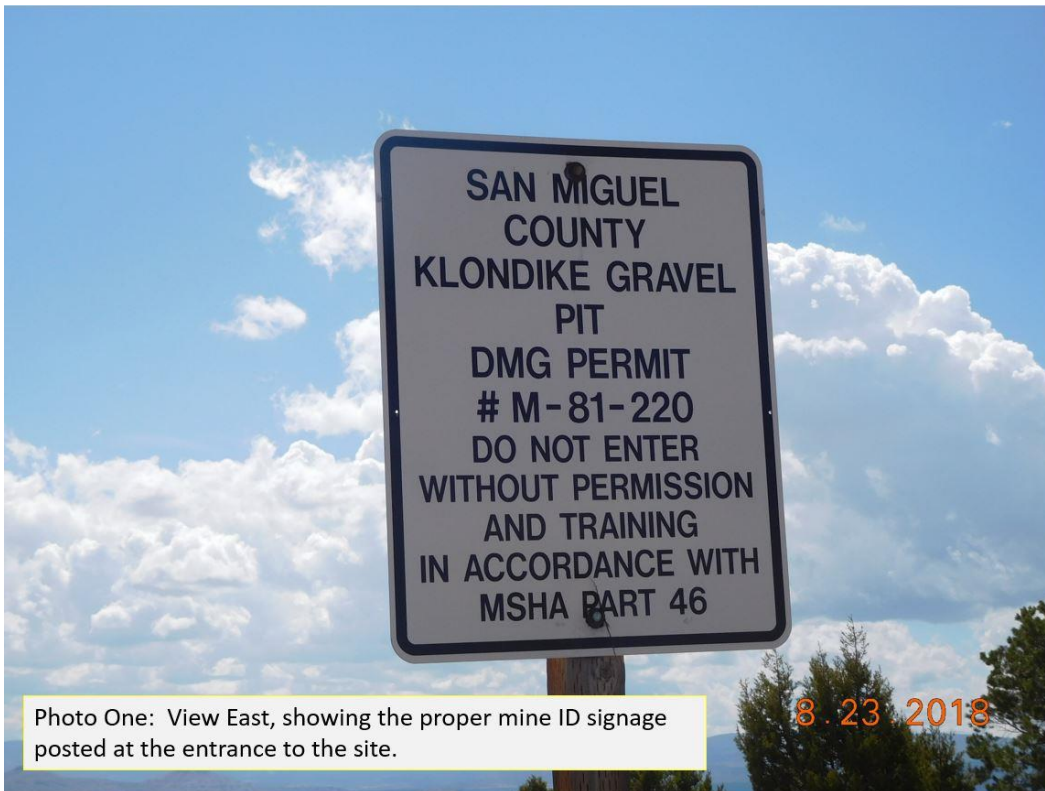
The proper mine identification signage was posted at the entrance to the site and can be seen in Photo One. The permit boundaries were also clearly delineated. The active mining area consists of a small highwall that is approximately 20 feet tall and 50 linear feet in length. The highwall appears to be stable, in good condition and can be seen in Photo Two. Various equipment including a dozer, front end loader and crusher were located on the pit floor. Also located on the pit floor were various stockpiles of materials that all appear to be in good condition and stable. An example of the stockpiles can be seen in Photo Three. Evidence of recent hauling from the stockpiles was noted. The remainder of the pit floor and stockpile area appears to be stable. The area is free from noxious weeds and can be seen in Photo Four.
