## MINERALS PROGRAM INSPECTION REPORT

| <b>MINE NAME:</b><br>Cash & Who Do Mines | <b>MINE/PROSPECTING ID#:</b><br>M-1983-141 | <b>MINERAL:</b><br>Gold and silver | <b>COUNTY:</b><br>Boulder |
| <b>INSPECTION TYPE:</b><br>Monitoring | <b>INSPECTOR(S):</b><br>Amy Eschberger | <b>INSP. DATE:</b><br>August 9, 2018 | <b>INSP. TIME:</b><br>12:15 |
| <b>OPERATOR:</b><br>Colorado Milling Company, LLC | <b>OPERATOR REPRESENTATIVE:</b><br>Chris Voorhees | <b>TYPE OF OPERATION:</b><br>110(2) - Hard Rock Limited Impact | |

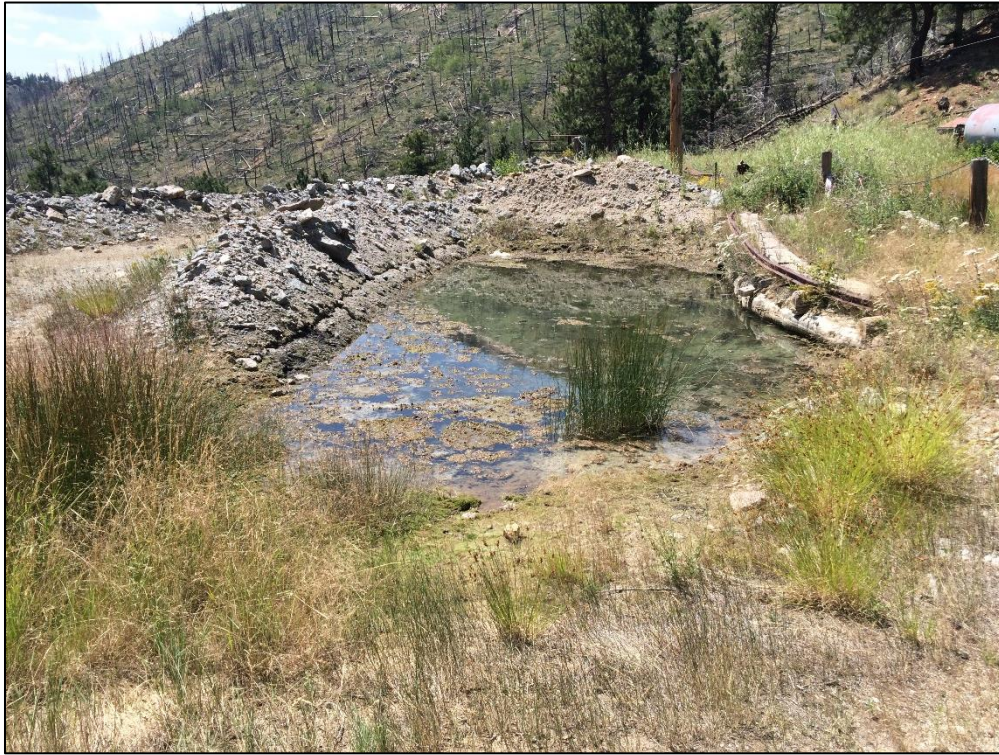
This inspection was limited to observations of the Mount Royale Adit area (see enclosed Google Earth image) which includes the main ore bin/loadout, waste rock dumps, the Mount Royale No. 1 Adit, and a small sediment pond located below the mine portal (on top of the waste rock pile; approximately 35 feet from the portal). The Division observed the Mount Royale No. 1 adit to be discharging water at approximately the same rate as observed during the Division's last inspection on August 1, 2017. The water leaves an orange stain on the ground surface consistent with an iron oxide precipitate. Several grasses and forbs were observed growing in the discharge area. The mine water reports to the sediment pond. The sediment pond was partially full of water during the inspection. No water was observed to be discharging from the pond. Additionally, no water was observed to be expressing at the toe of the waste rock pile. According to the permit record, the Division has asserted that a discharge permit is necessary for the water discharging from the mine. The Water Quality Control Division (WQCD) of the Colorado Department of Public Health and Environment has determined that a discharge permit is not required for this operation. The Division intends to follow up with the WQCD on this matter.

**Photo 1.** View looking southwest at small sediment pond located on top of waste rock pile, just below the Mount Royale No. 1 Adit. Note pond was partially full of water during inspection.

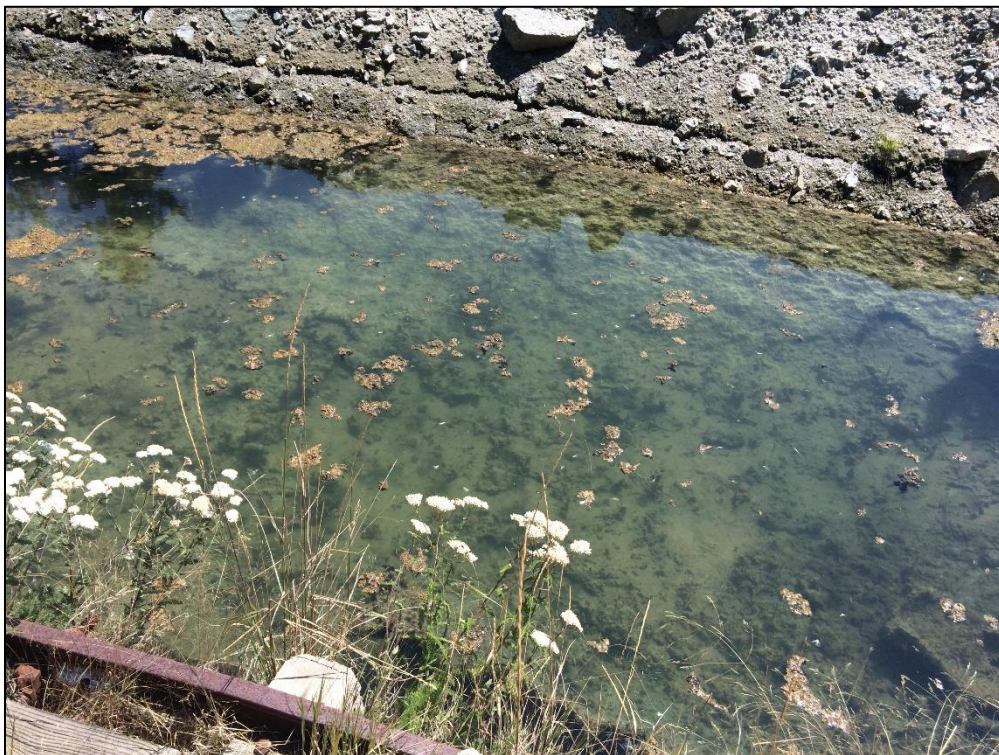
**Photo 2.** Closer view of water held in pond (shown in Photo 1). Note blue-green color of water possibly indicating elevated aluminum concentrations.

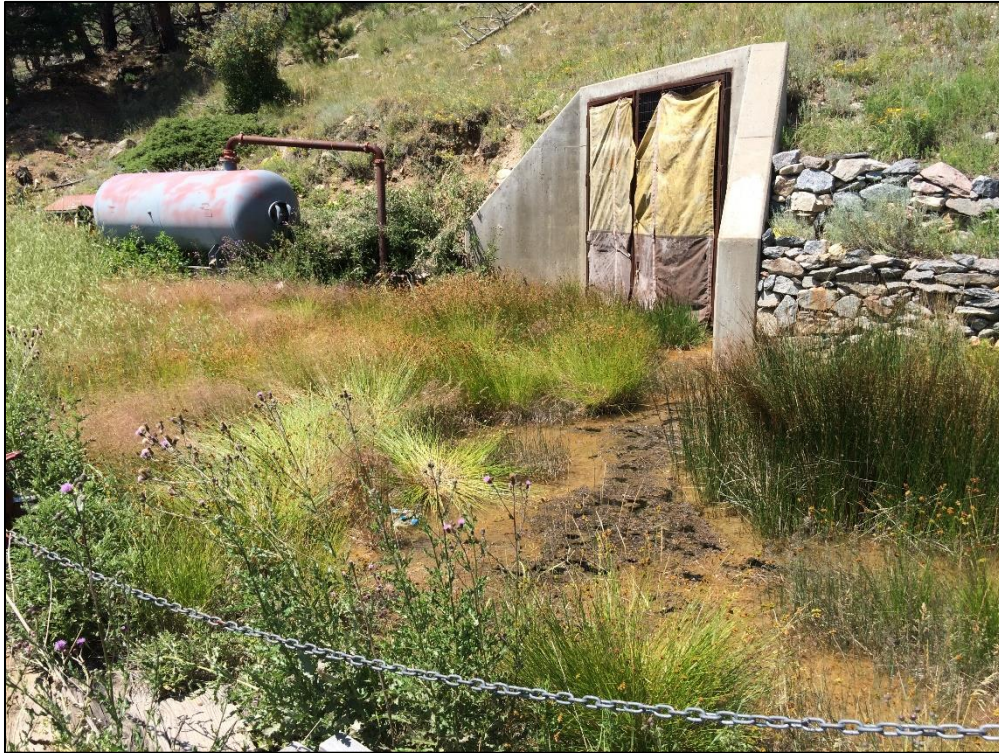
**Photo 3.** View looking west from edge of sediment pond showing water draining from Mount Royale No. 1 adit toward pond. Note orange staining of ground where drainage occurs.

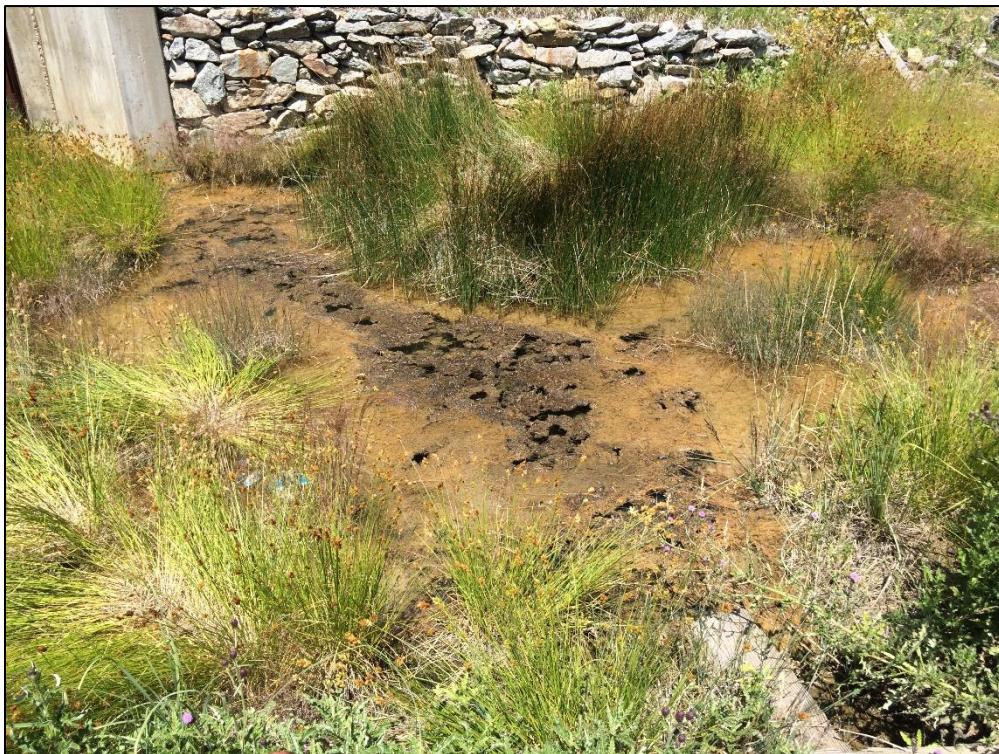
**Photo 4.** Closer view of water draining from Mount Royale No. 1 adit. Note orange staining of ground where drainage occurs.

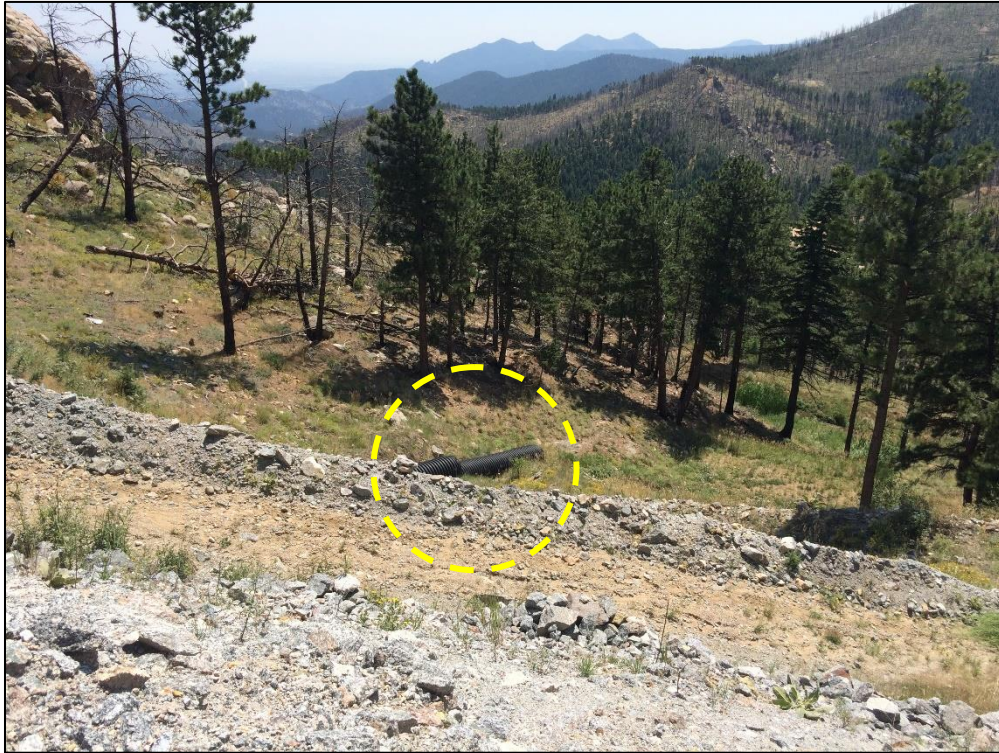
**Photo 5.** View looking down at toe of waste rock pile. Black pipe installed at toe (circled) drains the pile, including any water infiltrating the pile from the sediment pond. No water was exiting the pipe during the inspection.

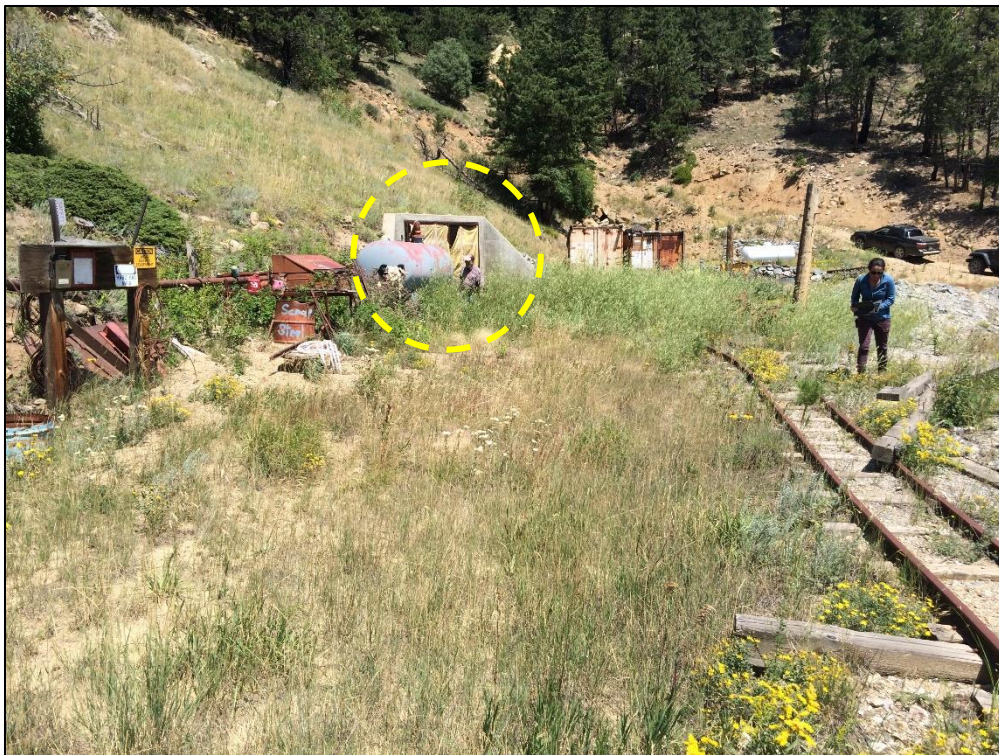
**Photo 6.** View looking northeast across Mount Royale Adit area. Adit is circled in background.
