COLORADO

MINERALS PROGRAM INSPECTION REPORT

MINE NAME: Gold Hill Mill	MINE/PROSPECTING ID#: M-1994-117	MINERAL: Gold and silver	COUNTY: Boulder
INSPECTION TYPE: Monitoring	INSPECTOR(S): Amy Eschberger	INSP. DATE: August 9, 2018	INSP. TIME: 10:30
OPERATOR: Colorado Milling Company, LLC	OPERATOR REPRESENTATIVE: Chris Voorhees	TYPE OF OPERATION: 110(2) - Hard Rock Limited Impact	
REASON FOR INSPECTION: Normal I&E Program	BOND CALCULATION TYPE: None	BOND AMOUNT: \$56,200.00	
DATE OF COMPLAINT: NA	POST INSP. CONTACTS: Stephanie Carter, Amber Sanderson	JOINT INSP. AGENCY: U.S.BLM	
WEATHER: Clear	INSPECTOR'S SIGNATURE:

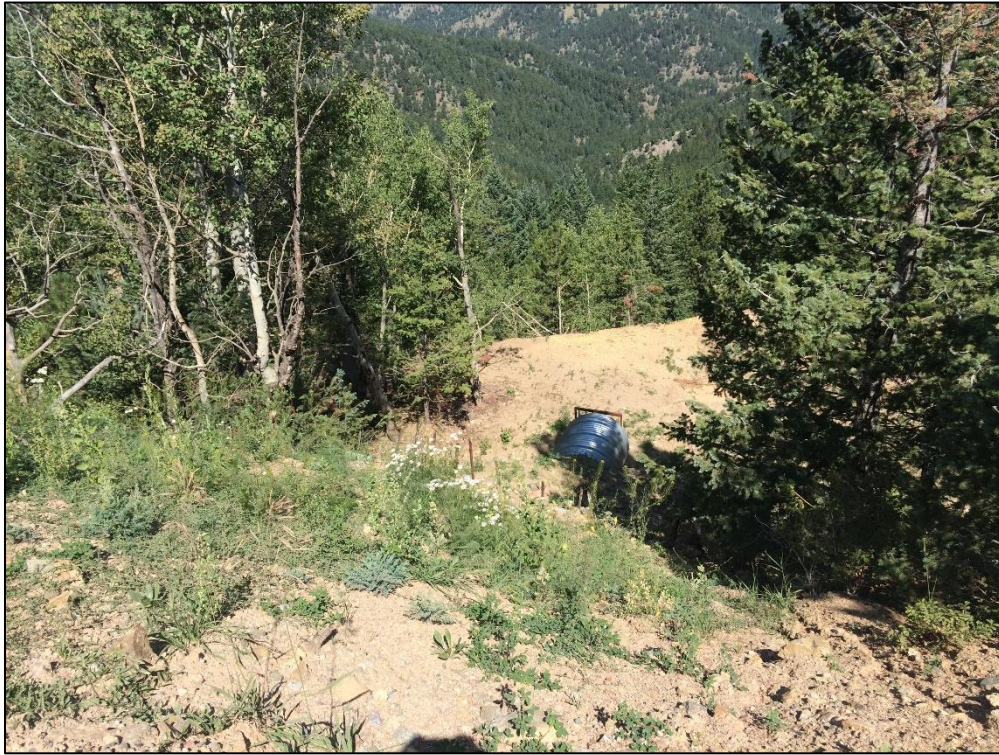
During the inspection, the Division observed the subsidence area from Sunshine Canyon Drive (**Photo 1**), and from the Time Mines adit below. The temporary structures being used to temporarily stabilize the subsidence area during the last inspection have been replaced with more permanent structures. The subsidence area appeared to be stabilized with some vegetative cover consisting primarily of annual weeds. No damage to Sunshine Canyon Drive was observed (**Photo 2**), and the orange cones the county had placed on the road to warn passersby had been removed. As mentioned above, the Division has no evidence indicated the subsidence area has been repaired in accordance with the county permit. The operator should provide this documentation to the Division as soon as possible.

Photo 1. View looking down from northern edge of Sunshine Canyon Drive at Times Mine subsidence area. Culvert extending from portal visible below.

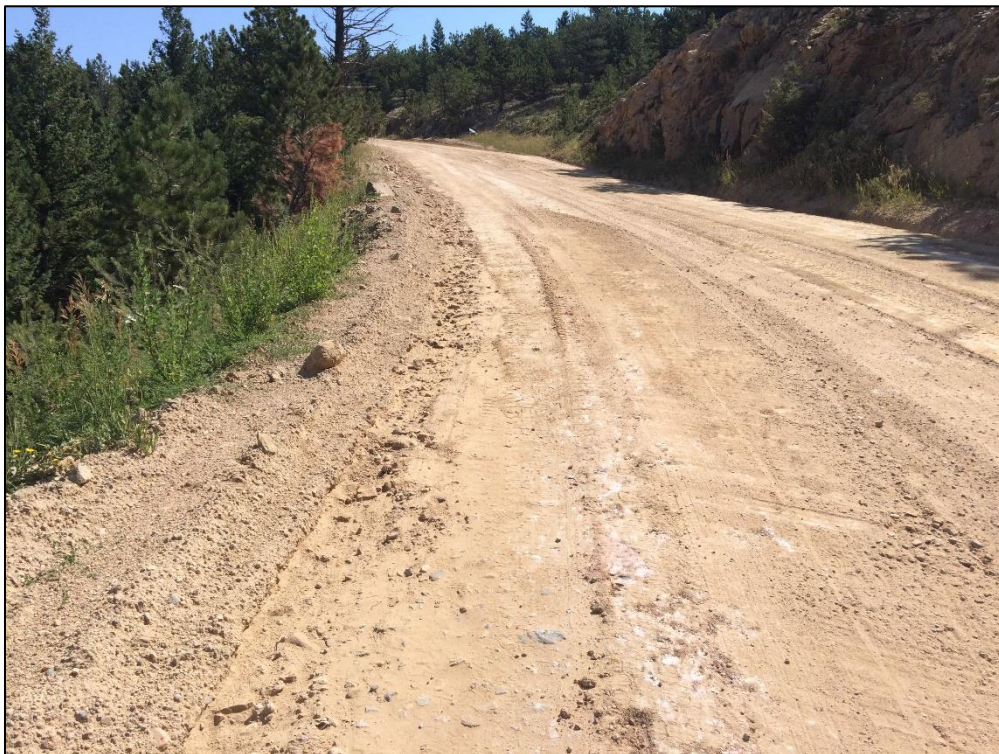
Photo 2. View looking east down Sunshine Canyon Drive (above Times Mine subsidence area), showing road in good condition at time of inspection.

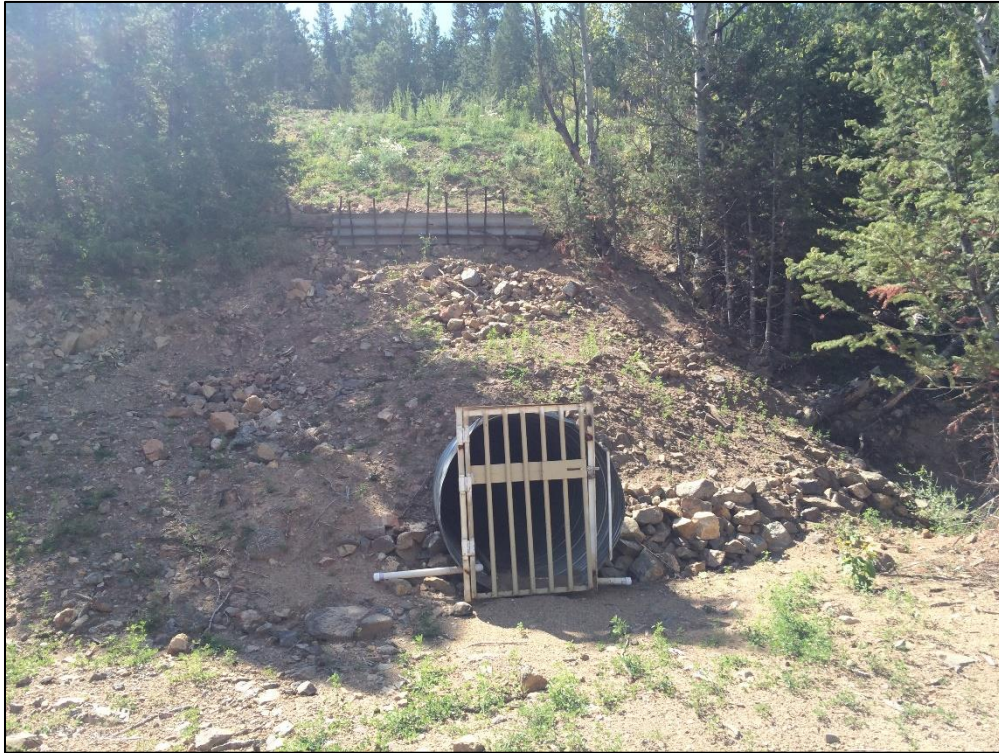
The Division observed the Times Mine adit (**Photos 3 and 4**) located approximately 50 feet below Sunshine Canyon Drive. An access road to the adit exists off Sunshine Canyon Drive, approximately 200 feet west of the adit. A new metal culvert is installed in the adit, which Mr. Voorhees indicated is 20 feet in length. The end of the culvert was secured by a locked metal gate. The Division observed two PVC pipes running through the culvert and extending out through holes punched in the sides of the culvert (**Photo 5**). The pipes extending out from the culvert were disconnected. The Division observed a portion of the existing PVC pipe that runs up Lick Skillet Gulch (**Photos 6 and 7**), which was used to convey water to the Times Mine adit in the past. This pipeline does not currently terminate in the adit area. The new pipe the operator wishes to install down Lick Skillet Gulch was still stored on top of the large ore stockpile adjacent to the mill (**Photo 8**), as observed during the last inspection. It appeared the operator is maintaining compliance with the cease and desist order issued by the Board Order mailed on October 30, 2017, prohibiting the operator from installing, replacing, maintaining or using any off-site infrastructure intended to convey or store water for the operation.

Photo 3. View of Times Mine adit located approximately 50 feet below Sunshine Canyon Drive. Fill area above adit appeared to be stable. Portal was secured by locked metal gate.

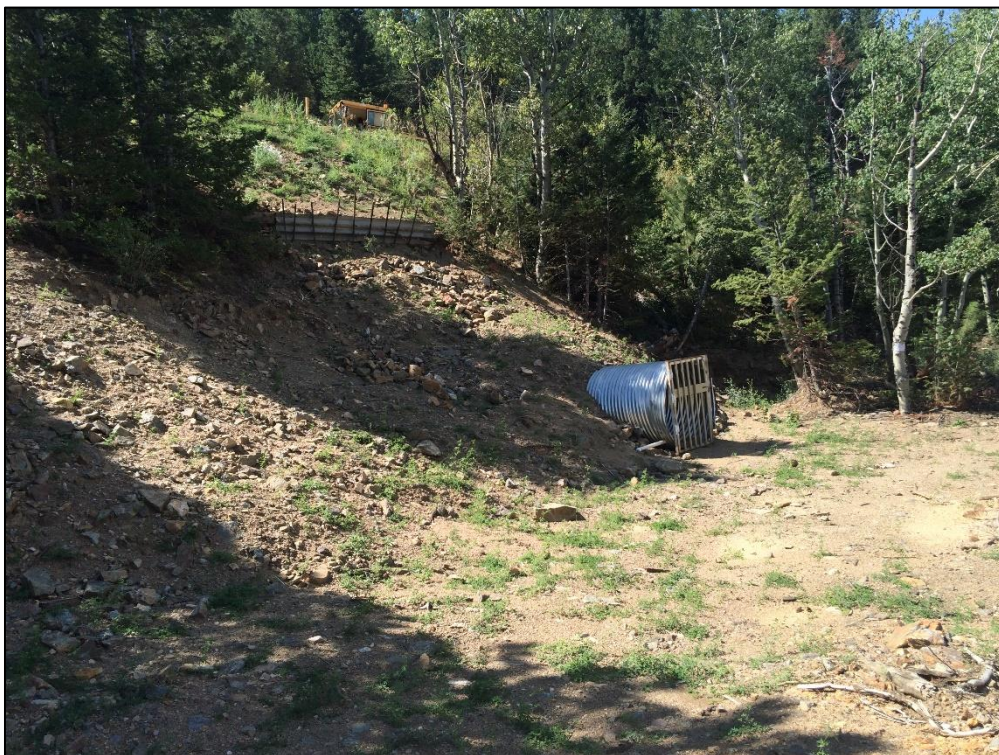
Photo 4. View of Times Mine adit located approximately 50 feet below Sunshine Canyon Drive. Fill area above adit appeared to be stable.

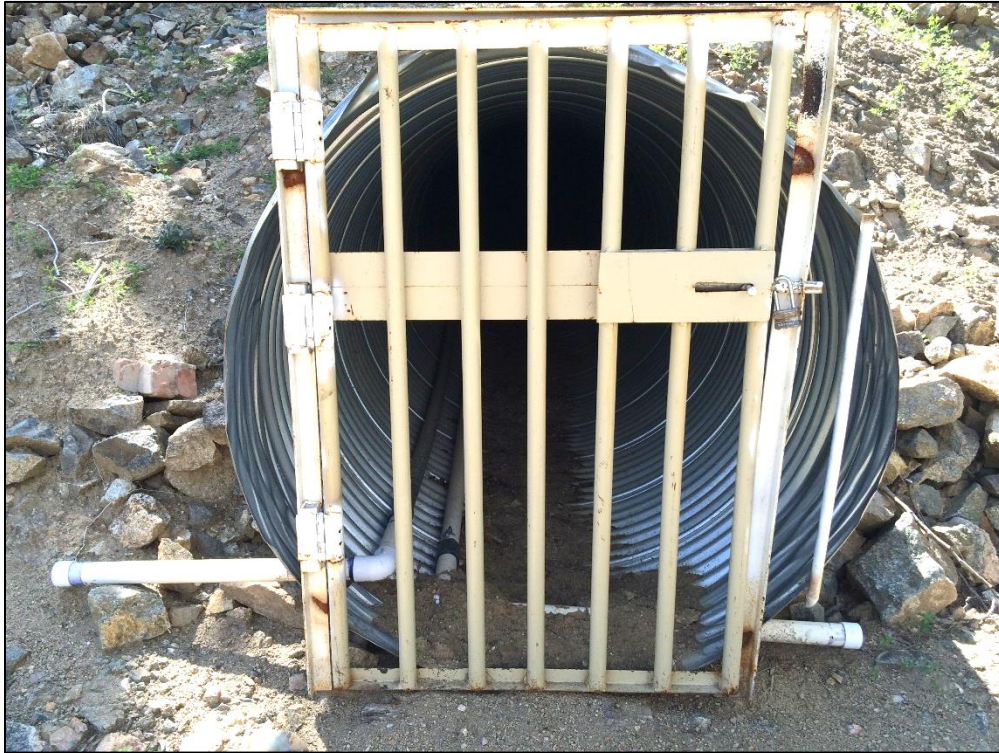
Photo 5. Closer view of Times Mine adit, showing portal secured by locked metal gate. Note two disconnected pipelines extending from adit.

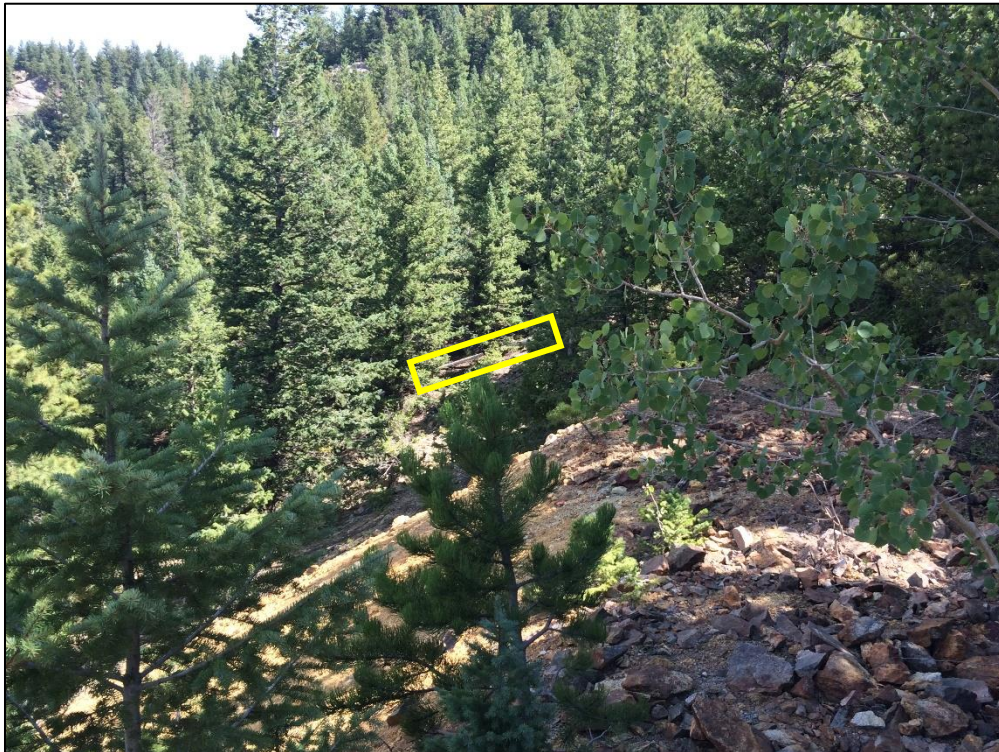
Photo 6. View looking northeast from Times Mine area, showing portion of existing pipeline in Lick Skillet Gulch visible (indicated with box). This pipeline was once used to convey water from the creek to the mill operation.

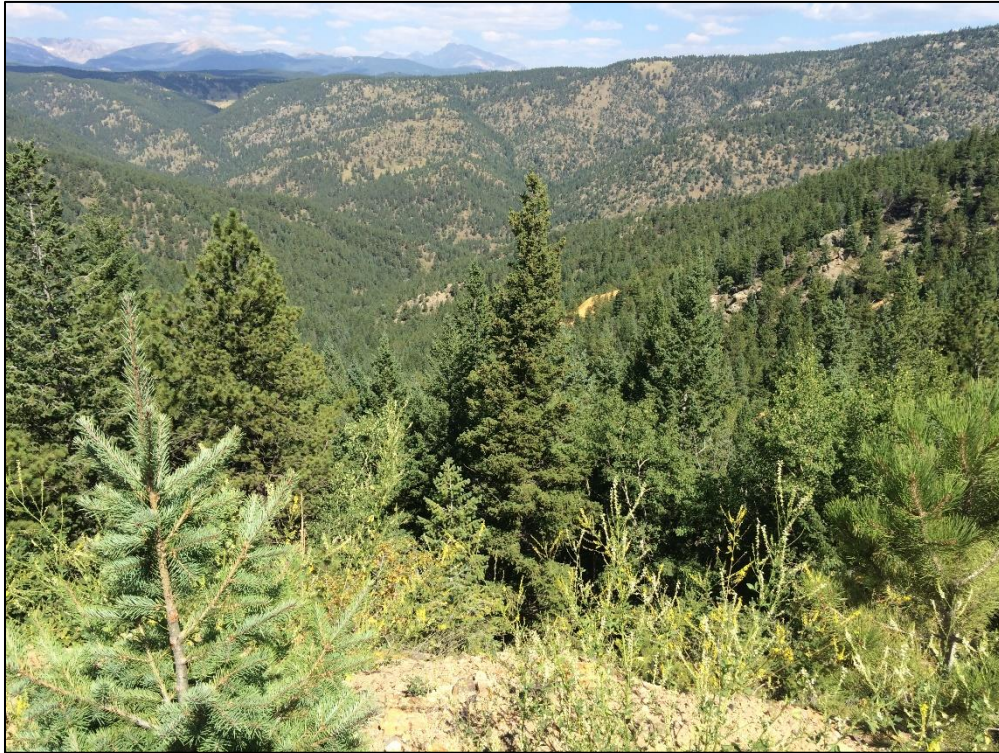
Photo 7. View looking down Lick Skillet Gulch where operator proposes installing a new water pipeline to convey water from Left Hand Creek to the mill.

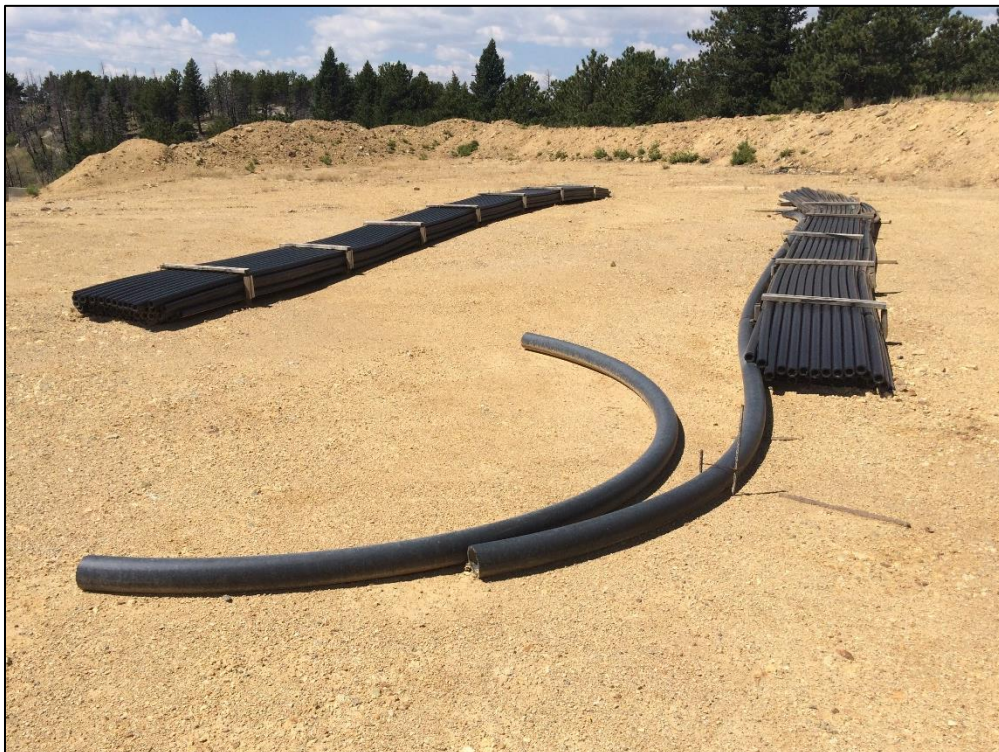
Photo 8. View of two-inch HDPE pipe currently stored on top of ore stockpile. This pipe is intended to replace the existing pipeline present in Lick Skillet Gulch to convey water pumped from Left Hand Creek to the mill.

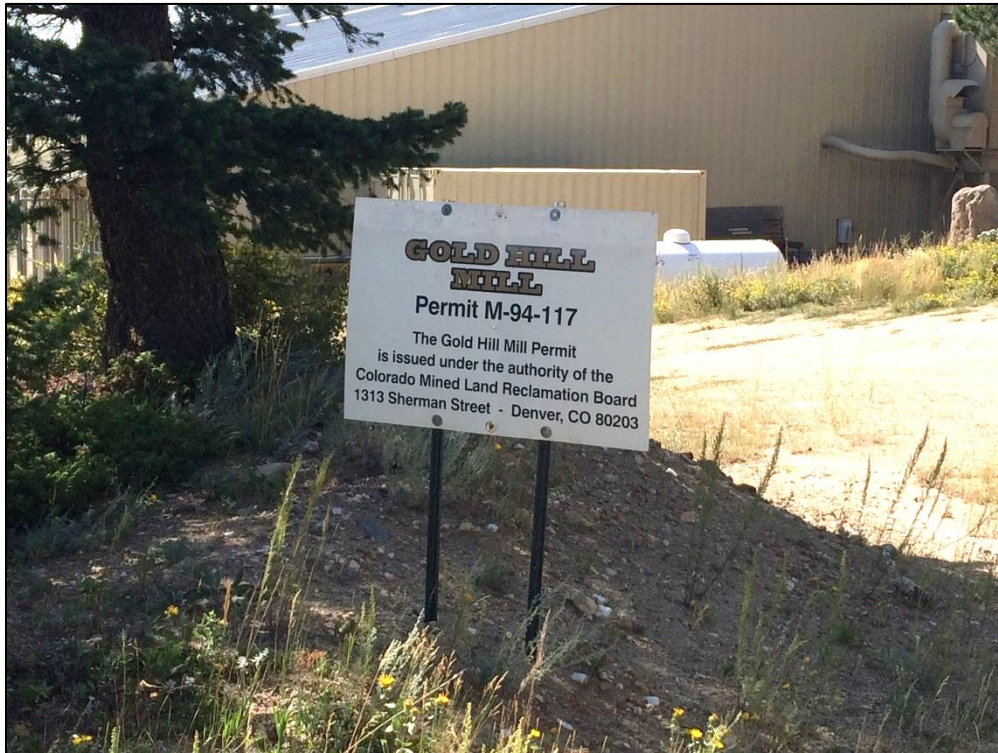
The Division's August 1, 2017 inspection report cited a problem for failure to post a mine identification sign at the entrance of the mine site. This problem was considered abated on September 27, 2017 after the operator submitted photographic documentation showing the permit sign had been placed at the mine entrance as required. During the inspection, the Division observed the permit sign was still present at the mine entrance off of Sunshine Canyon Drive (**Photo 9**).

Photo 9. View of permit sign for Gold Hill Mill posted at mine entrance.

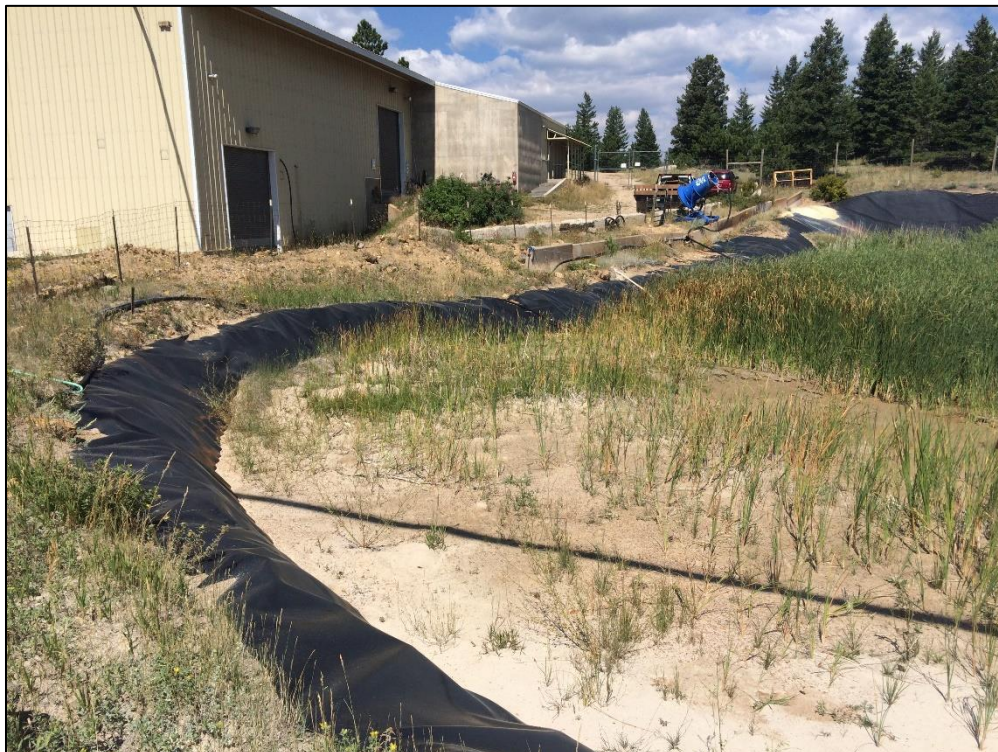
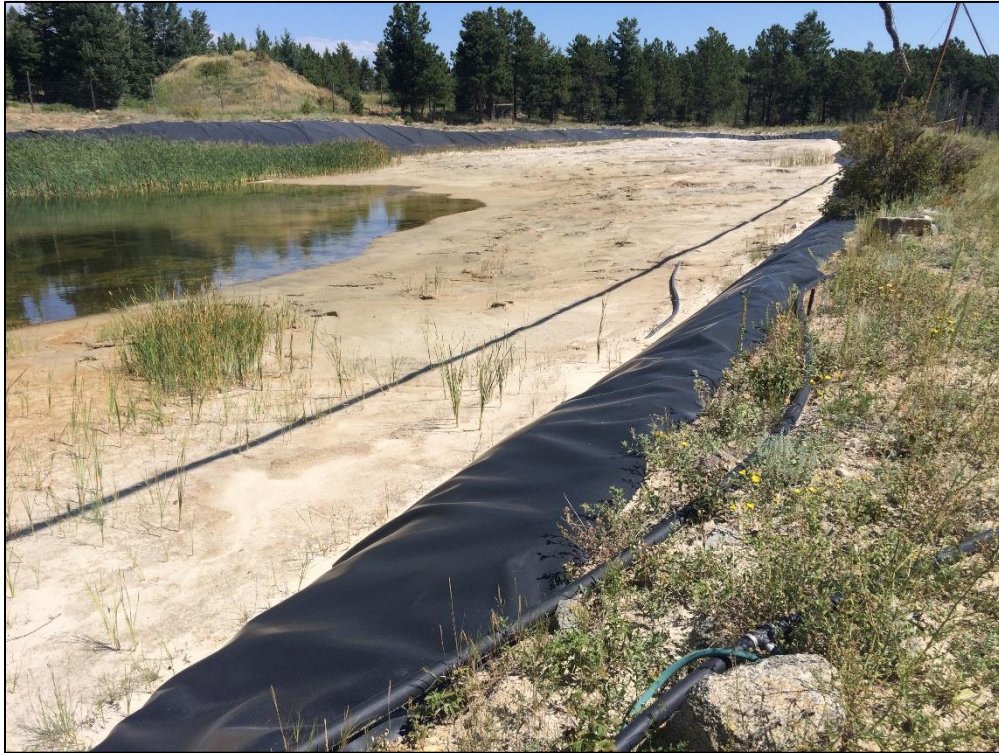
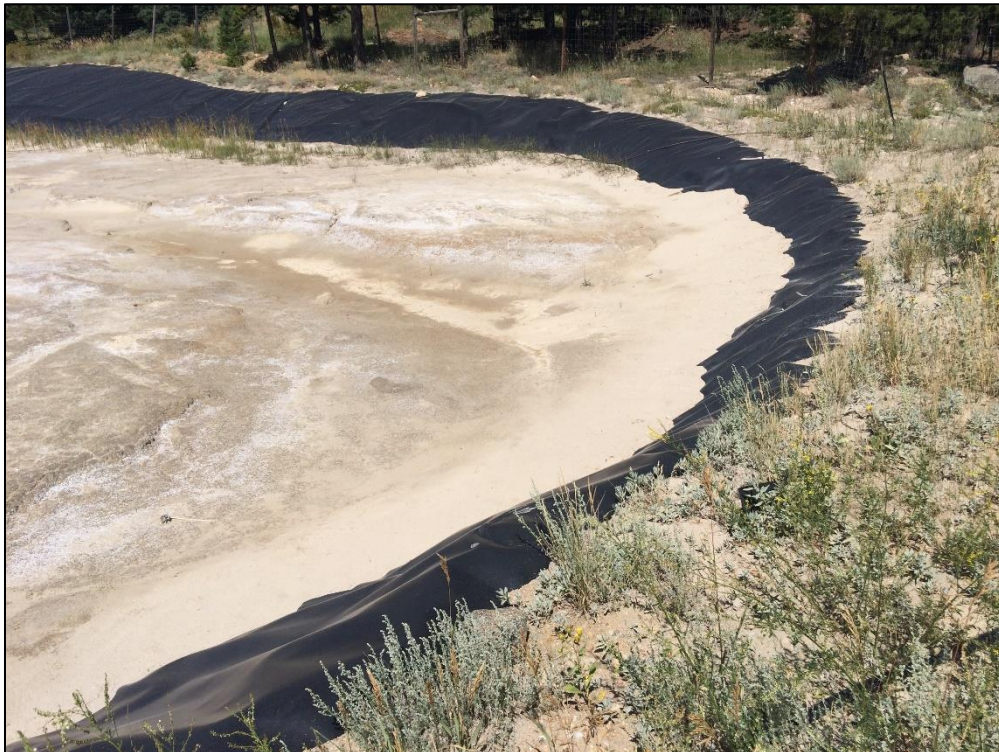
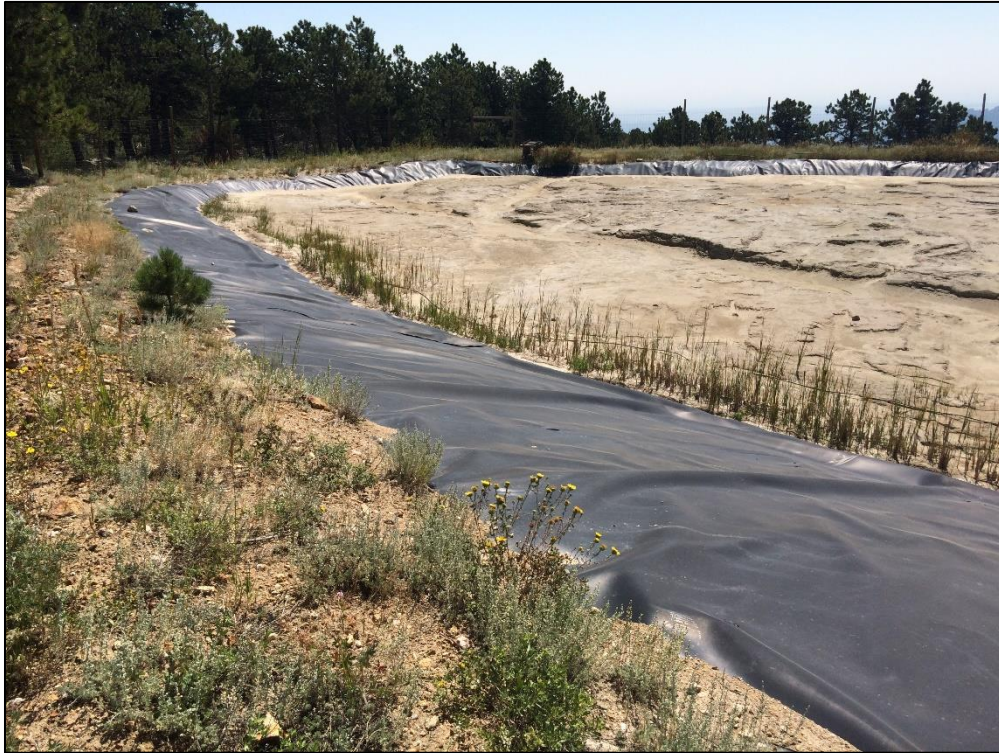
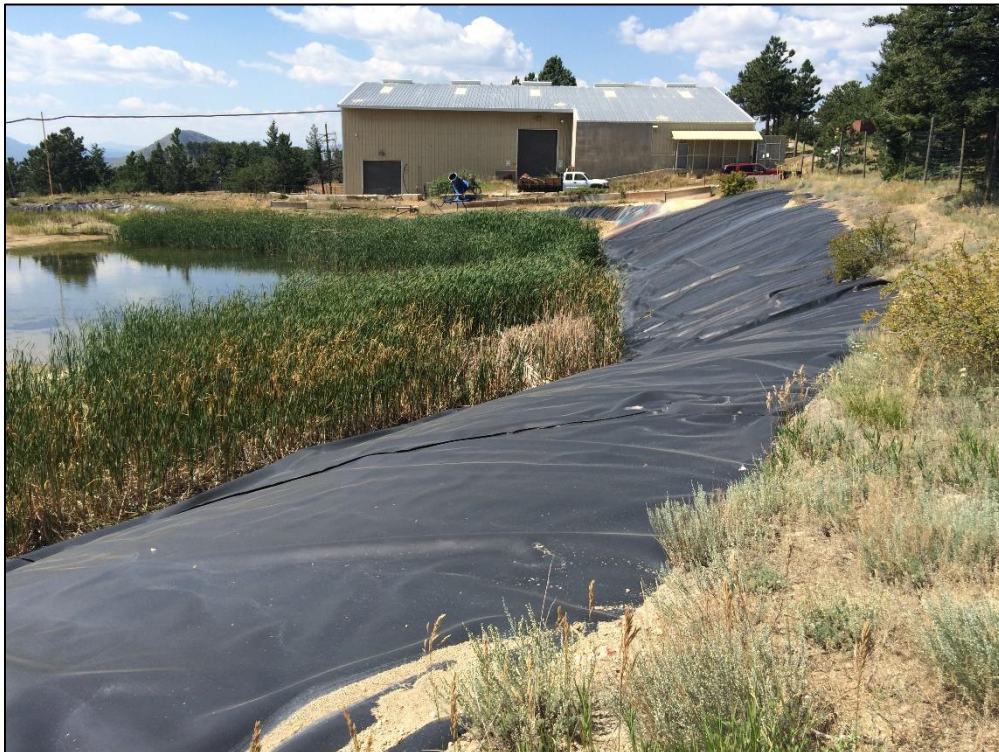
In the Division's August 1, 2017 inspection report, a problem was cited for failure to maintain the approved two feet of freeboard in the tailings impoundment. This problem was considered abated on October 27, 2017 after the operator submitted photographic documentation showing the tailings had been relocated inside the tailings impoundment to allow for a minimum two feet freeboard around the perimeter of the impoundment in accordance with the approved mining plan. During the inspection, the Division observed the tailings impoundment to have the required minimum two feet of freeboard (**Photos 10-14**). However, prior to recommencing with mill operations, the operator will need to clean out the dense cluster of cattails and other vegetation growing on the tailings deposited in the impoundment.

Photo 10. View looking across southwestern corner of tailings impoundment, showing an available freeboard of at least two feet (as required).

Photo 11. View looking across southern edge of tailings impoundment, showing an available freeboard of at least two feet (as required).

Photo 12. View looking across southeastern corner of tailings impoundment, showing an available freeboard of at least two feet (as required).

Photo 13. View looking across northeastern corner of tailings impoundment, showing an available freeboard of at least two feet (as required).

Photo 14. View looking across northern edge of tailings impoundment, showing an available freeboard of at least two feet (as required).

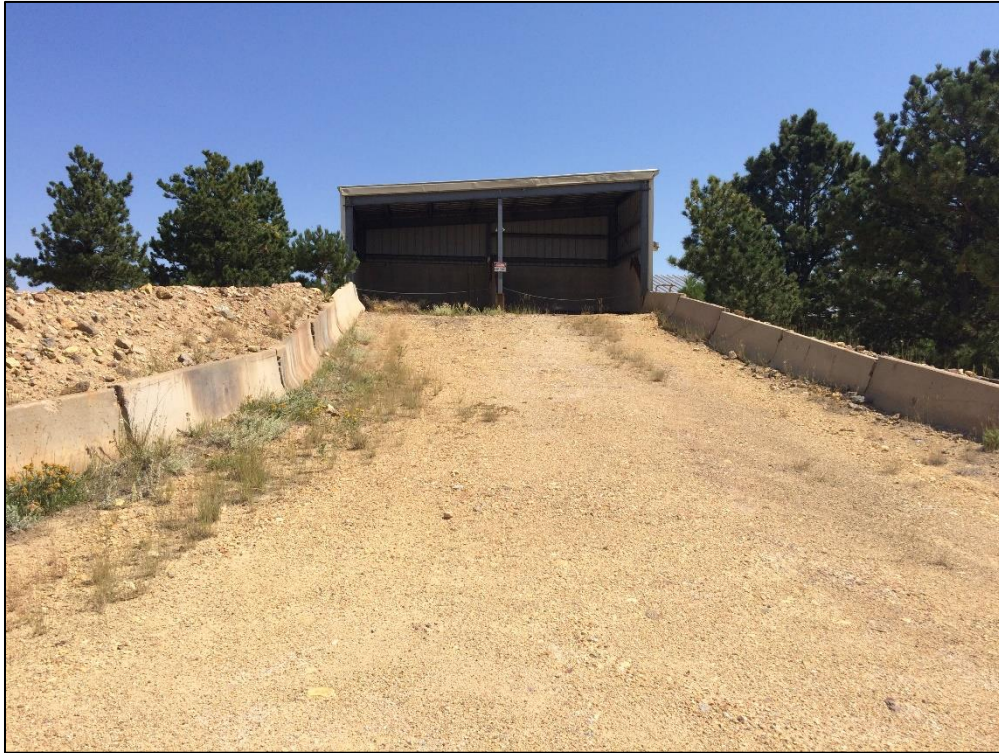
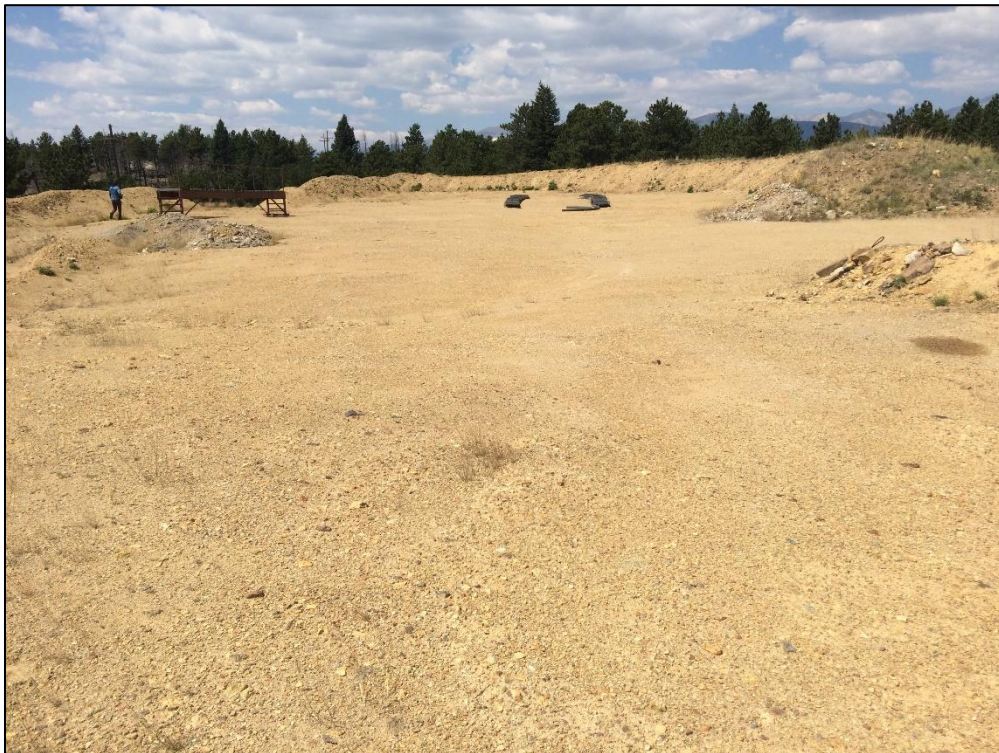
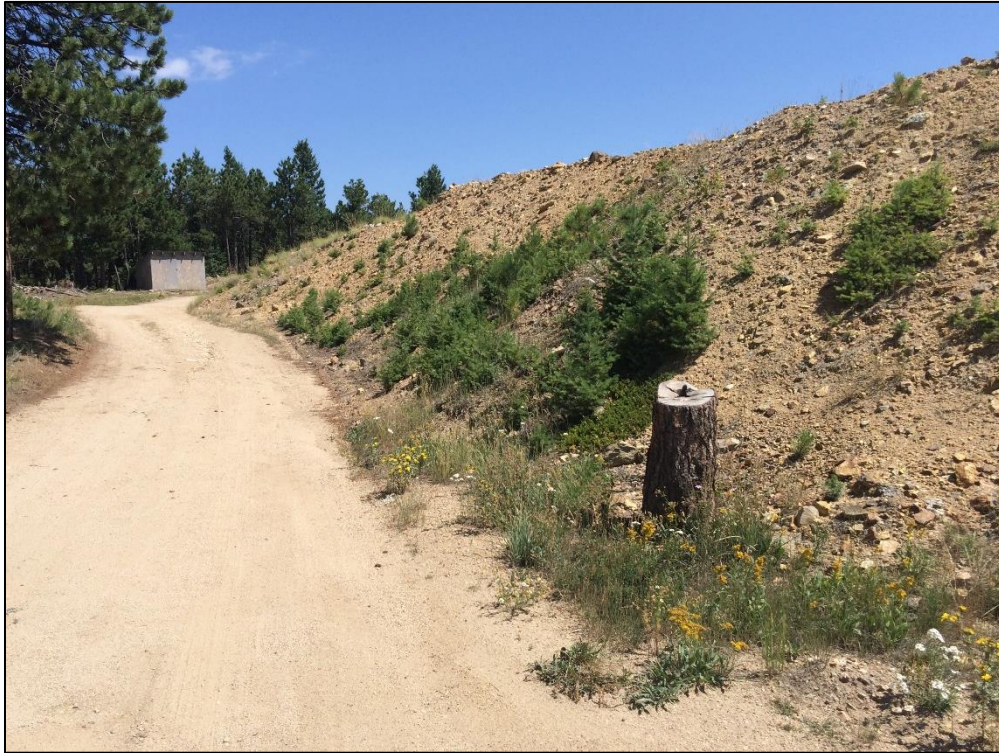
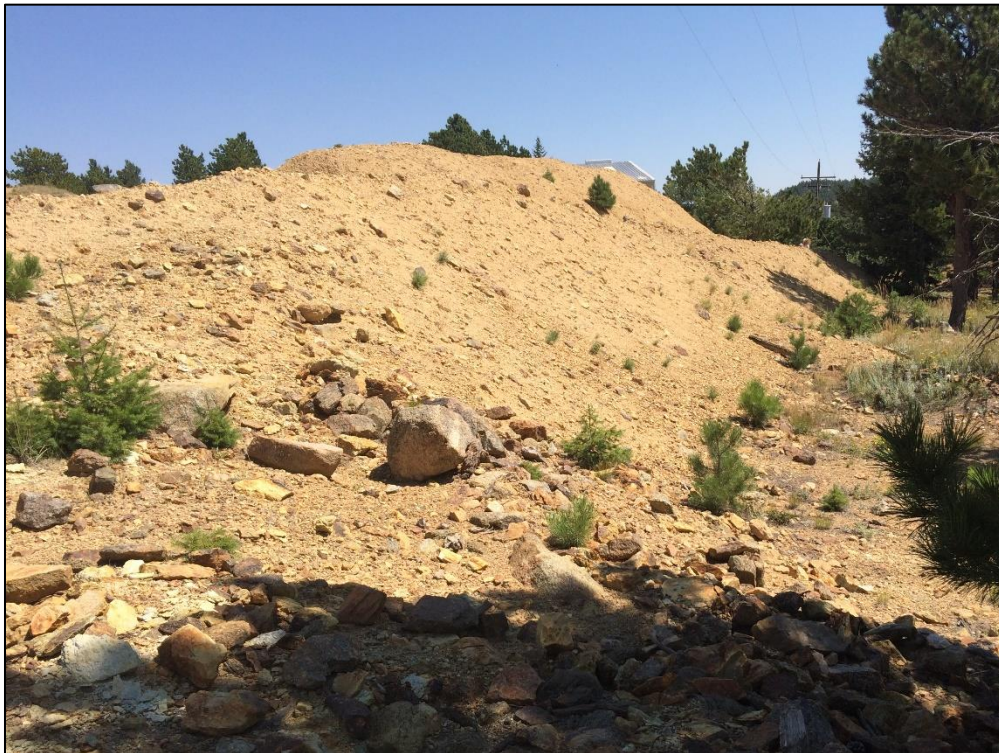
The Division observed the ore stockpile area located southwest of the mill building (**Photos 15-18**). According

to the permit file, this ore was derived from the Cash Mine located just downhill from the mill site, which is part of Permit No. M-1983-141. The operator has estimated the ore stockpile to contain approximately 35,000-40,000 tons of material that could be processed in the mill. A ramp connects the top of the stockpile to the two coarse ore bins located at the southwestern edge of the mill building. The stockpile appeared to be stable. No signs of acid rock drainage from the stockpile was observed.

Photo 15. View looking up at two coarse ore bins located at top of ramp (on ore stockpile) at southwestern edge of mill building.

Photo 16. View looking southwest across top of ore stockpile stored southwest of mill building.

Photo 17. View looking east from access road, showing northern side of ore stockpile. The stockpile slopes appeared to be stable.

Photo 18. View looking east from access road, showing southern side of ore stockpile. The stockpile slopes appeared to be stable.

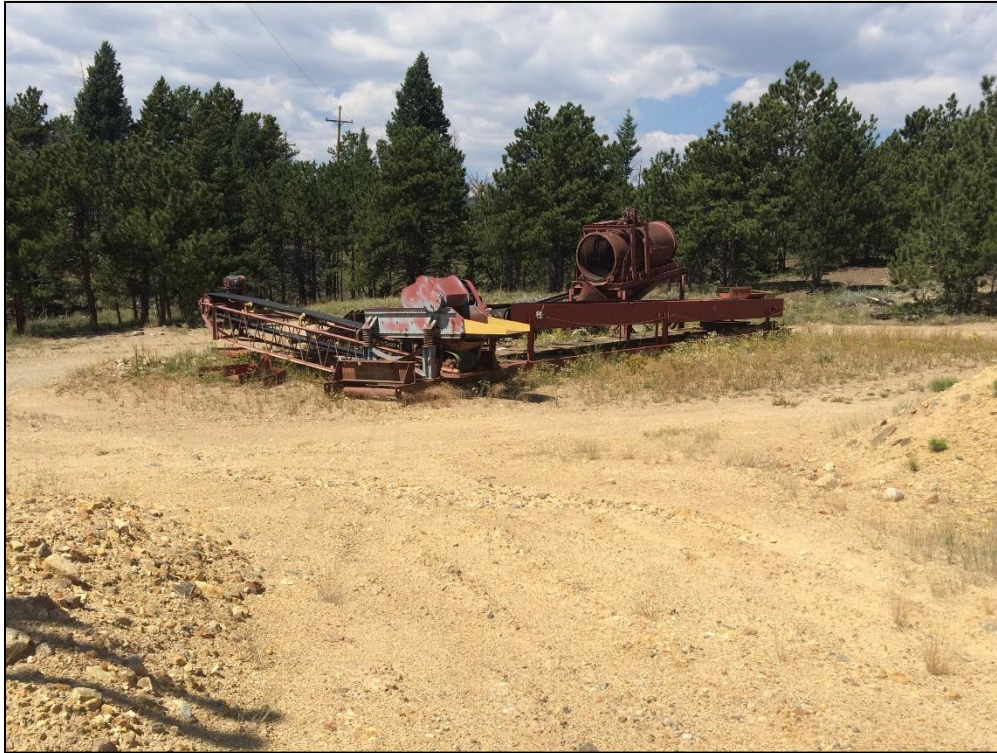
Photo 19. View looking across equipment storage area located southwest of ore stockpile. This area is within the approved permit area.

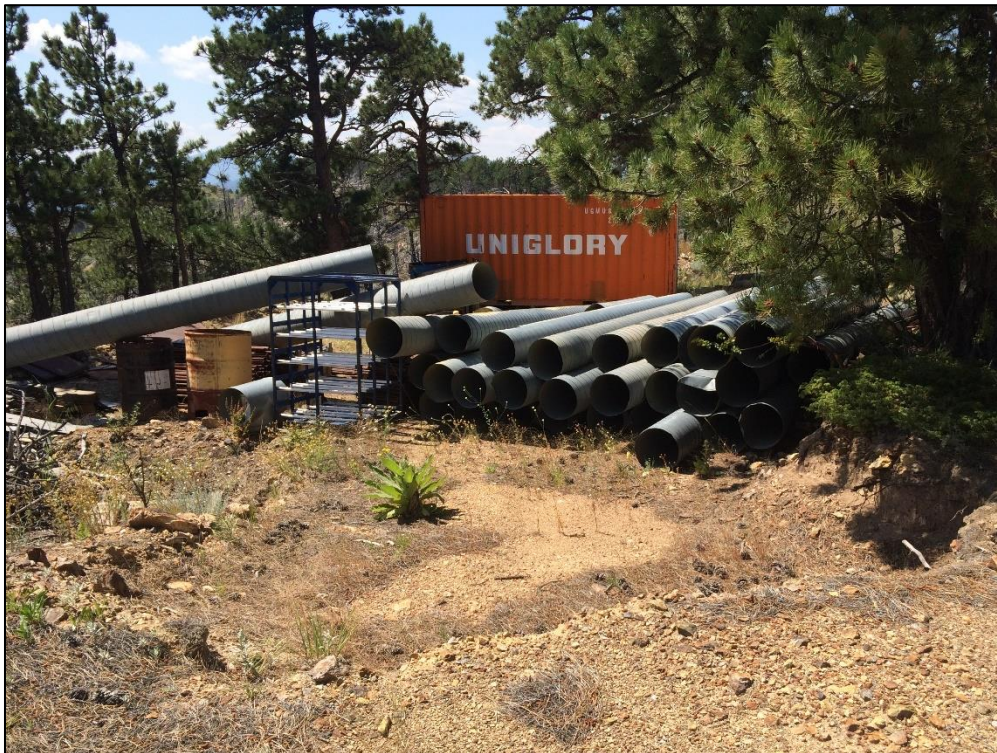
The Division observed an equipment storage area located southwest of the ore stockpile (**Photos 19 and 20**). Some of the equipment is stored partially outside of the southern permit boundary. The operator should be advised that any equipment storage areas for the mill operation are considered to be affected lands. Therefore, the operator should be sure these areas are included in the proposed amended permit area for AM-1, or relocate the equipment to within the permit area.

Photo 20. View looking across equipment storage area located southwest of ore stockpile. This area is located partially outside of the approved permit area.
