**COLORADO**Division of Reclamation,
Mining and Safety

MINERALS PROGRAM INSPECTION REPORT**PHONE: (303) 866-3567**

MINE NAME: Patty's Pit	MINE/PROSPECTING ID#: M-1998-103	MINERAL: Sand and gravel	COUNTY: Elbert
INSPECTION TYPE: Preoperation Inspection	INSPECTOR(S): Jared L. Ebert	INSP. DATE: September 5, 2018	INSP. TIME: 08:45
OPERATOR: Town of Limon	OPERATOR REPRESENTATIVE: Greg Tacha and Ed Grimes	TYPE OF OPERATION: 110c - Construction Limited Impact	
REASON FOR INSPECTION: Normal I&E Program	BOND CALCULATION TYPE: None	BOND AMOUNT: \$0.00	
DATE OF COMPLAINT: NA	POST INSP. CONTACTS: None	JOINT INSP. AGENCY: None	
WEATHER: Clear	INSPECTOR'S SIGNATURE:

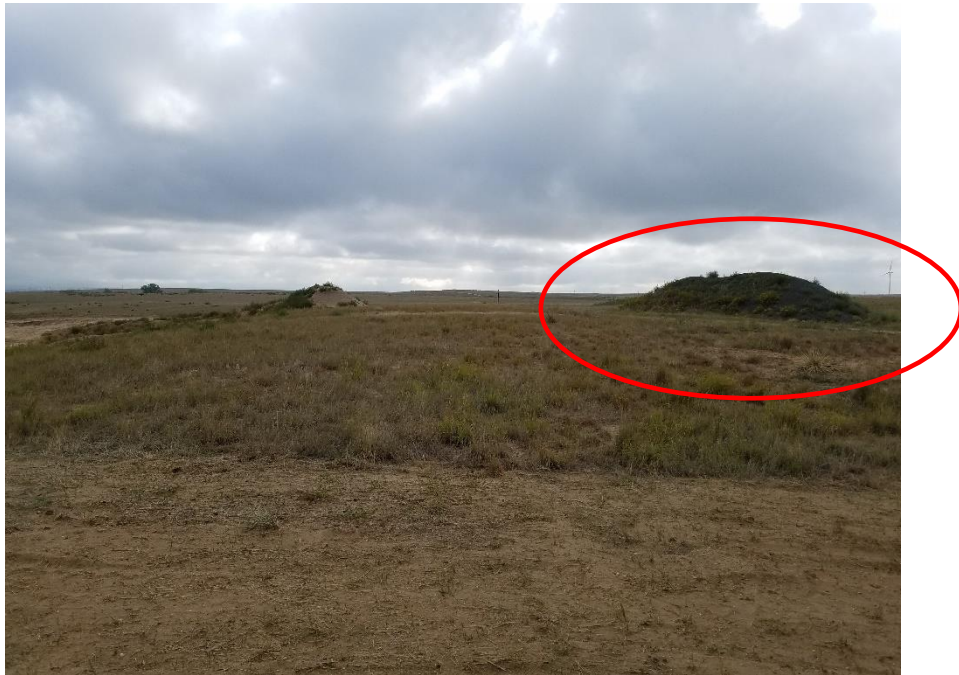
The proposed expansion area is rangeland consisting primarily of native grasses and cactus. Mining related disturbance was not observed in the expanded permit area. However, a pile of old asphalt was stockpiled southeast of the current permit area that will likely be located within the Phase 3 mining area. The structures identified in the CN01 application appear accurate and no additional structures were identified.

**Figure 1. From the south central portion of the current permit boundary looking east.
Stockpile of asphalt highlighted.**

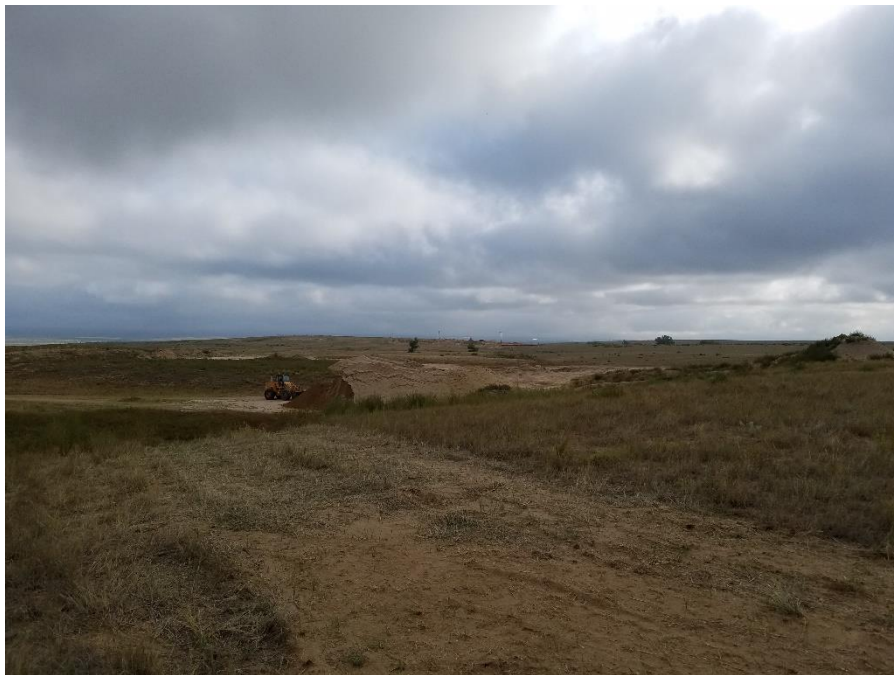
**Figure 2. From the south central portion of the current permit boundary looking
northeast.**

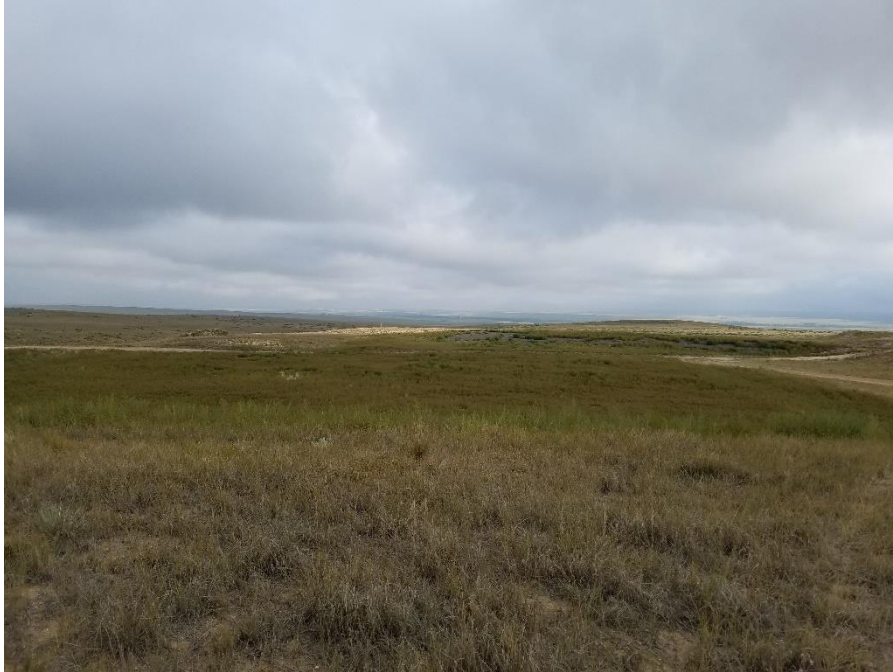
The Operator is excavating material on the north and east side of the current permit area. Previous mining to the west of the current excavation area consists of a shallow pit with a gentle pit floor. The north and south side slopes have been graded to a 3H:1V ratio or less and are relatively stable with annual vegetation primarily consisting of Kochia.

Figure 3. From the south central portion of the current permit boundary looking north.
Pit floor and north side slope visible.

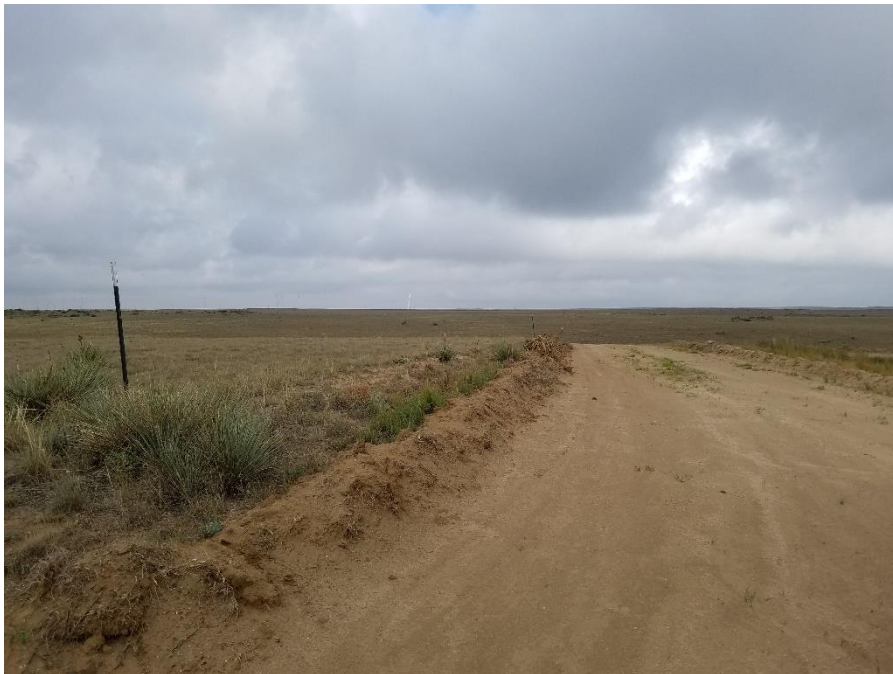
Figure 4. From the south central portion of the current permit boundary looking west.

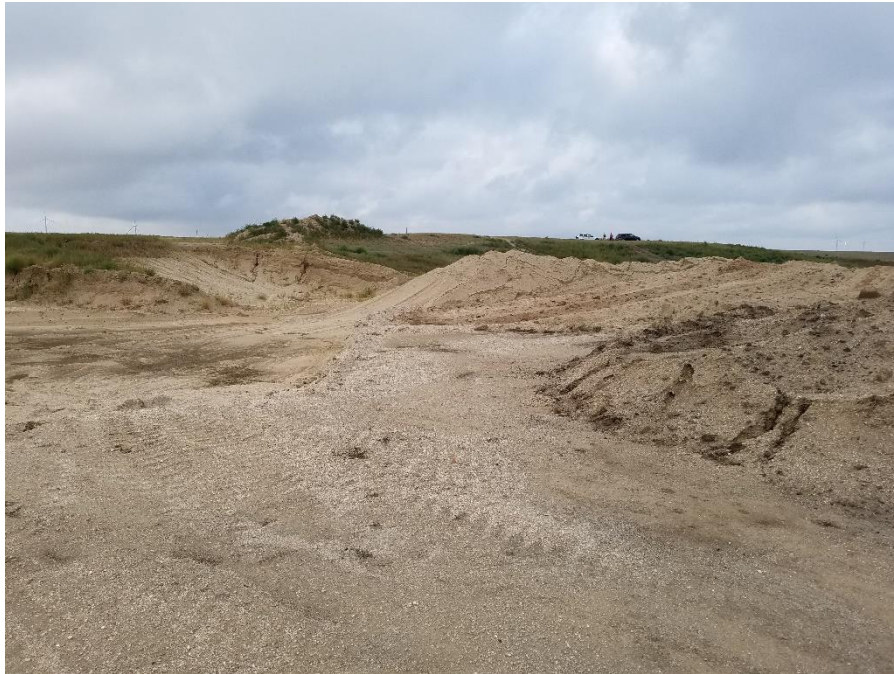
Figure 5. Eastern pit excavation.

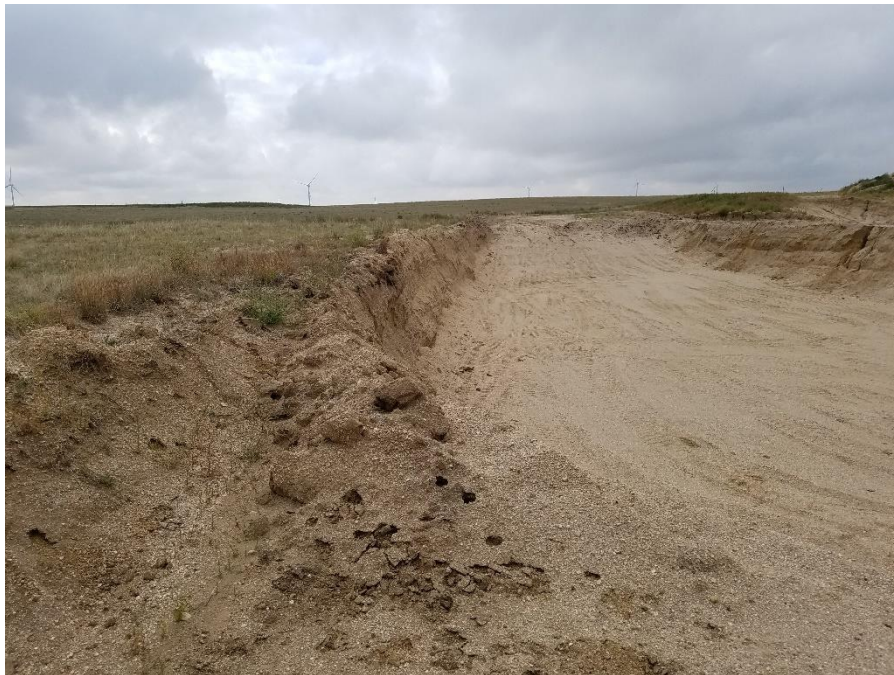
Figure 6. From the northeast corner of the current pit looking south.

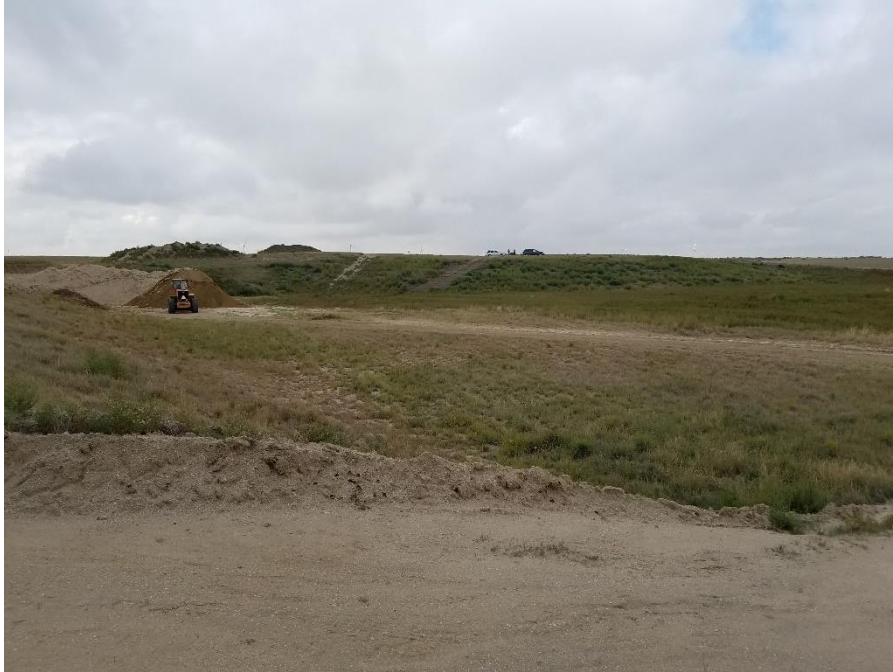
Figure 7. From the northcentral portion of the current permit boundary looking south.

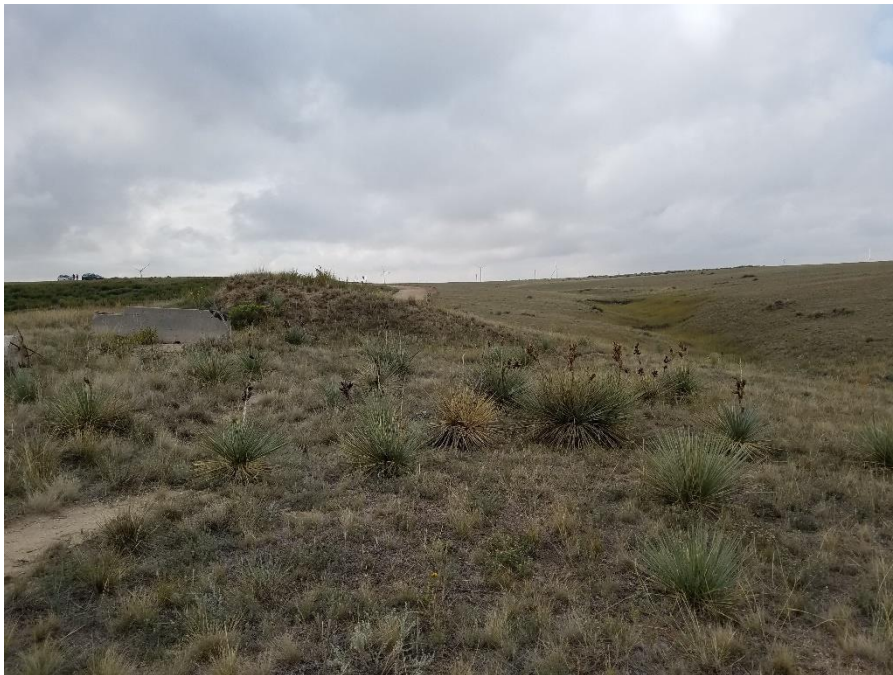
Figure 8. Drainage west of the current permit area looking south.

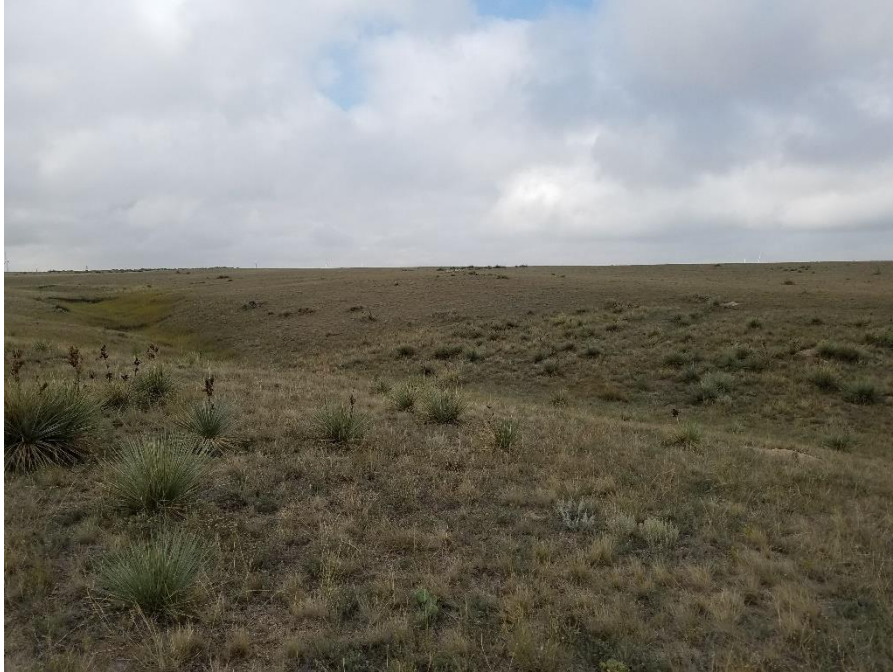
Figure 9. Drainage in-between the Phase 1 and Phase 2 mine area.

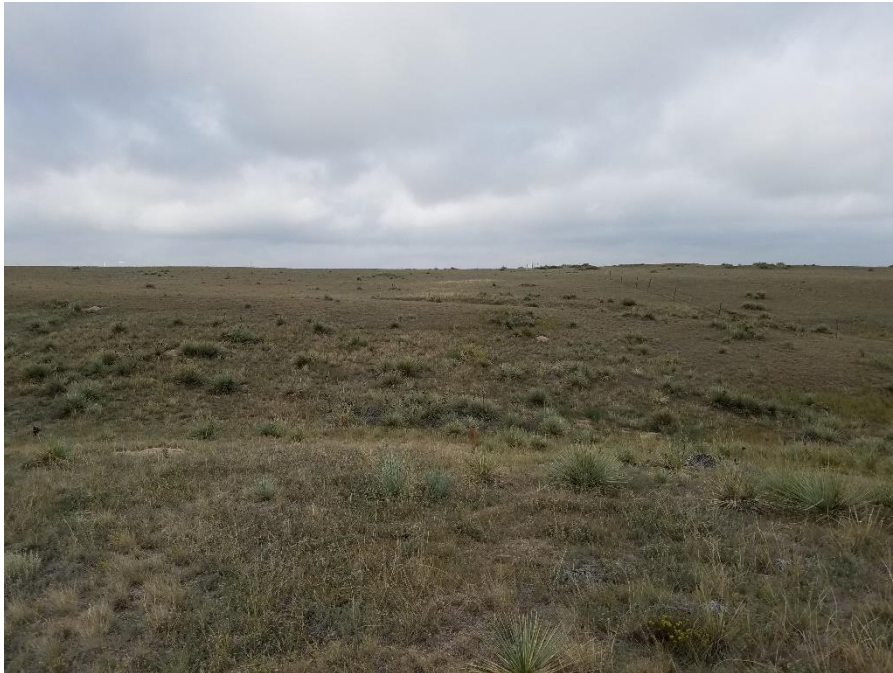
Figure 10. From the east side of the Phase 2 mine area looking west.
