**COLORADO**Division of Reclamation,
Mining and Safety

MINERALS PROGRAM INSPECTION REPORT**PHONE: (303) 866-3567**

MINE NAME: Deer Trail Pit	MINE/PROSPECTING ID#: M-1988-090	MINERAL: Sand and gravel	COUNTY: Arapahoe
INSPECTION TYPE: Monitoring	INSPECTOR(S): Jared L. Ebert	INSP. DATE: September 5, 2018	INSP. TIME: 10:00
OPERATOR: 5A Aggregate LLC	OPERATOR REPRESENTATIVE: None	TYPE OF OPERATION: 112c - Construction Regular Operation

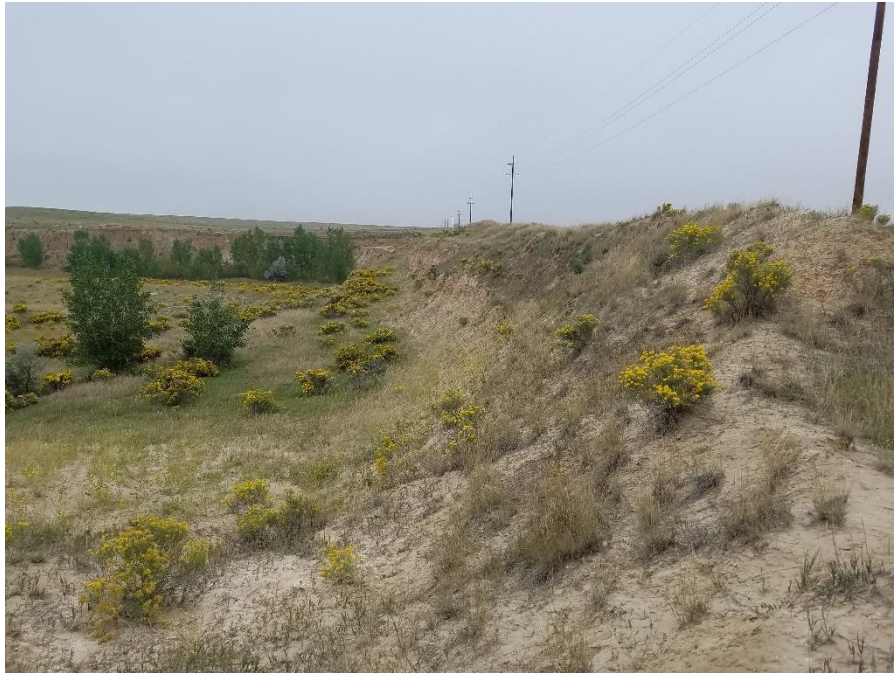
At this time, no reclamation of the land cited in the above problem has occurred. The highwall adjacent to County Road 213/Bartlett Road has not been backfilled and graded. Also no additional excavation work was noted. The mine identification sign was not posted. The Operator has failed to complete the corrective actions required.

Figure 1. From the northwest corner of the site looking south. Highwall along County Road 213/Bartlett Road

CORRECTIVE ACTIONS: Complete backfilling, grading, topsoiling and seeding in accordance with the approved plan on at least 6.8 acres of affected land. Mining appears to be complete within the affected area along County Road 213/Bartlett Road and this 6.8 acres shall include this area. By **December 31, 2018**, the Operator shall submit a written notice, photographic documentation and a map documenting the completion of the earthwork portion of the reclamation. By **March 29, 2019** the Operator will seed the site in accordance with the approved reclamation plan. By this date the Operator shall submit evidence this work has been completed, this can include an invoice from a contractor completing the work and/or receipts for the seed and photographic evidence this activity has been completed.

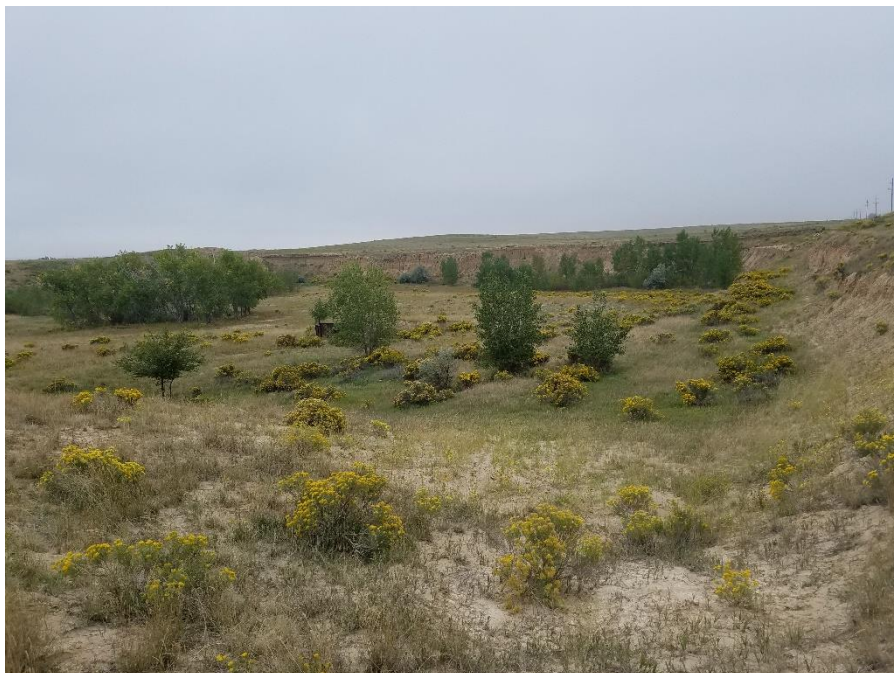
Figure 2. From the northwest corner of the site looking southeast.

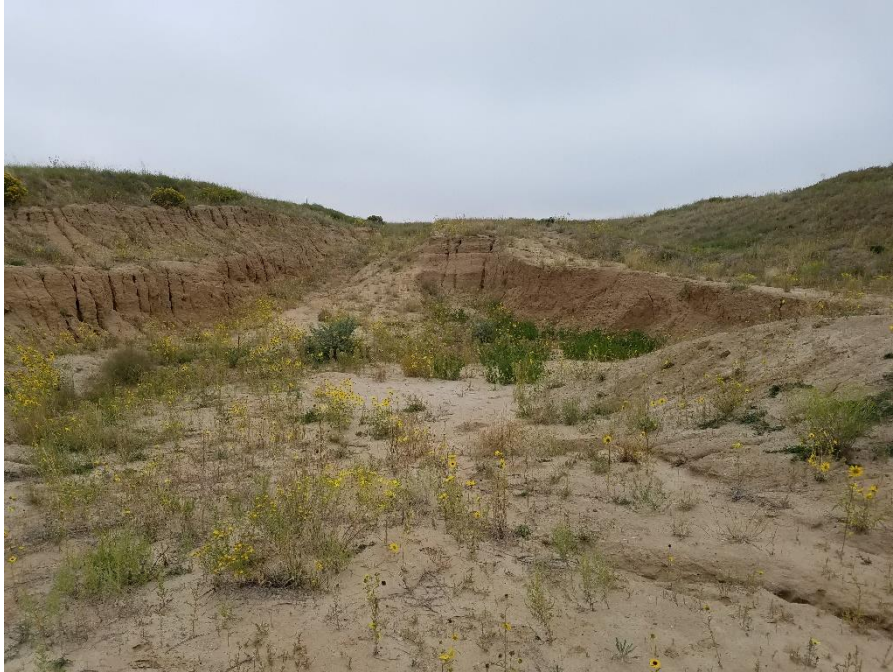
Figure 3. Most recent excavation in southeast corner.

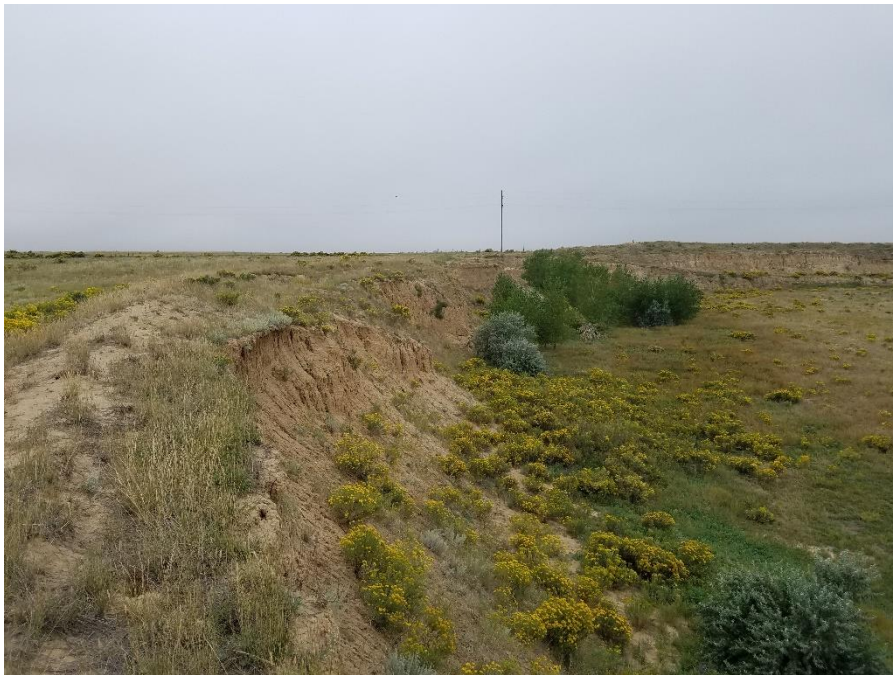
Figure 4. From the southeast corner of the site looking west.
