MINERALS PROGRAM INSPECTION REPORT**PHONE: (303) 866-3567**

MINE NAME: Sand Creek Mine	MINE/PROSPECTING ID#: M-1992-038	MINERAL: Sand	COUNTY: Adams
INSPECTION TYPE: Monitoring	INSPECTOR(S): Jared L. Ebert	INSP. DATE: September 5, 2018	INSP. TIME: 11:10
OPERATOR: Jones Fine Sand	OPERATOR REPRESENTATIVE: Daren Palizzi	TYPE OF OPERATION: 112c - Construction Regular Operation	
REASON FOR INSPECTION: Normal I&E Program	BOND CALCULATION TYPE: Complete Bond	BOND AMOUNT: \$7,210.00	
DATE OF COMPLAINT: NA	POST INSP. CONTACTS: None	JOINT INSP. AGENCY: None	
WEATHER: Cloudy	INSPECTOR'S SIGNATURE:

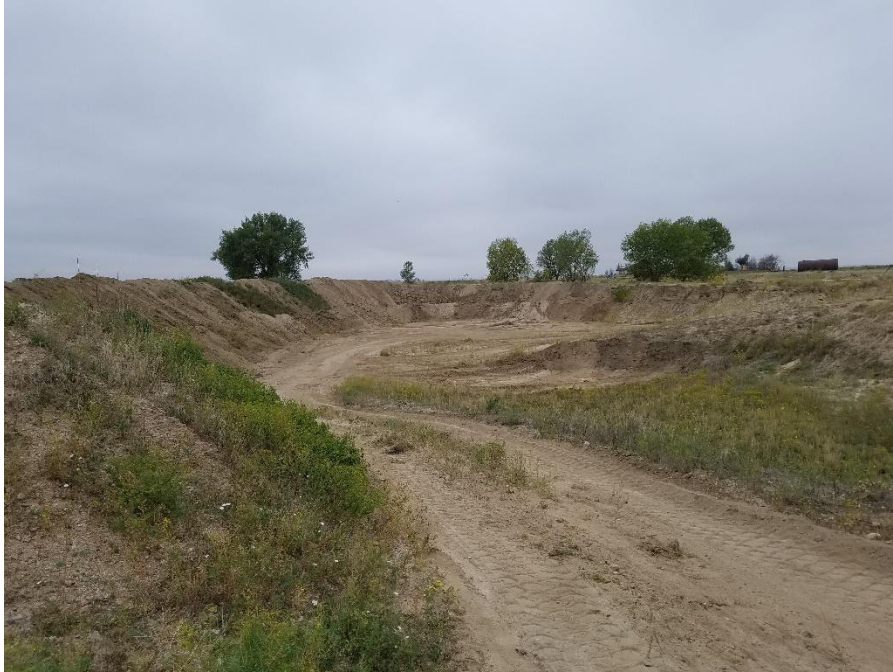
The active mine area is depicted on the latest annual report map received by the Division on August 28, 2018. A small area is backfilled at the south end of the current pit excavation that exists outside of the creek channel.

Two pit excavations are occurring at the site, one is located outside of the creek channel near the southwest corner of the site. The other is located within the creek channel north of the entrance to the site. Both pits were dry at the time of the inspection.

Figure 1. Small pit area, outside of creek channel located at the southwest corner of the site.

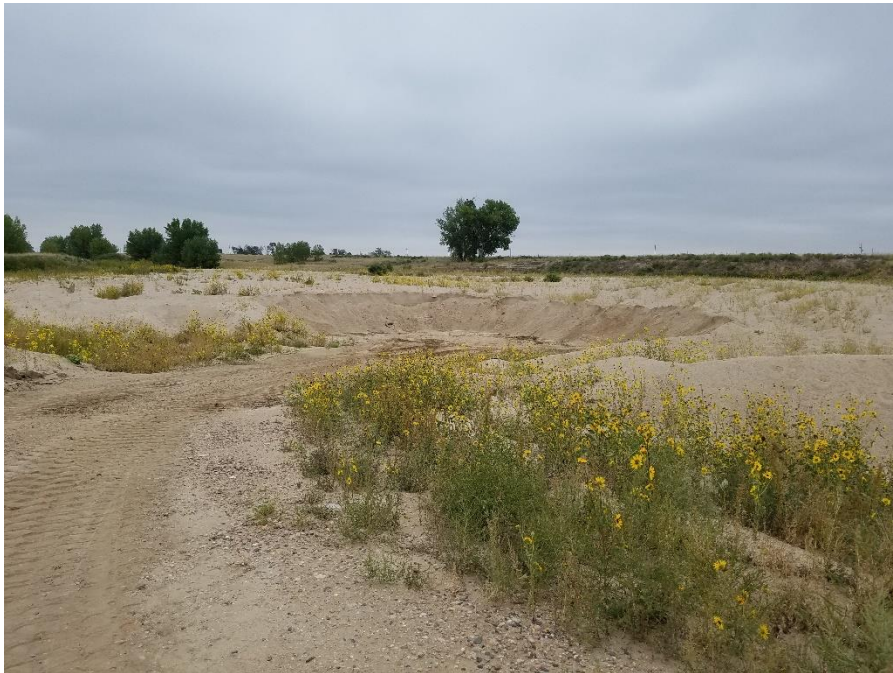
Figure 2. Small pit within the creek channel, located north of the entrance.

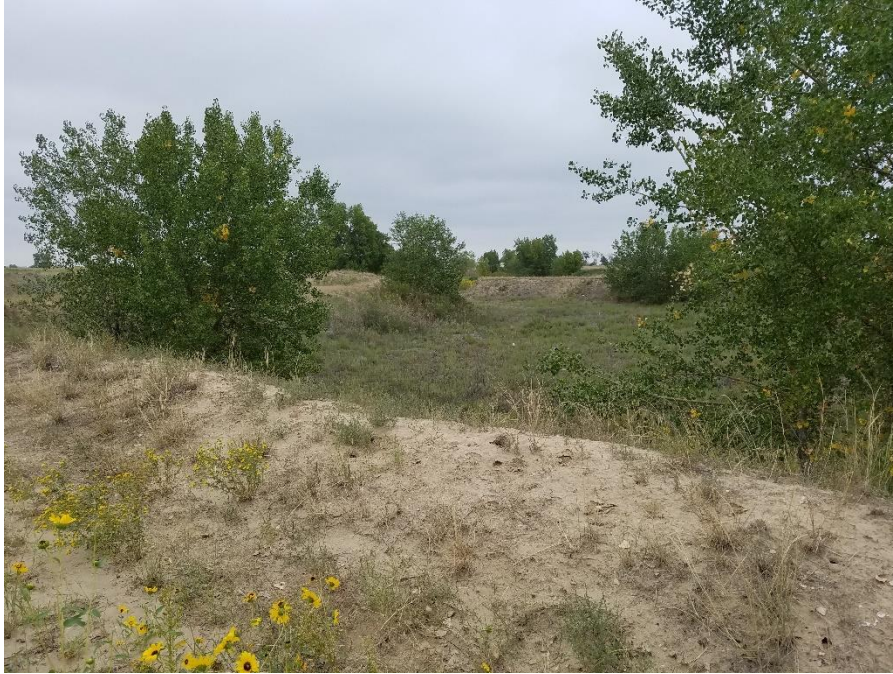
Mining appears to have occurred throughout the southern half of the site over the life of the mine. Previous mining appears to have been largely conducted in the creek channel with the exception of several small pits north of the current excavated area. Mr. Palizzi indicated the previous operator had used these small pits as wash ponds. Previous mining within the creek channel area is nearly undetectable as storms throughout the last several years has filled previous excavations with sediment. The former wash pond areas appear stable and have largely been revegetated with grasses and forbs.

Figure 3. Former wash basin area.

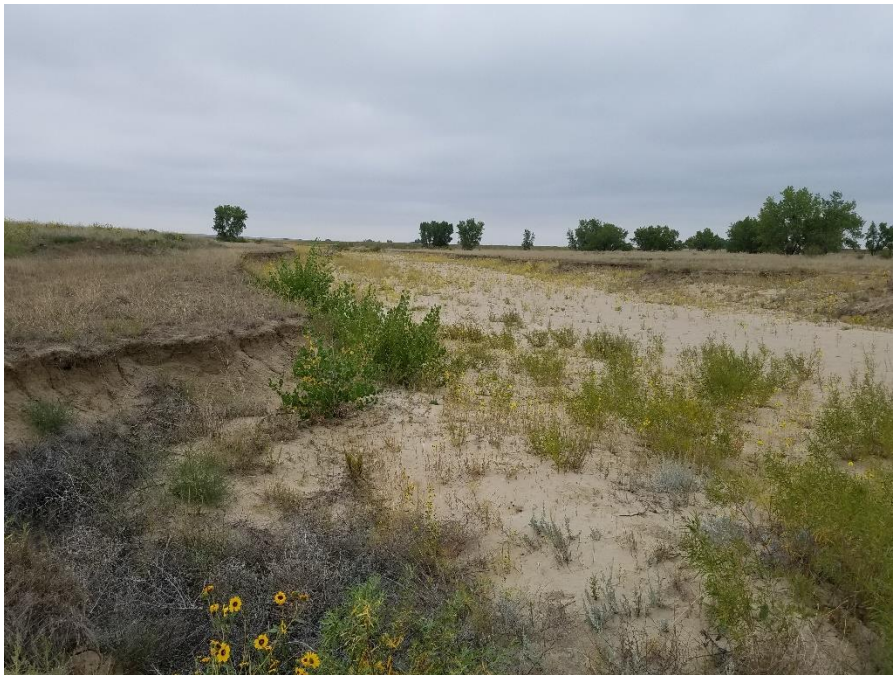
The majority of the affected land that has been affected north of the current disturbed area was observed. This area blends in well with the surrounding area and has vegetation established similar to unaffected land surrounding it.

Figure 4. Creek channel north of the current affected area.
