MINERALS PROGRAM INSPECTION REPORT
PHONE: (303) 866-3567

MINE NAME: Mid-Continent LST	MINE/PROSPECTING ID#: M-1982-121	MINERAL: Limestone (general)	COUNTY: Garfield
INSPECTION TYPE: Monitoring	INSPECTOR(S): Amy C. Yeldell	INSP. DATE: August 28, 2018	INSP. TIME: 10:45
OPERATOR: RMR Aggregates, Inc.	OPERATOR REPRESENTATIVE: Robert Wagner	TYPE OF OPERATION: 112c - Construction Regular Operation	
REASON FOR INSPECTION: Normal I&E Program	BOND CALCULATION TYPE: None	BOND AMOUNT: \$222,081.00	
DATE OF COMPLAINT: NA	POST INSP. CONTACTS: None	JOINT INSP. AGENCY: U.S.BLM	
WEATHER: Clear	INSPECTOR'S SIGNATURE:

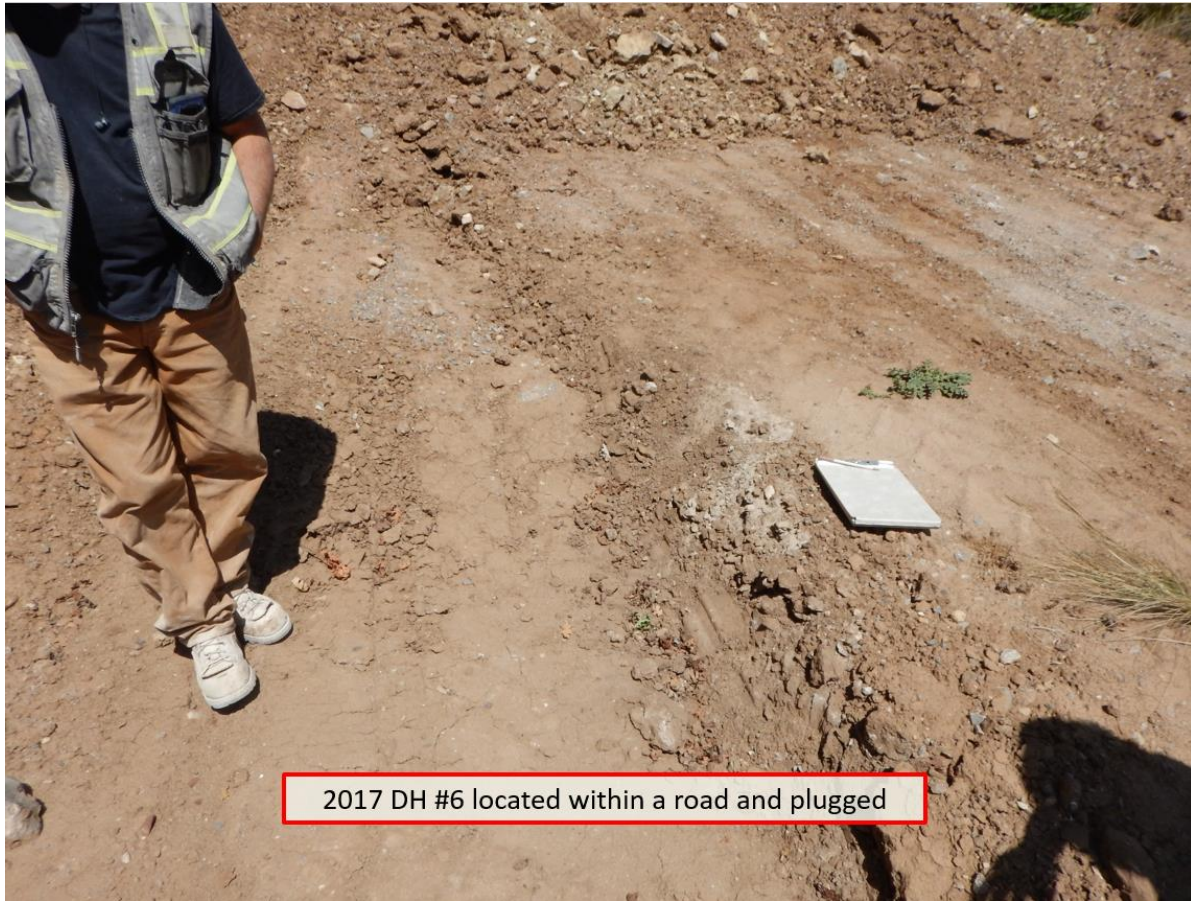
A couple of the 2017 drill holes were inspected. Several of the holes were within the active mine bench and have been re-disturbed and mine through (drill holes #1-4). Drill holes #5 and #6 are to the east of the mine benches. Both holes were located on a pre-existing road. The drill holes were plugged and abandoned. Excess drill cuttings were graded and only the color variation in rock/soil was evident. Neither hole has resulted in an additional reclamation impact. These disturbances will be fully reclaimed along with the rest of the project. None of the additional drill holes permitted under TR-5 have taken place yet.

2017 DH #6 located within a road and plugged

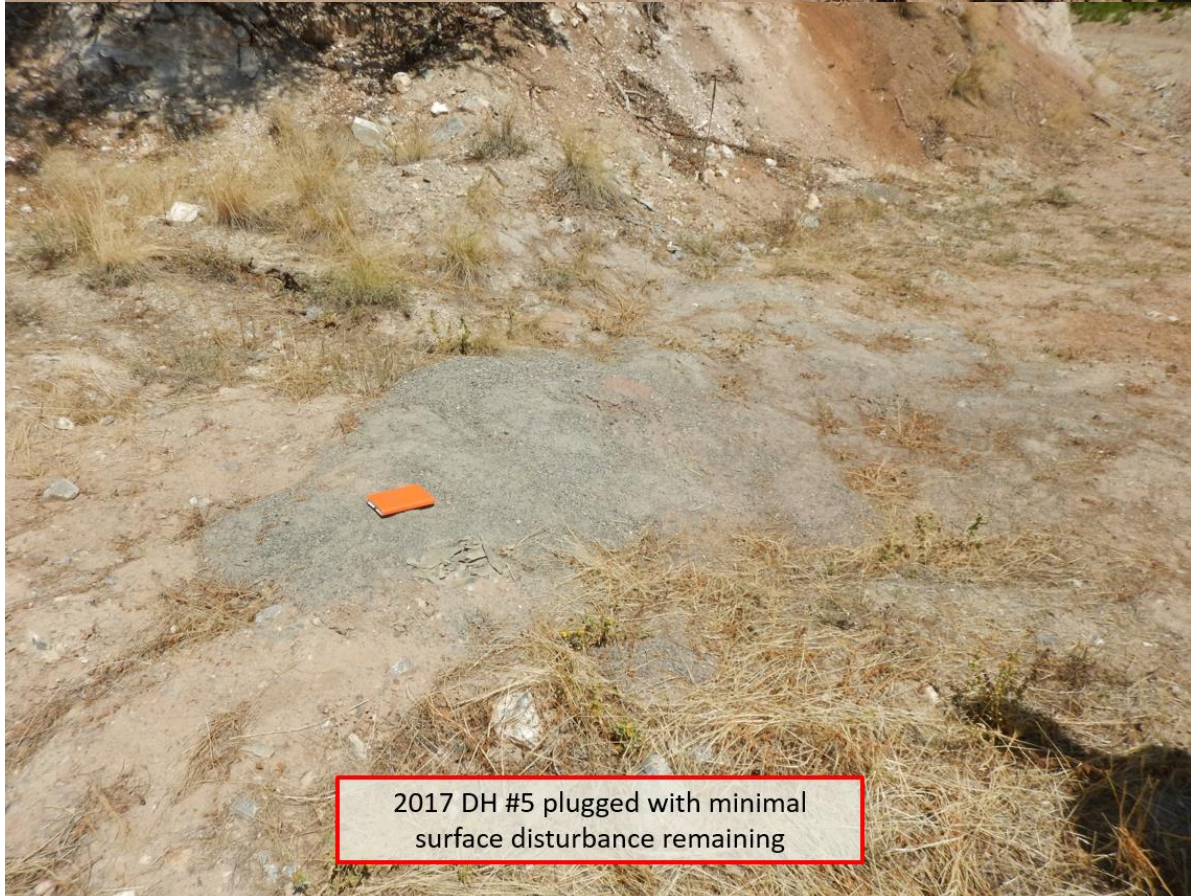
2017 DH #5 plugged with minimal
surface disturbance remaining
